Site Visit Report Form

FTR # 383 QR

Program (JSEP or SKEP): SKEP III Package I
School Name: Khadija Bint Khwailed Basic Mixed
Supervisory Engineer (SE): Medanat Consultant Engineers
Construction Contractor (CC): Derar Al Saraireh & Sons
Date and Time of Field Trip: May 19th, 2021
Date of Report: May 23rd, 2021
Weather During Visit: Sunny 32°
Prepared By: Abedalaziz Abu wandi CMTO/Trigon
Submitted By: Osama Obeid CMTO/Trigon

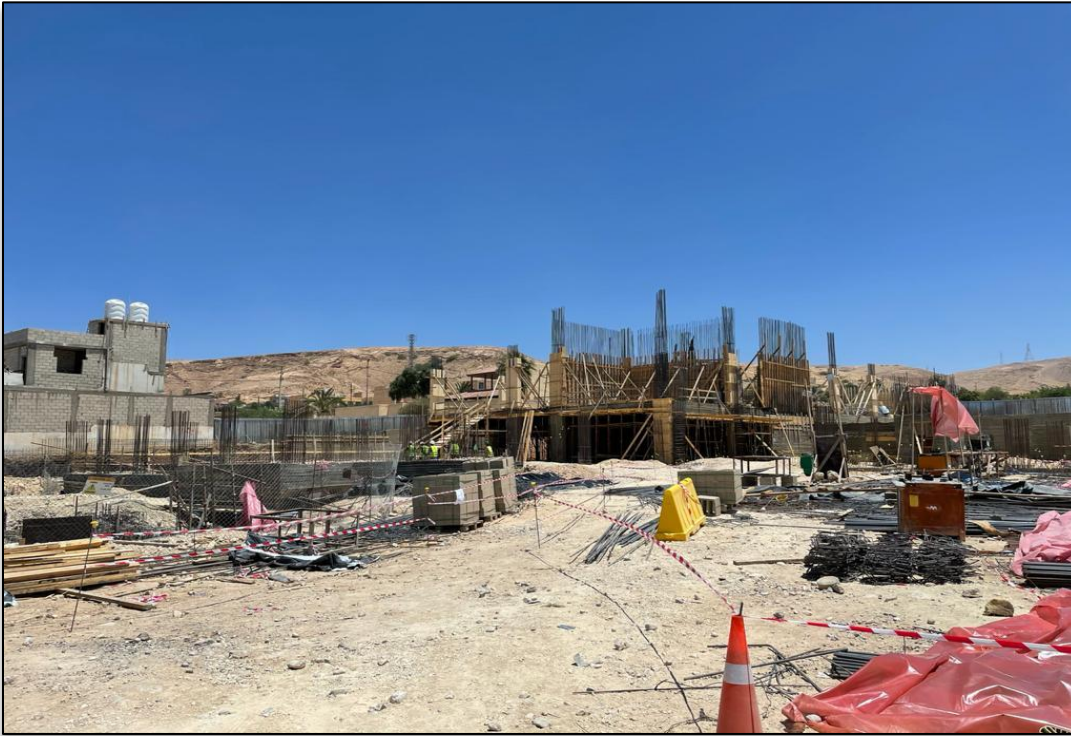
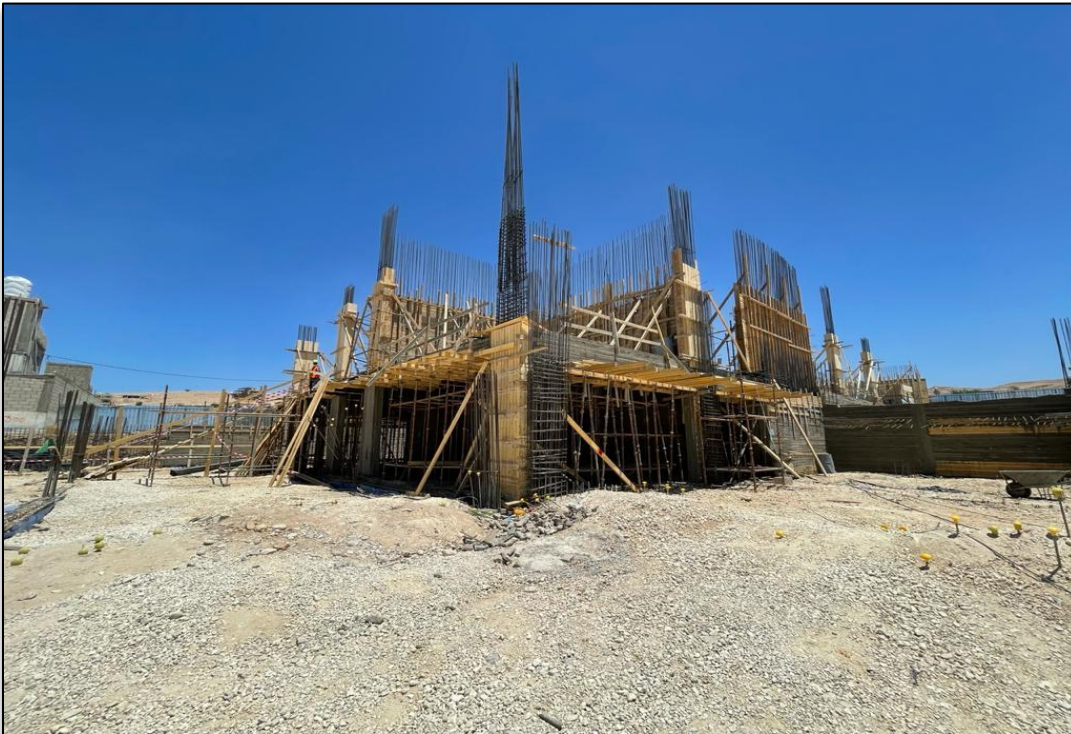
Figure 1&2 : Construction site and main ongoing activities

The new School will be a 5362 sq.m, 4-storey building and will consist of 22 classrooms, 4 KGs and 1 for special need. The school will service up to 928 Students, starting from KG2 to 10th grade

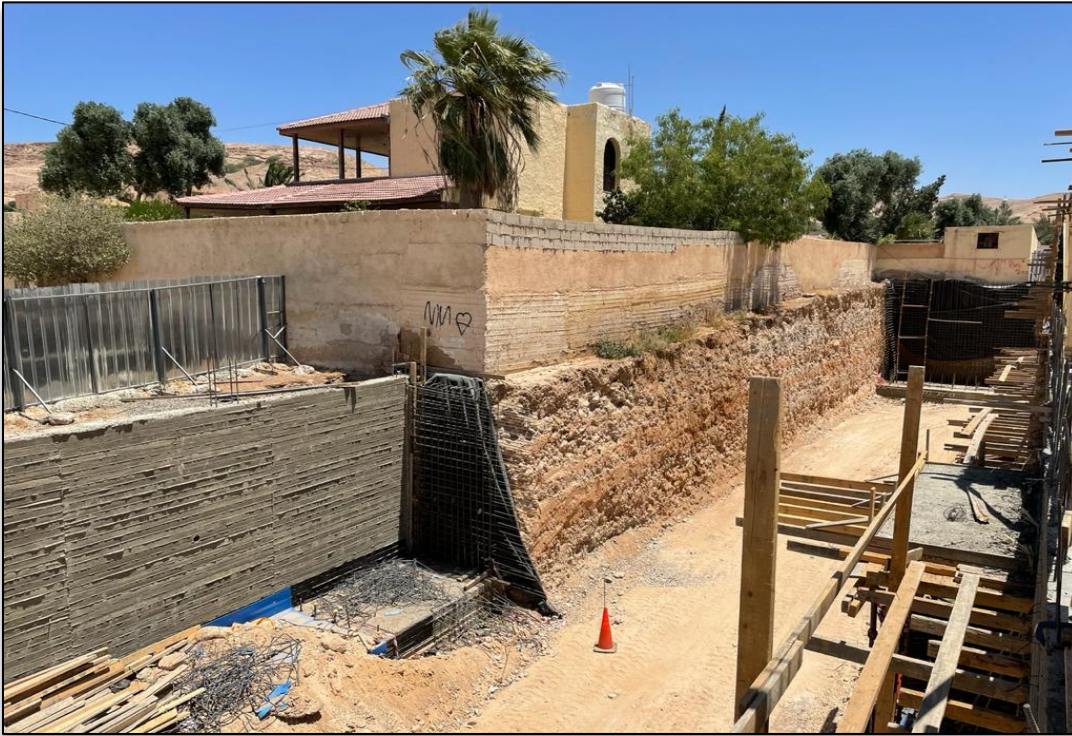
Figure 3: Neighbour's Boundary Wall

1. According to Medanat, physical progress has reached 22%, while planned progress is 26%,
2. The negative progress variance is caused from the delay in construction the boundary wall section adjacent to the neighbors building and the failing compaction tests of the basecourse fill material under the SOG for a section of the building,
3. The average number of labors working daily on site in the past week is 26.

Neighbors encroaching boundary wall issue is solved and the Contractor started the Boundary wall Construction

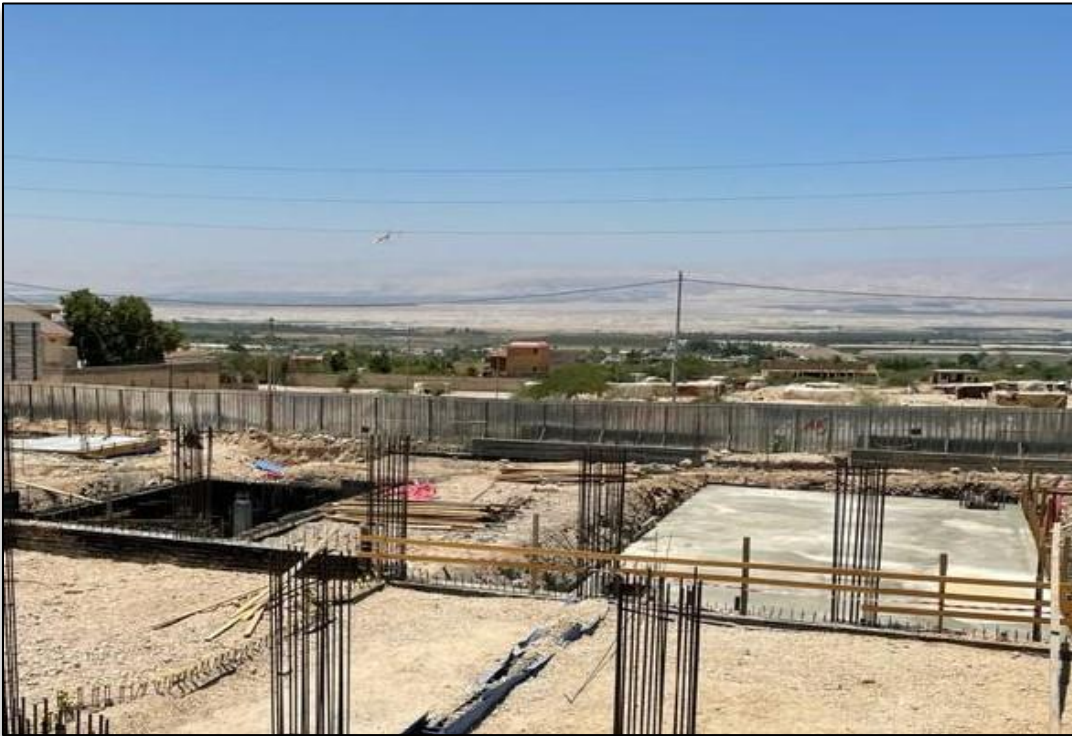
Figure 4: Water & Septic Tanks

Water and Septic tanks are constructed and are being waterproofed.

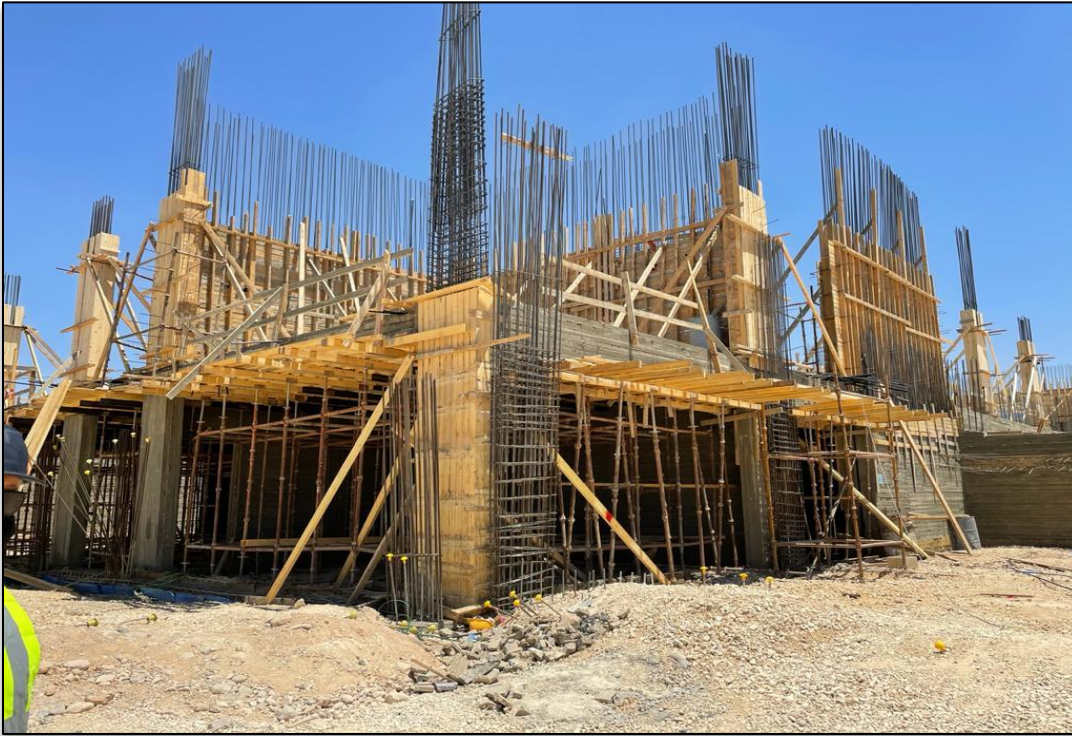
Figure 5: Section B is Progressing Ahead of the Other Building Sections

Reinforcement steel fixing and frameworks shuttering works are ongoing at section B.

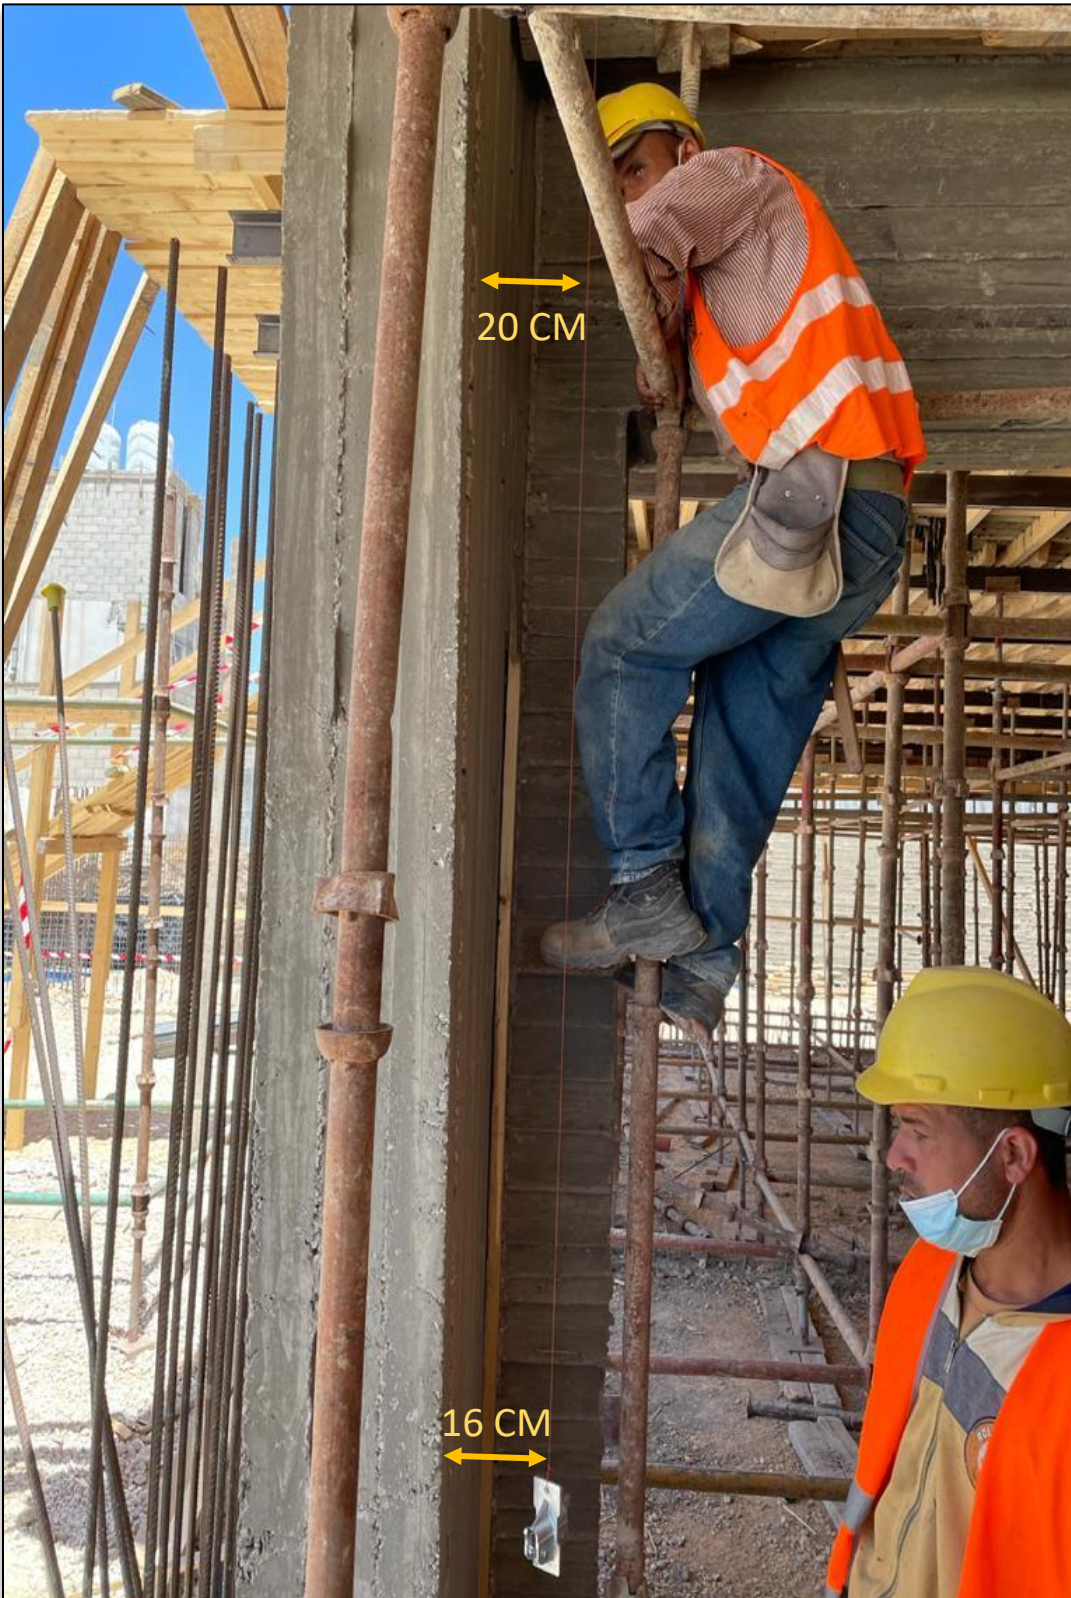
Figure 7: Measuring Column plumbness

1. One casted column was found seriously out of plumb and twisted, the plumb test showed a horizontal difference of 4-5 cm in a 3.5 m column, this column must be replaced/rectified,
2. Percentage of segregation in the new constructed elements are decreasing as better framework shuttering methods and materials are used, it can stand harder concrete vibrating,
3. Basecourse fill materials are continually failing compaction test, which is leading to significant delays on constructing the SOG and the following works for a considerable section of the site.

Column on the ground floor was found seriously out of plumb, the horizontal difference between the top of the column and the bottom is 4-5 cm, which is clearly out of allowable tolerances. The SE were asked to investigate the plumbness of this element and hold placing concrete in the columns above it.

D. SuperStructural, Concrete, Masonry works				
1	Columns	Y	Verticality problem / Out of Plumb	Must Be Replaced/Rectified
2	Beams			
3	Slabs			
4	Roof			
5	Hollow Concrete Block (internal)			
6	Hollow Concrete Block (external)			
7	C-Channel			
8	Clading Natural Stones			
9	Electrical conduits/ sleeves			
10	Mechanical pipes/sleeves

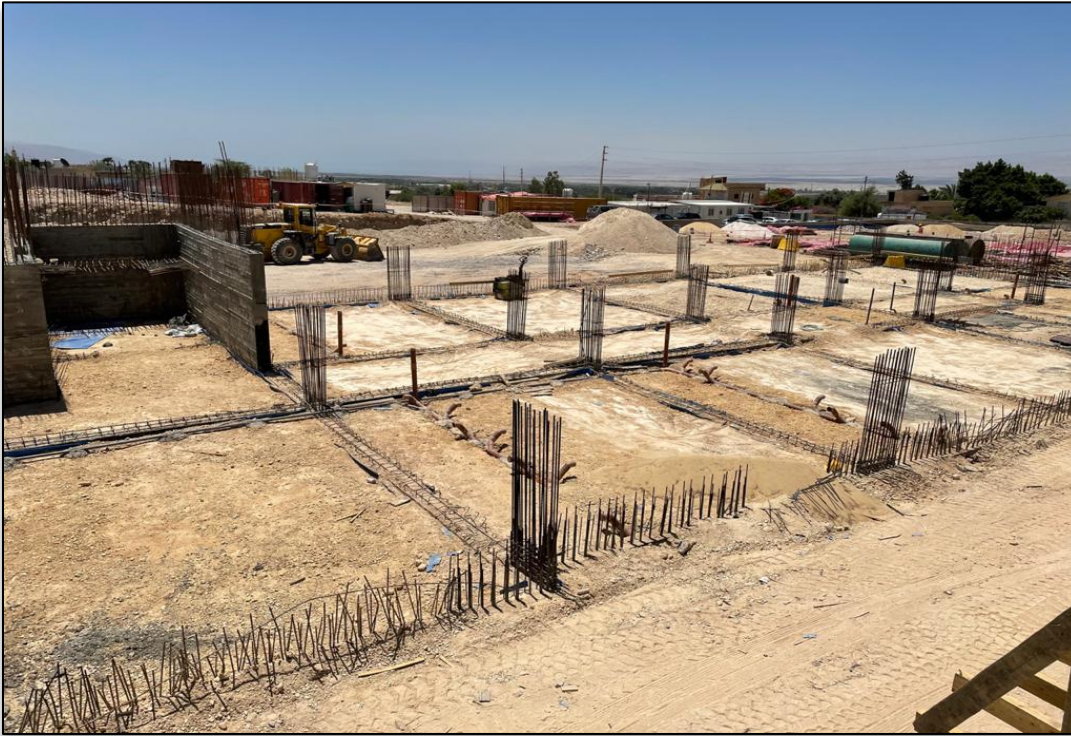
Figure 8: Unprogressive Construction Sections

The sections showed in the figure are not progressing due to the continually failing compaction tests of the fill materials under the SOG. This case has been ongoing for the 4 weeks and it is causing delays to the schedule

#	Task / Activity	Observations (Y/N)	Findings	Recommendations / Corrective Actions
A. Excavation				
B. Backfilling				
		Y	Fill Material Failing Compaction Tests	Better Quality of Material and Compaction Methods to be Used

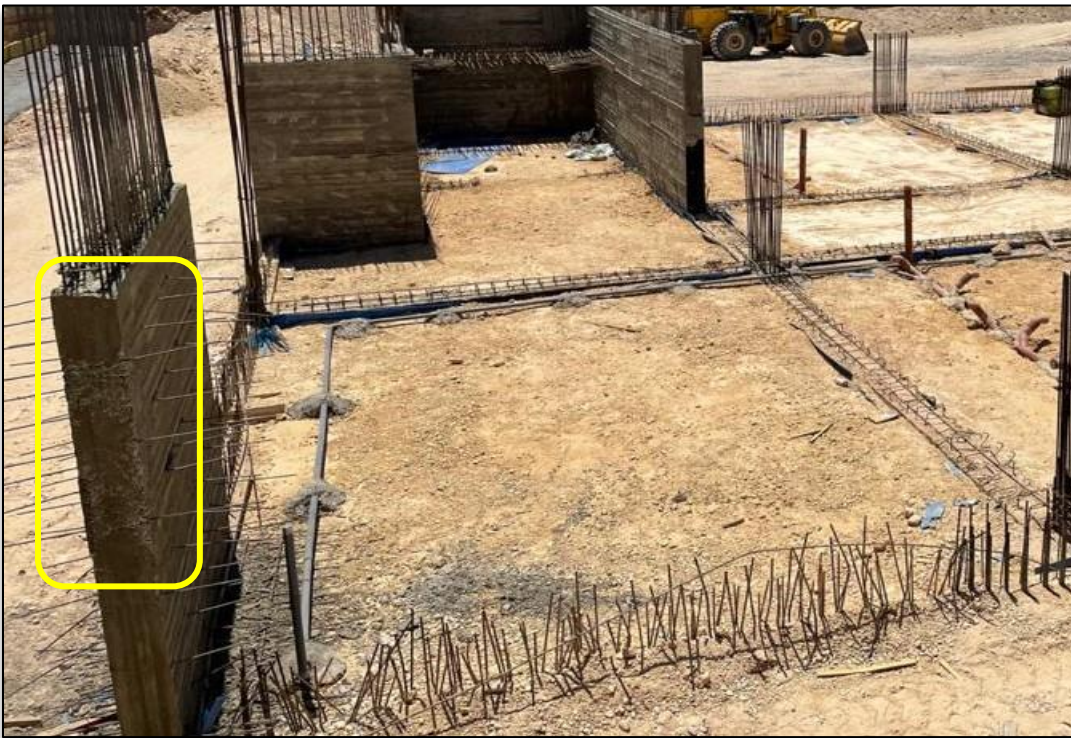
Figure 9: Concrete Segregation

Better quality of placing concrete was noticed during this visit, however minimal amount of segregation was observed

H. External Works				
1	Boundary walls	Y	Segregation Observed	Treated with Accepted Materials
2	C-Channel Finishings
