Quality Control Report

Consultant **Wahib Medanat** Consultant Engineers
Site Name Hay Al Iskan Basic mixed - Jerash
Package Package 2
Contractor Dijlah Est. Construction Co.
Tender No. 10/2019/USAID/SKEP/3/2

Rep No. QC-21 21
Date 15 / 06 / 2022

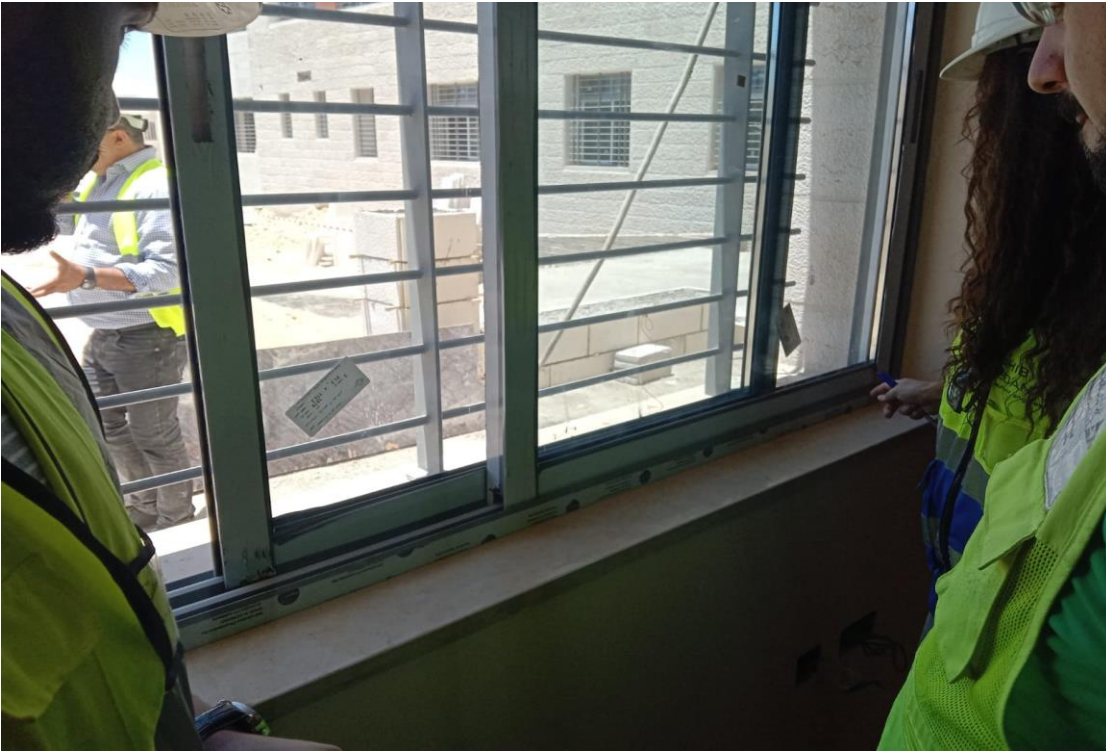
Discontinuity of aluminum rubber

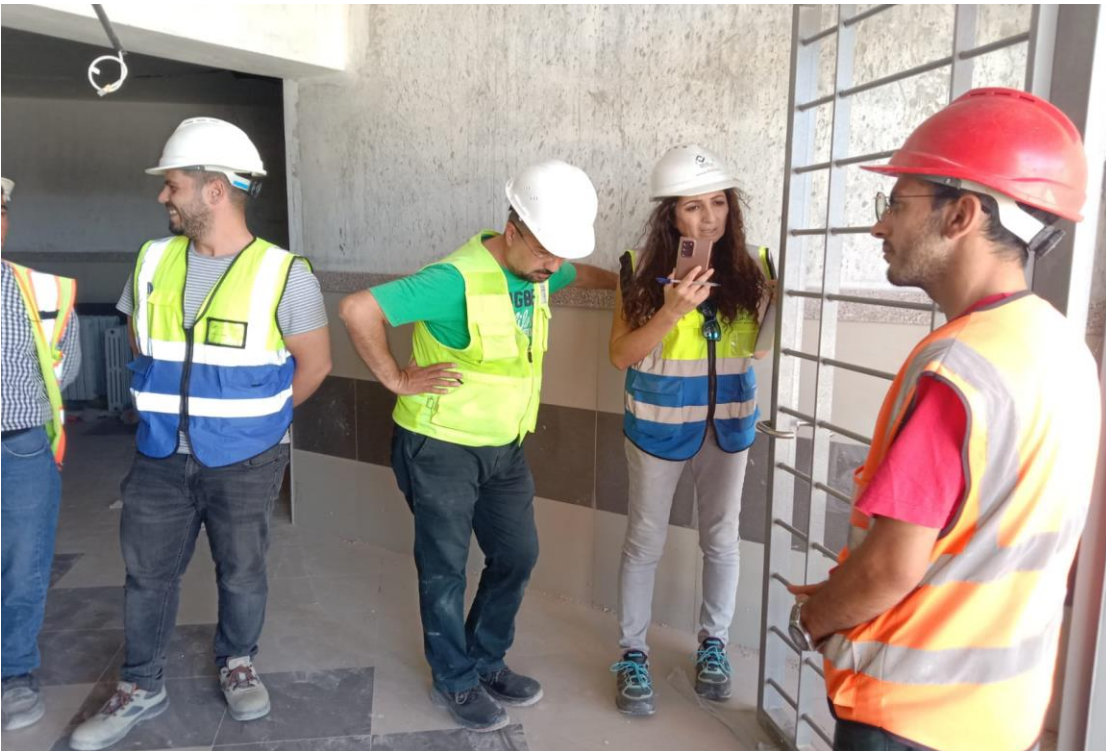
Door part does not comply with architectural details

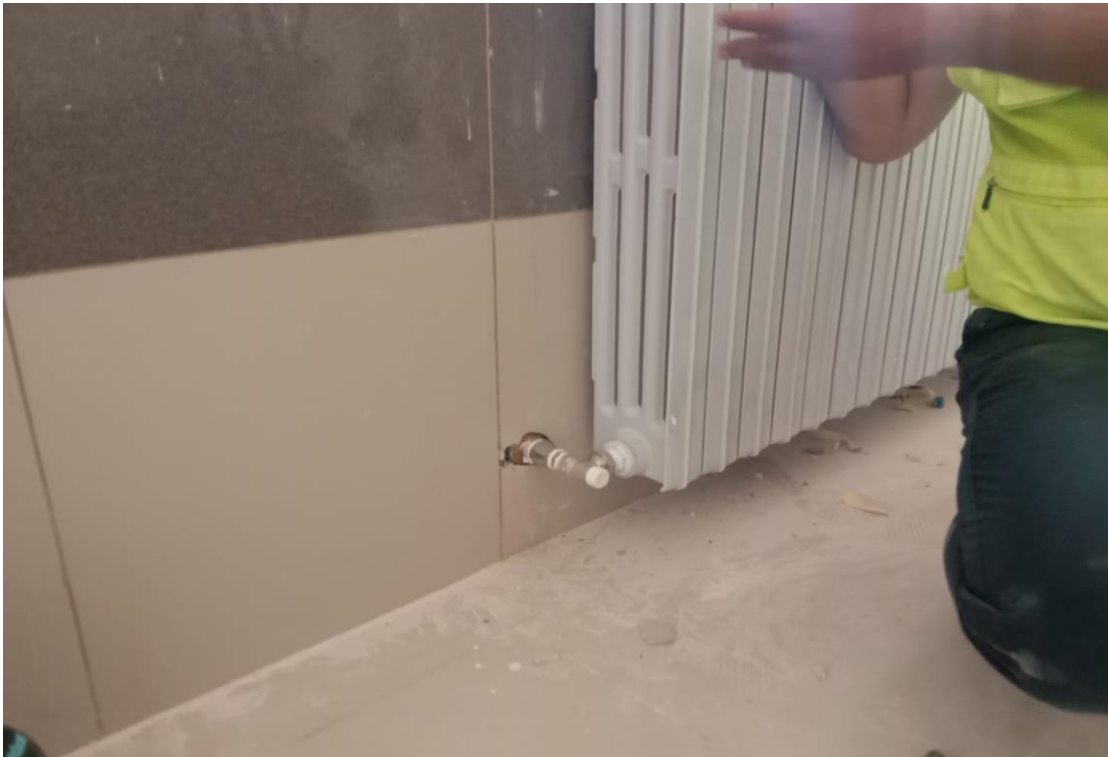
Broken tiles around the radiator connection
