SKEP III Home Office Support Site Visit Report

Consultant	Wahib Medanat Consultant Engineer	Rep No.	12-09052022
Contractor	Derar Saraireh & Sons for Engineering & Contracting	Tender No.	(11/2019/USAID/SKEP/3/S) Schools for a Knowledge Economy Project (SKEP) - Phase (3) Package (1, 2)
Site Name	Al Khansa' Basic Mixed School- Al Balqa	Day/ Date	Mon. 09/05/2022
Duration of Project	450 Calendar Days	Total Project Budget	9,789,417.840 JD

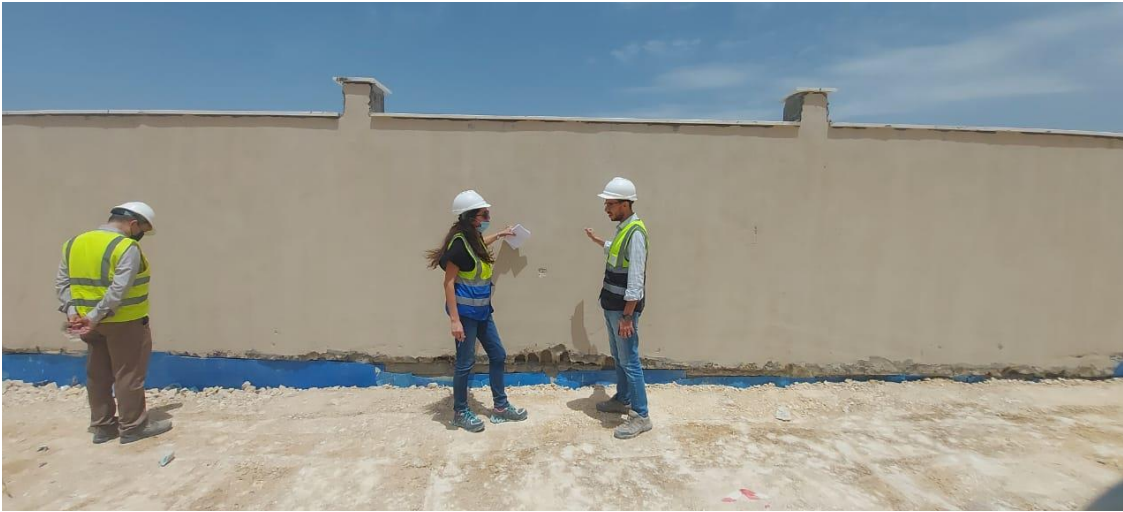
(Figure: 05)

Inspecting the external colored plastering sample for boundary walls

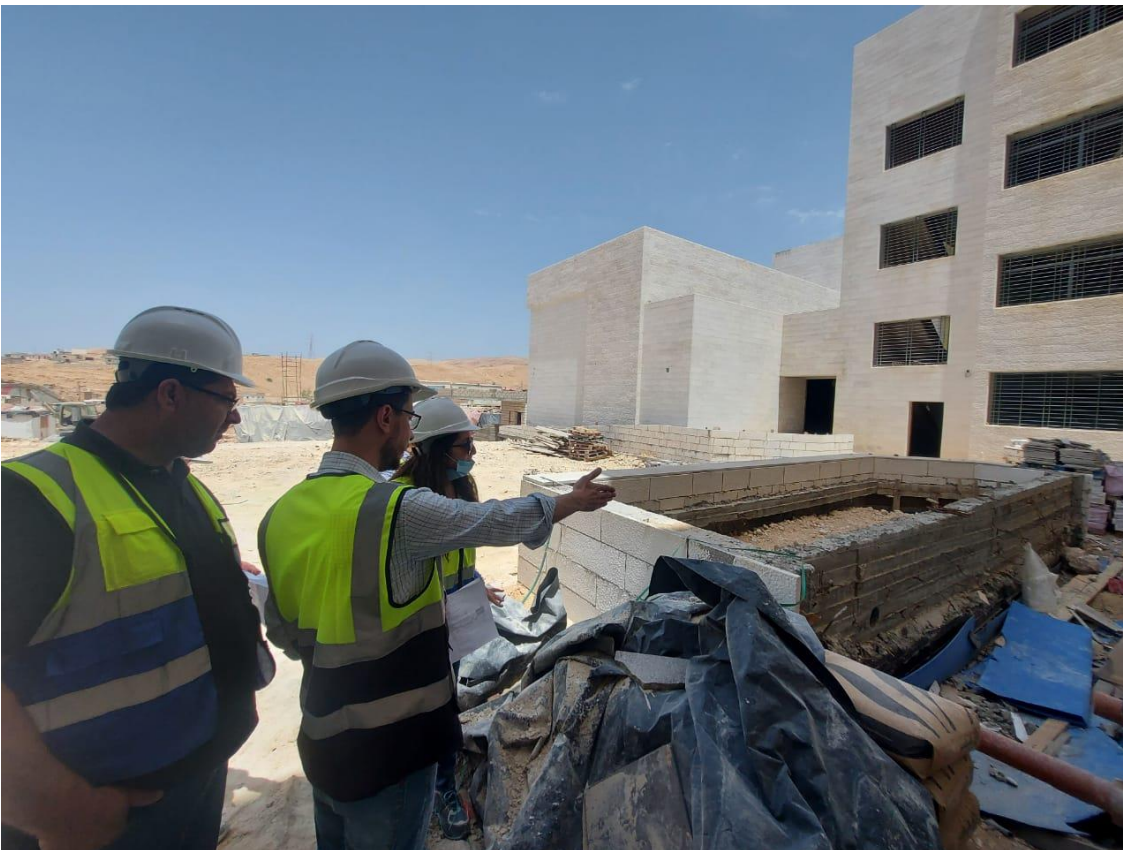
(Figure: 06)

The team discussed with the Contractor the details related to the execution work of the external ramp adjoining the main entrance and observed variation from the approved workshop drawings

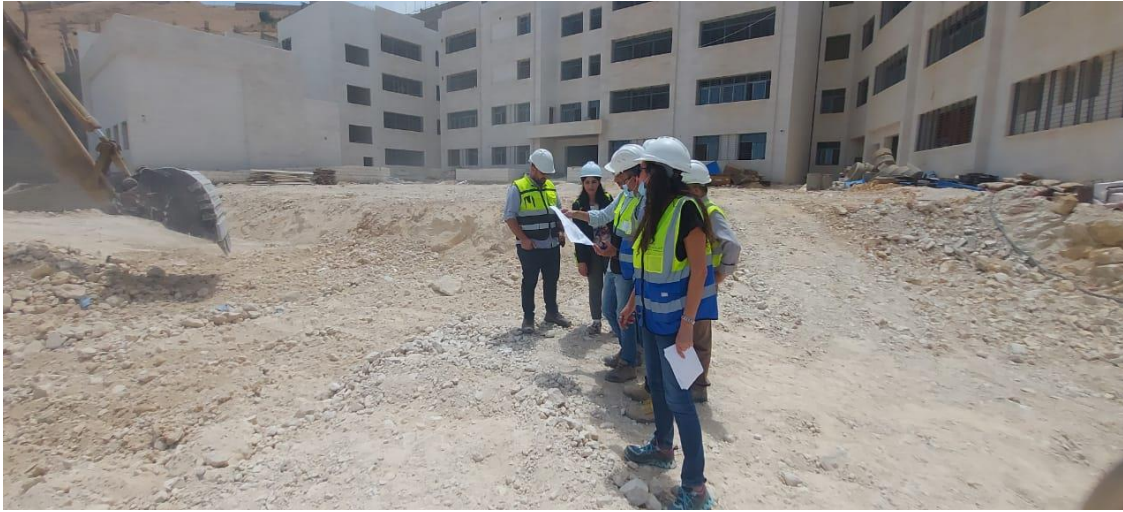
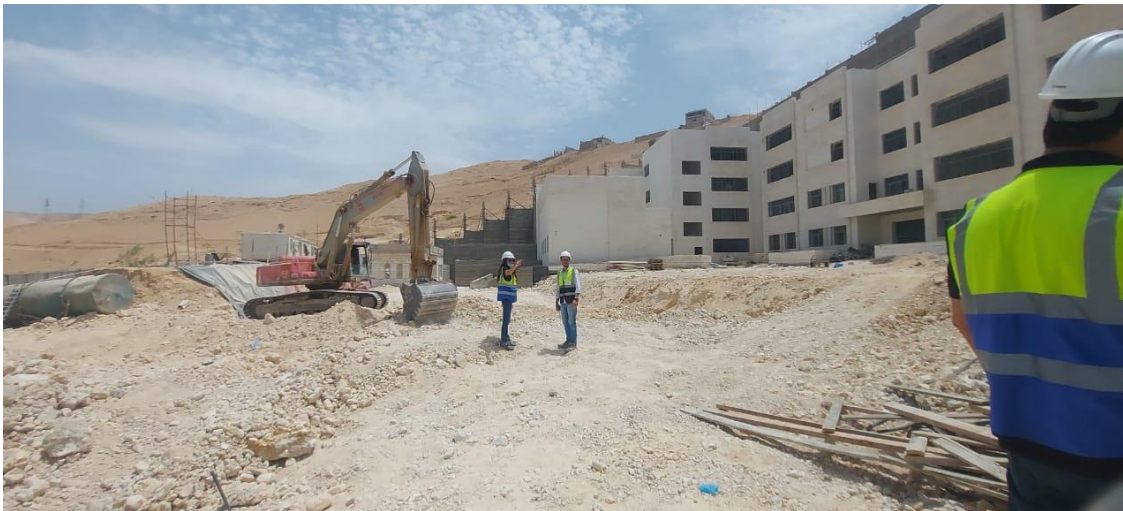
(Figure: 07 & 08)

The team inspected the current works in the excavations of the playing yard and the external wall

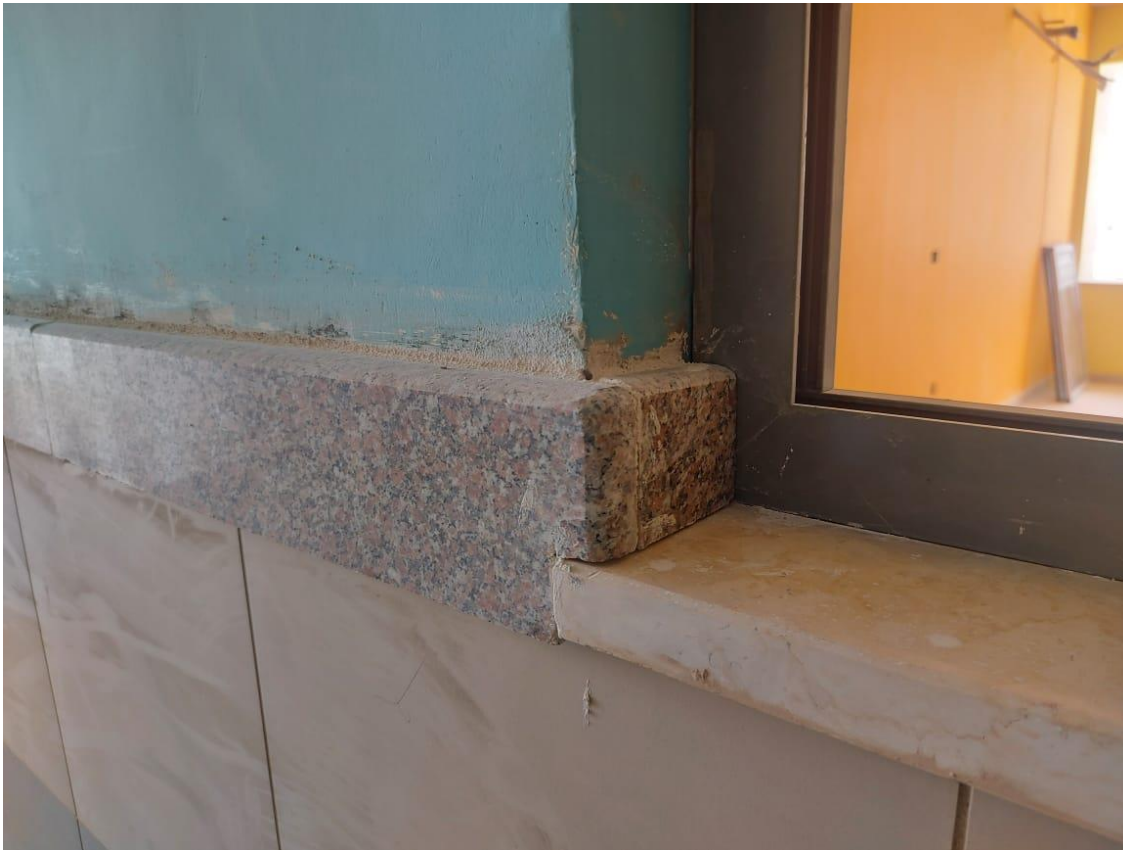
(Figure: 09)

The team inspected the sample prepared by the Contractor for the granite coping continuation at the window jamb and approved it

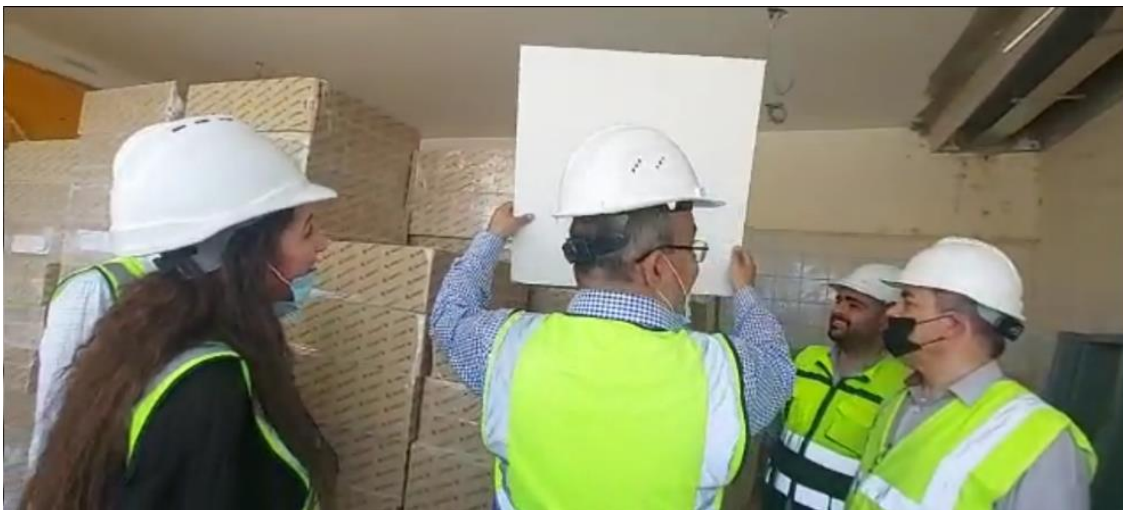
(Figure: 10)

Inspecting delivered quantities of acoustical gypsum tiles (60cm*60cm) and ensuring they comply with the approved sample

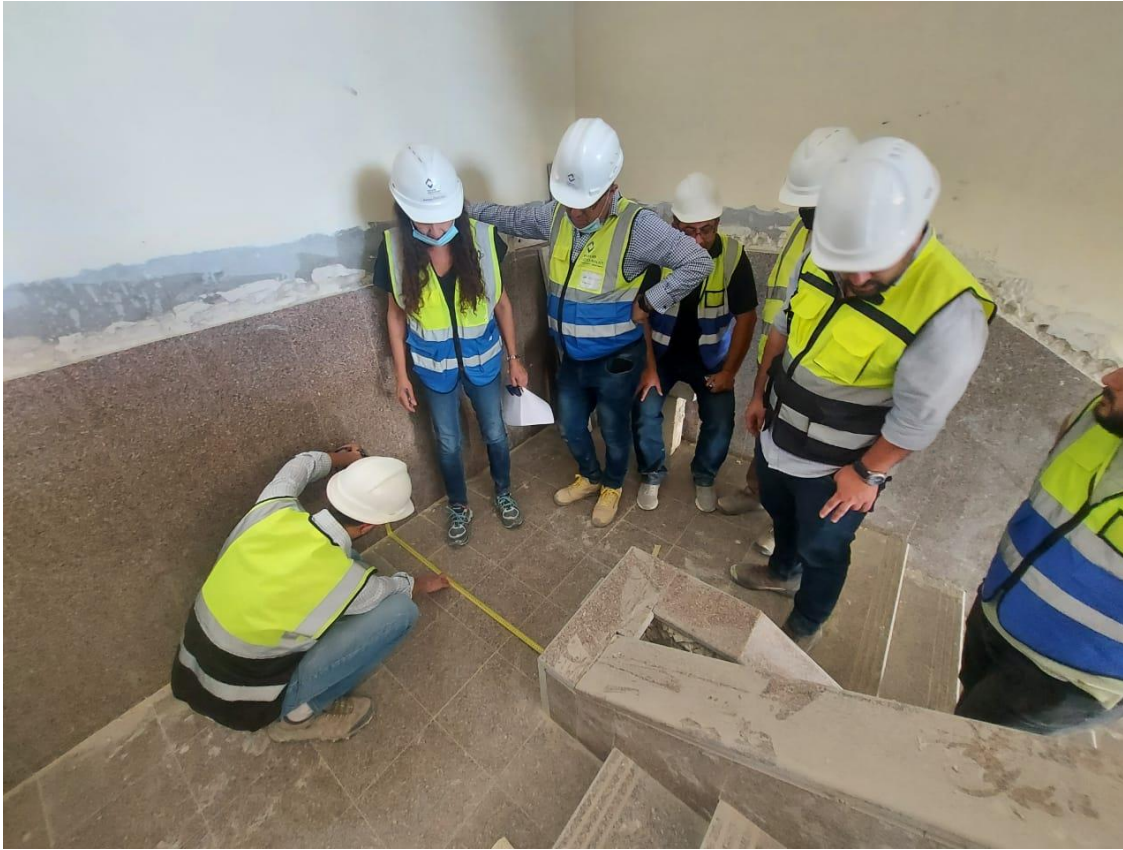
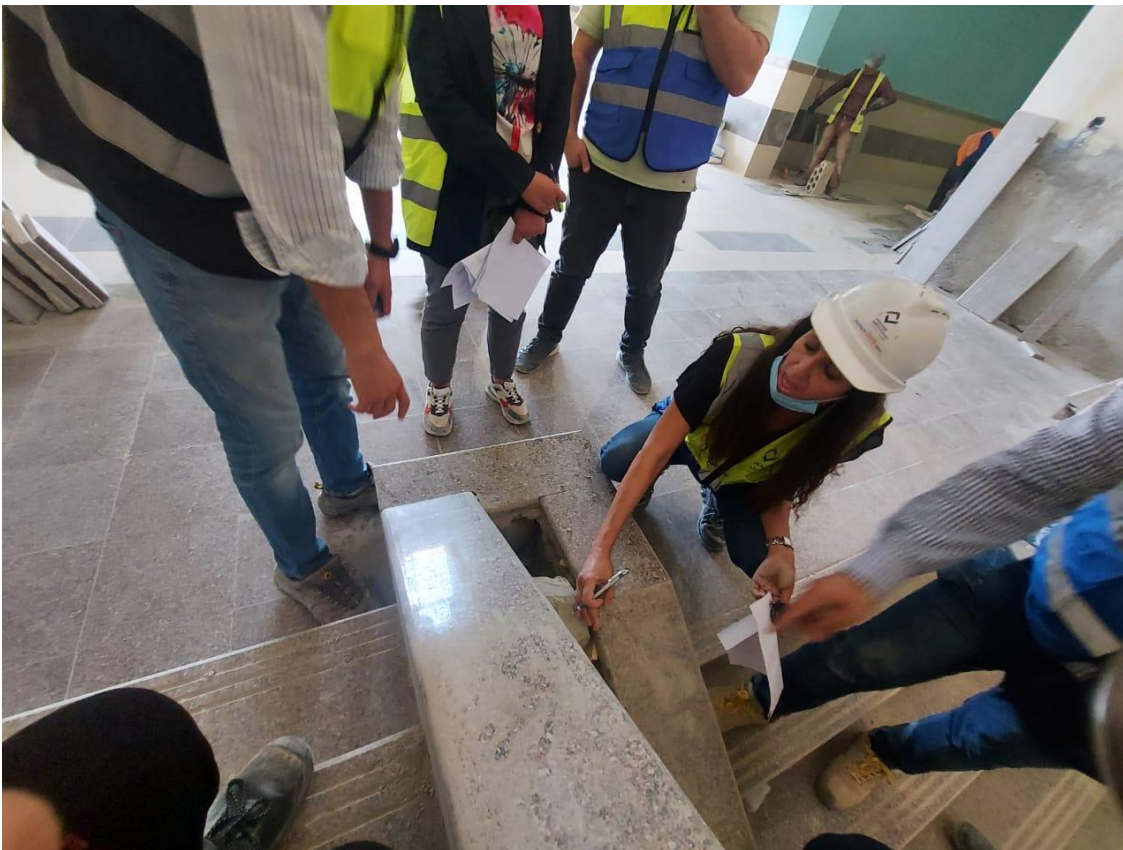
(Figure: 11 & 12)

The team discussed with the Contractor the details related to the staircases granite upstands and the connection between coping, staircase and handrail

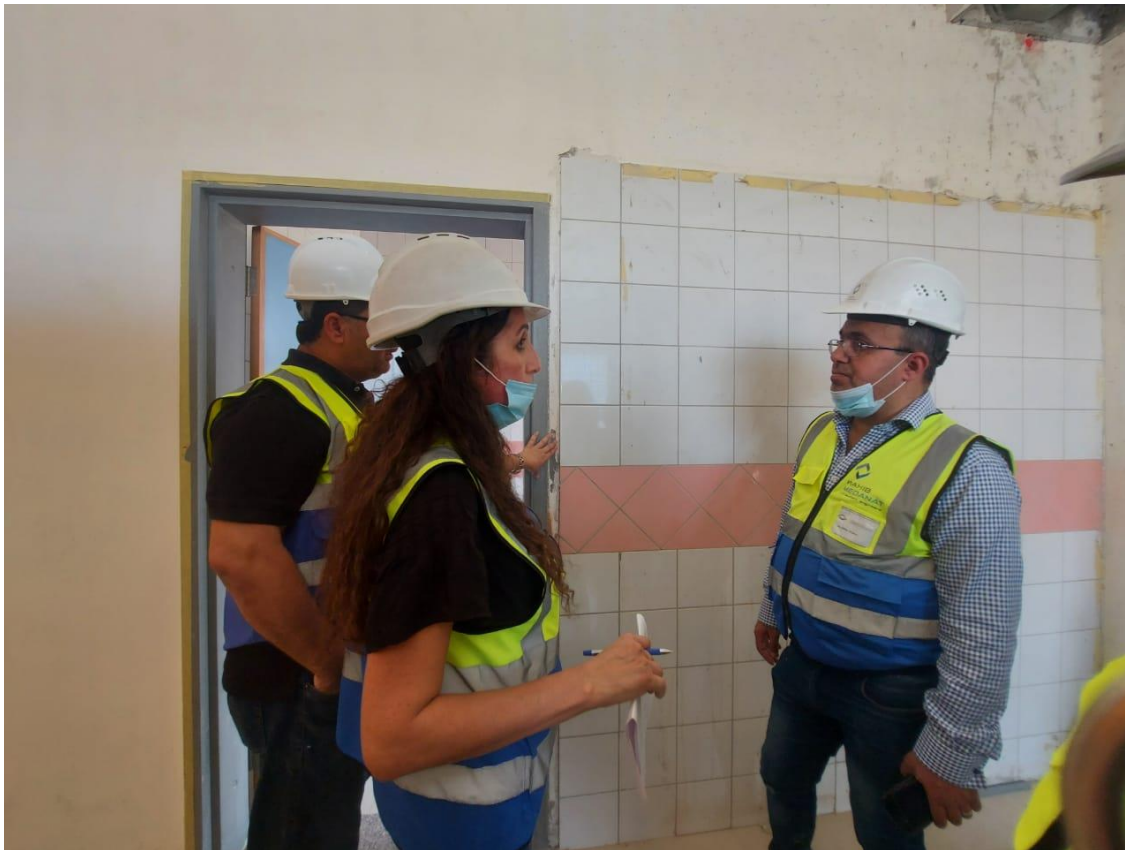
(Figure: 13)

The team inspected the wall tiles and the relation with the door frame at the child care at the (KG) area

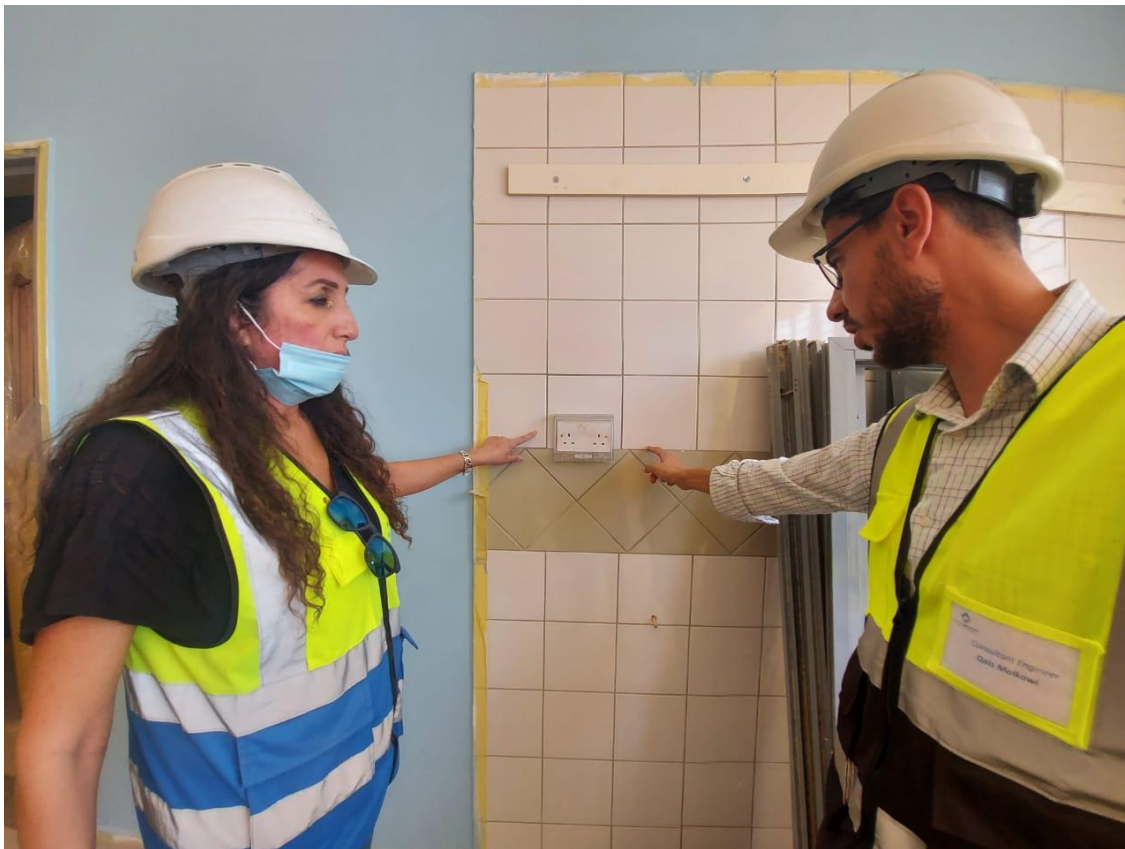
(Figure: 14)

The team inspected the installed sample of electrical socket with cover at the (KG) area and approved it based on the approved workshop drawings

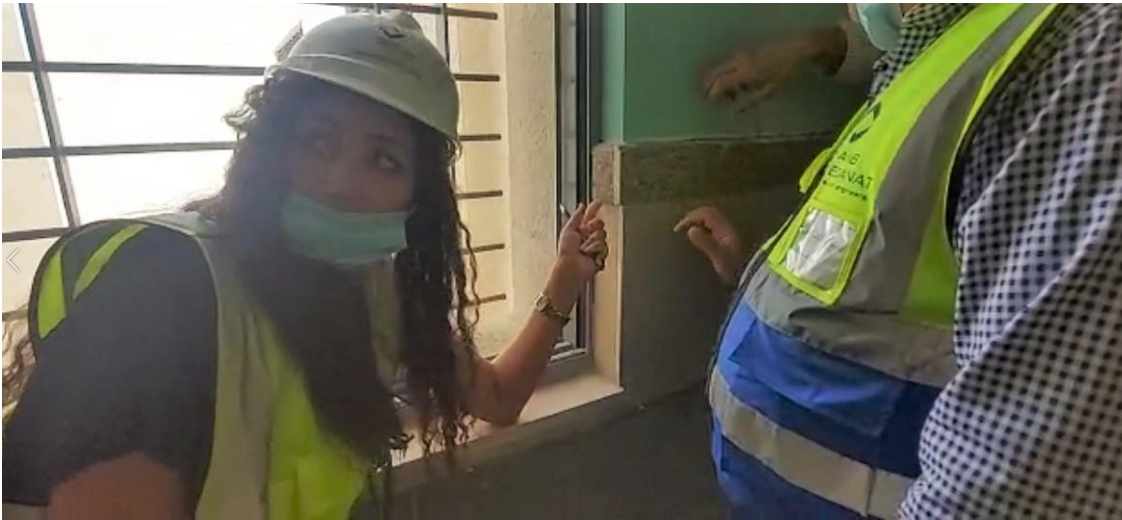
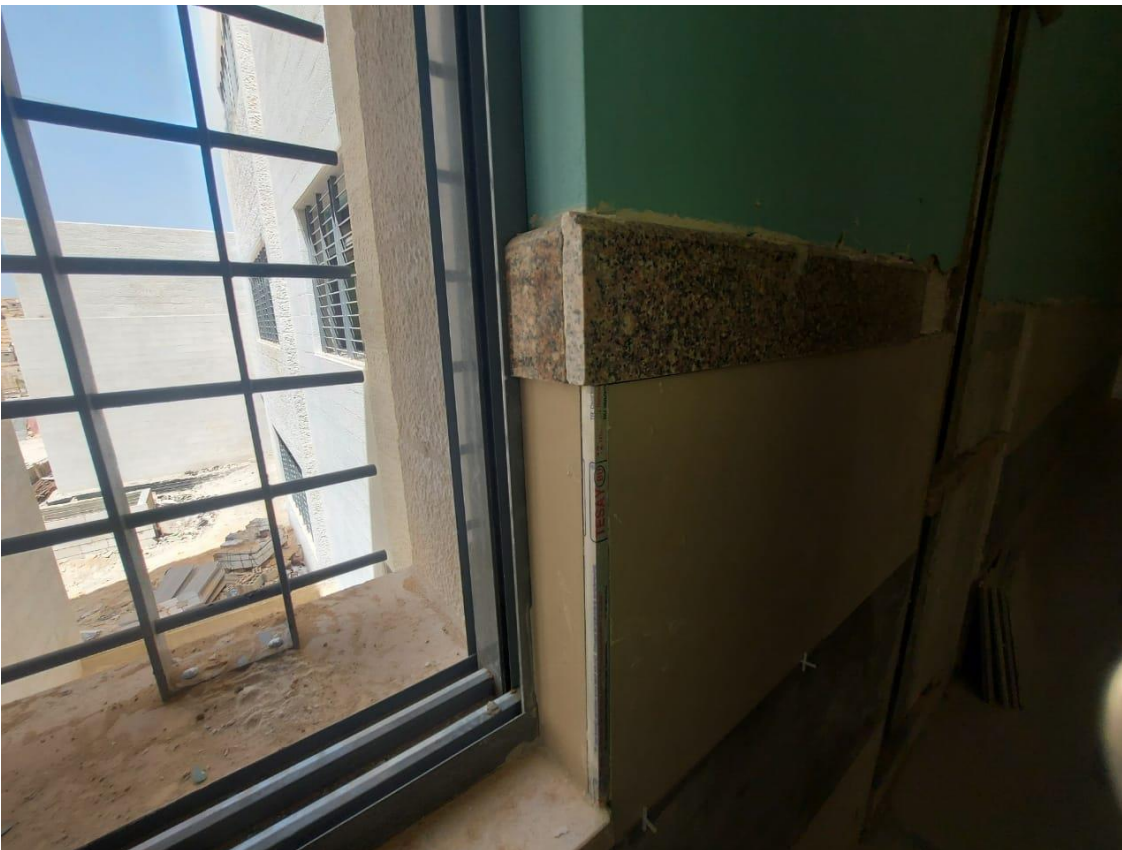
(Figure: 15 & 16)

General view of the project site
(Figure: 01, 02, 03 & 04)

The team inspected the executed granite coping at the window jamb (see point no.3 above) and observed a contradiction with the approved sample regarding the prominence of the granite piece. The Contractor was requested to rectify

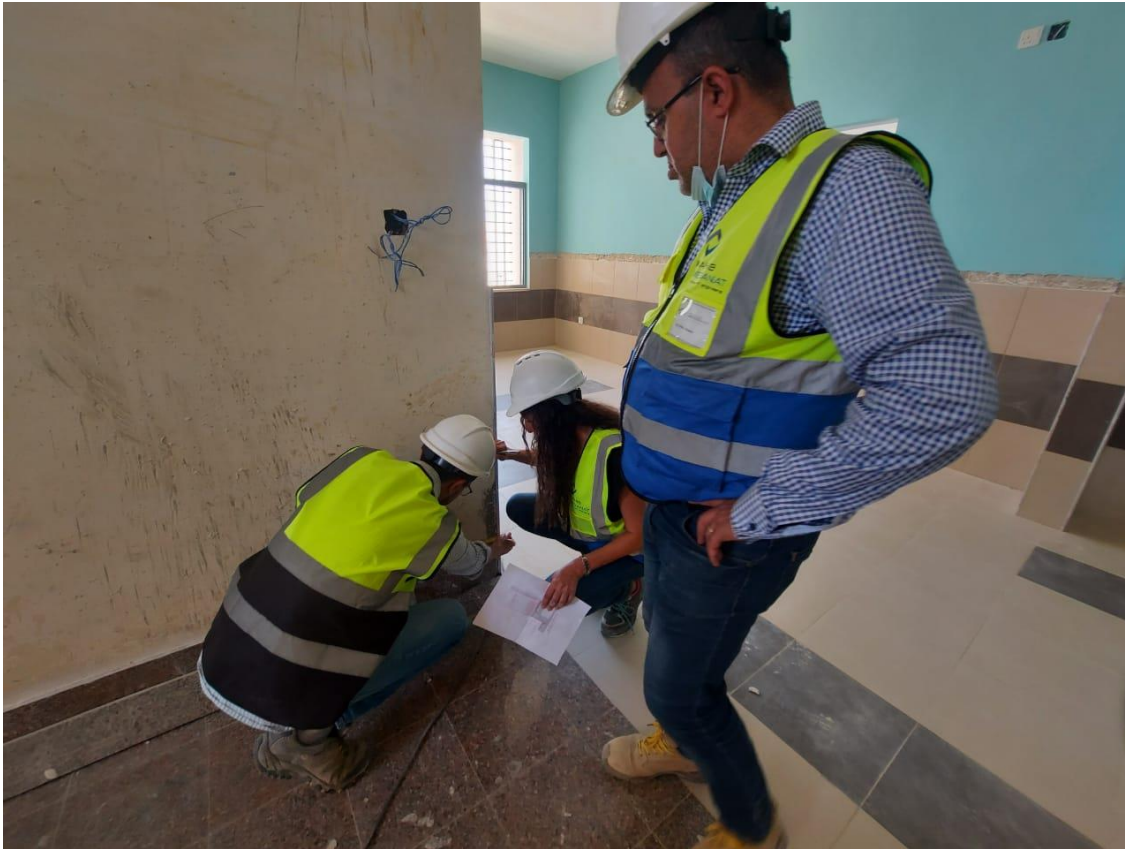
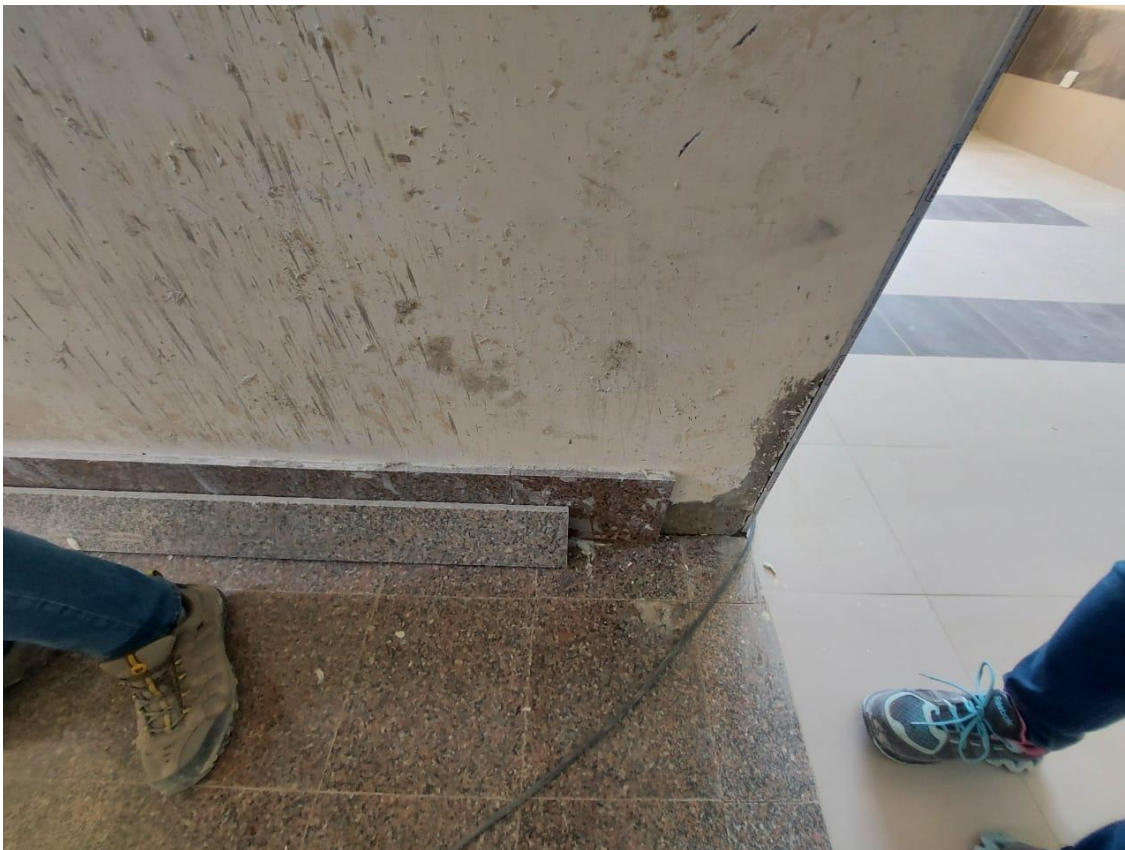
(Figure: 17 & 18)

The team inspected the executed granite skirting for the staircases

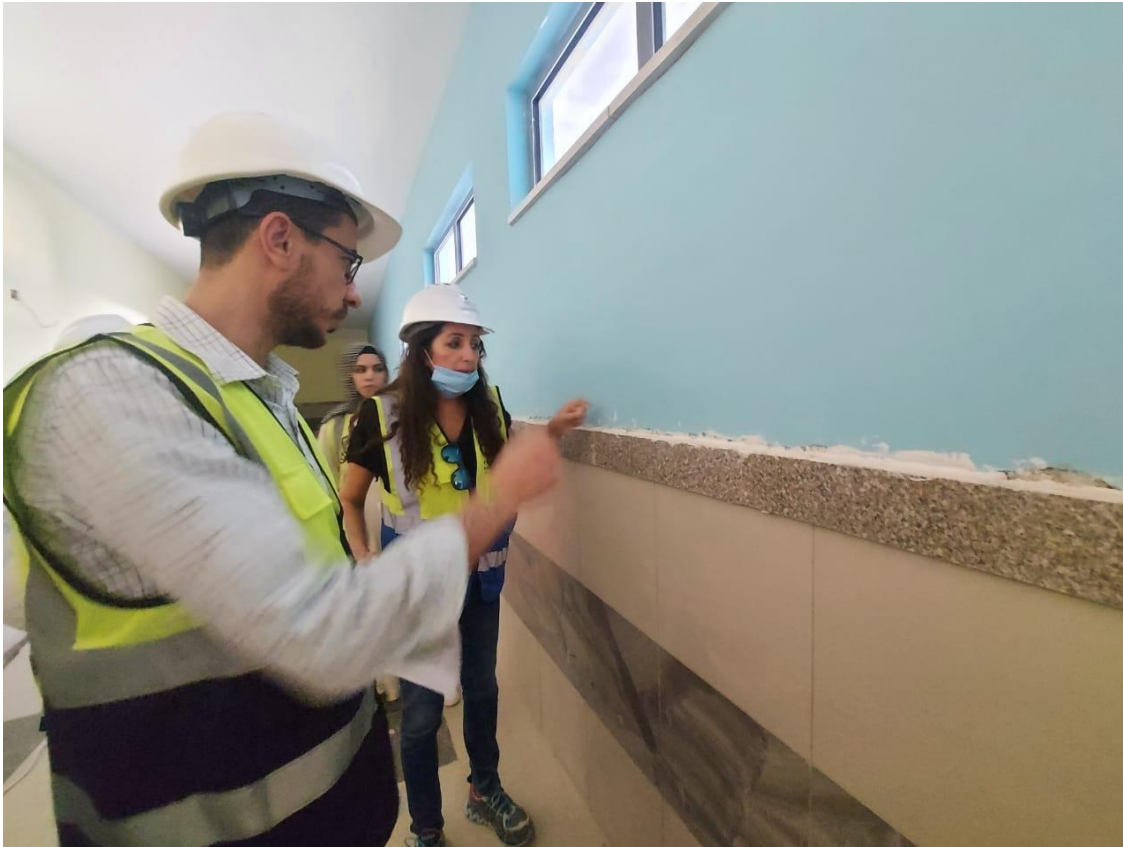
(Figure: 19)

The team inspected the preparation by the Contractor to install the granite coping at the corridors, chipping of plastering at the coping line to ensure compliance with the drawings

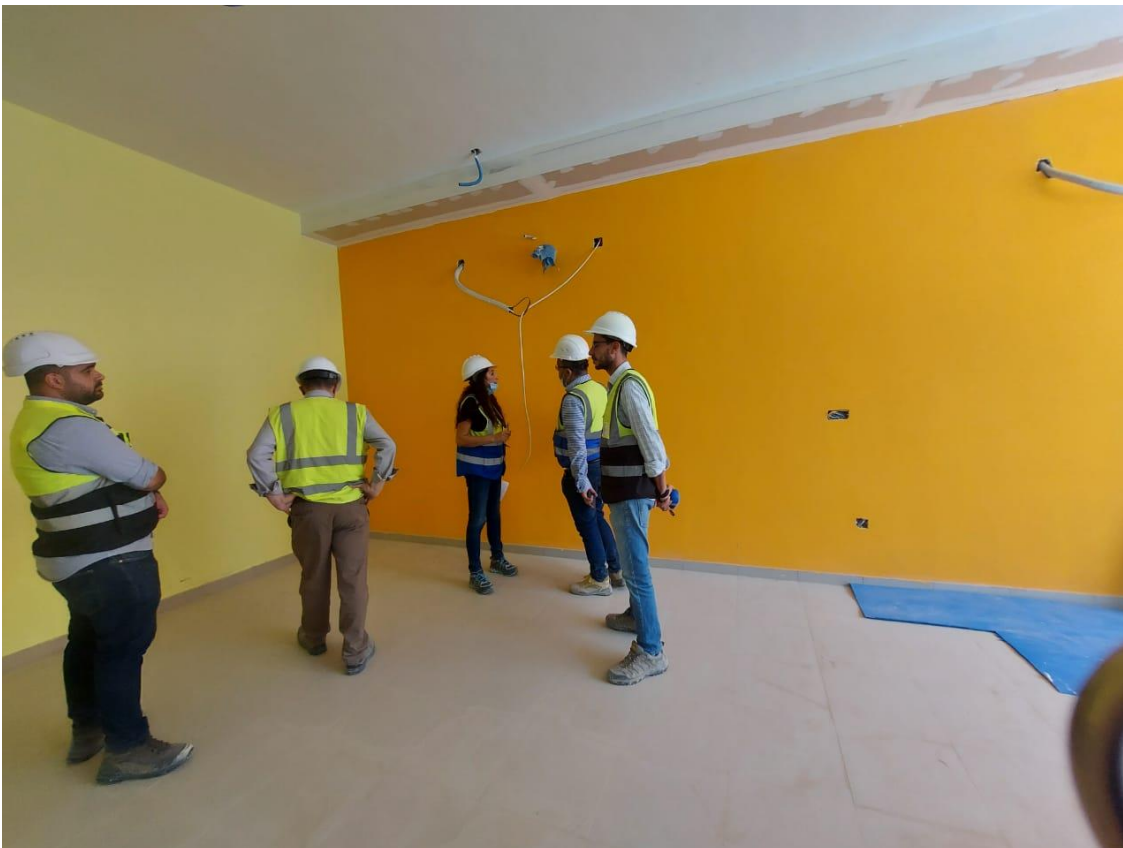
(Figure: 20)

The team discussed with the Contractor the color distribution scheme for the (KG)

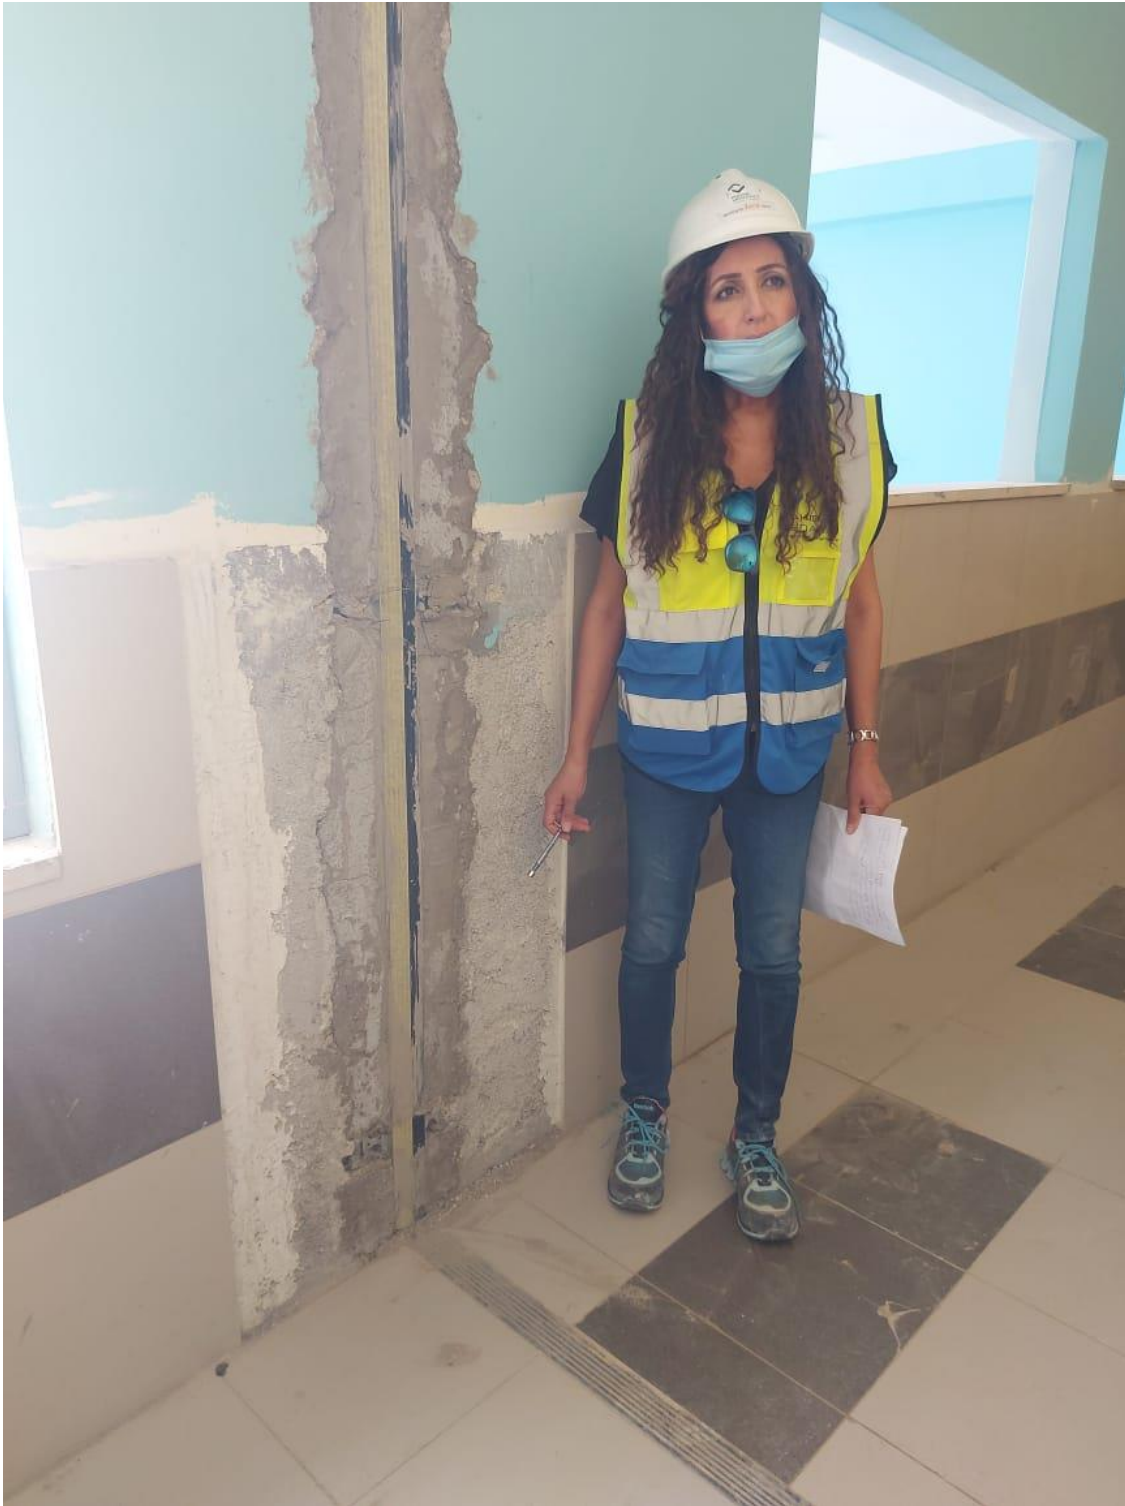
(Figure: 21)

The team inspected the executed expansion joints at the corridors

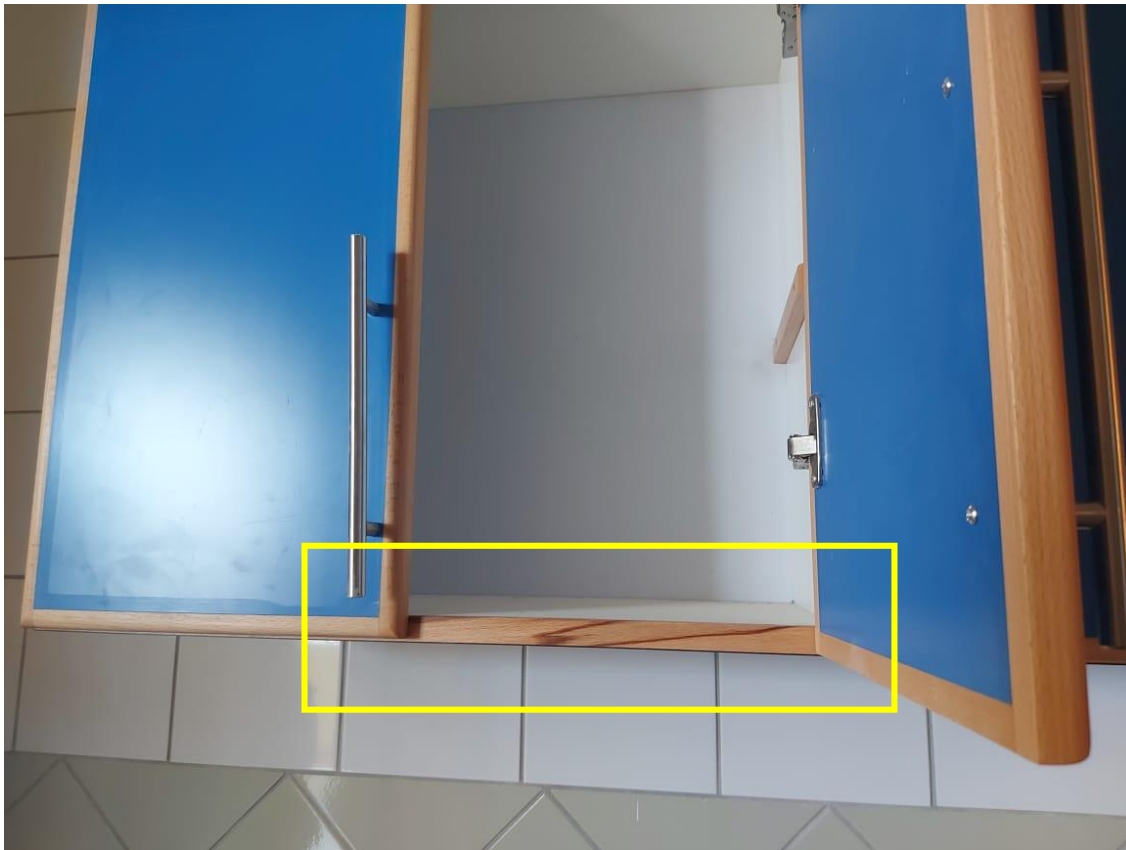
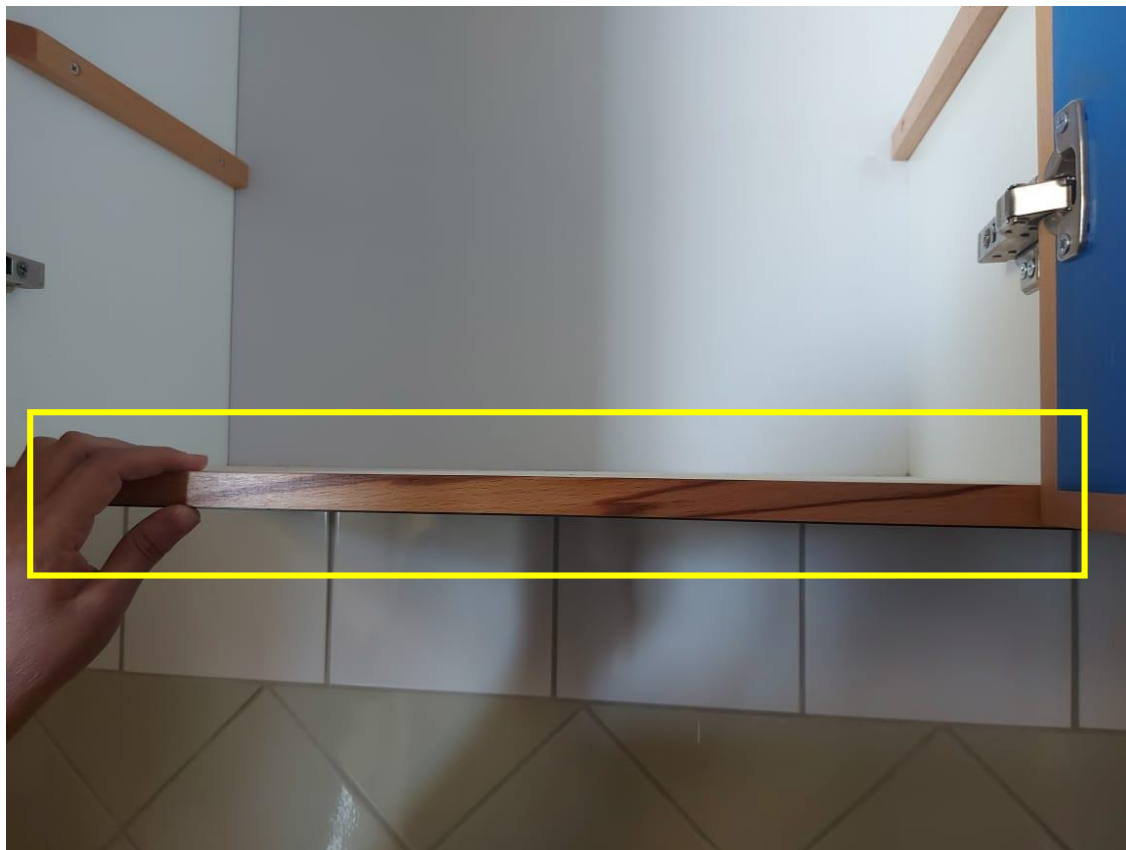
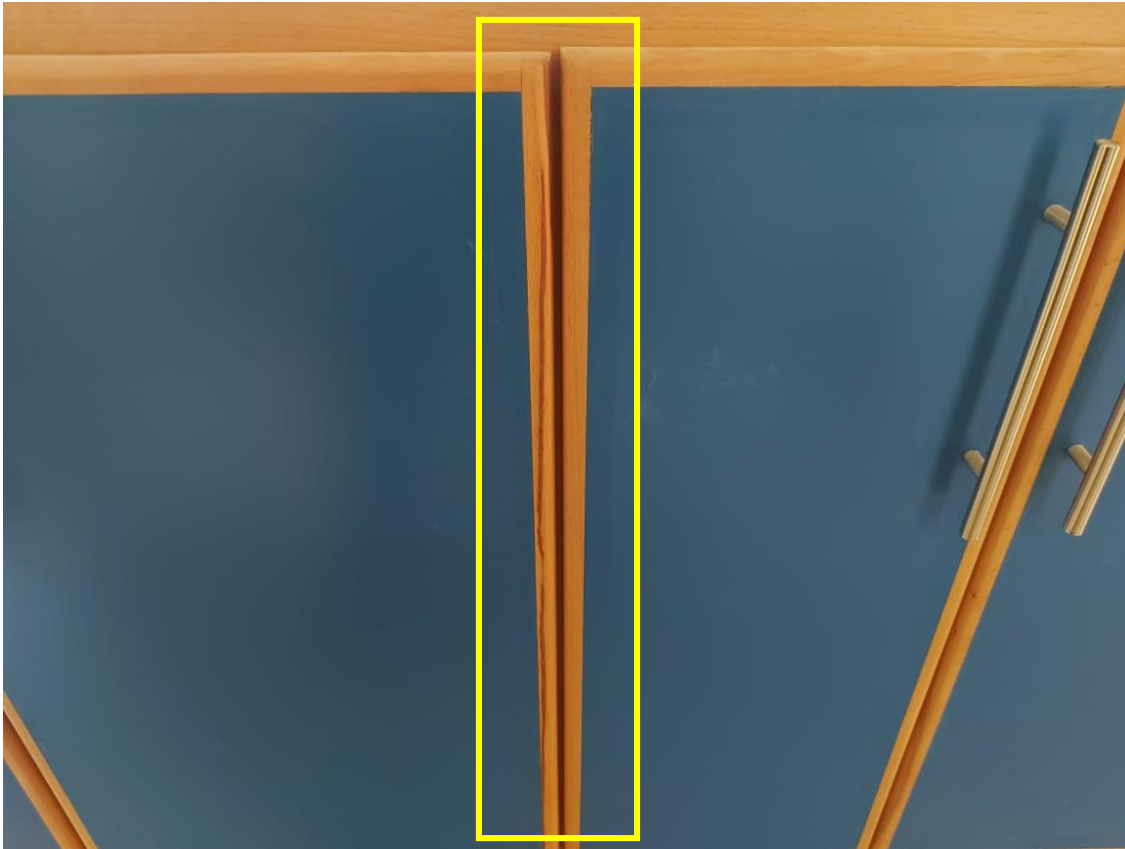
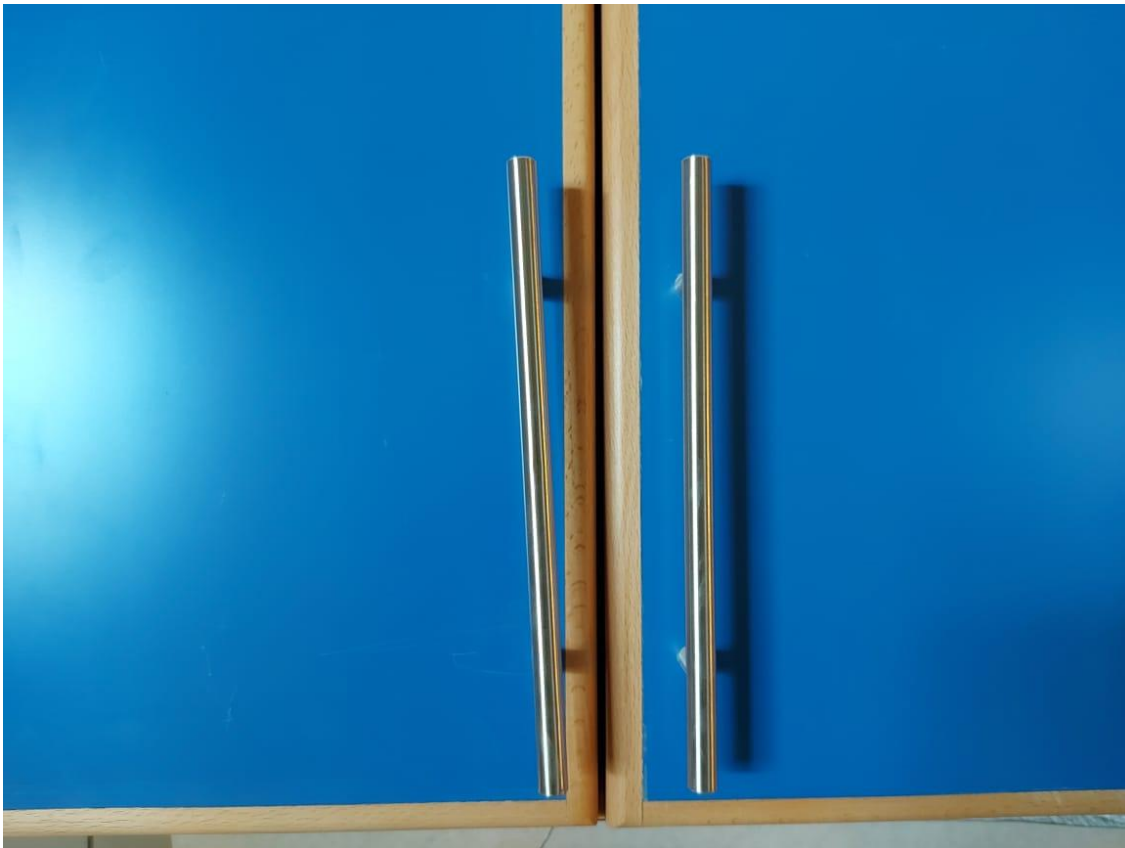
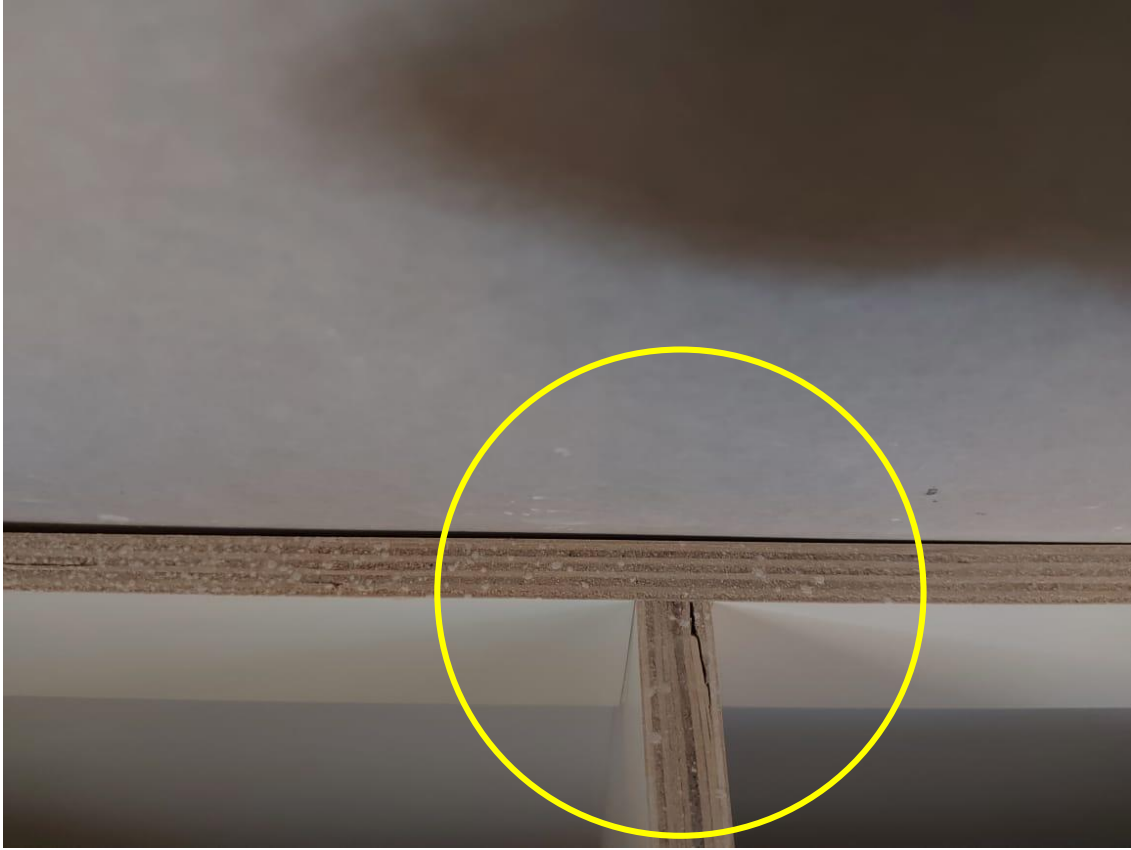
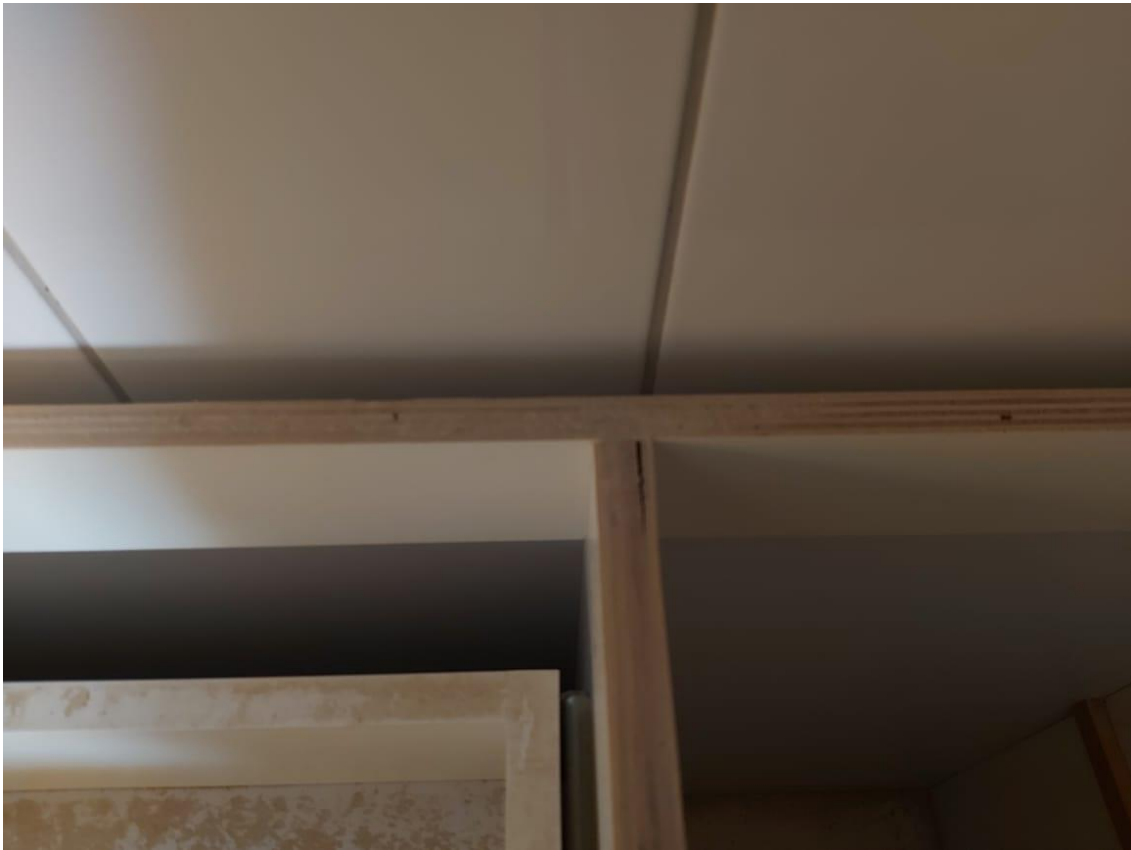
(Figure: 22, 23, 24, 25, 26 & 27)

The team observed defects in the delivered cabinets for the (KG) and requested the Contractor to rectify. The defects include the laminated partitions, unvertical ironmongery handles and defects in beech wood sections.

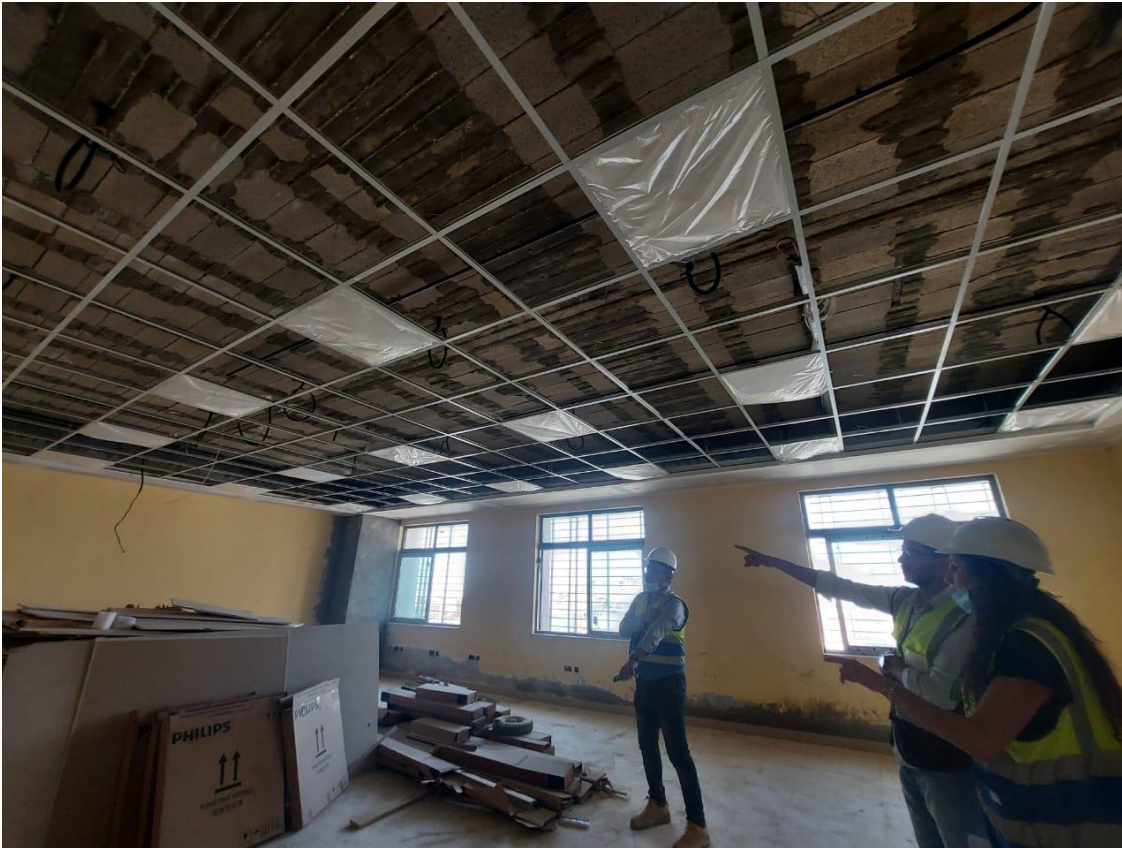
(Figure: 28)

The team observed that the Contractor delivered and started with the installation of lighting fixtures at the library and the corridors
