SKEP III Home Office Support Site Visit Report

Consultant	Wahib Medanat Consultant Engineer	Rep No.	12-09052022
Contractor	Derar Saraireh & Sons for Engineering & Contracting	Tender No.	(11/2019/USAID/SKEP/3/S) Schools for a Knowledge Economy Project (SKEP) - Phase (3) Package (1, 2)
Site Name	Al Khansa' Basic Mixed School- Al Balqa	Day/ Date	Mon. 09/05/2022
Duration of Project	450 Calendar Days	Total Project Budget	9,789,417.840 JD

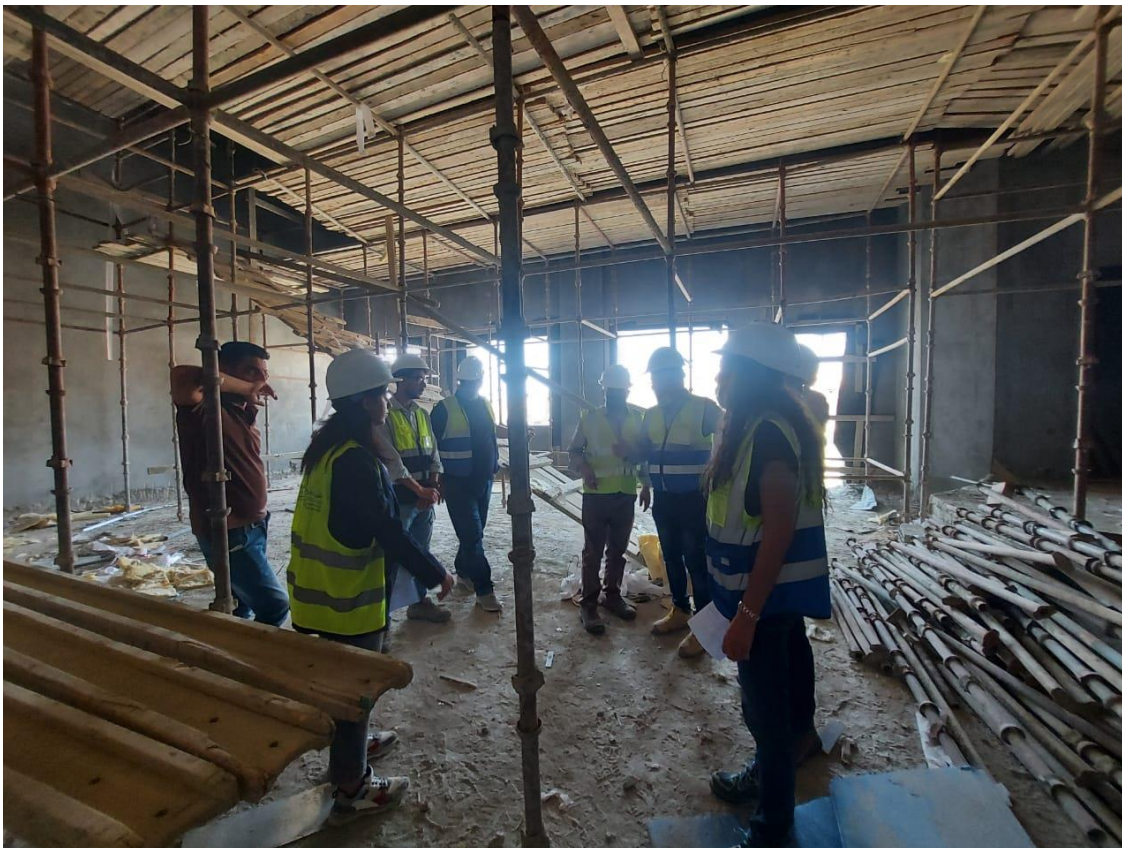
(Figure: 29)

The team inspected the current works going on in the multi-purpose hall
