Quality Control Report

Consultant **Wahib Medanat** Consultant Engineers
Site Name **Jumana Bint Abi Taleb Basic Mixed - Marka**
Package **Package 2**
Contractor **Dijlah Est. Construction Co.**
Tender No. **10/2019/USAID/SKEP/3/2**

Rep No. **QC-23 16**
Date **27 / 03 / 2022**

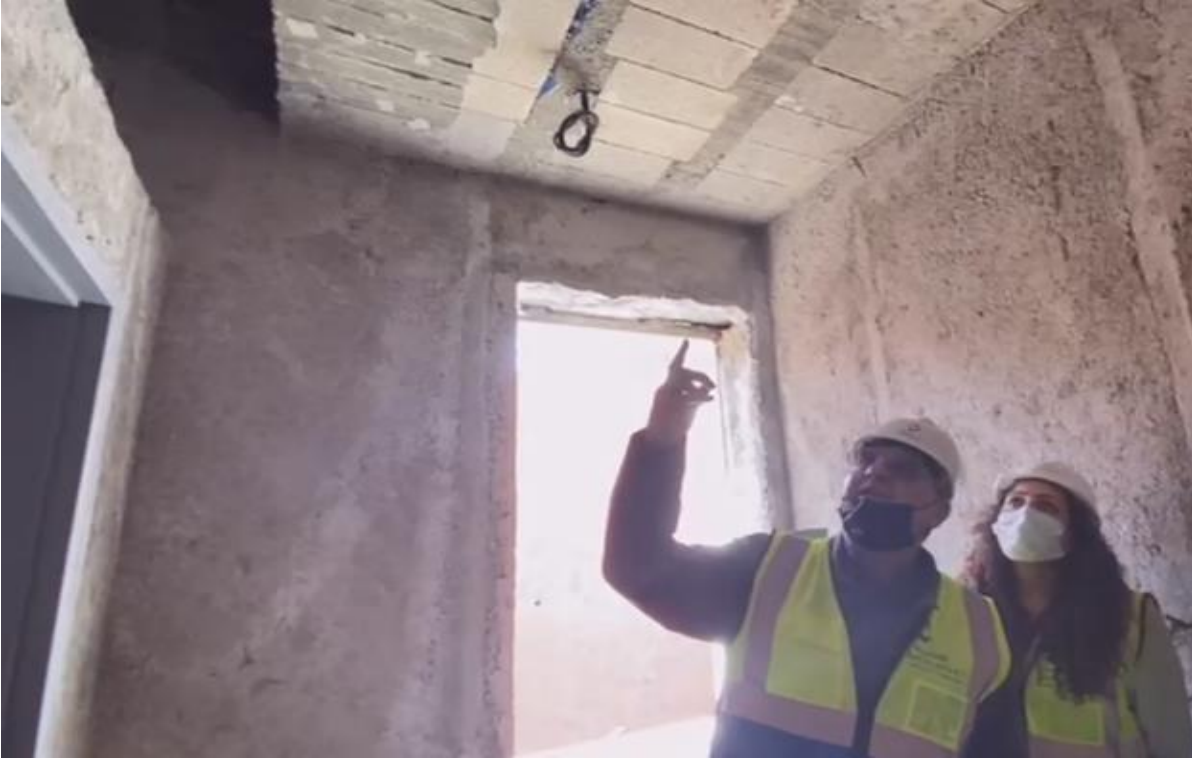
Gaps within the block walls over the suspended ceiling at wet area

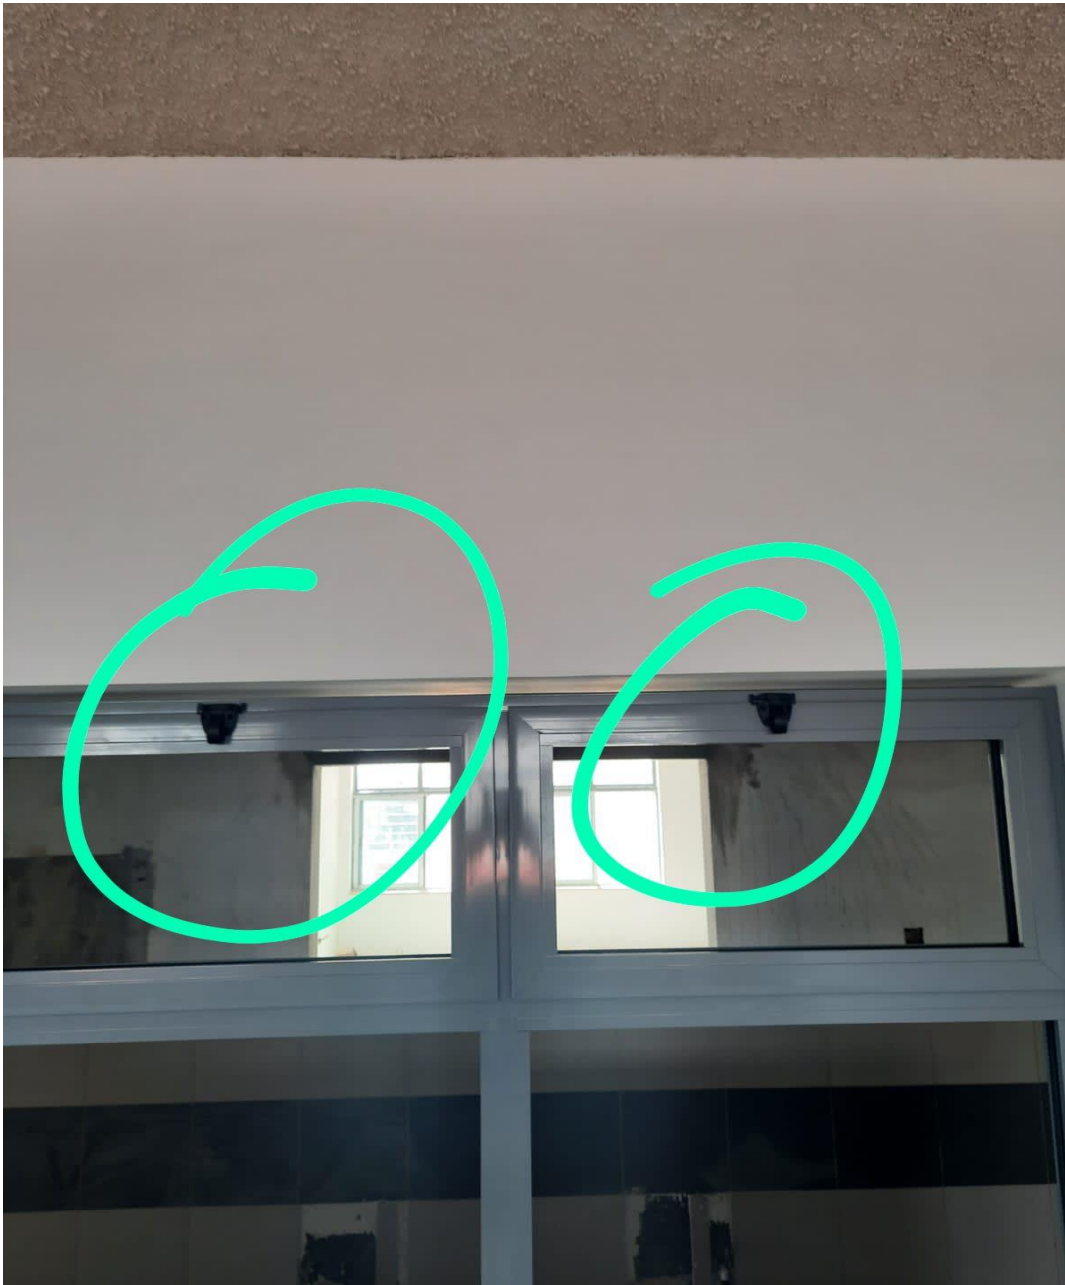
Example of contradiction in dimension and unapproved accessories

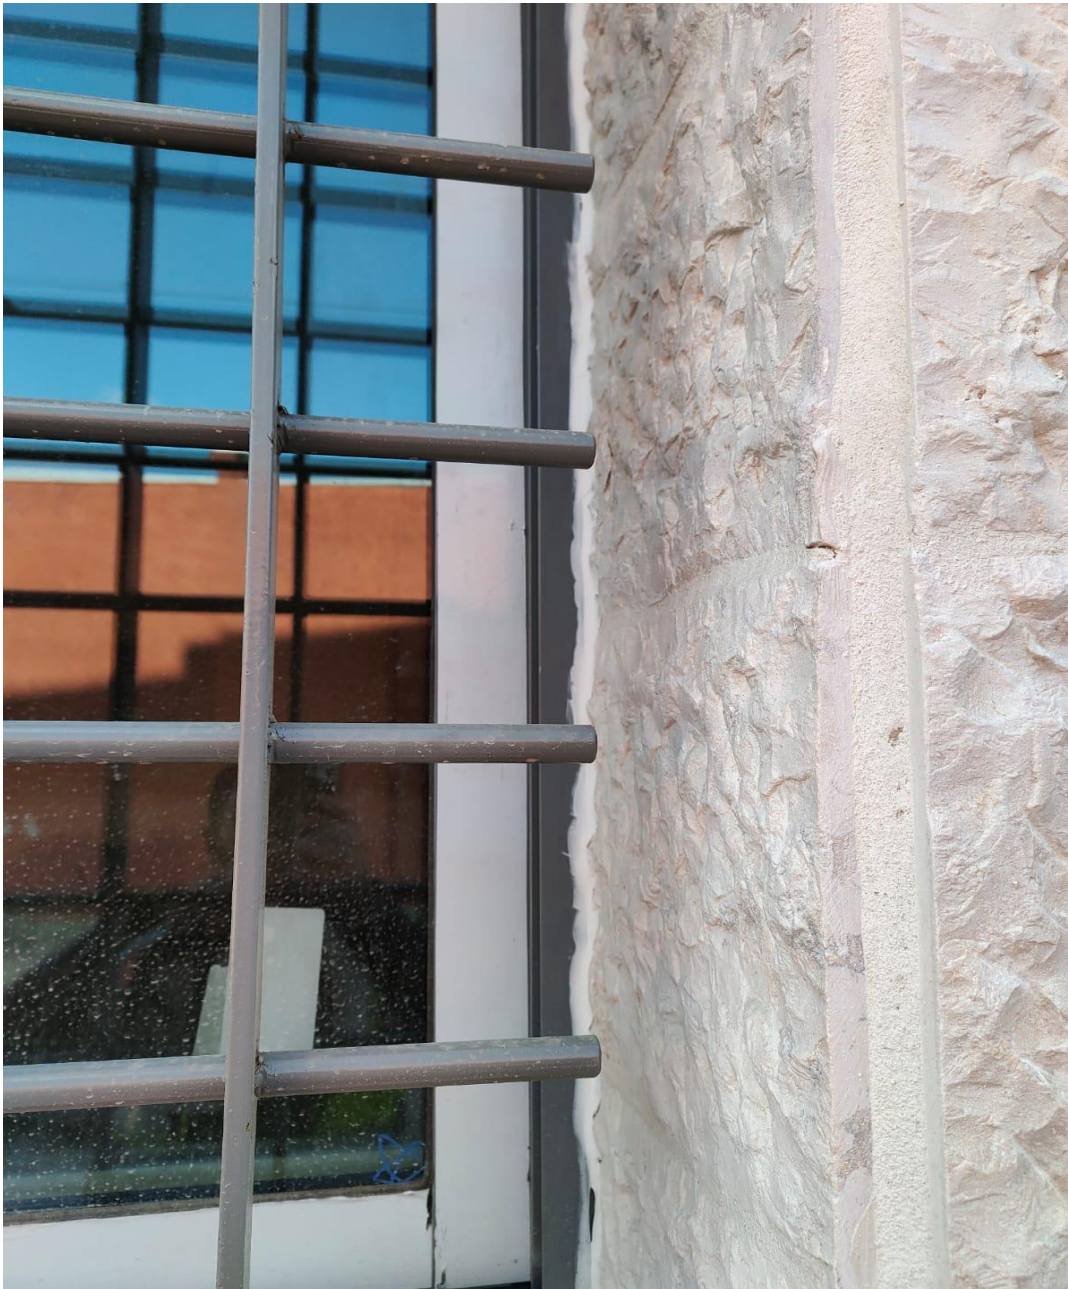
Example of unapproved sealant

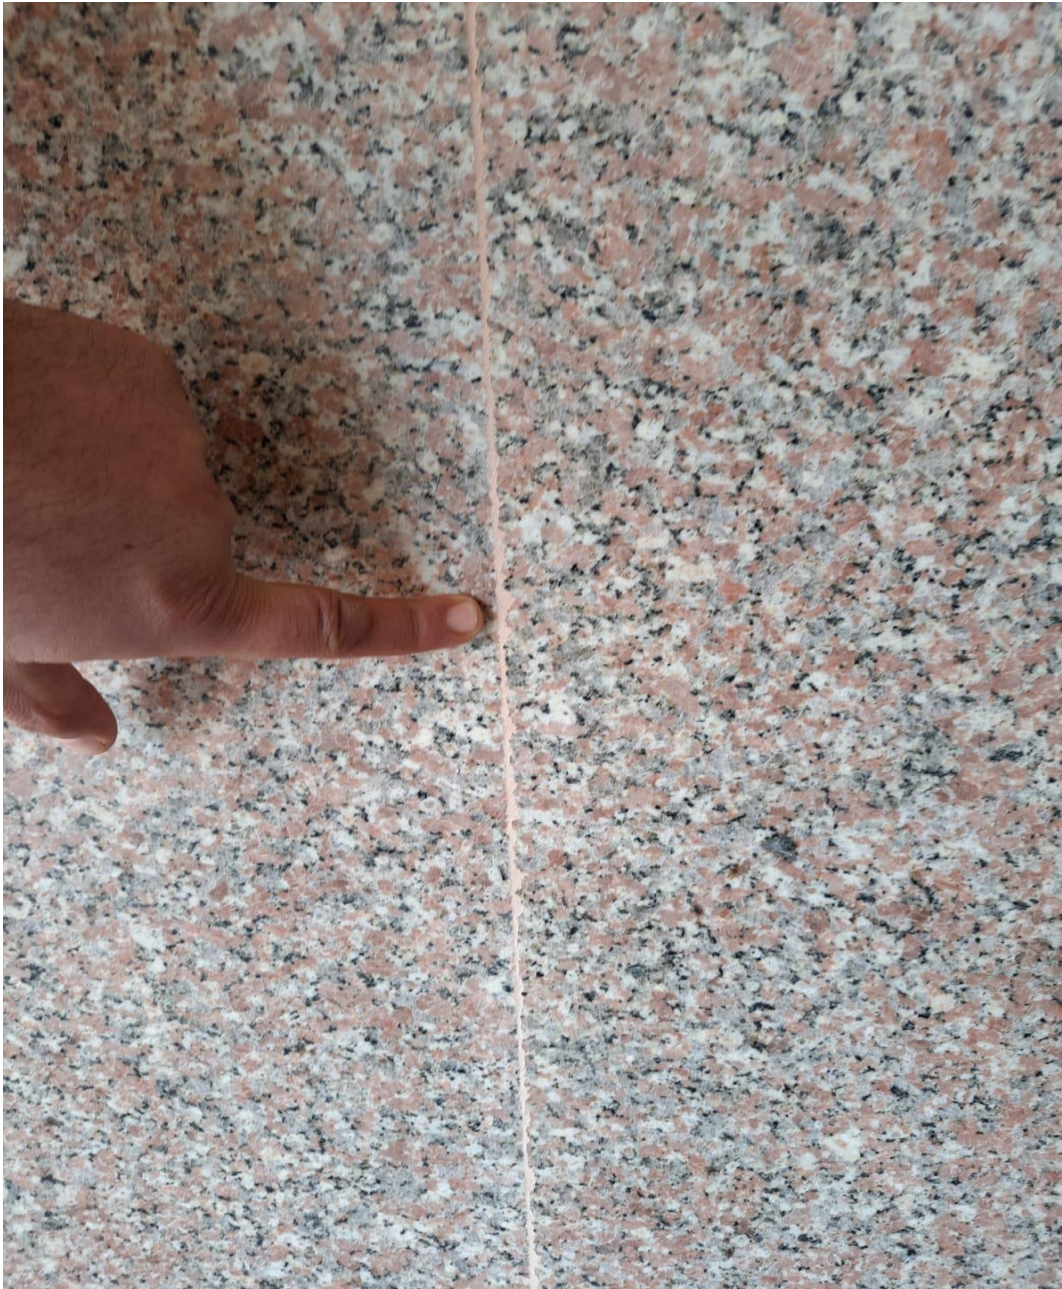
Defect in wall cladding

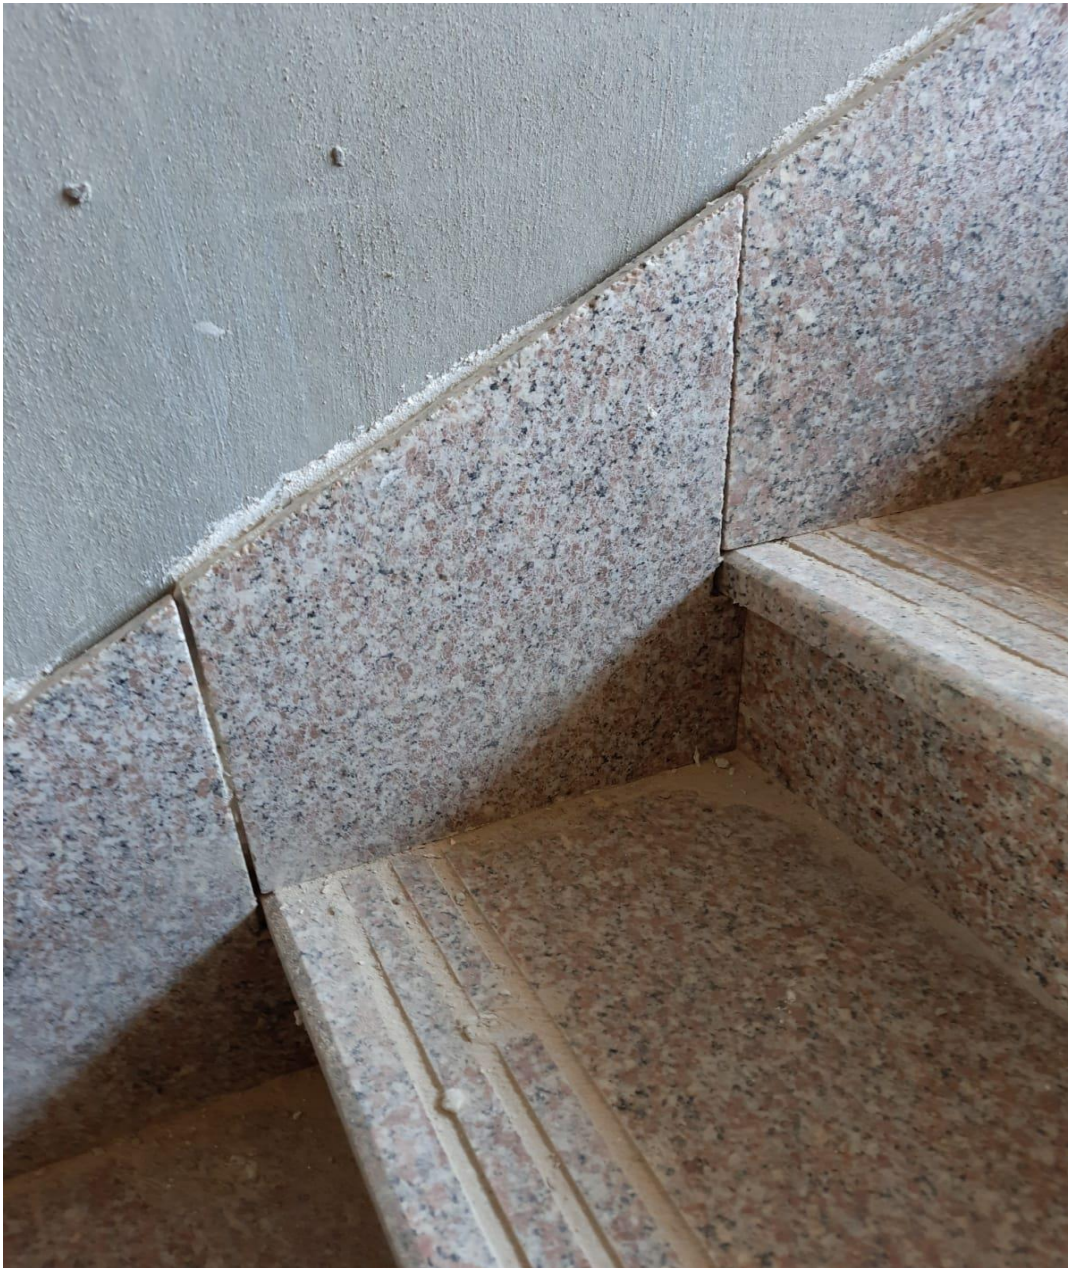
Defects in inclined skirting

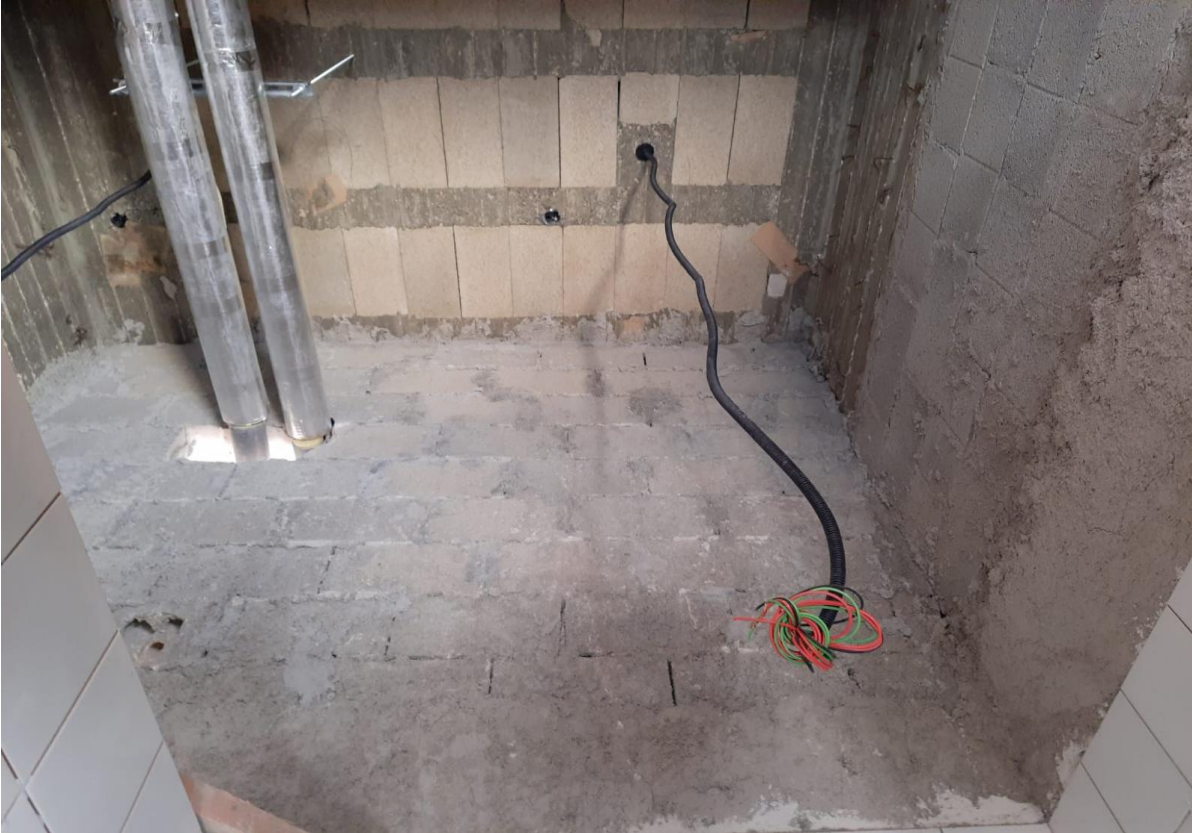
Rectified block wall
