Quality Control Report

Consultant **Wahib Medanat** Consultant Engineers
Site Name **Hay Al Iskan Basic mixed - Jerash**
Package **Package 2**
Contractor **Dijlah Est. Construction Co.**
Tender No. **10/2019/USAID/SKEP/3/2**

Rep No. **QC-21 17**
Date **22 / 02 / 2022**

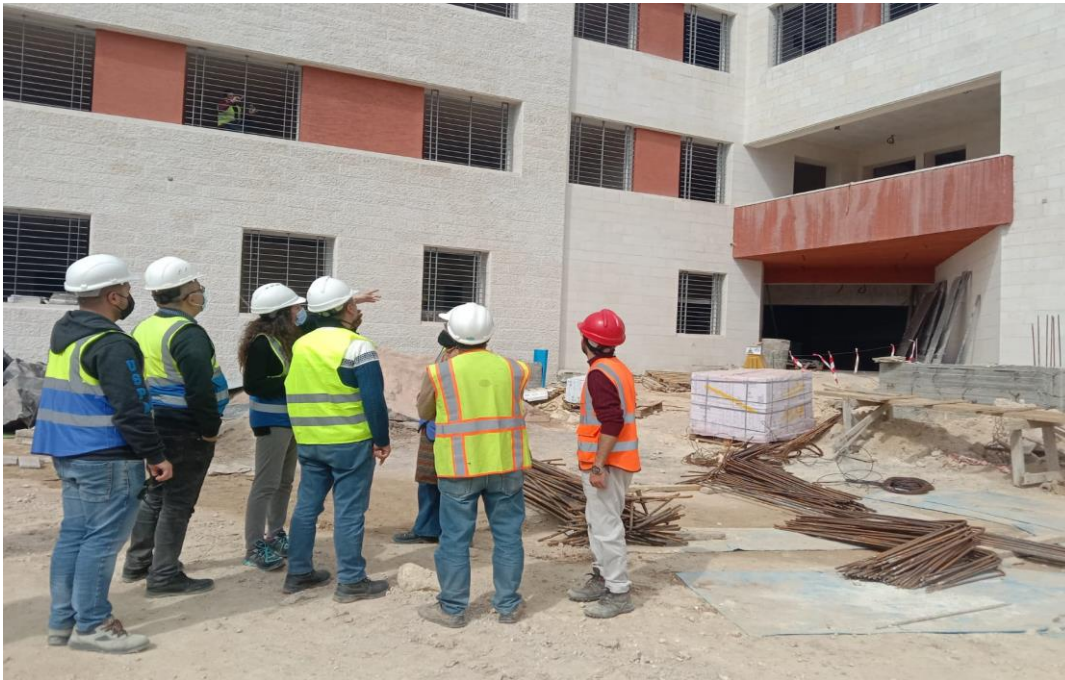
White color appears on the surface of external plastering

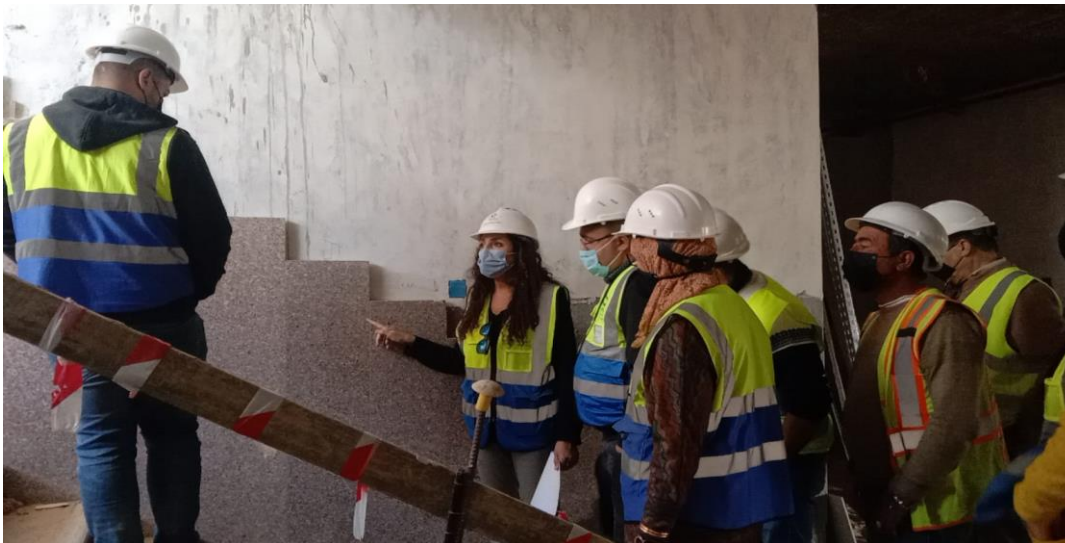
Defects in the granite cladding for staircase walls

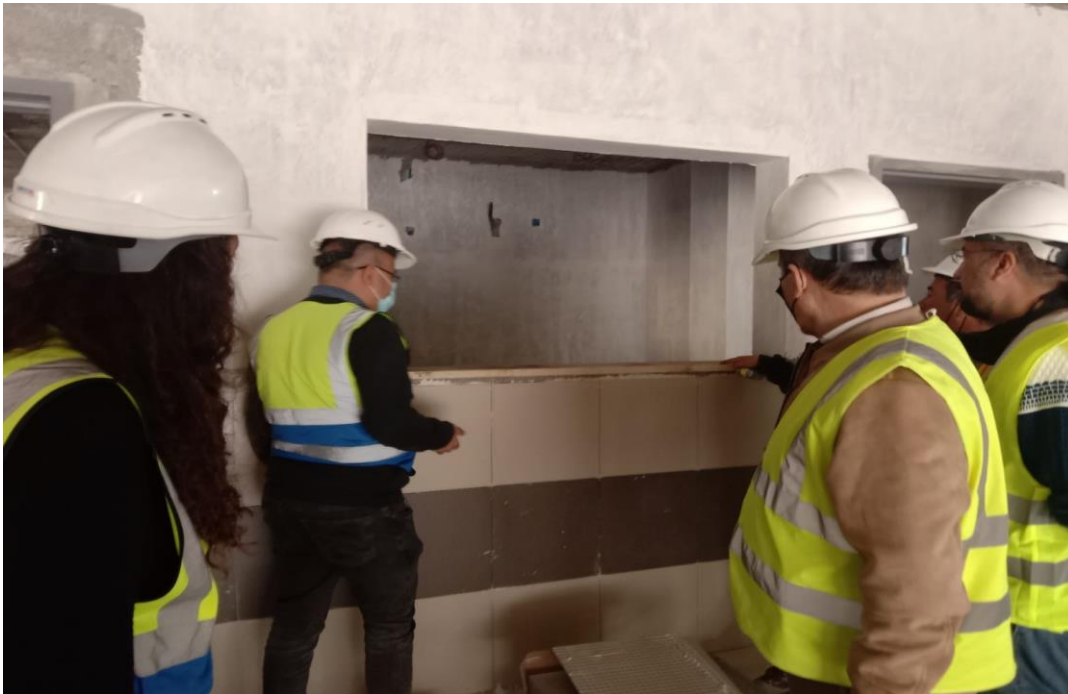
Wrong level of the window sills

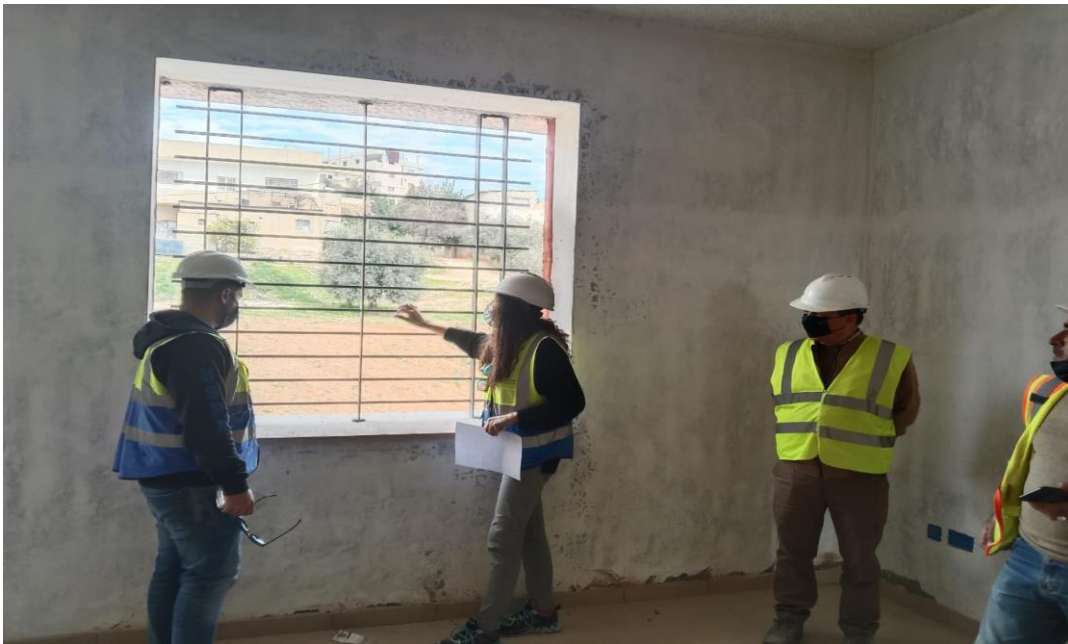
Corrosion appears on the steel protection screens

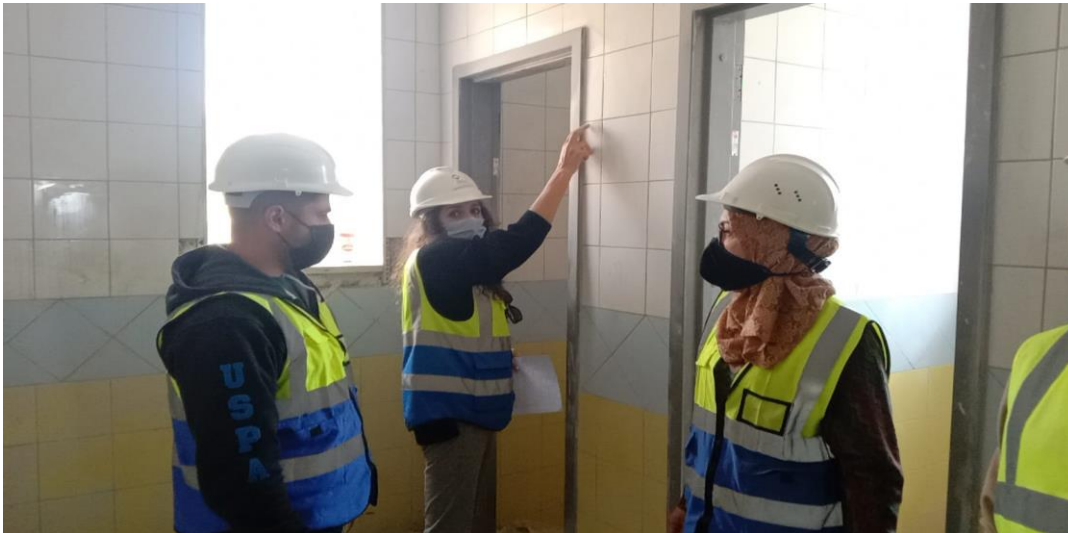
Defects in the wall ceramic tiles cutting adjoining the door frames
