Quality Control Report

Consultant **Wahib Medanat** Consultant Engineers
Site Name **Um Al Dananir Basic Mixed - Balqa**
Package **Package 1**
Contractor **Derar Saraireh & Sons for Engineering & Contracting**
Tender No. **1/2020/USAID/SKEP/3/1**

Rep No. **QC-11 19**
Date **21 / 05 / 2022**

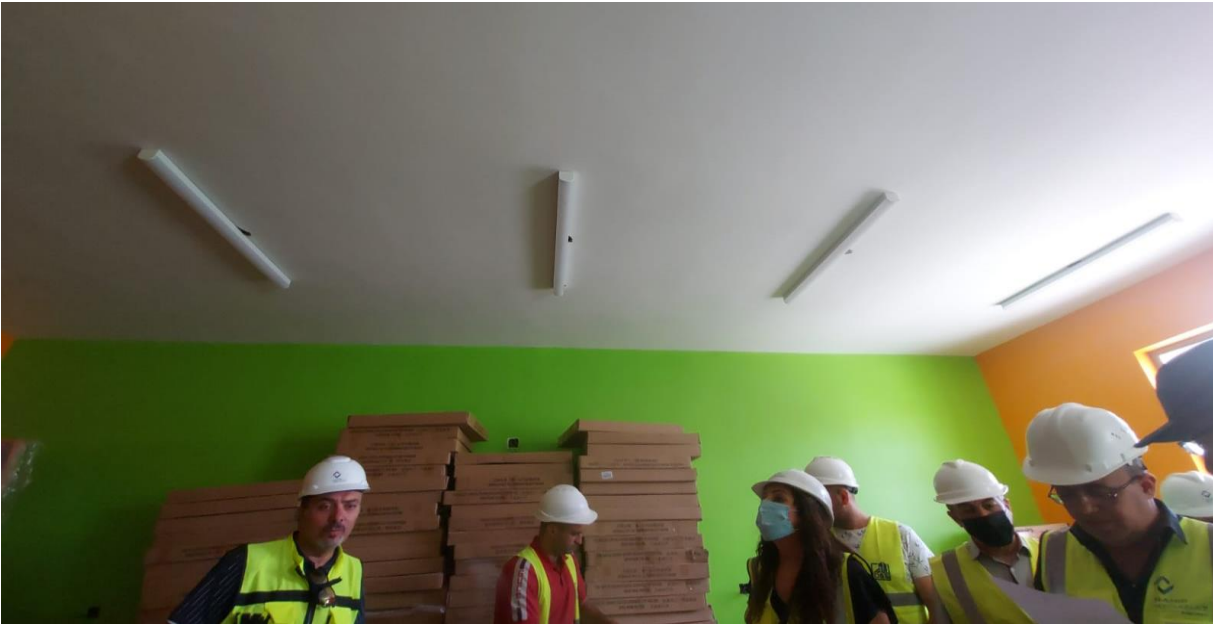
Gaps around the lighting fixtures

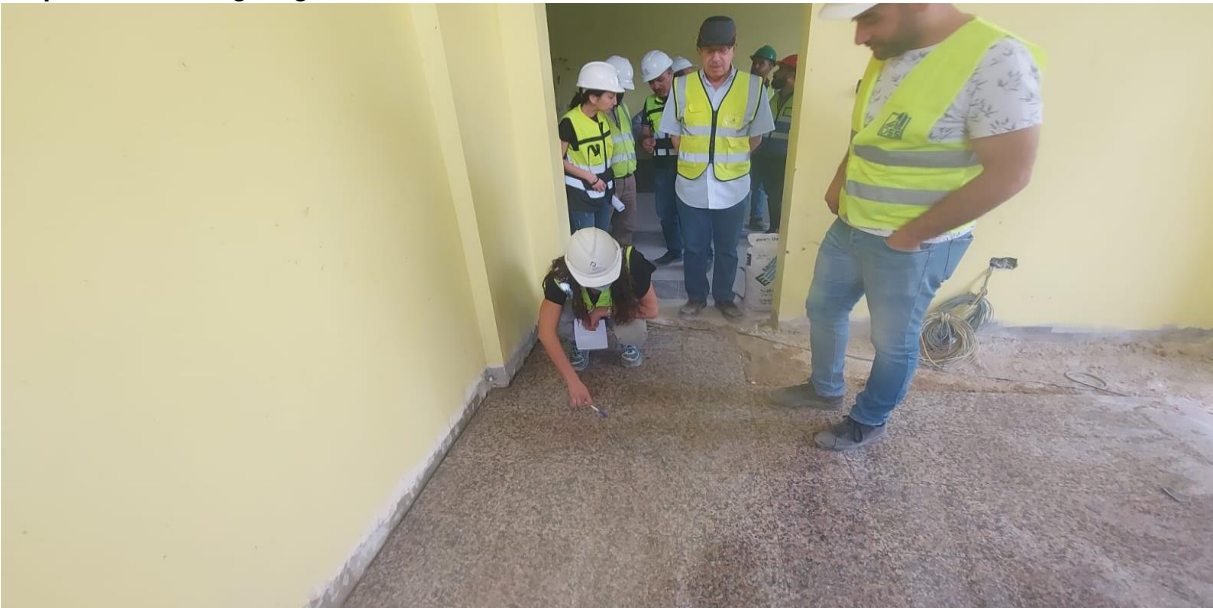
Broken edges of granite

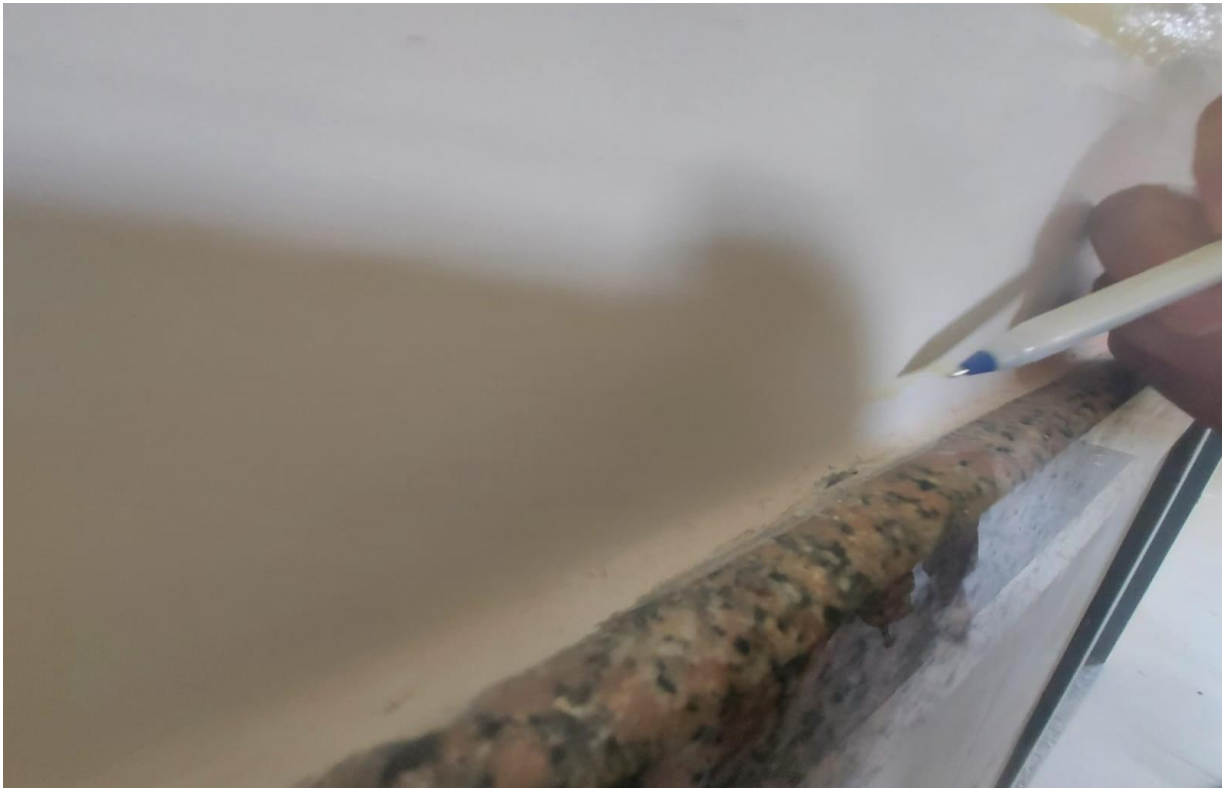
Defects in granite coping

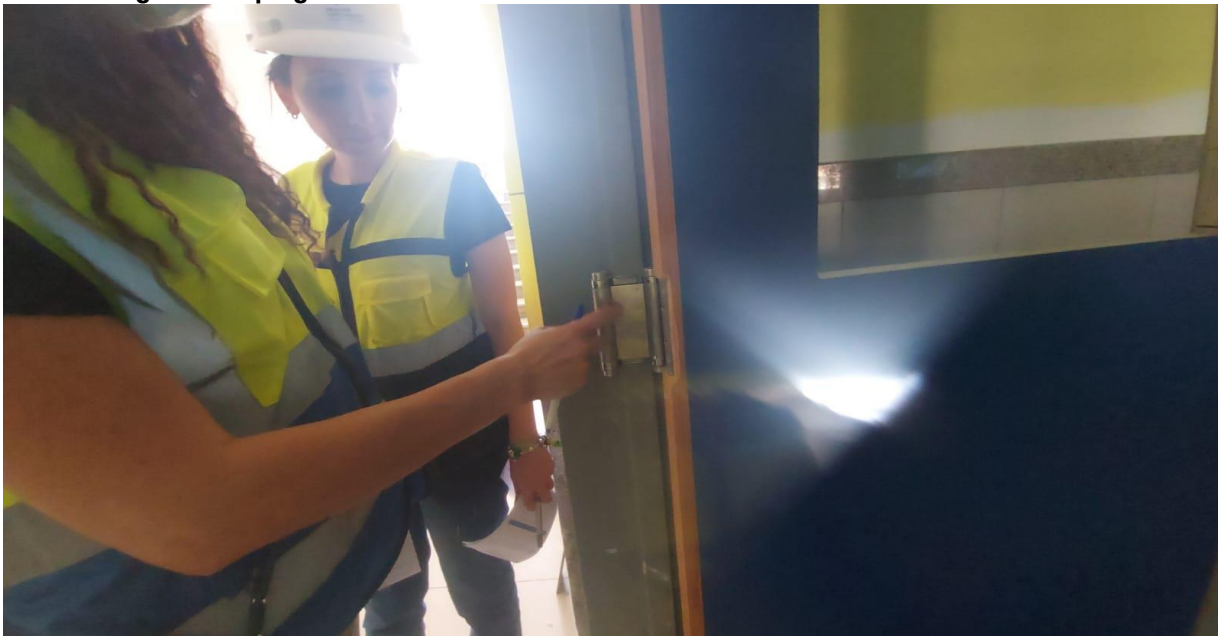
Unacceptable installation for door hinges

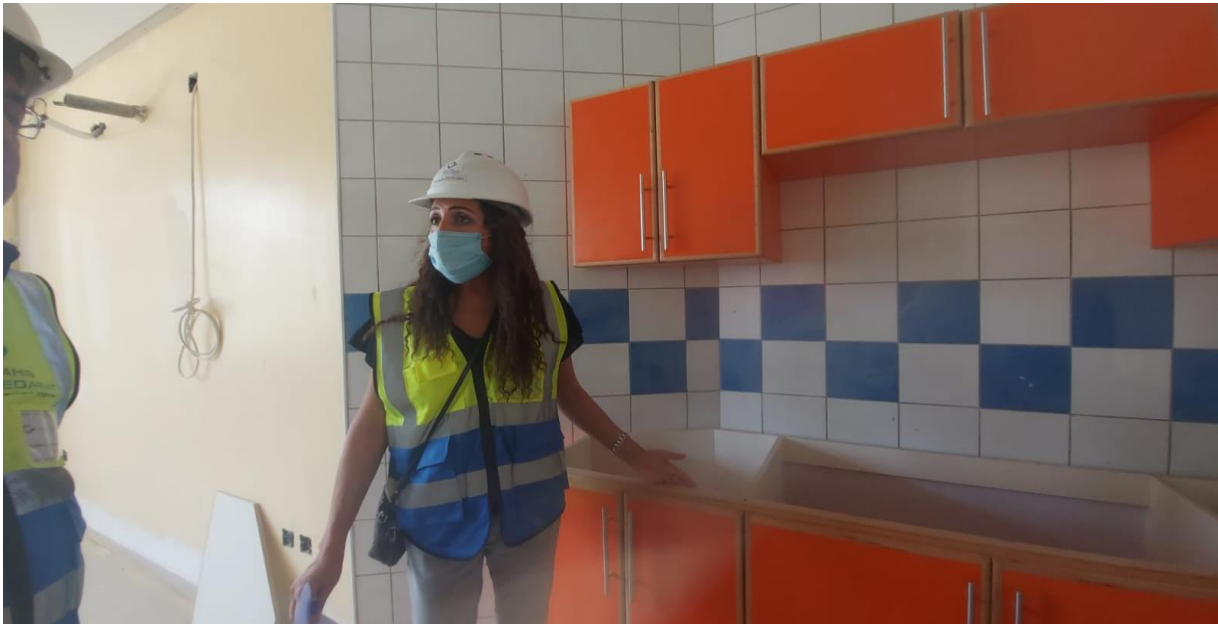
Defects in the beech wood frames

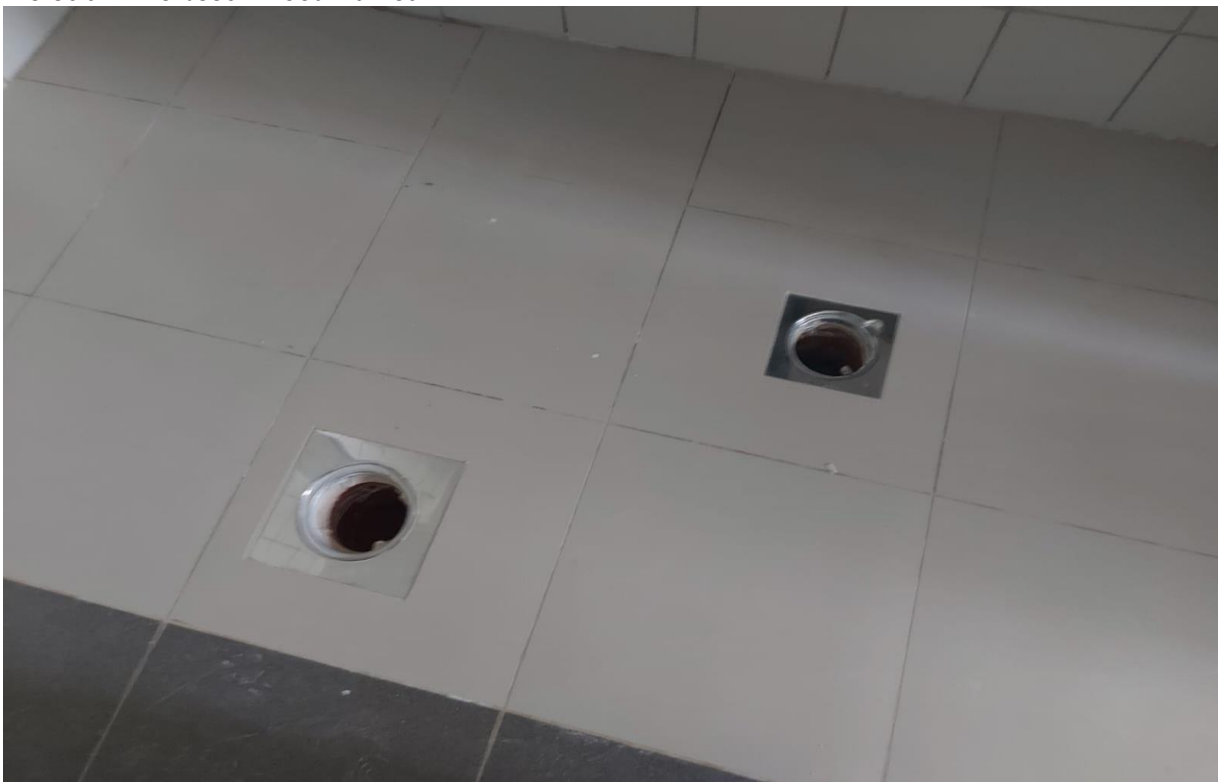
Open cleanouts and drains

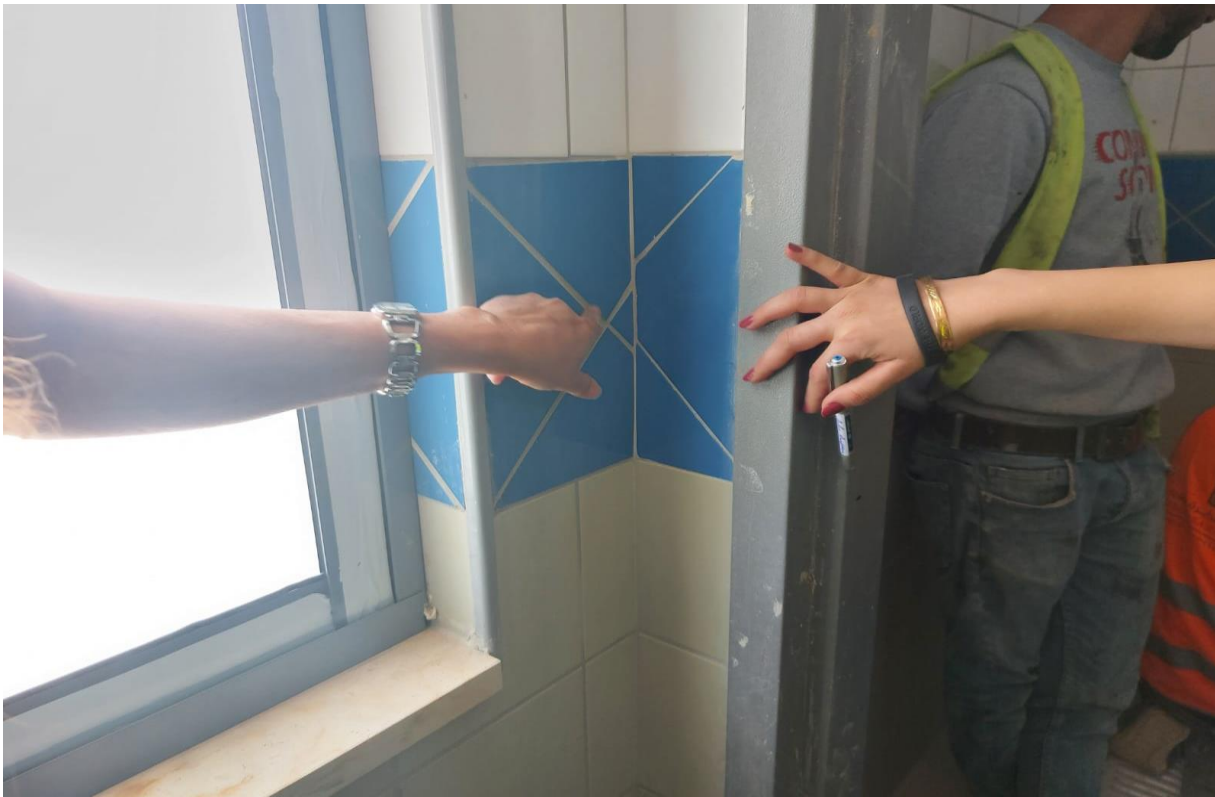
Wider gaps at the tiled wet areas

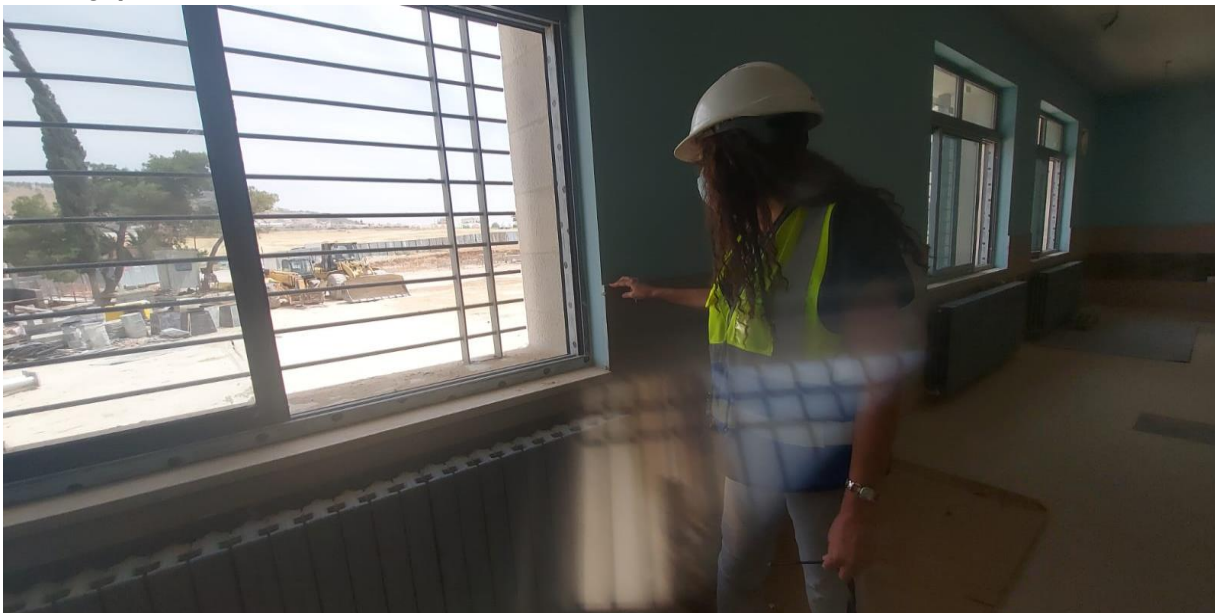
Smaller dimension for aluminum section
