# Quality Control Report

**Consultant** **Wahib Medanat** Consultant Engineers  
**Site Name** **Jumana Bint Abi Taleb Basic Mixed - Marka**  
**Package** **Package 2**  
**Contractor** **Dijlah Est. Construction Co.**  
**Tender No.** **10/2019/USAID/SKEP/3/2**

**Rep No.** **QC-23 19**  
**Date** **5 / 06 / 2022**

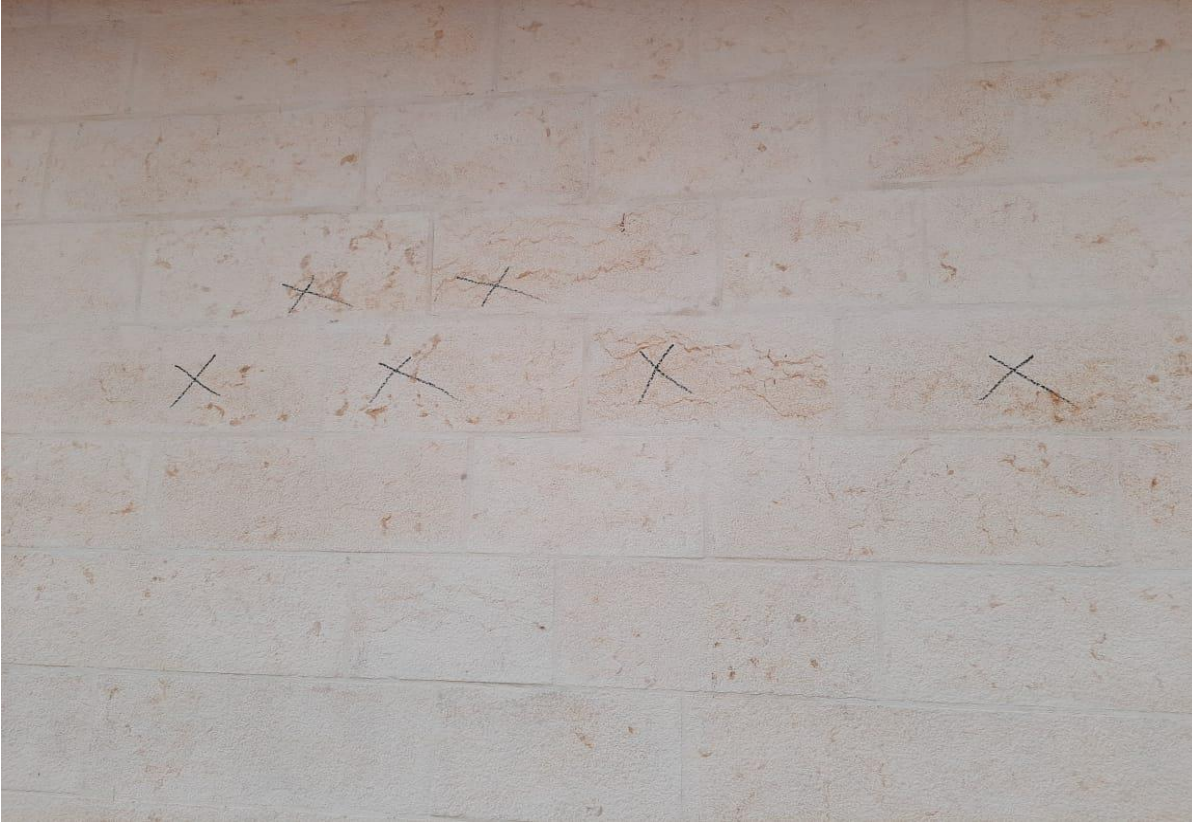
**Defected stones at canteen façade**

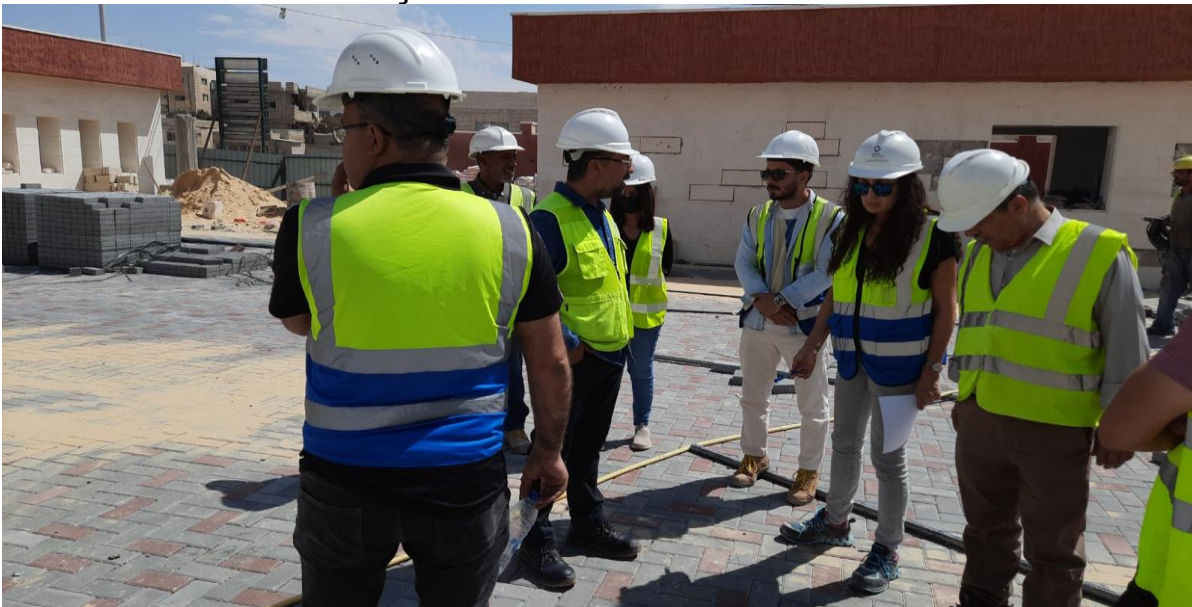
**Defects in levelling of interlock tiles**

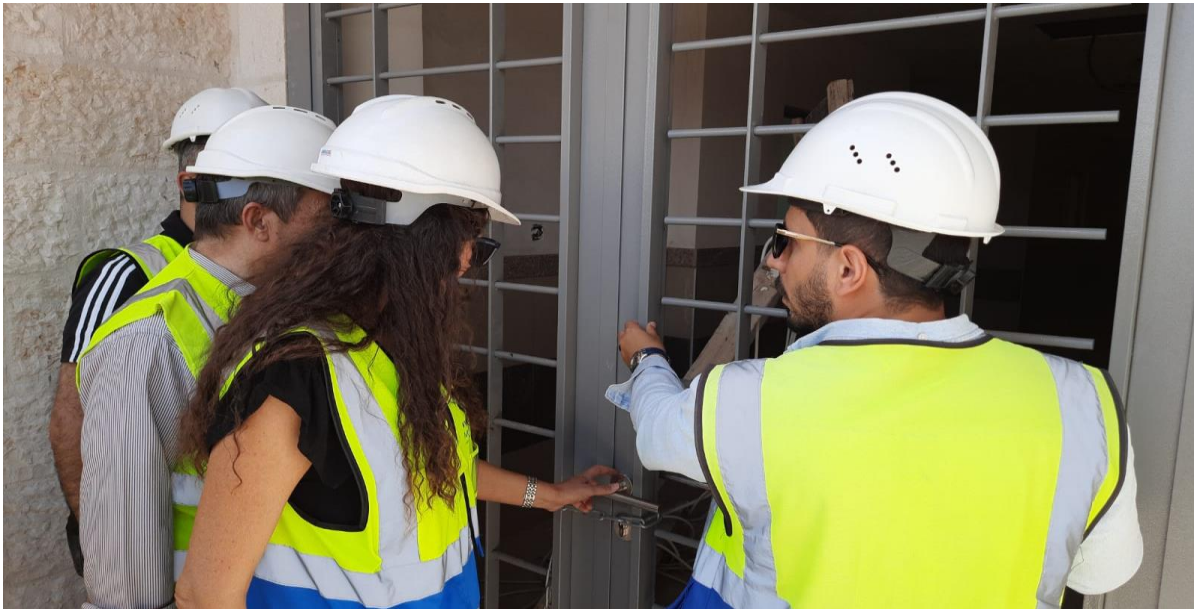
**Door part does not comply with architectural details**

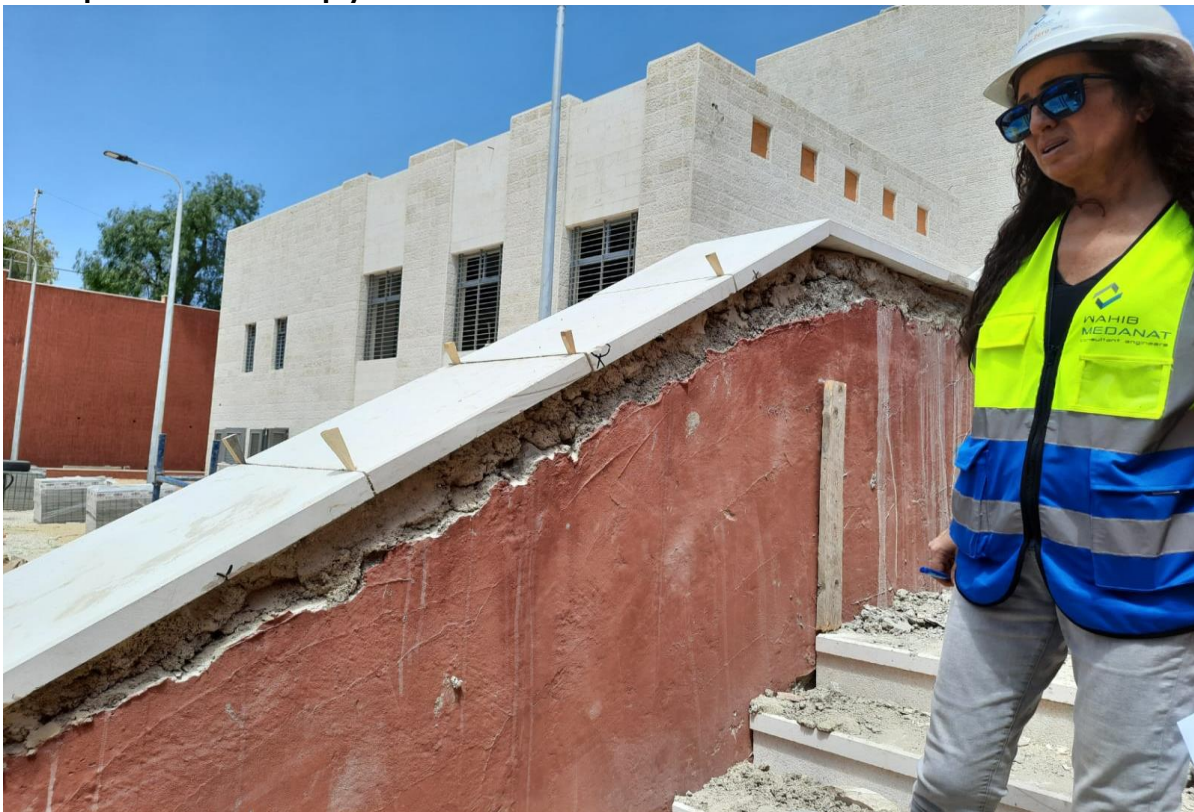
**Broken stone coping**

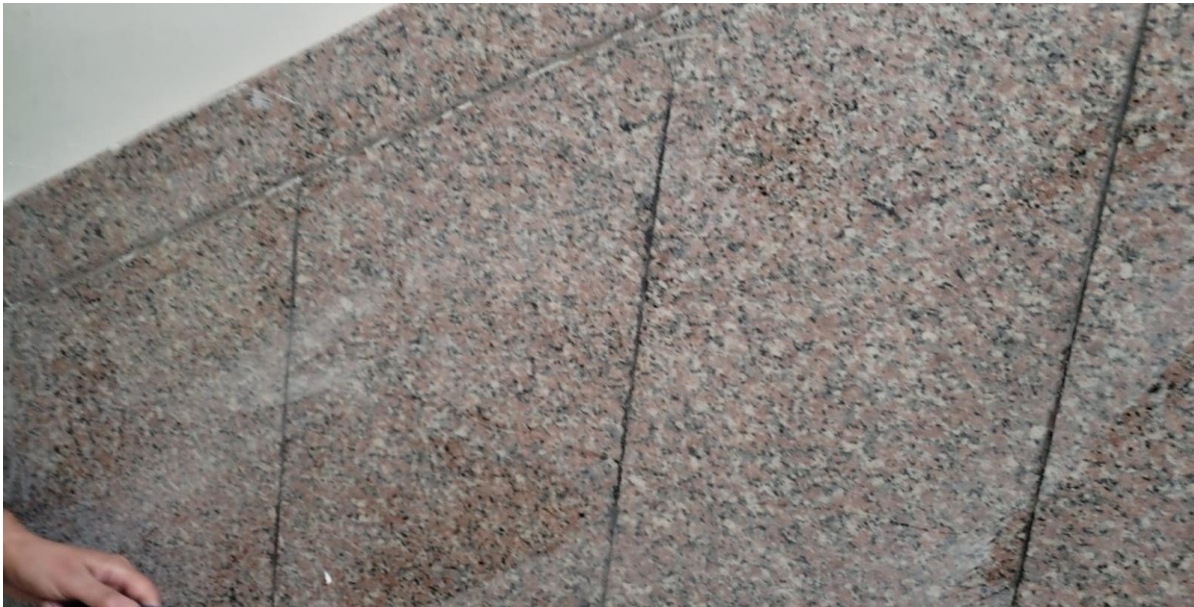
**Defected granite pieces**
