# SKEP III Home Office Support Site Visit Report

Consultant	Wahib Medanat Consultant Engineer	Rep No.	22-06032022
Contractor	Dijlah Establishment Constr. Contracting	Tender No.	(11/2019/USAID/SKEP/3/S) Schools for a Knowledge Economy Project (SKEP) - Phase (3) Package (1, 2)
Site Name	Thahr Al Sarow Basic School for Boys- Jerash	Day/ Date	Sun. 06/03/2022
Duration of Project	450 Calendar Days	Total Project Budget	8,314,983.735 JD

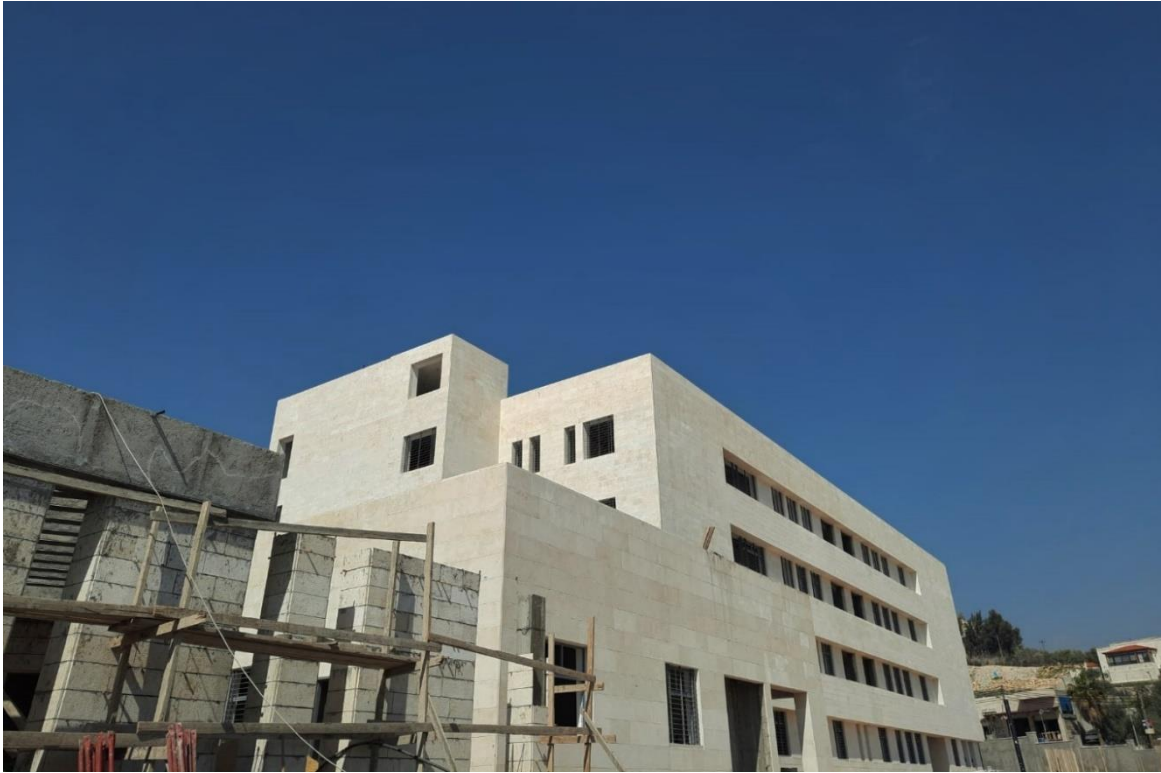
(Figure: 01)

General view of the project

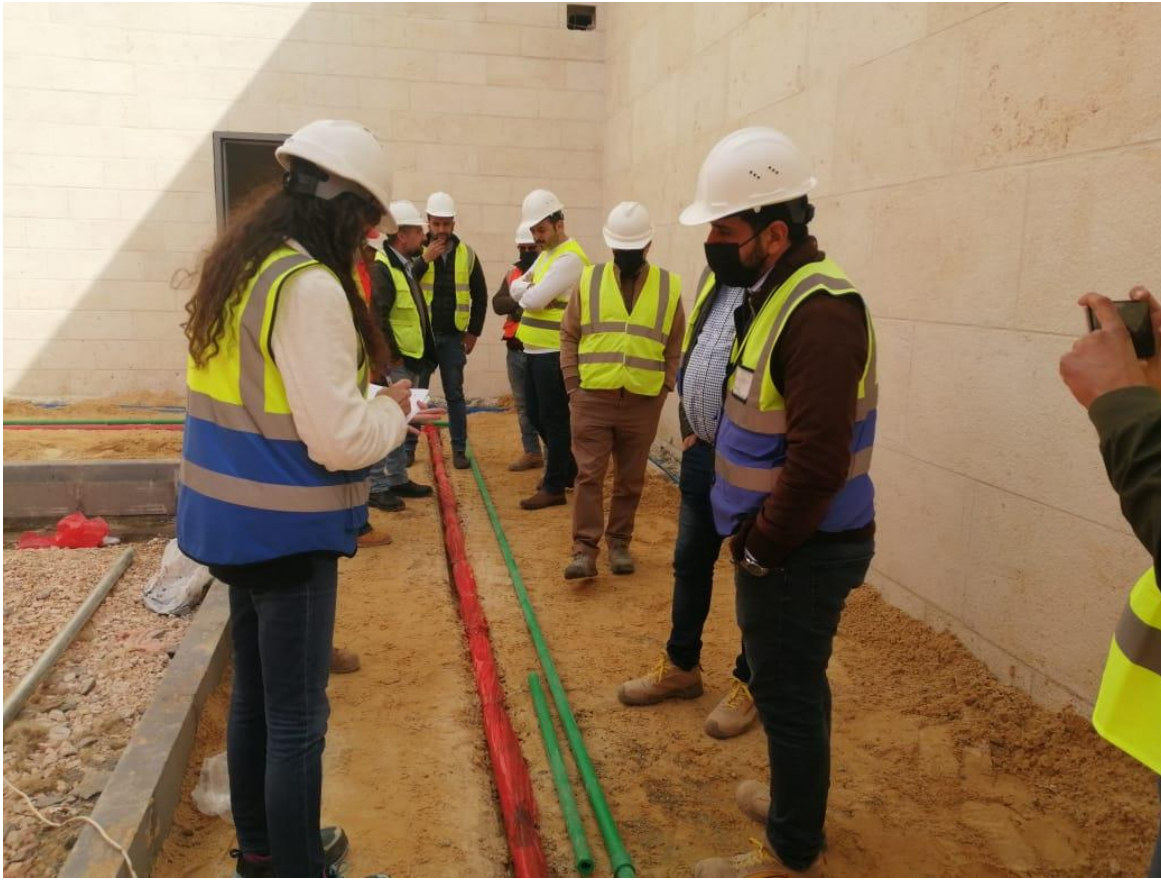
(Figure: 05)

The team observed the execution of water pipes under the external sidewalks

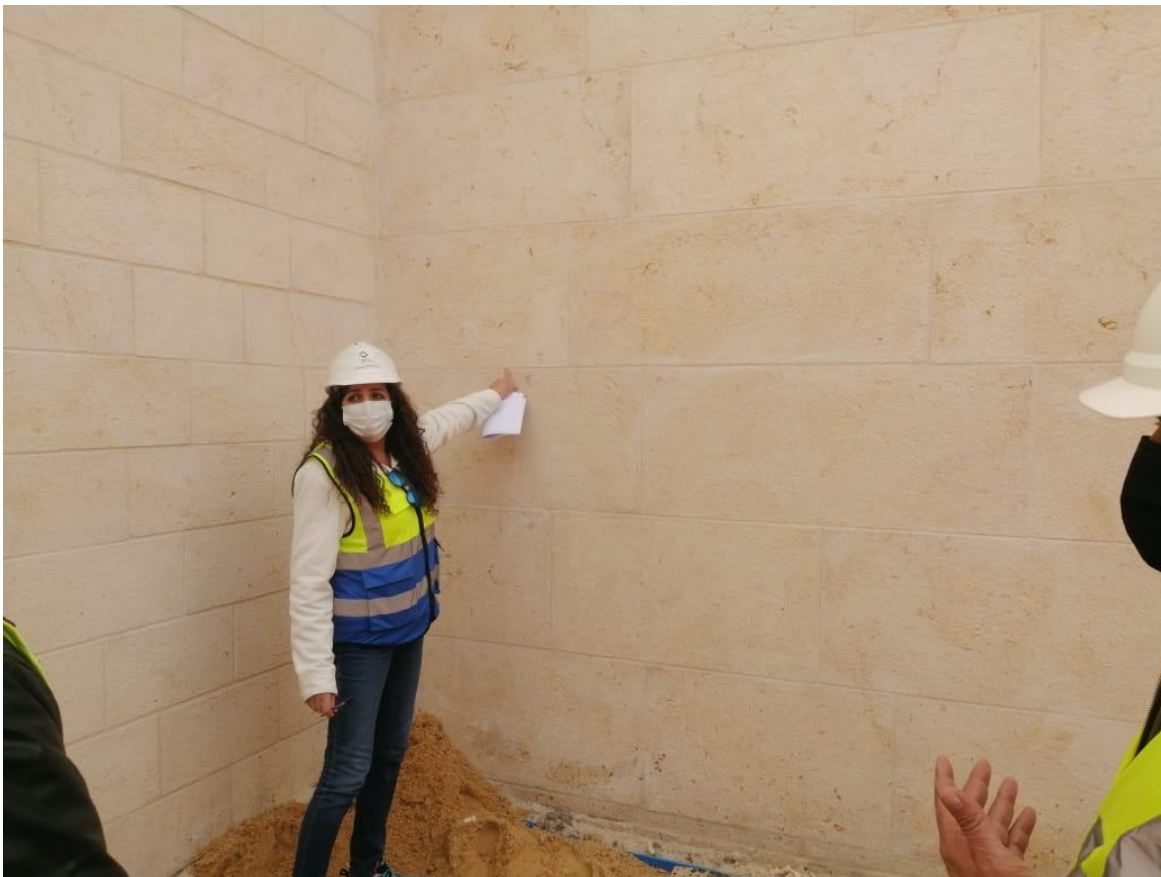
(Figure: 06)

The team observed that the Contractor tried to rectify a number of stones by covering the defects with cement mixes, but that is not accepted

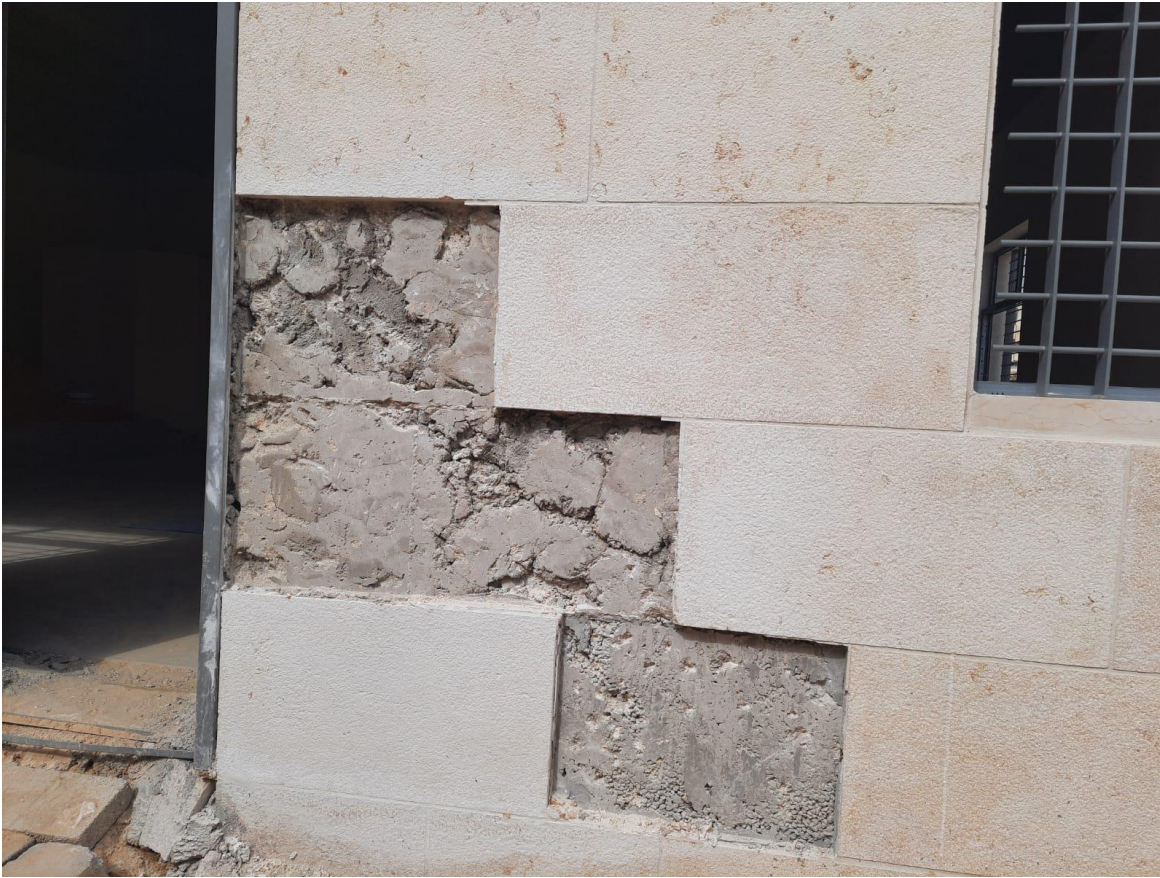
(Figure: 07)

The supervision team observed that the Contractor started with the removal of the defected stones to replace those stones with acceptable ones

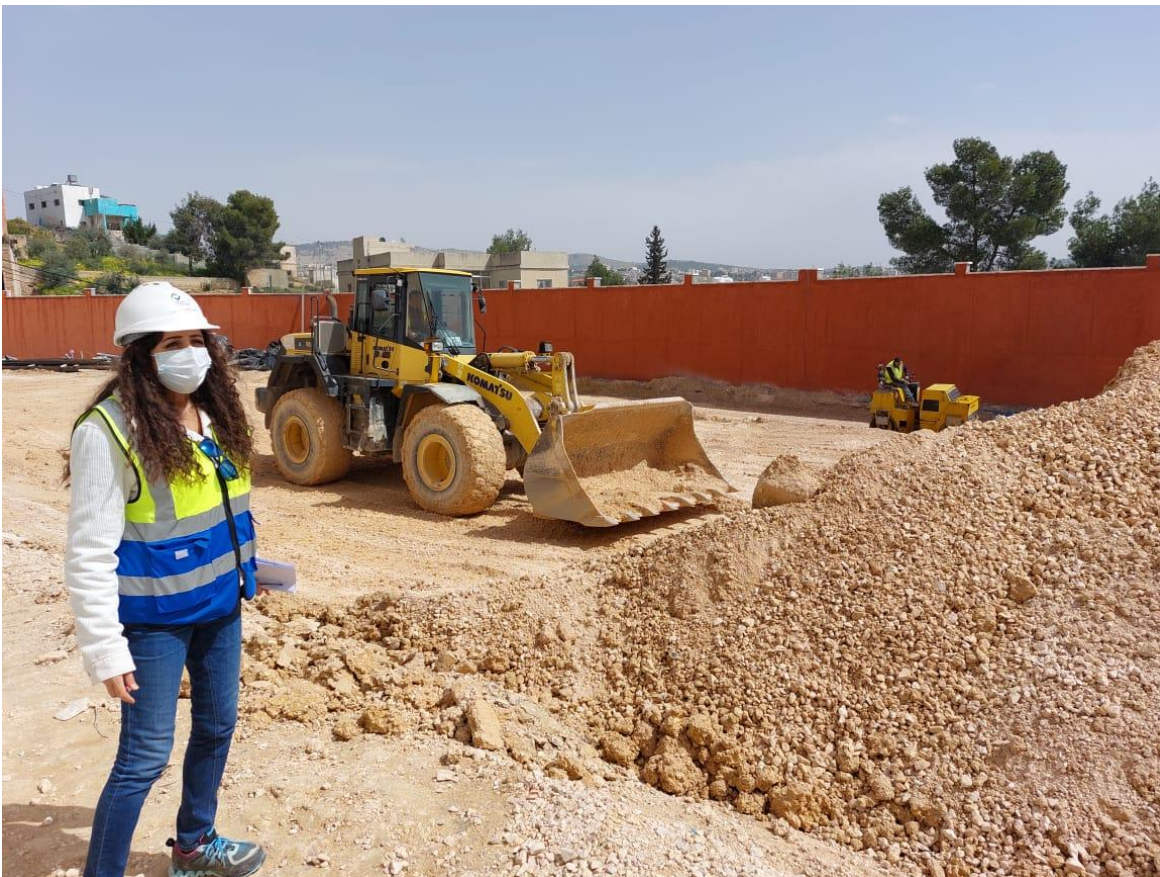
(Figure: 08)

The team inspected the work going on in the external yards which is mainly backfilling

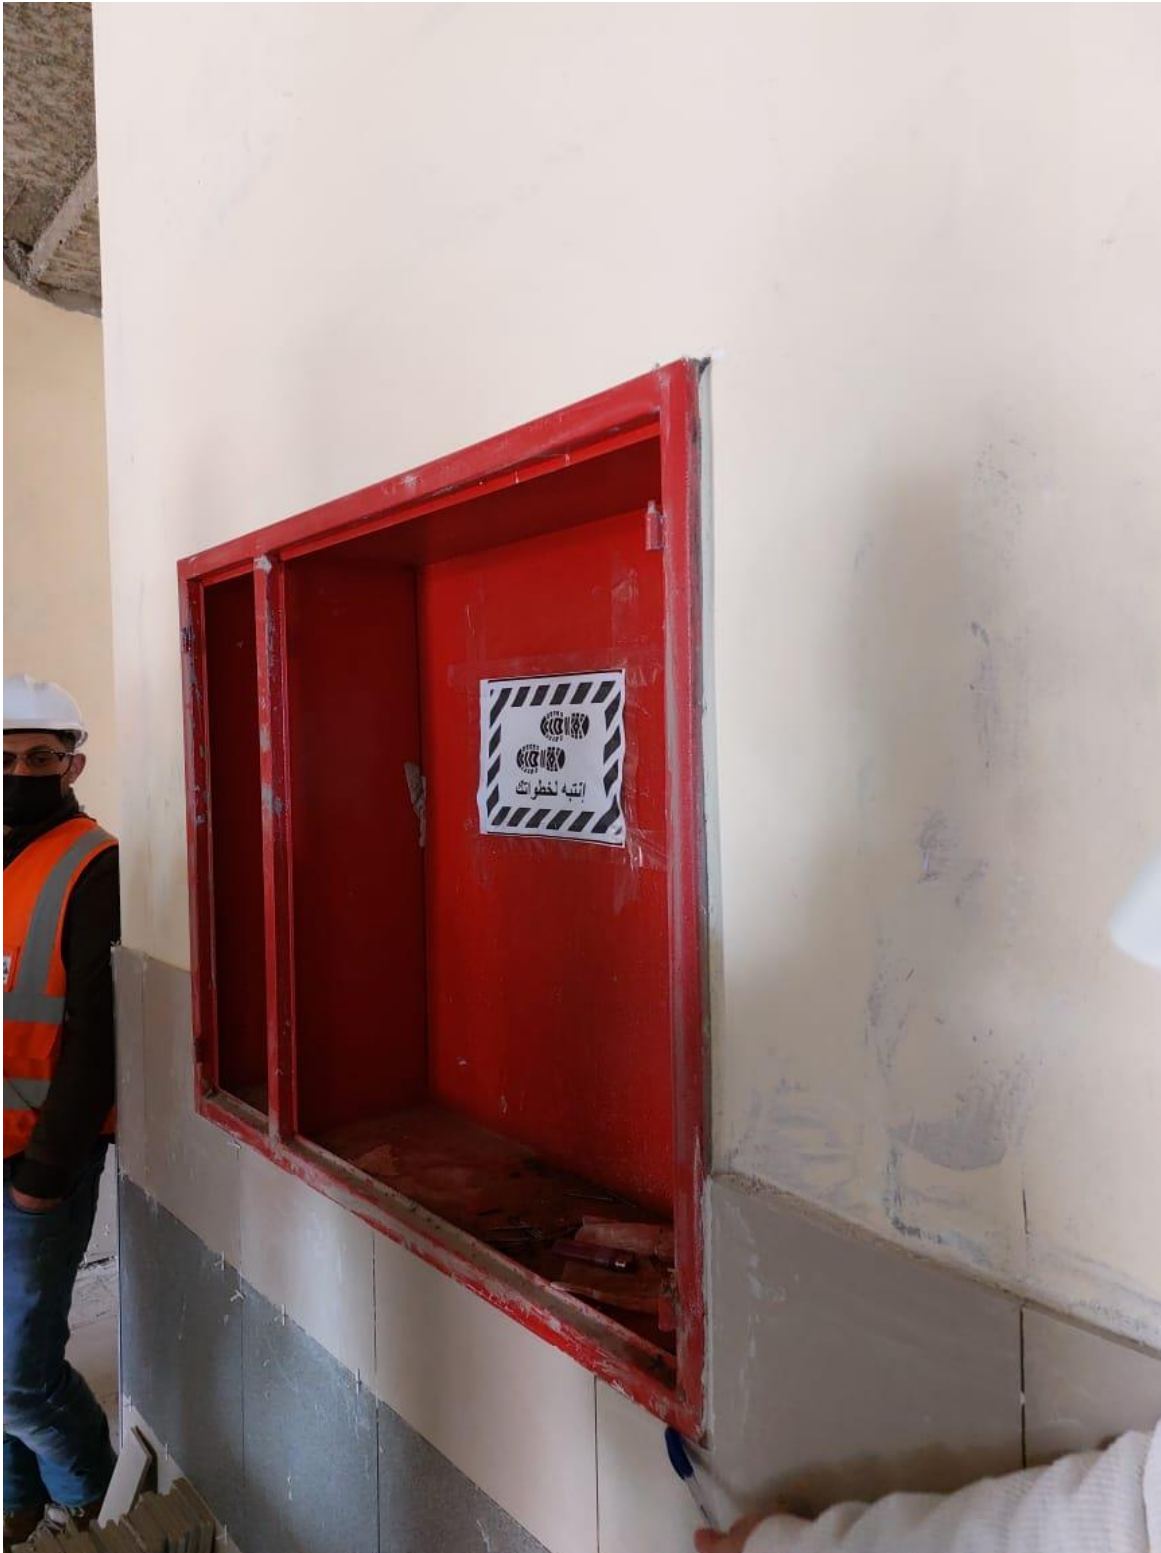
*(Figure: 09)*

The Supervision team observed defects in the installation of the fire hose cabinets:

- Large gap between the cabinet frame and the wall

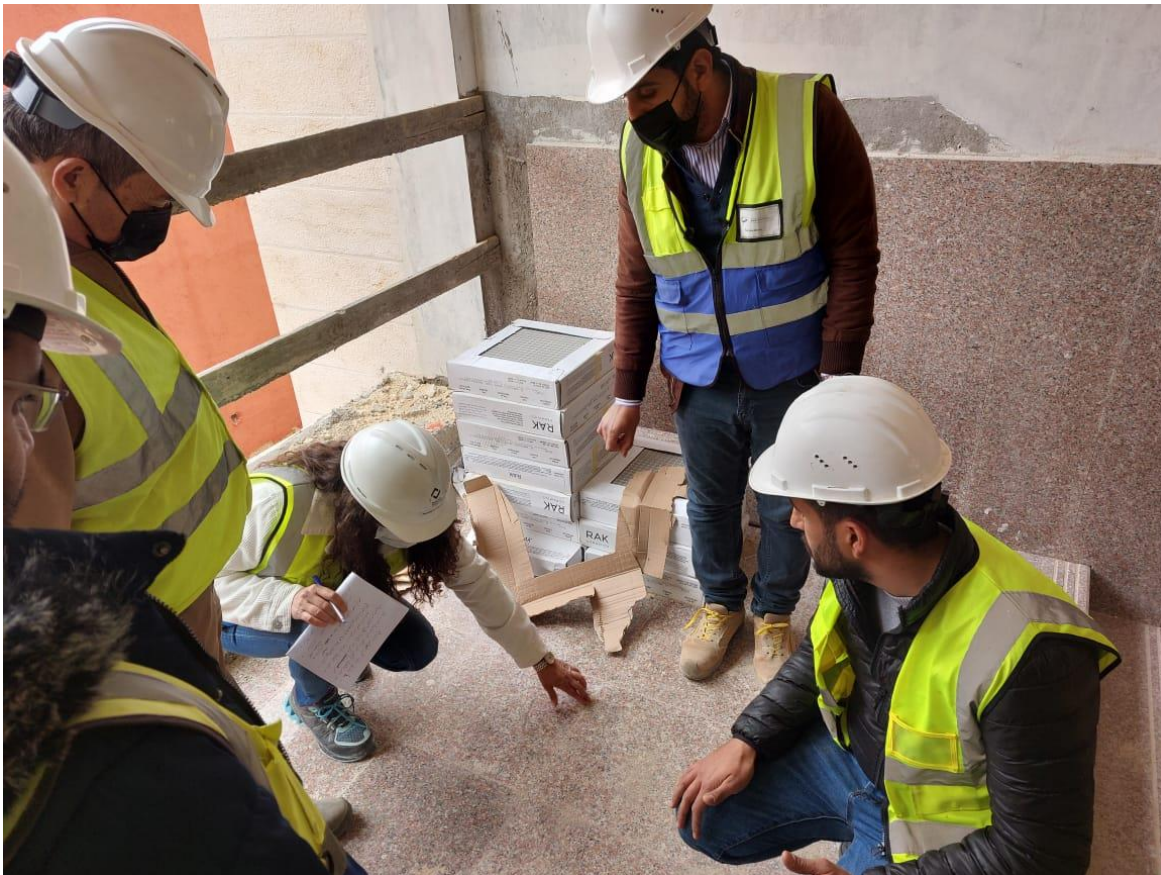
(Figure: 11)

The team observed that the granite tiling for stair landing is not rectified by the Contractor and the teething is still visible

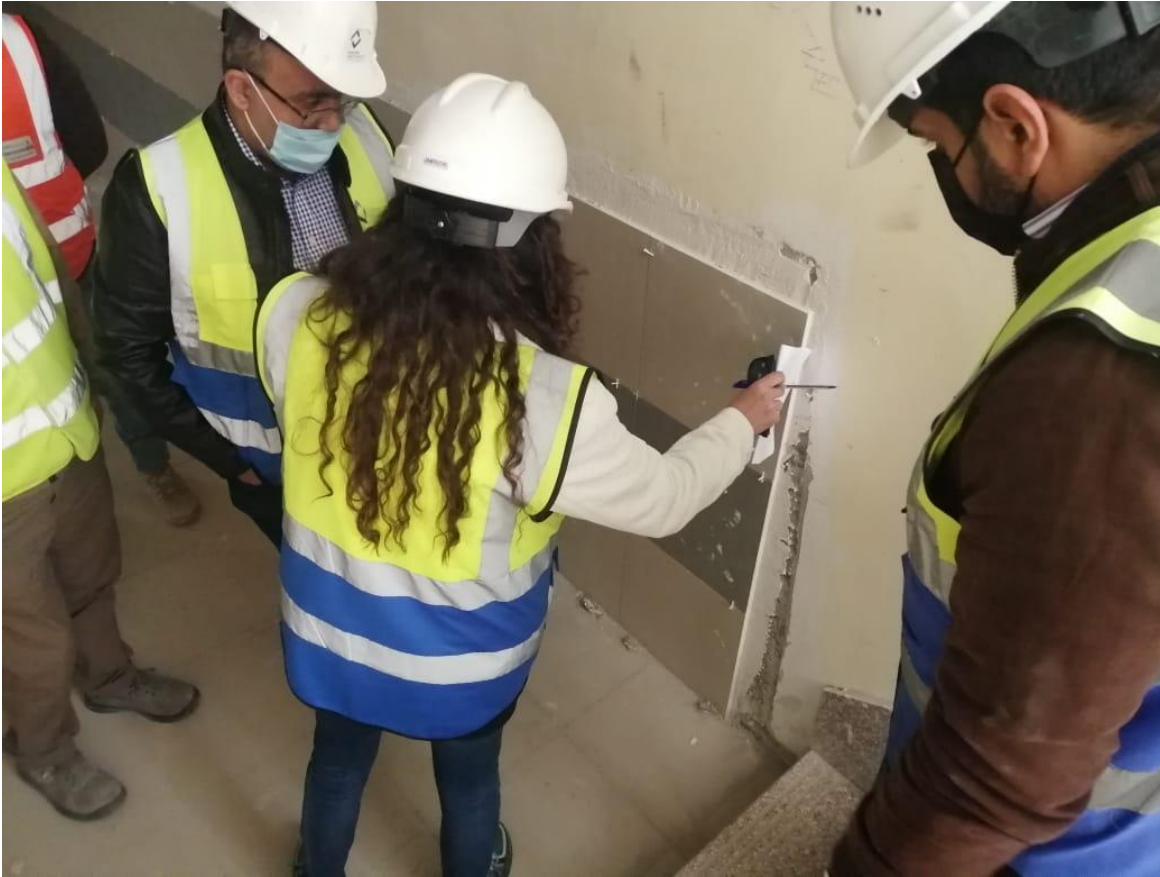
(Figure: 12)

The team discussed with the Contractor the connection between porcelain wall tiles and the granite skirting at the staircase area and also other architectural details were discussed

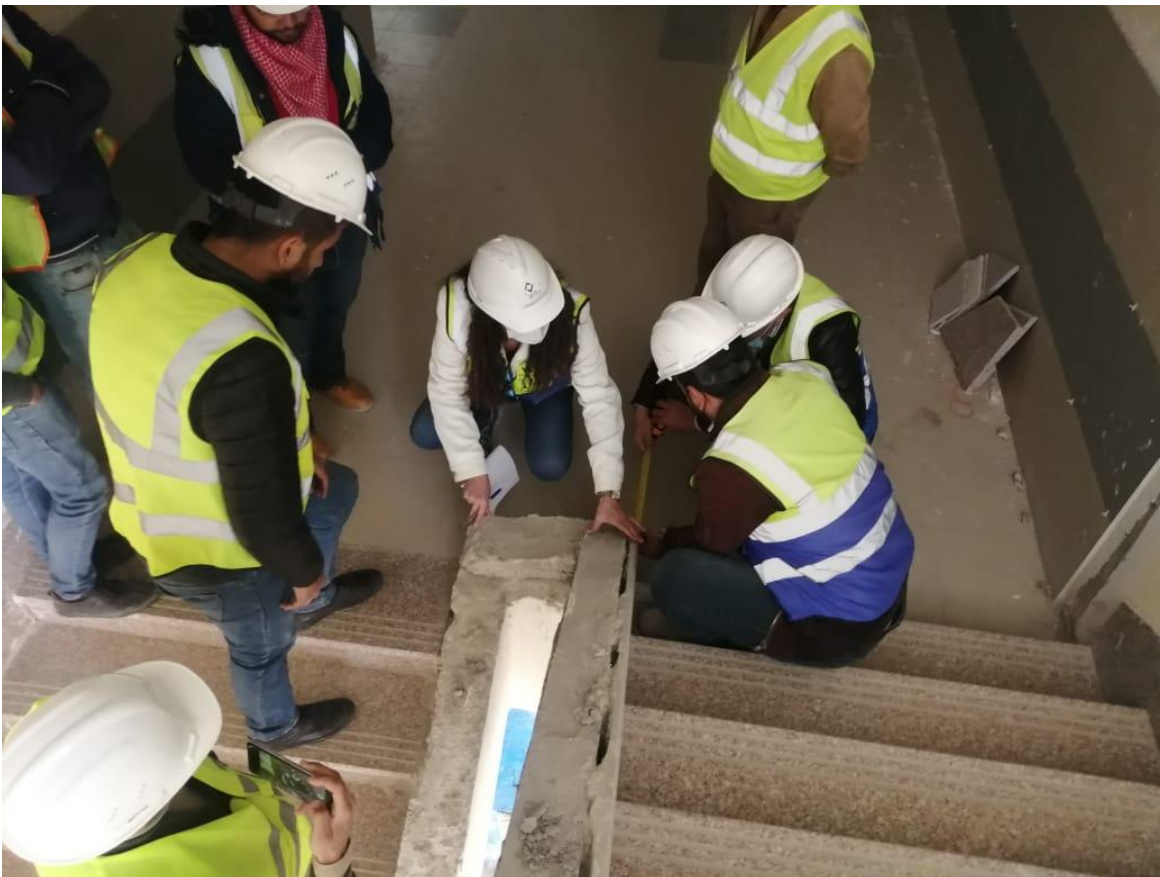
(Figure: 13)

Discussing staircase parapet detail

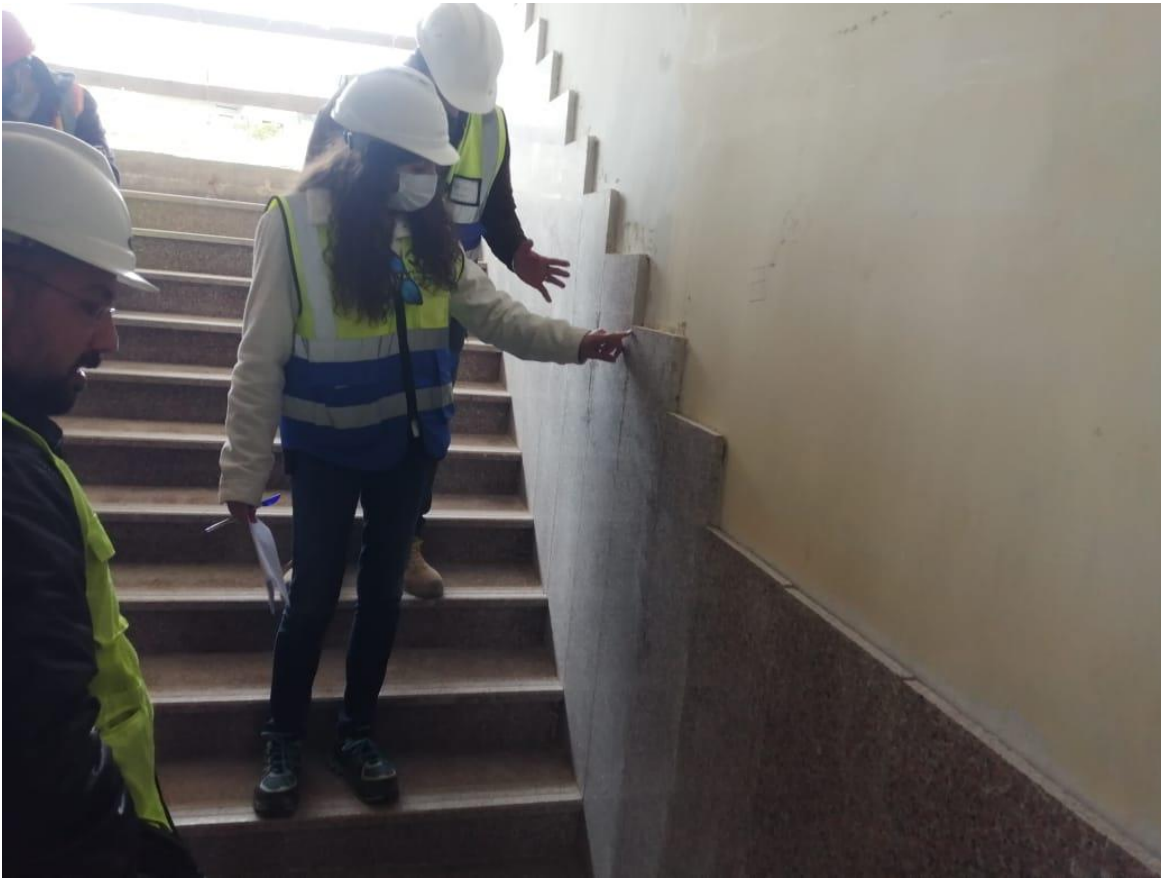
(Figure: 14)

The team observed the unacceptable status of granite cladding for the staircases and stressed on the Contractor to rectify all defected parts due to wrong cutting of granite pieces

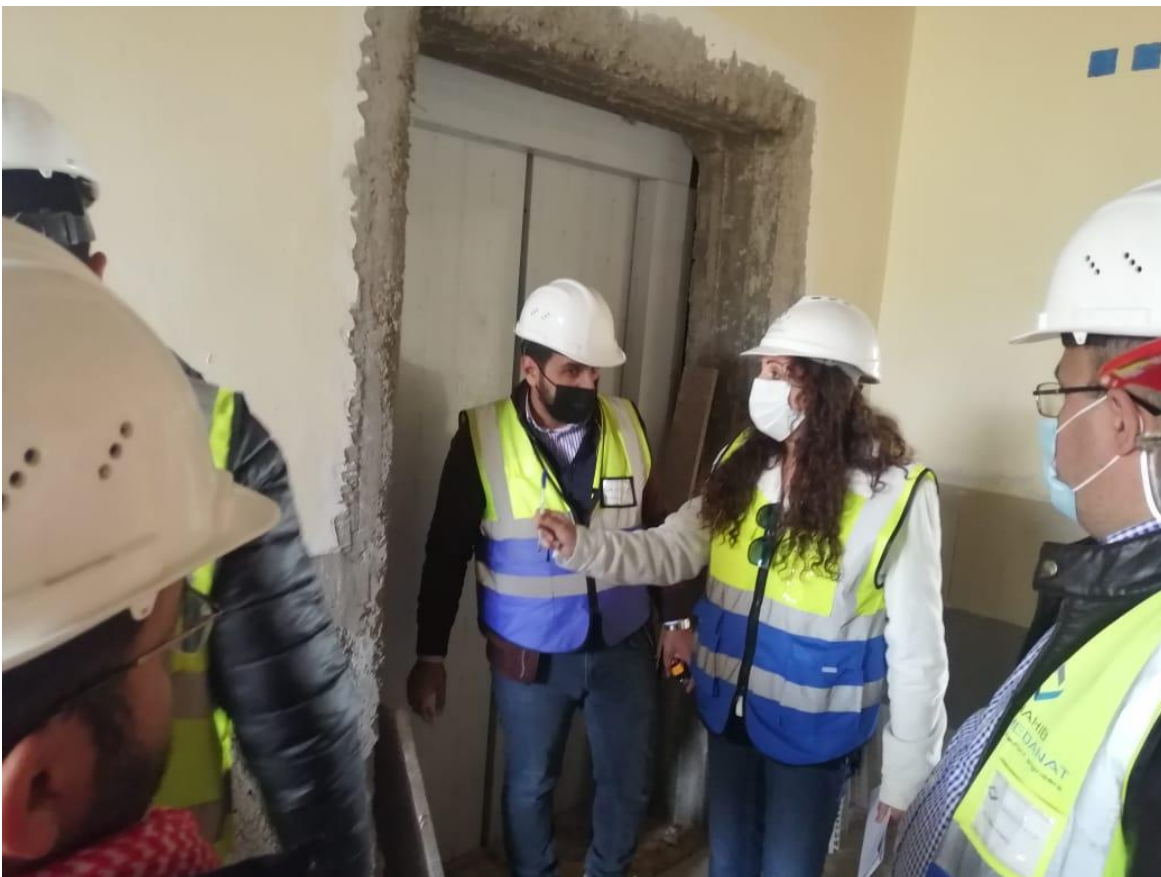
(Figure: 15)

The granite cladding around the elevator door was discussed with the Contractor

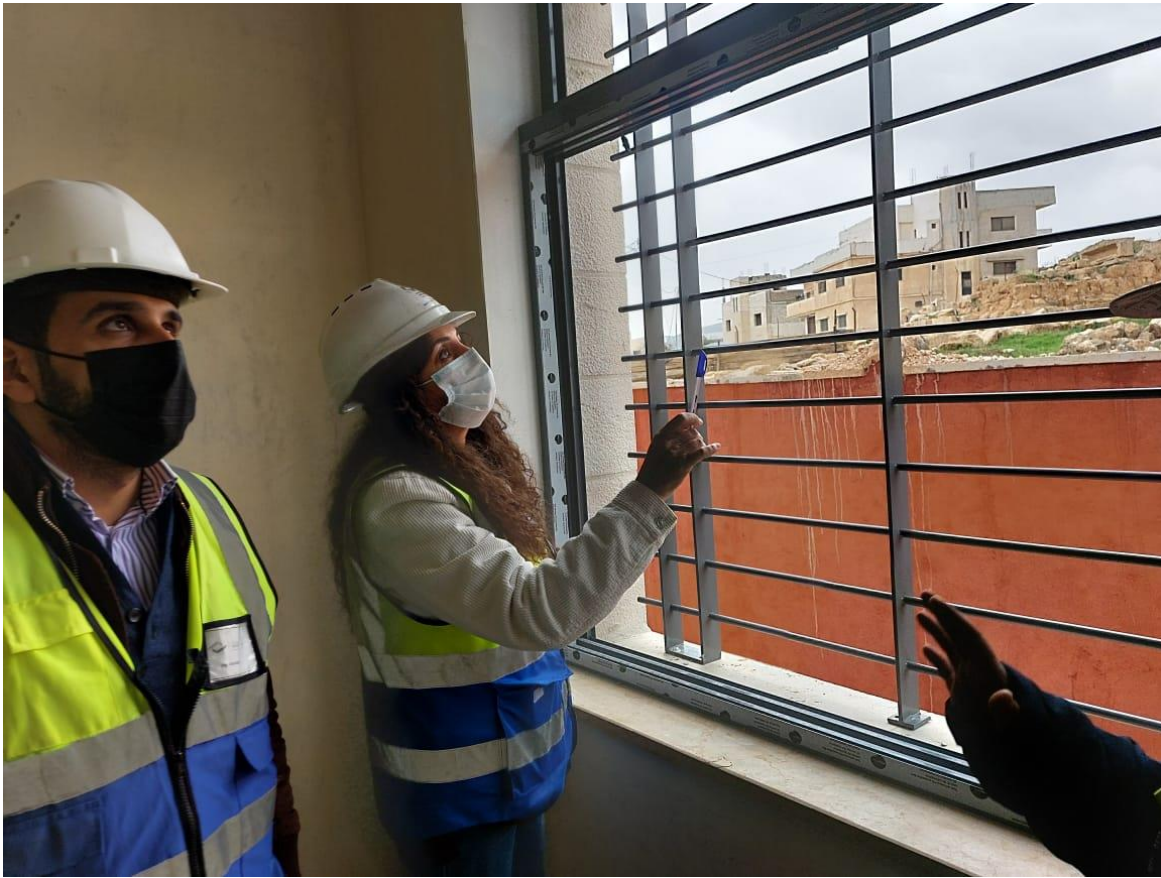
(Figure: 16)

The team inspected the fixation of the steel protection screen and observed corrosion in some parts

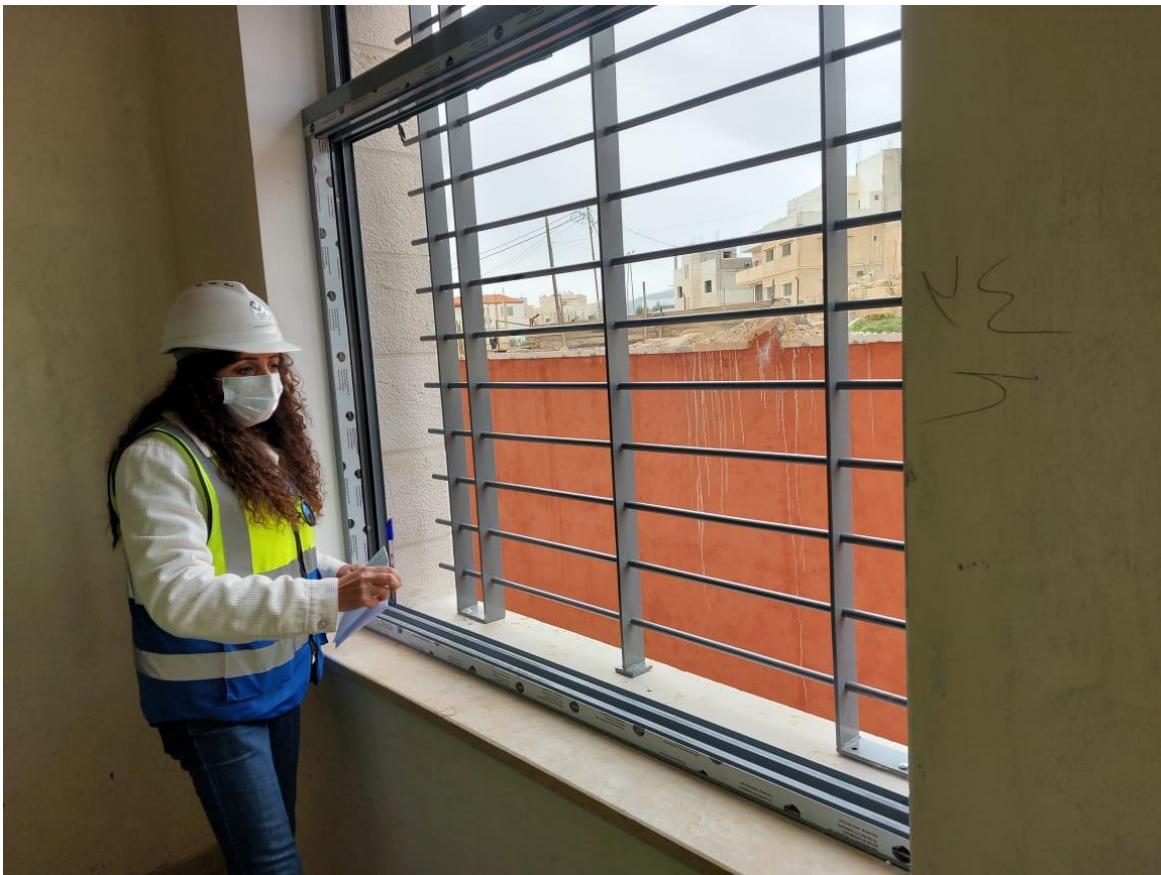
(Figure: 17)

The team inspected the fixation of aluminum window frames for windows

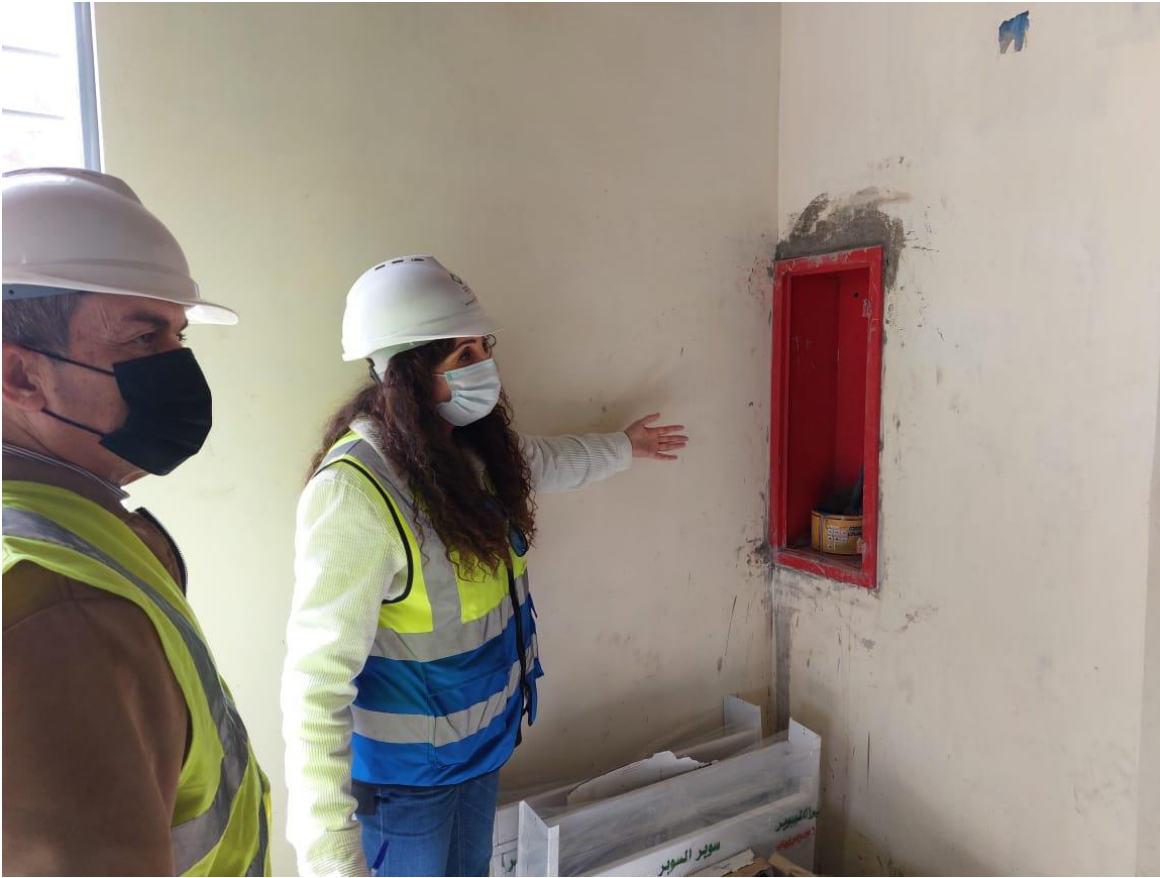
(Figure: 18)

Inspecting fire extinguisher installation at the multi-purpose hall

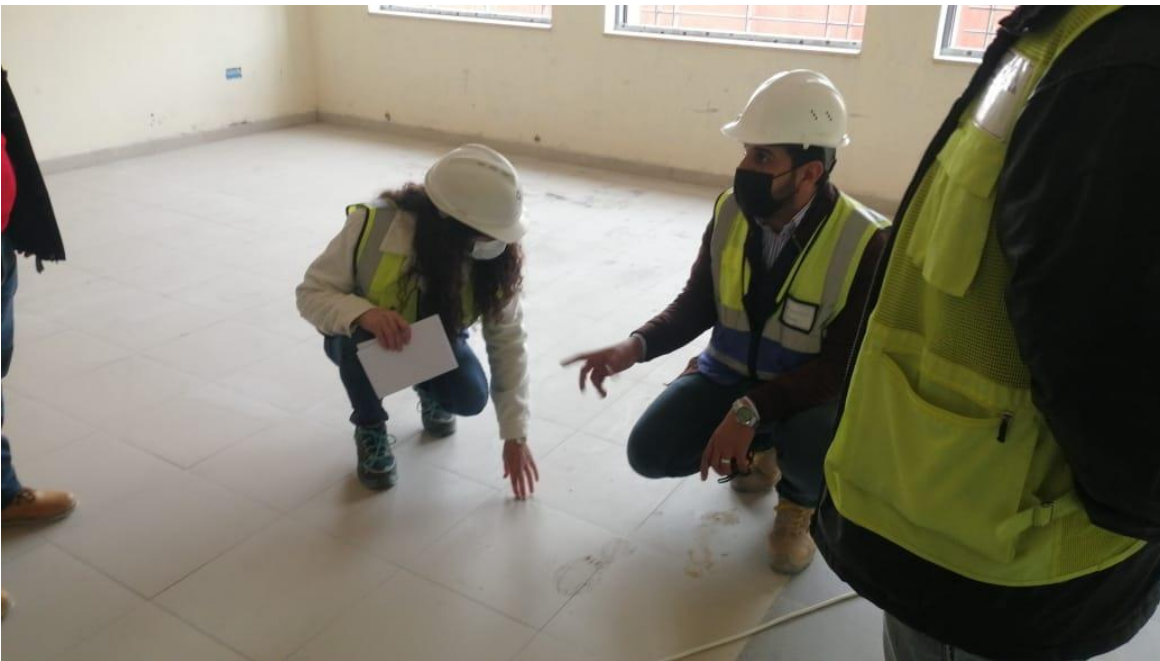
(Figure: 19)

The team observed minor teething in some parts in the porcelain floor tiles and requested the Contractor to rectify

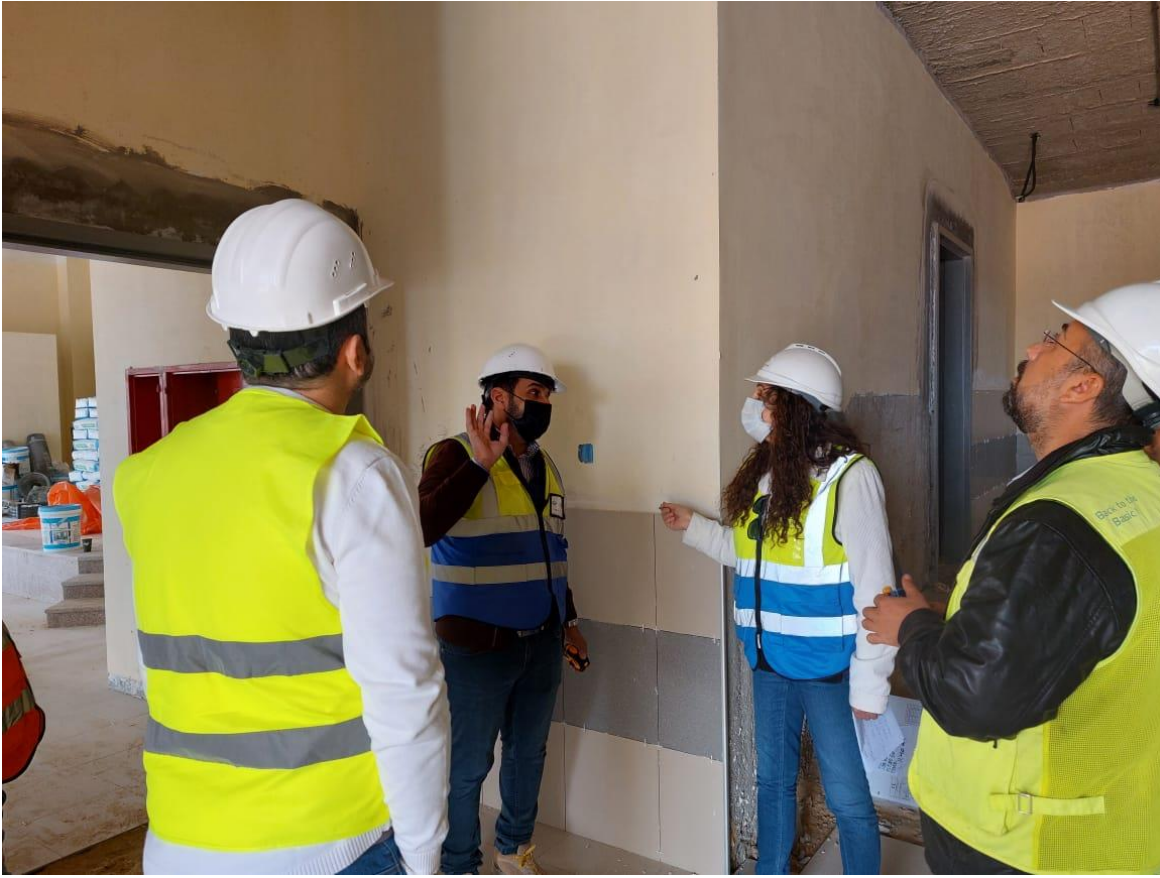
(Figure: 20)

The team discussed with the Contractor creating a core in one drop beam for the purpose of installing heating pipes under the ceiling

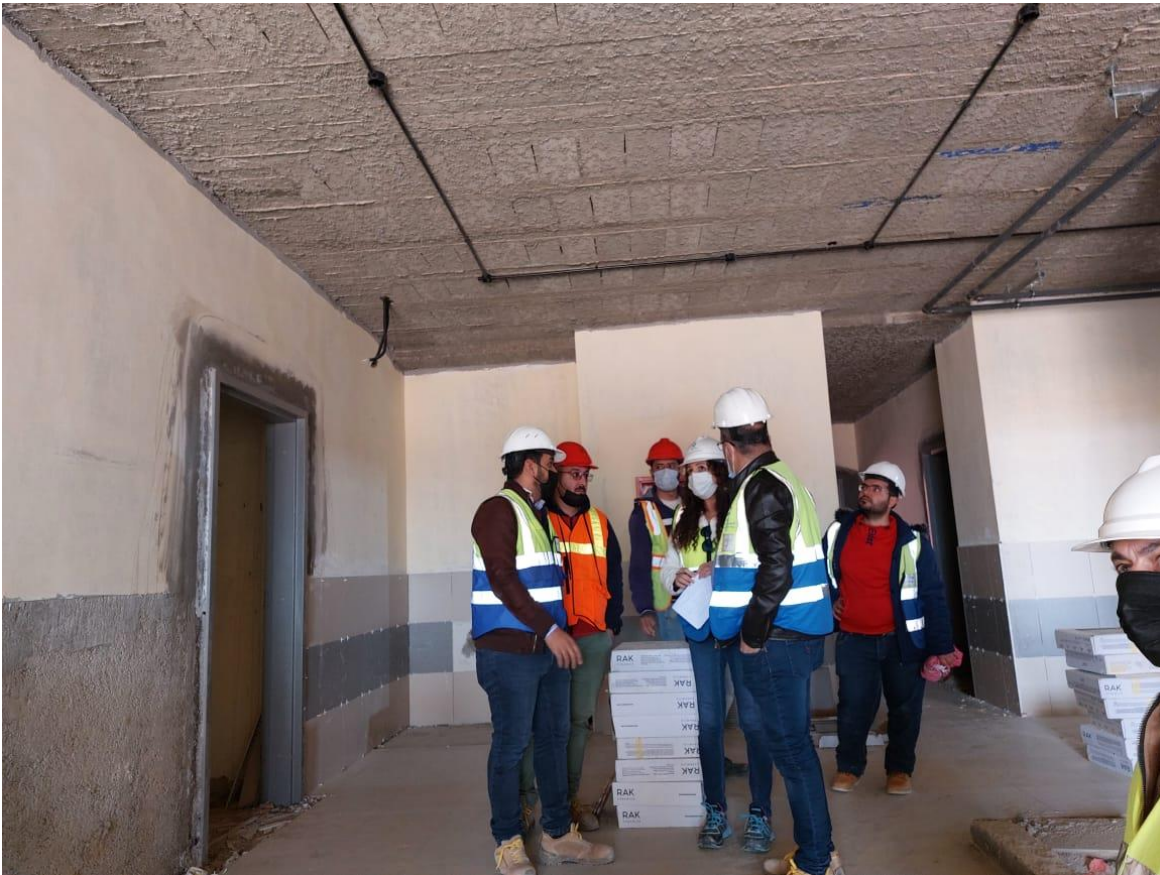
(Figure: 21)

The team discussed with the Contractor the tracks of heating pipes under the ceiling at the entrance of the multi-purpose hall and to find out the appropriate track

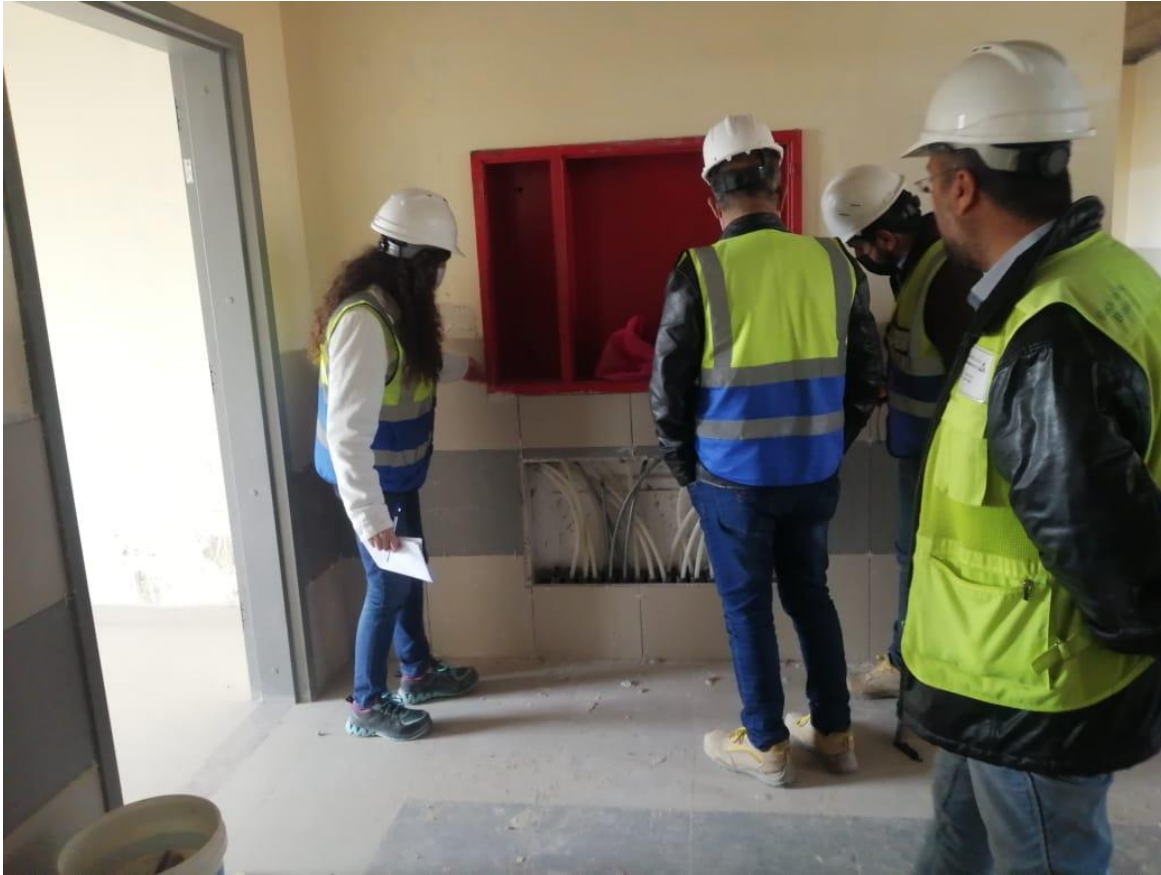
(Figure: 22)

The team observed that a number of water cabinets are not installed in level and requested the Contractor to rectify
