SKEP III Home Office Support Site Visit Report

Consultant	Wahib Medanat Consultant Engineer	Rep No.	23-05062022
Contractor	Dijlah Establishment Constr. Contracting	Tender No.	(11/2019/USAID/SKEP/3/S) Schools for a Knowledge Economy Project (SKEP) - Phase (3) Package (1, 2)
Site Name	Jumana Bint Abit Taleb Basic Mixed School - Jerash	Day/ Date	Sun. 05/06/2022
Duration of Project	450 Calendar Days	Total Project Budget	8,314,983.735 JD

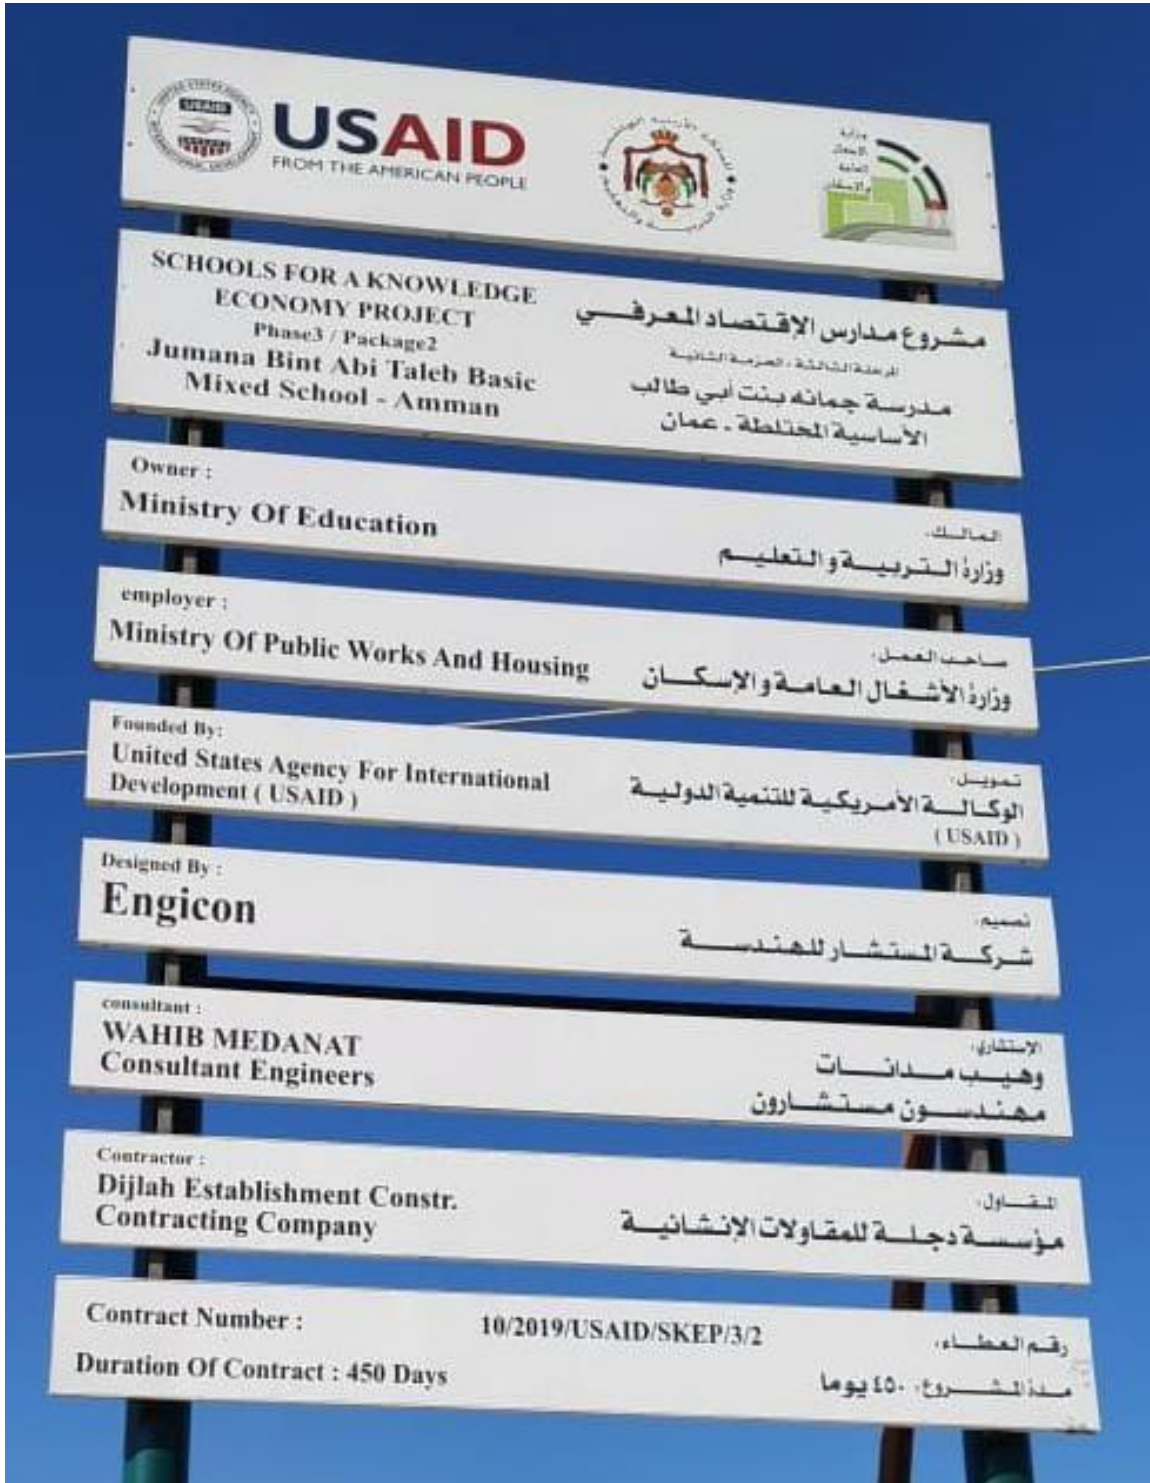
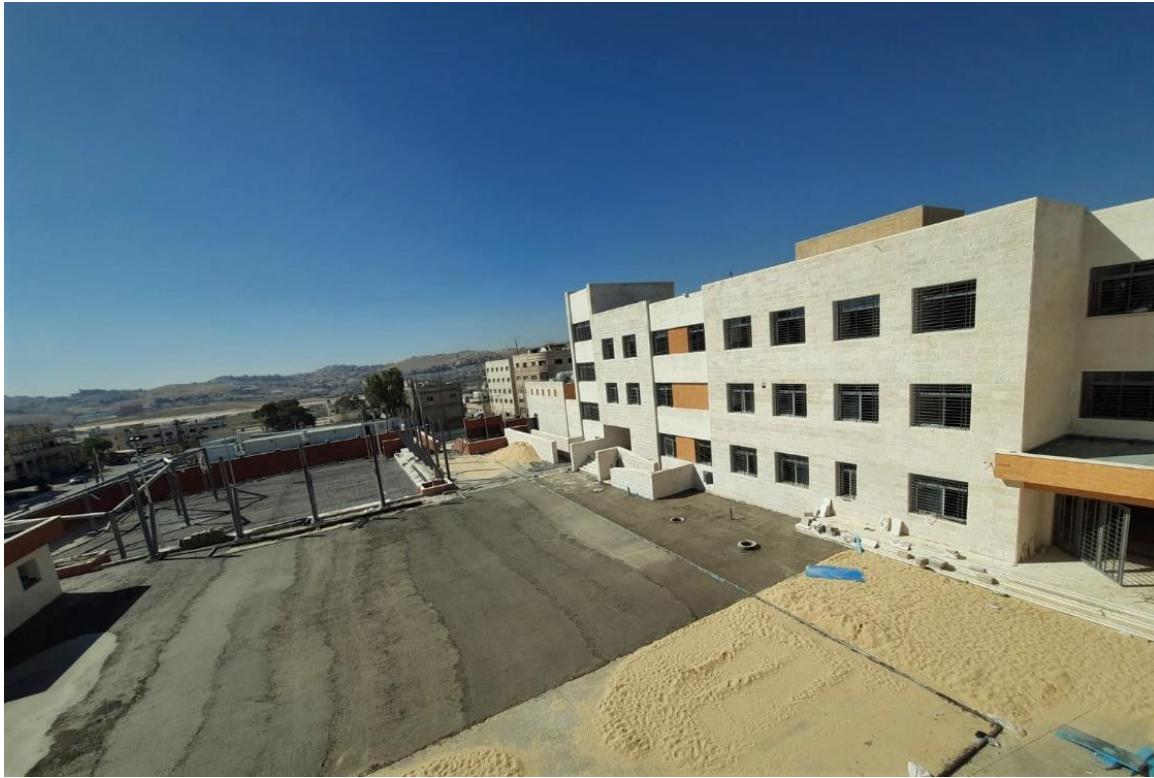
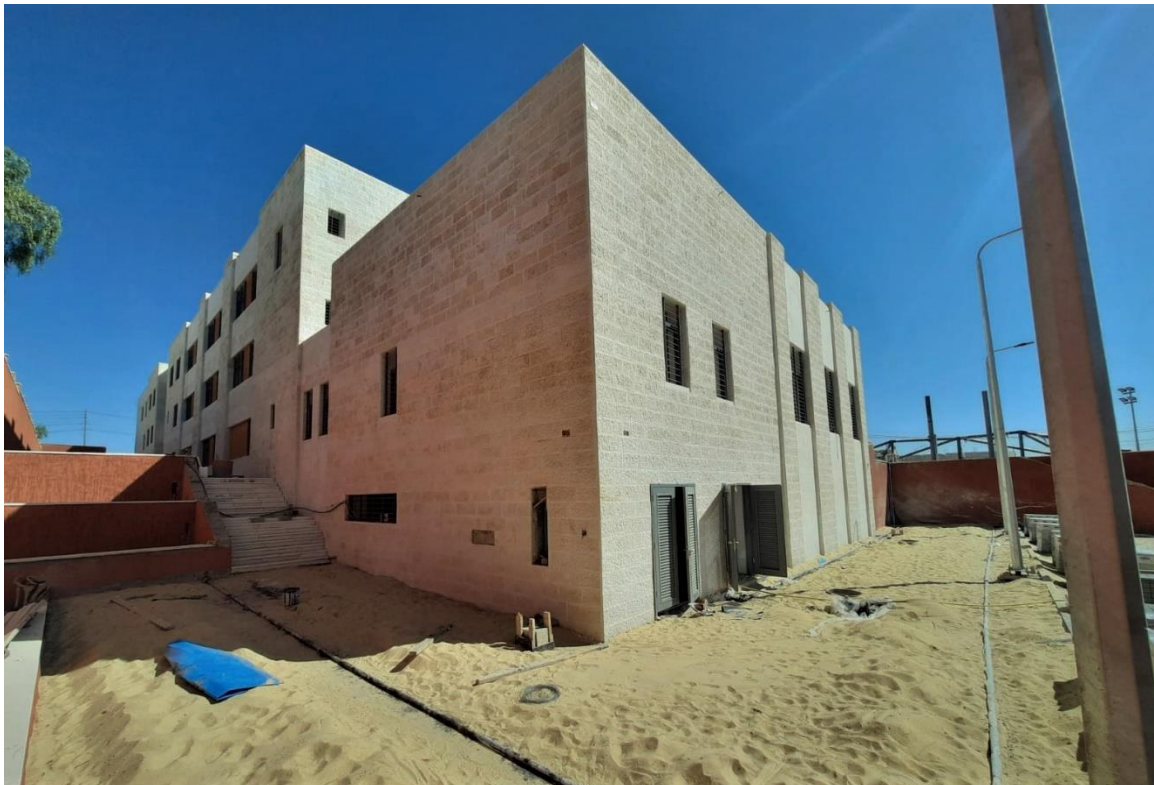
(figures: 01, 02 & 03)

General view of the project site

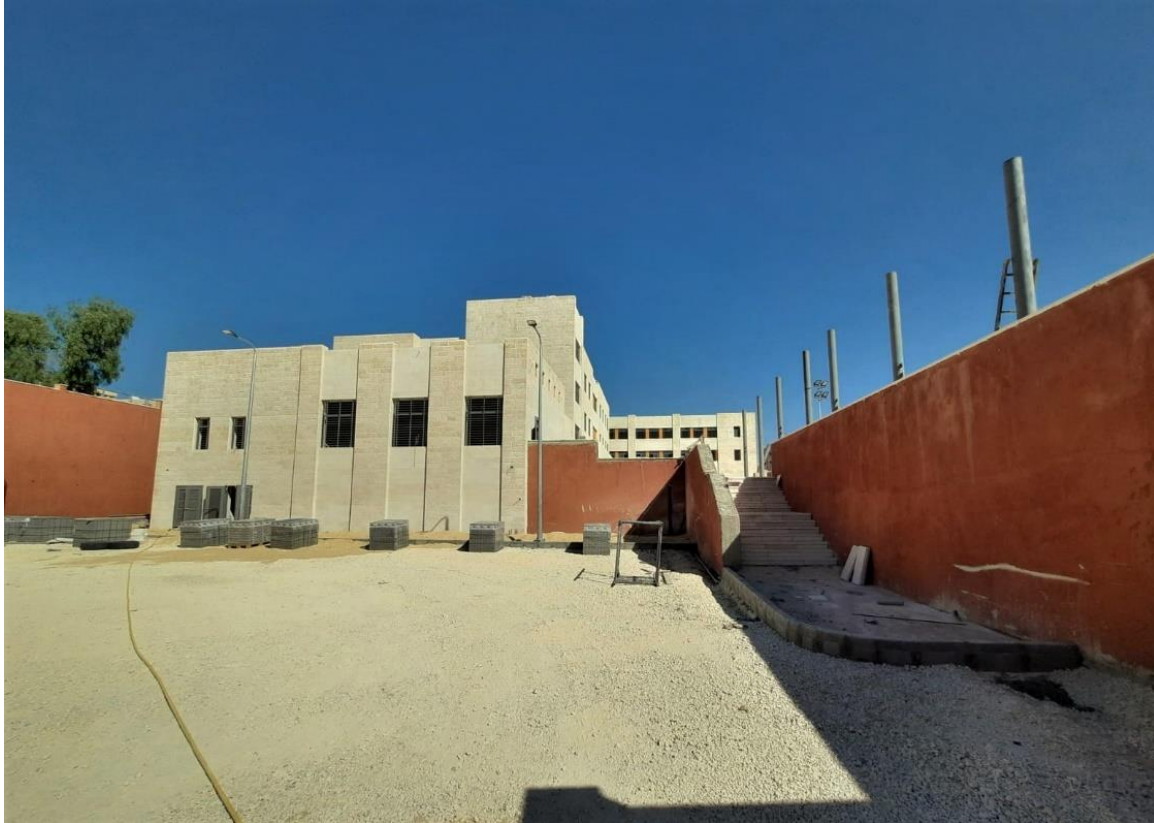
(Figure: 03)

The supervision team observed that the Contractor has removed the defected stones at the facades of the canteen and replaced them by stones that conform to the requirements

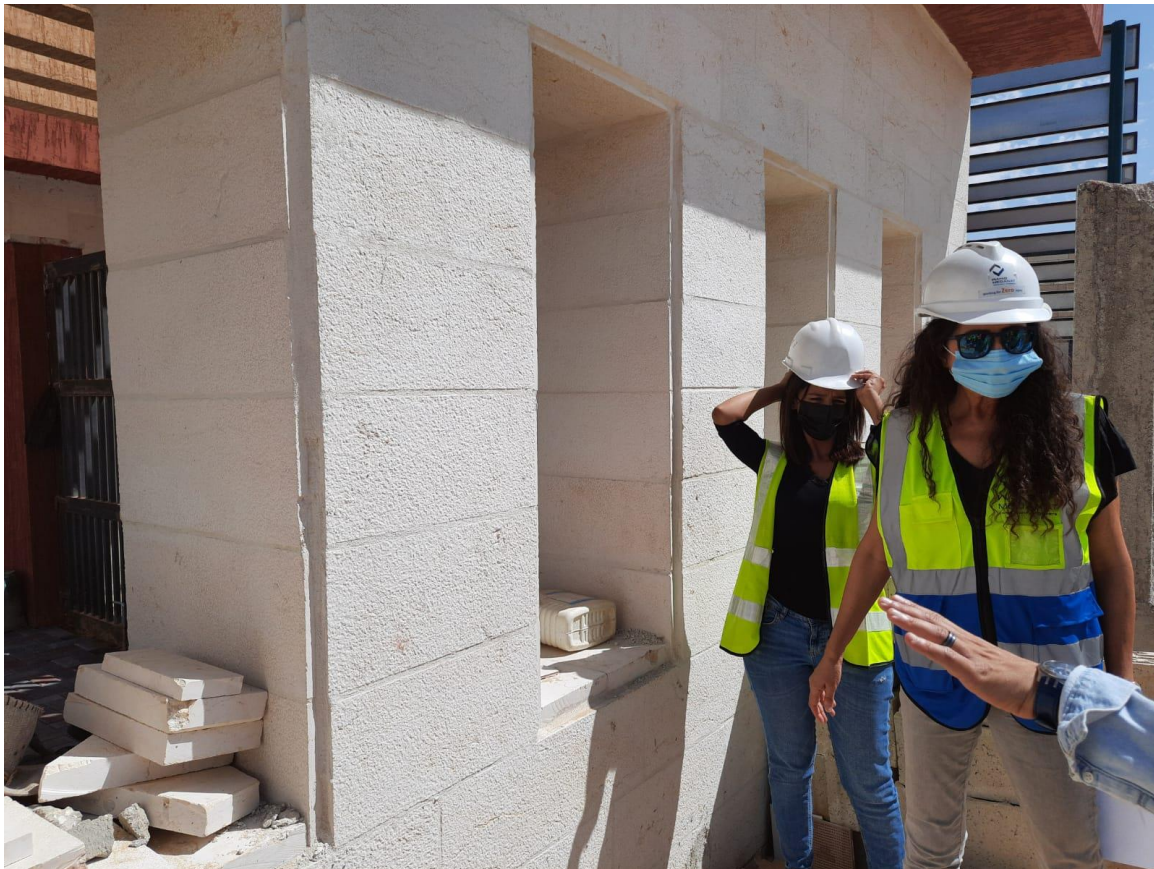
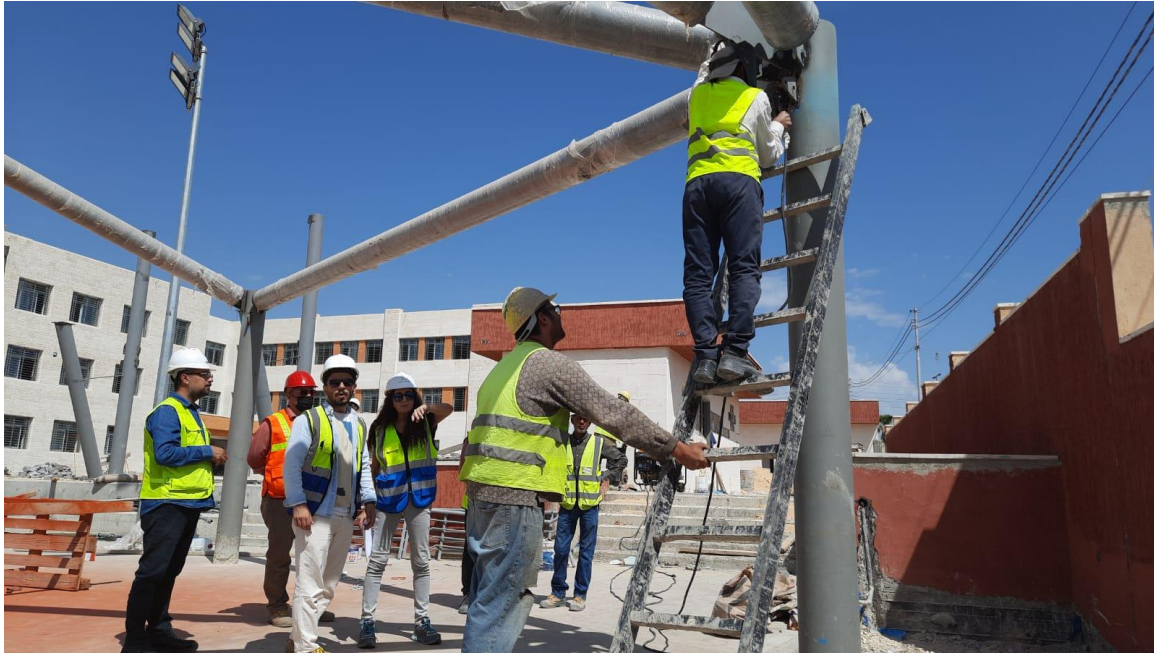
(Figure: 05 & 06)

The team inspected the stage of work in the canopies at the yards

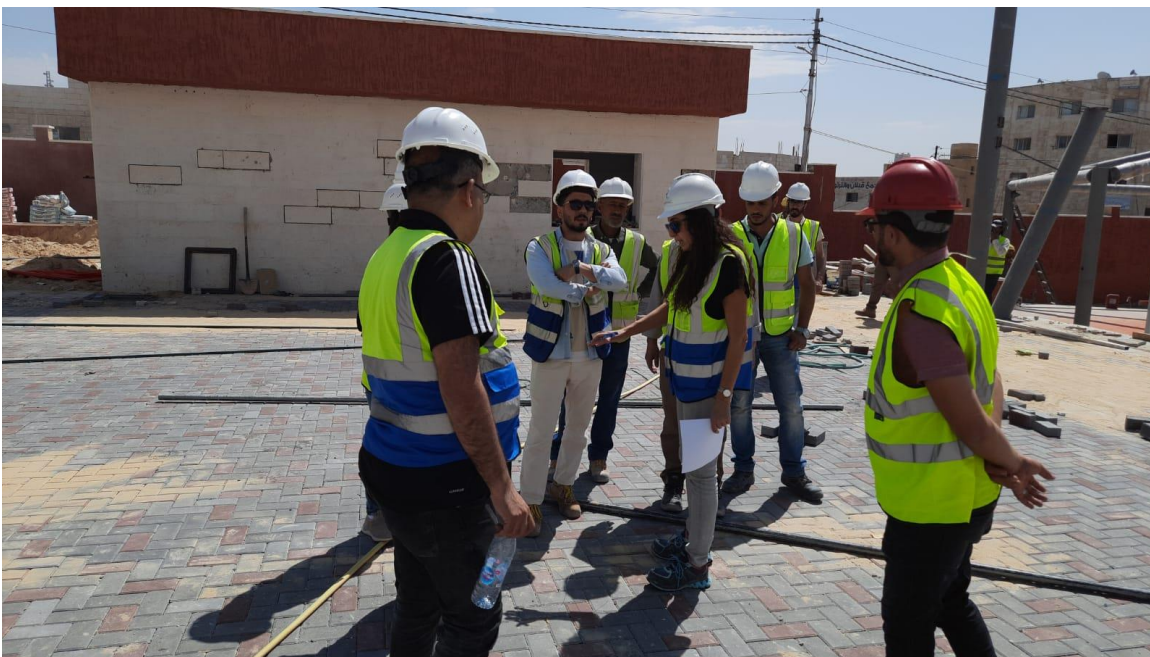
(Figure: 08)

The team observed the compaction process for interlocking tiles to adjust the levels as per requirements

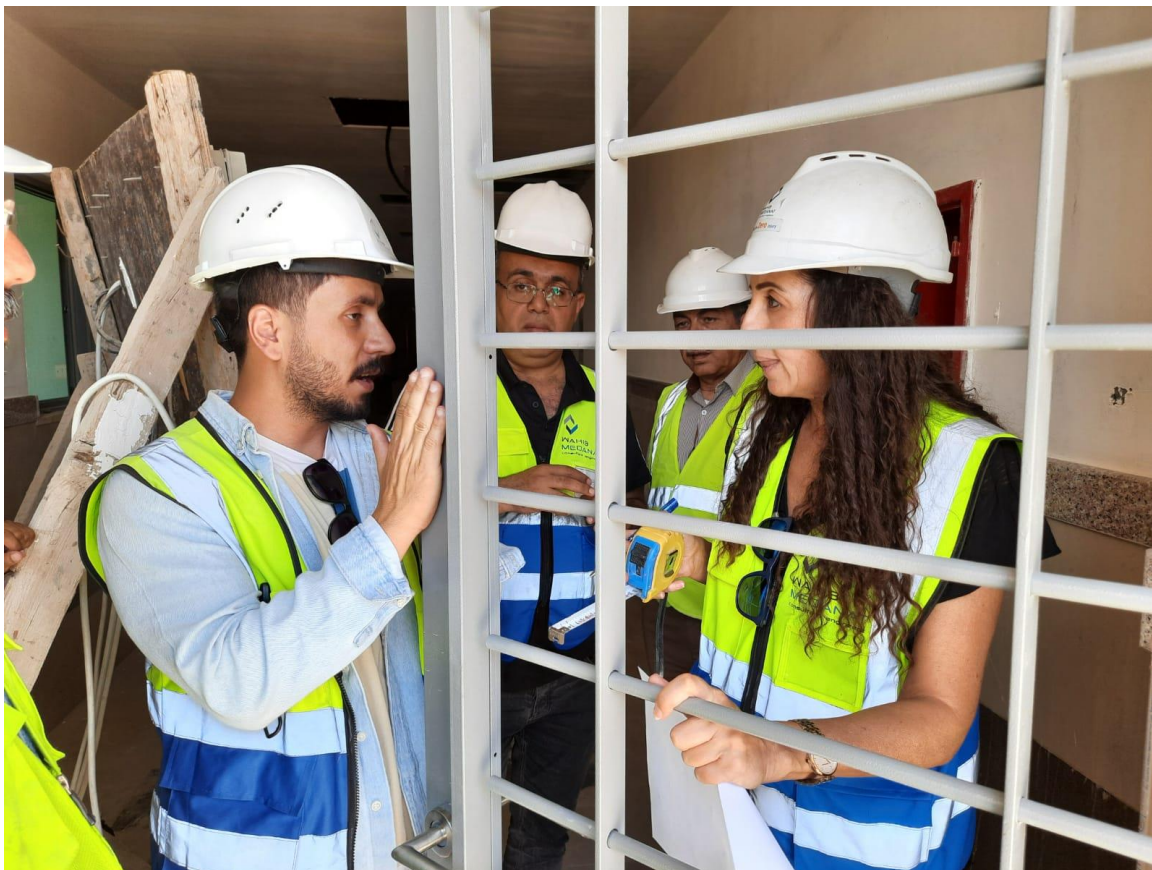
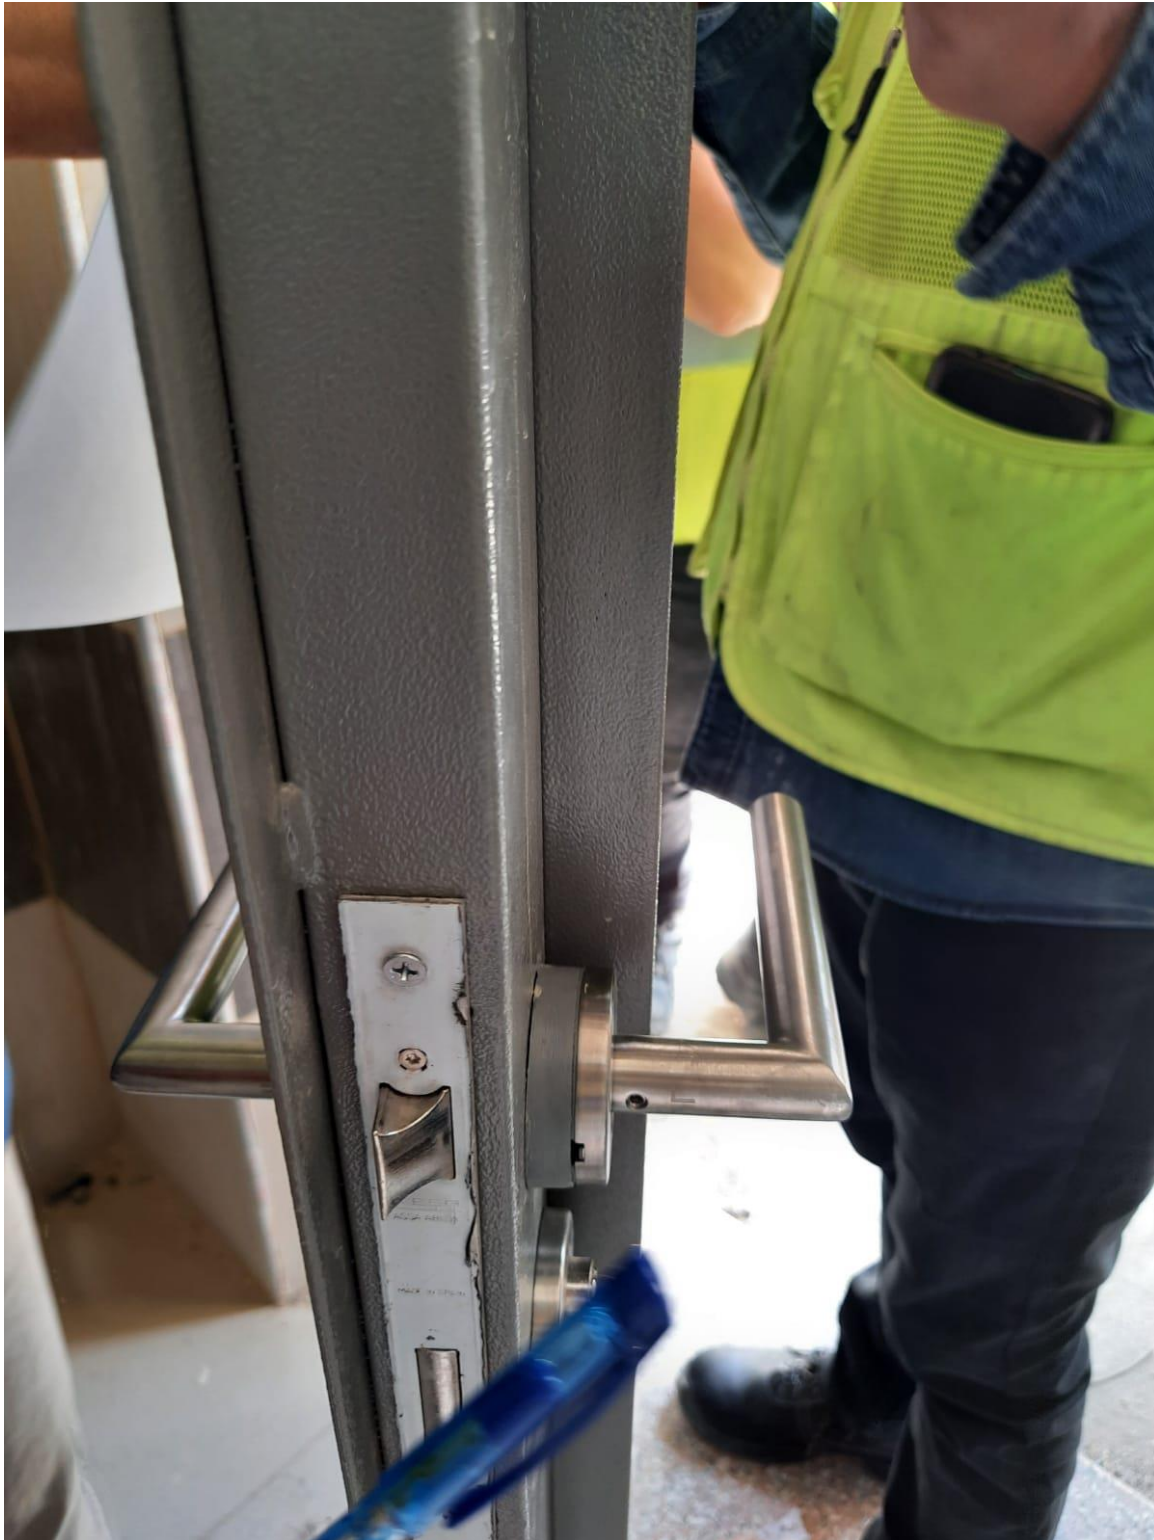
(Figure: 10 & 11)

The team closely inspected the steel door sample at the school's entrance and observed that the sample does not comply with the design drawings in relation to the dimensions of steel sections of the door

Due to this non-compliance, the entire sample is considered as not complying with the architectural details

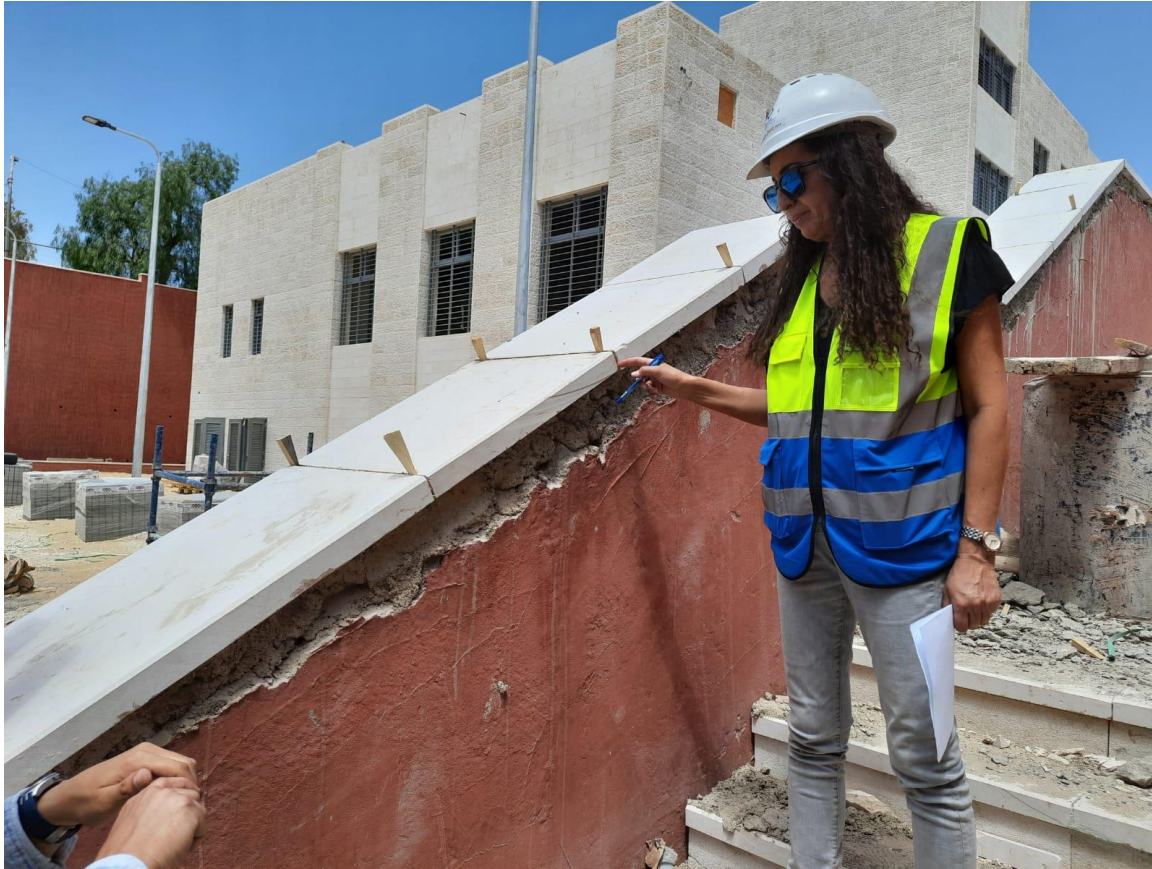
(Figure: 11)

The team inspected the installed stone coping at the top of external walls and observed a number of broken pieces and requested the Contractor to replace those pieces

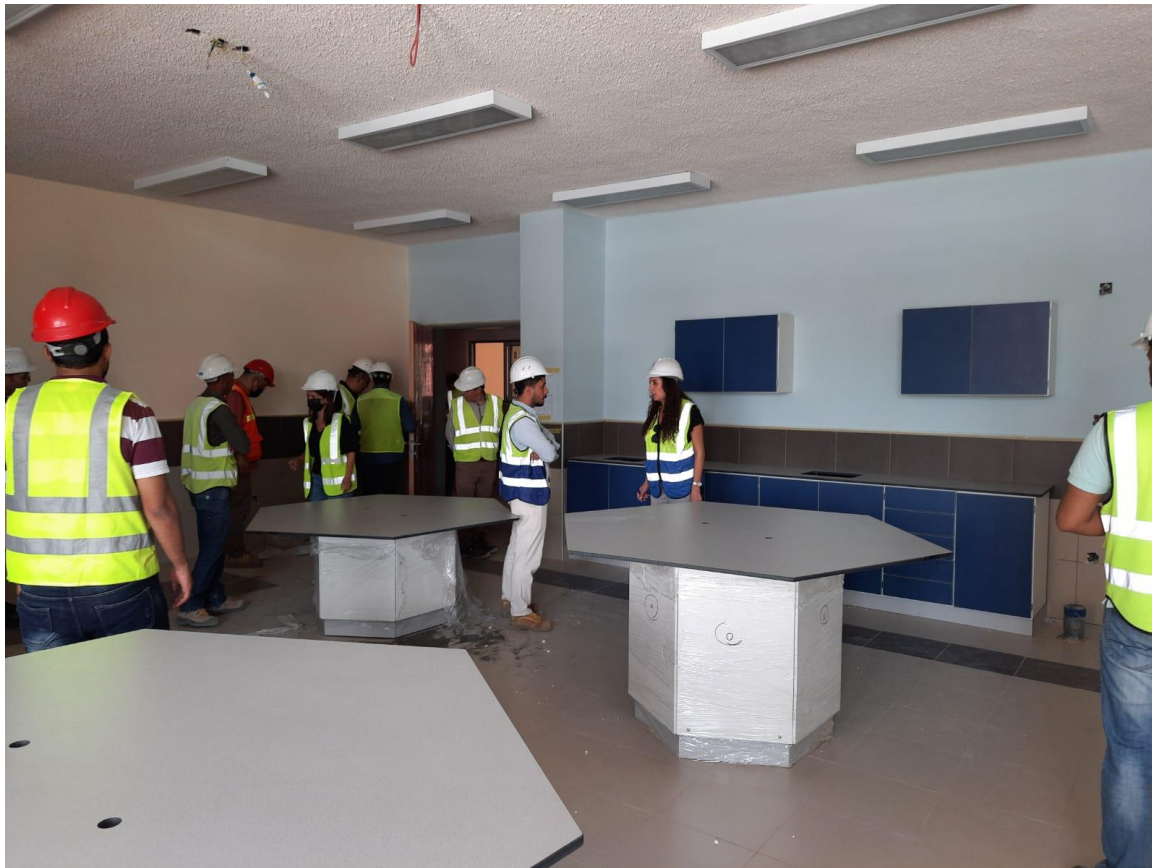
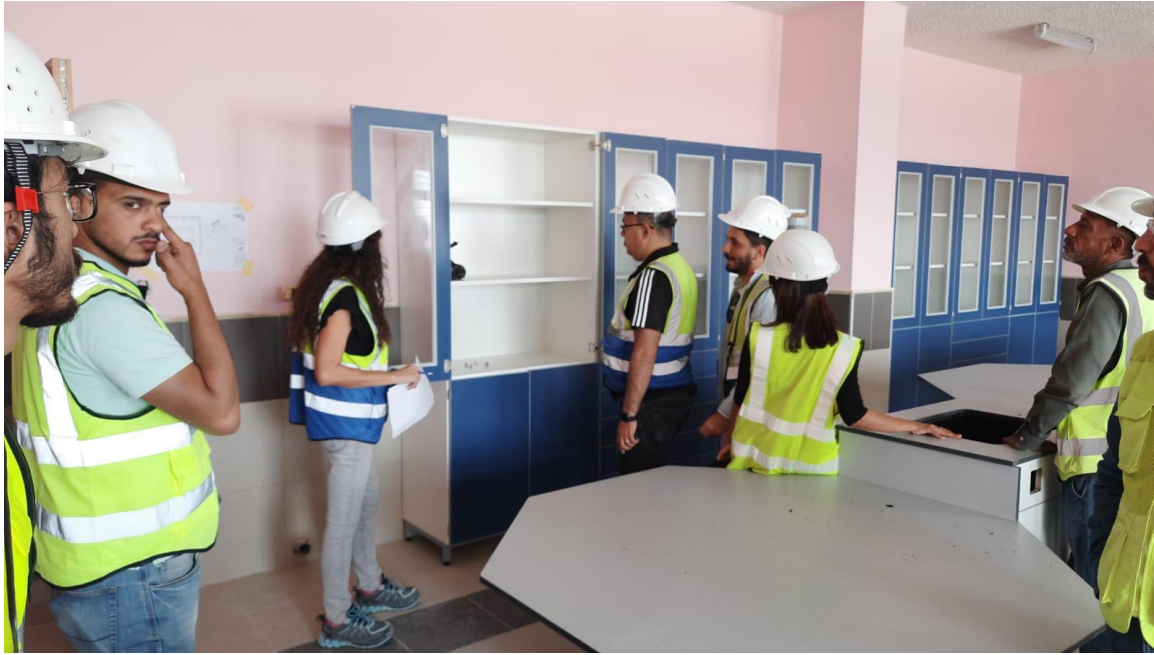
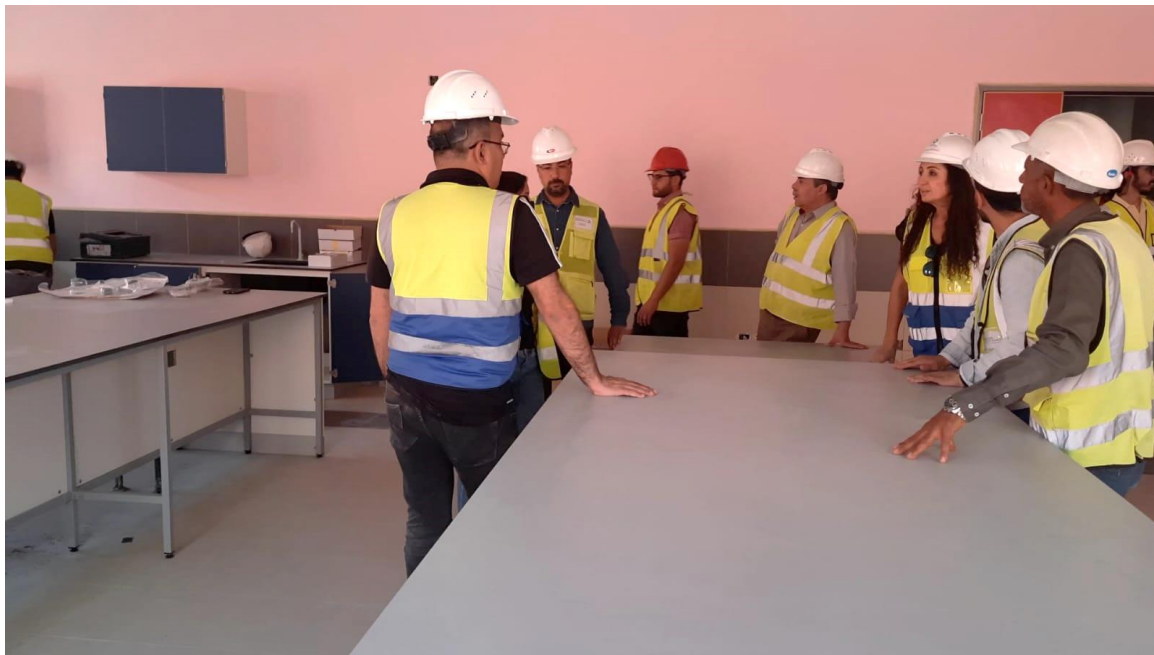
(Figure: 13, 14 & 15)

The team observed the delivered laboratory furniture for the vocational laboratory, art room and labs by the manufacturer (Protech)

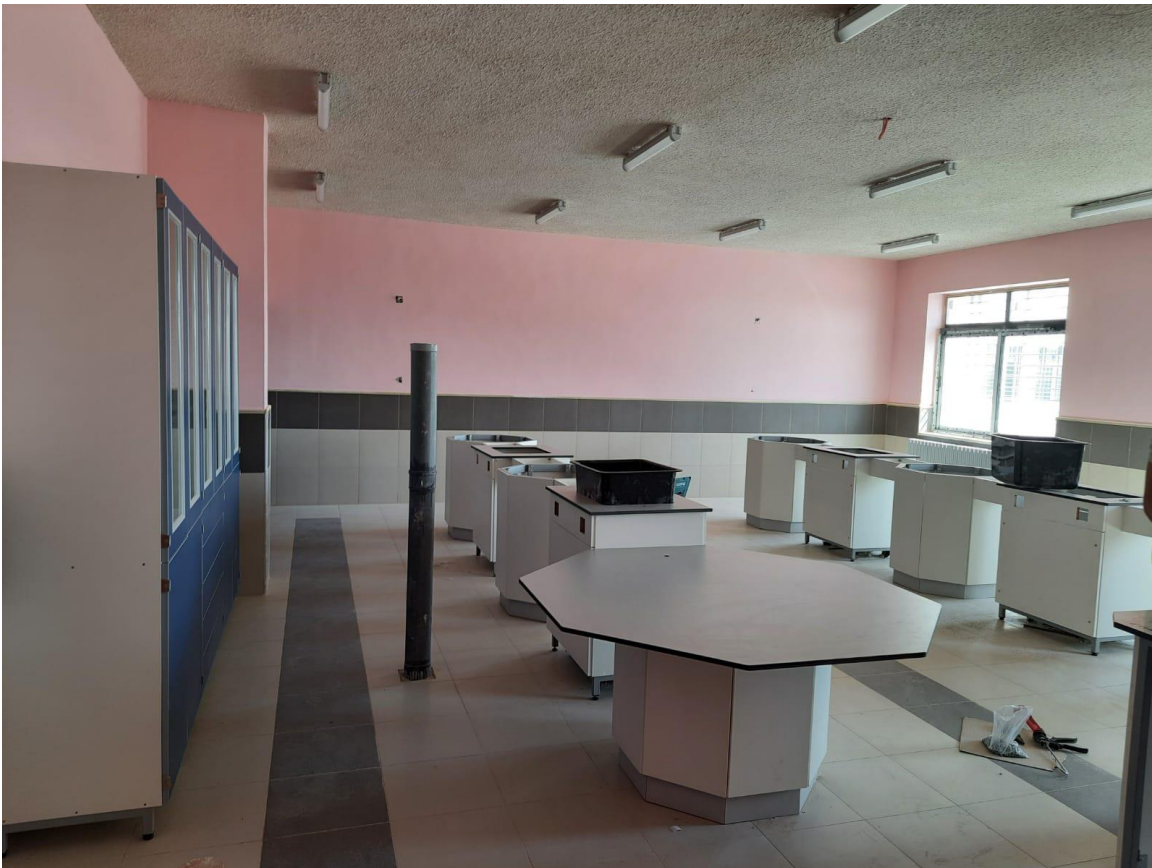
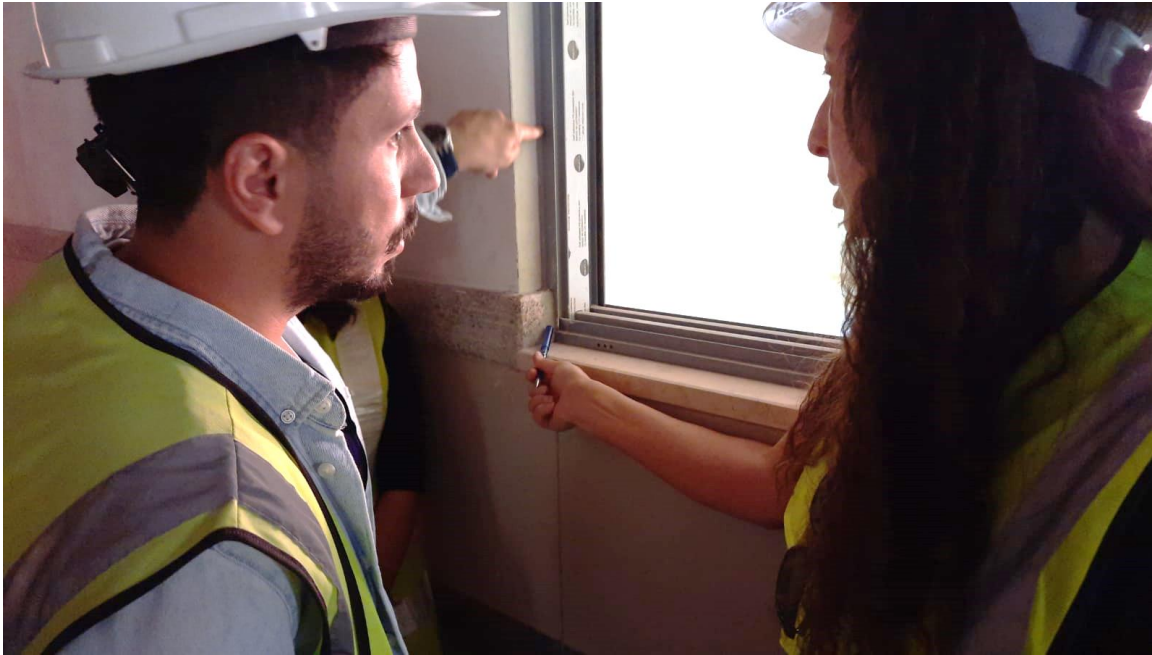
(Figure: 18 & 19)

The team observed the execution of granite coping at the corridors and the relation with aluminum windows

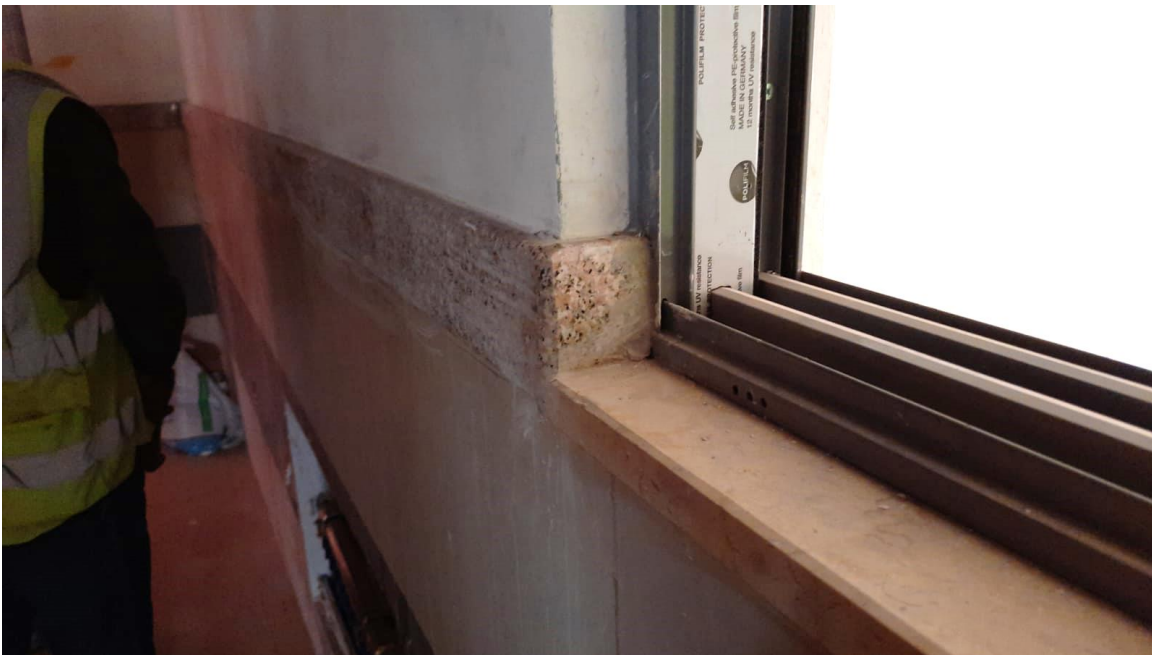
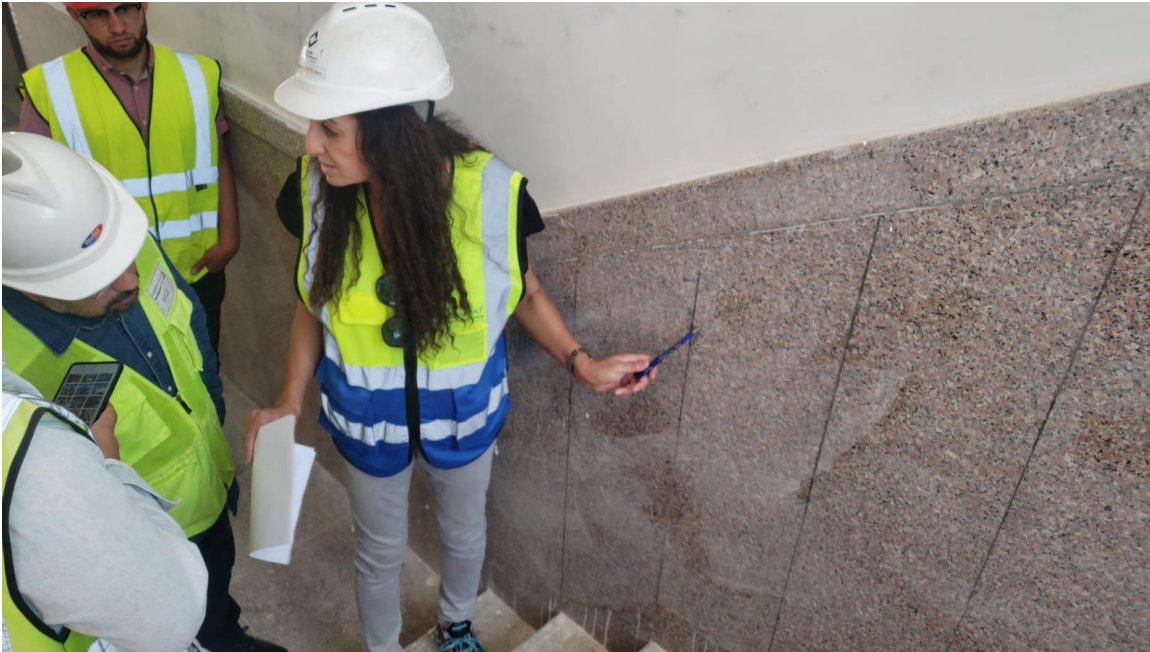
(Figure: 20 & 21)

The team inspected the granite cladding at the staircases and observed that a number of defected pieces are not replaced. The Contractor was requested to replace those pieces

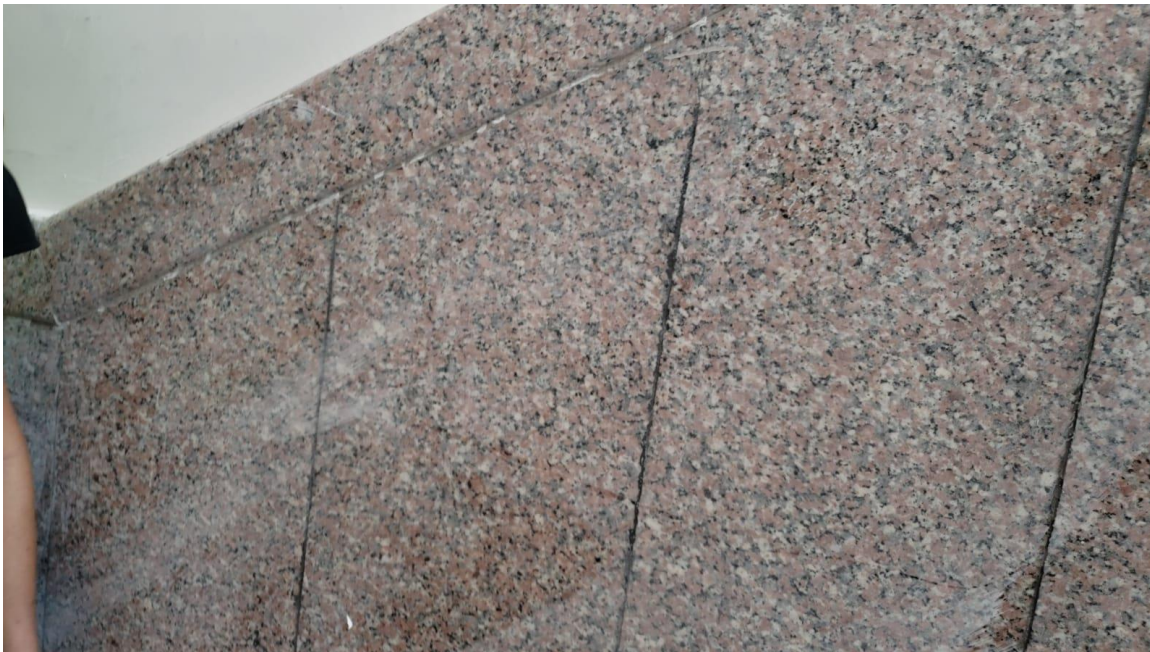
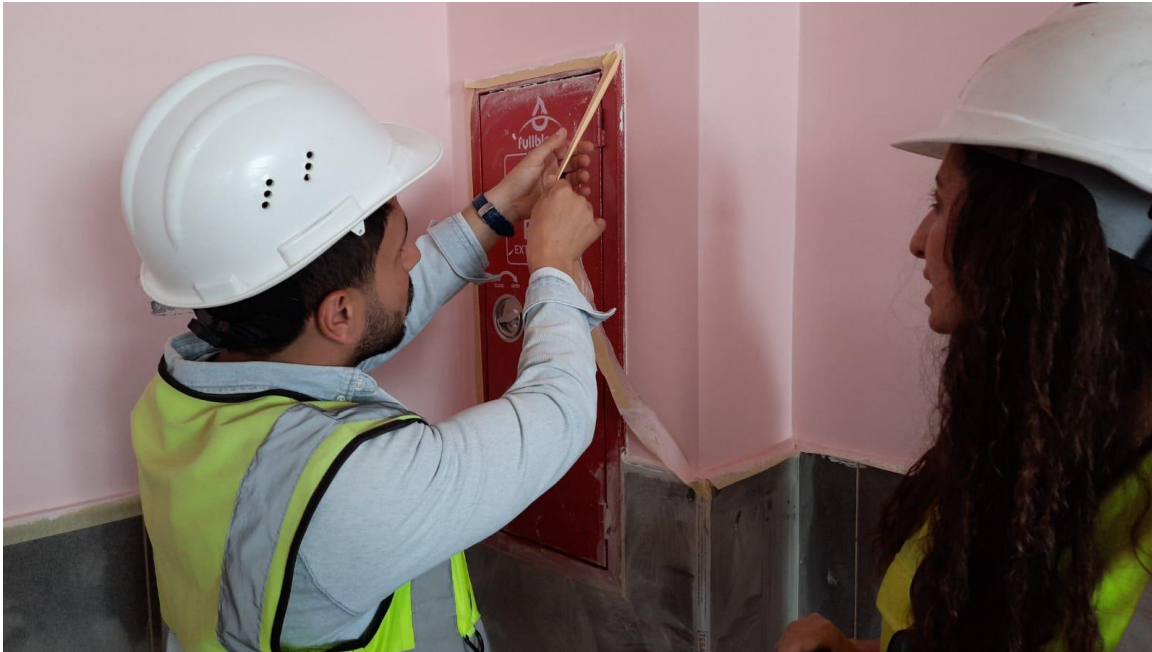
Extinguishers' cabinets at the labs in relation to finishing and protrusion range from the wall were inspected and found complying with the architectural and mechanical requirements

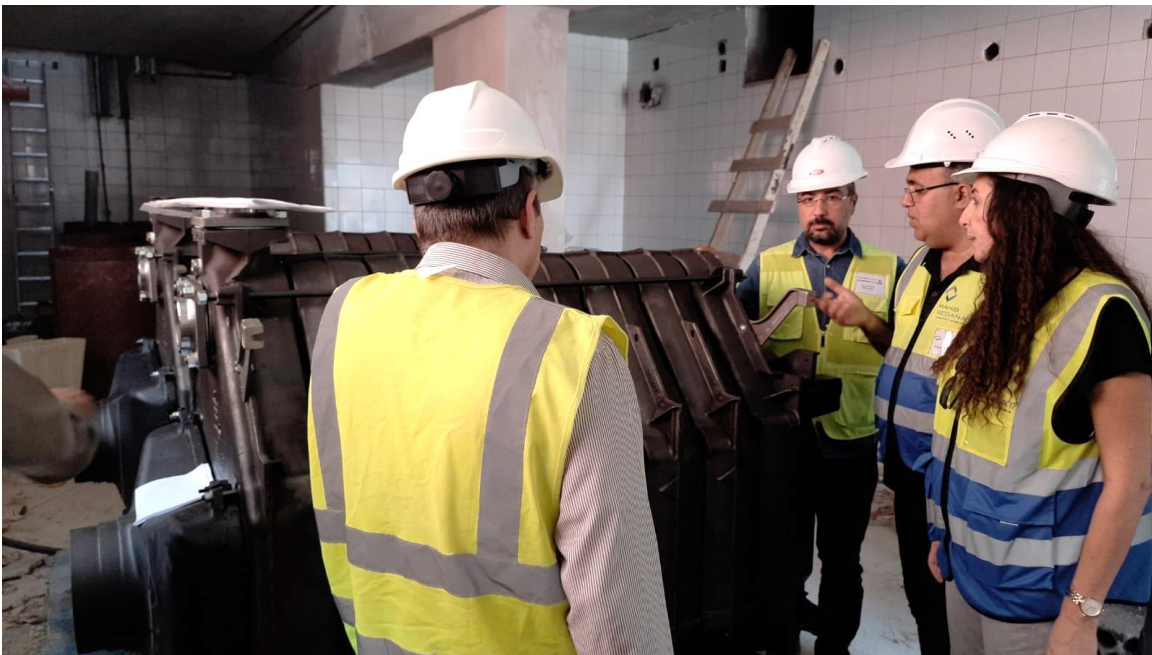
(Figure: 23)

The team inspected the installed boilers at the boiler room and observed that the Contractor maintained the two boilers and removed the corrosion seen at some parts of the boilers
