# Quality Control Report

**Consultant** **Wahib Medanat** Consultant Engineers  
**Site Name** **Hay Al Iskan Basic mixed - Jerash**  
**Package** **Package 2**  
**Contractor** **Dijlah Est. Construction Co.**  
**Tender No.** **10/2019/USAID/SKEP/3/2**

**Rep No.** **QC-21 16**  
**Date** **2 / 01 / 2022**

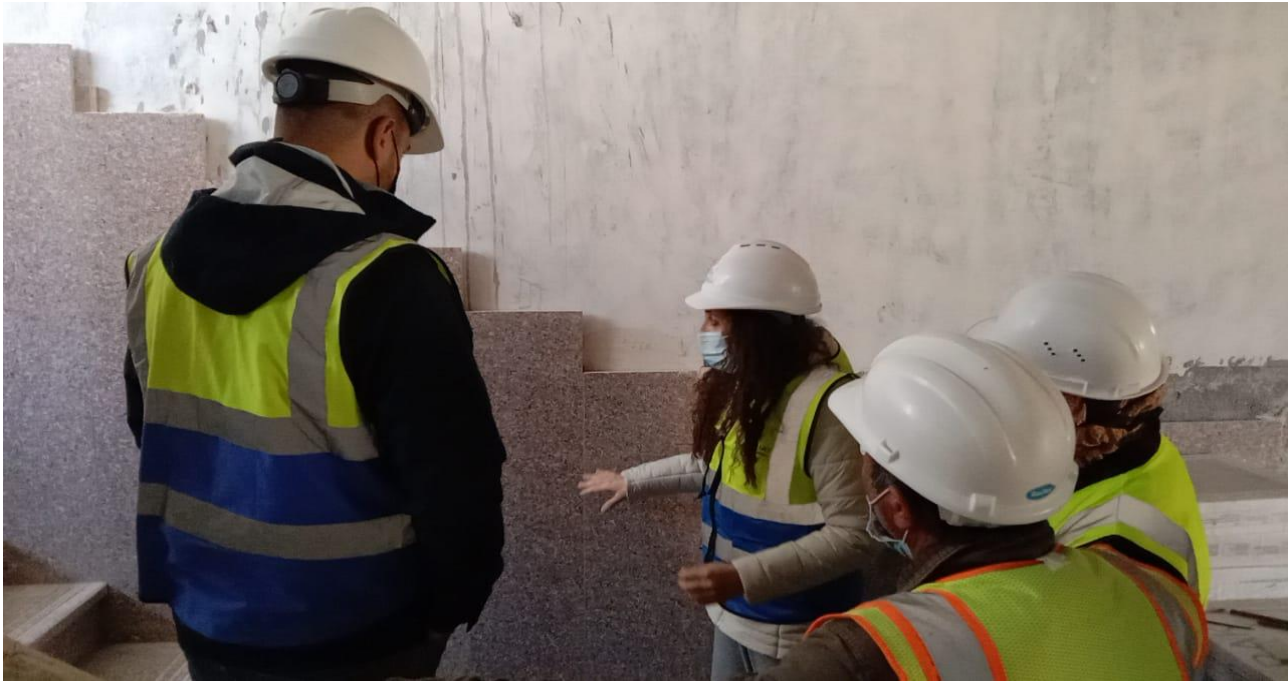
**Defected granite for the staircases**

Description of Non Conformance	Corrective Action	Required by / When
1. Defected granite pieces at the staircases. 2. Water penetration from the pump room at the roof to the ceiling of the top floor.	1. To be replaced. 2. To be replaced.	The Contractor/Immediately
<p align="center"><b>Report Prepared by</b></p>	Hassan Shaqbua, Supervision Quality Control Manager	
<p align="center"><b>Contractor's Response</b></p>		
No response yet		
<p align="center"><b>Notes</b></p>

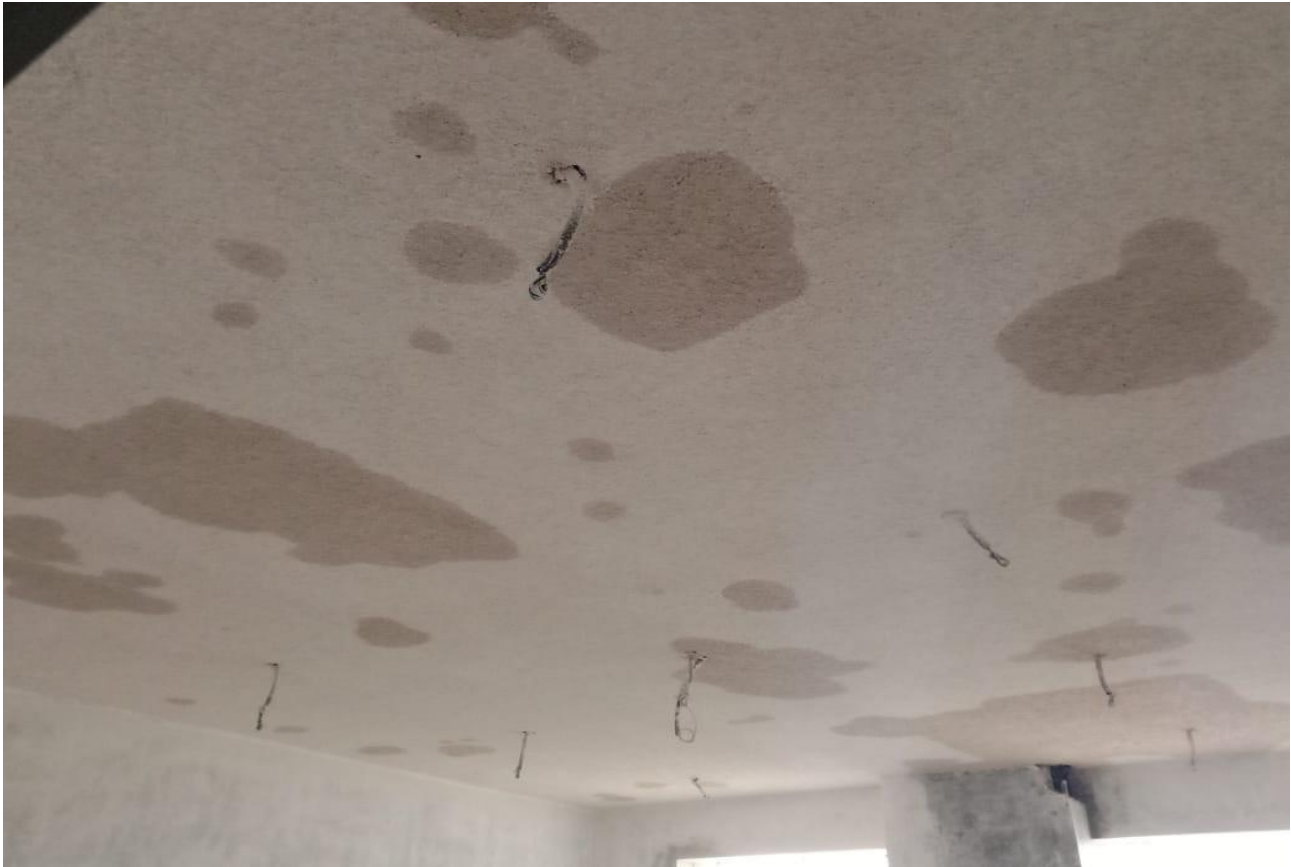
**Water penetration from the pumps room at the roof**
