# SKEP III Home Office Support Site Visit Report

Consultant	Wahib Medanat Consultant Engineer	Rep No.	13-25062022
Contractor	Derar Saraireh & Sons for Engineering & Contracting	Tender No.	(11/2019/USAID/SKEP/3/S) Schools for a Knowledge Economy Project (SKEP) - Phase (3) Package (1, 2)
Site Name	Khadija Bint Khwailed Basic Mixed School- Shouna Janoubia	Day/ Date	Sat. 25/06/2022
Duration of Project	450 Calendar Days	Total Project Budget	9,789,417.840 JD

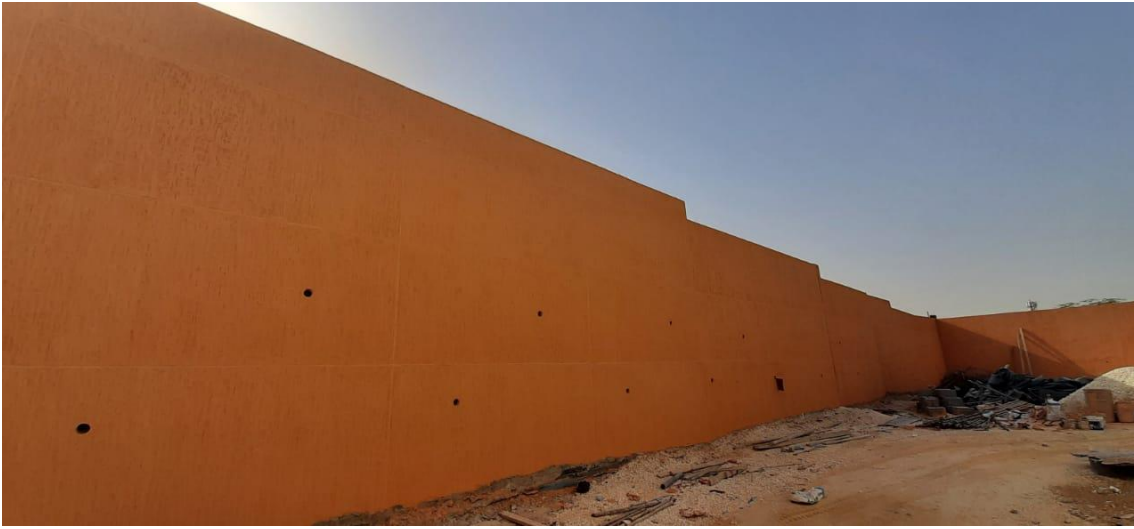
(Figure: 07)

The Contractor executed the external plastering in accordance to the sample approved by the Engineer

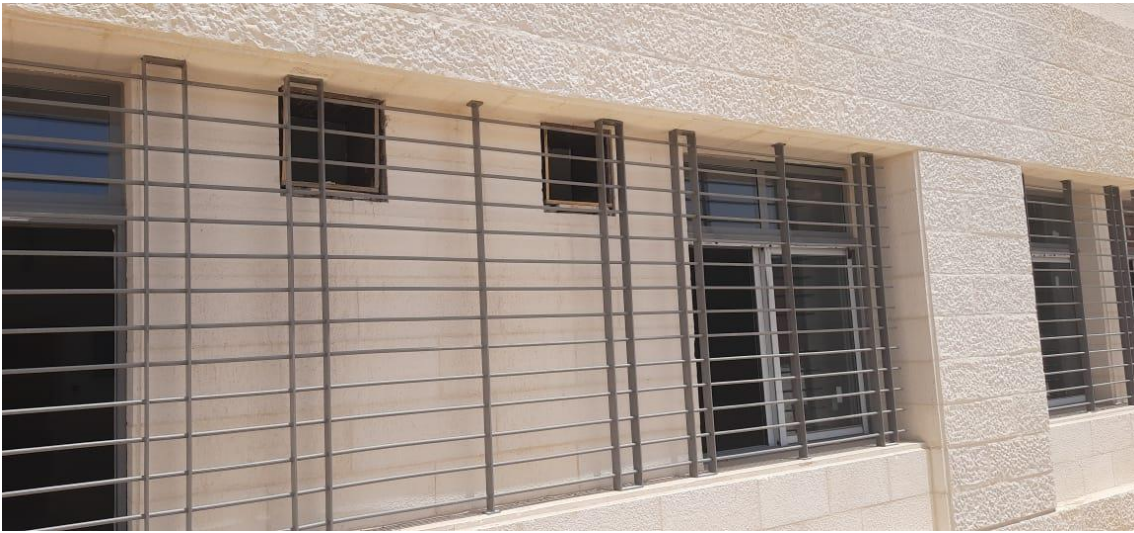
(Figure: 08)

The team observed that the Contractor rectified previously defected steel protection screens

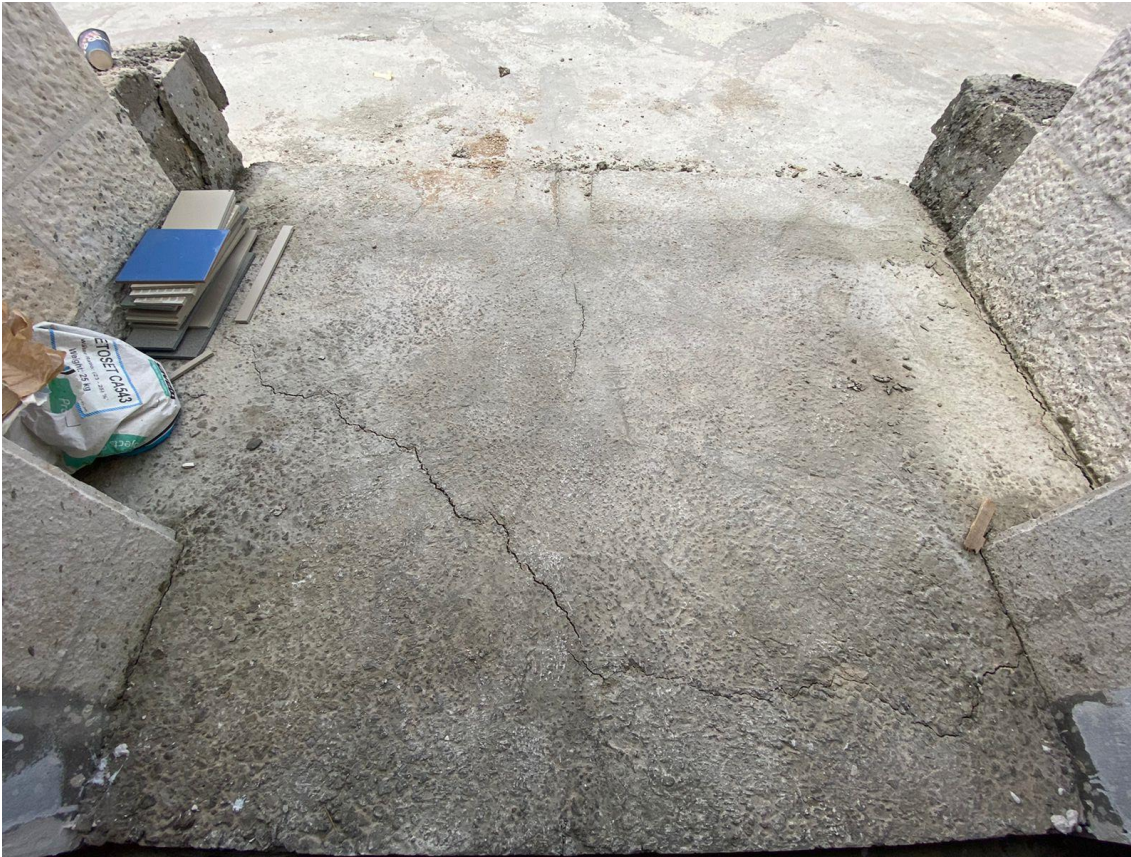
(Figure: 09)

The team previously observed cracks in the casted concrete over the expansion joint at the roof of the multi-purpose hall. The Contractor was requested to rectify using special materials

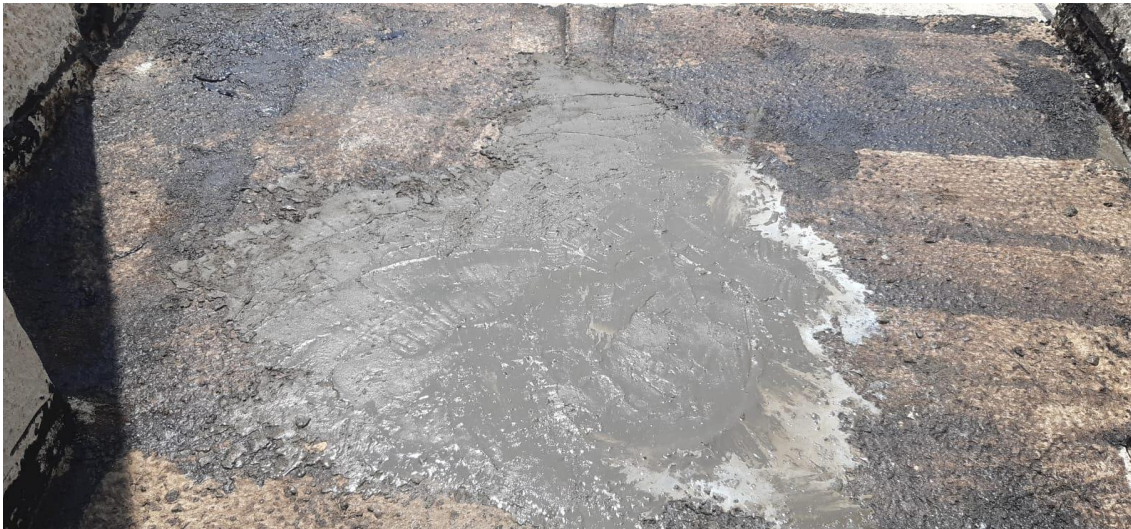
(Figure: 10)

The Contractor started with rectification

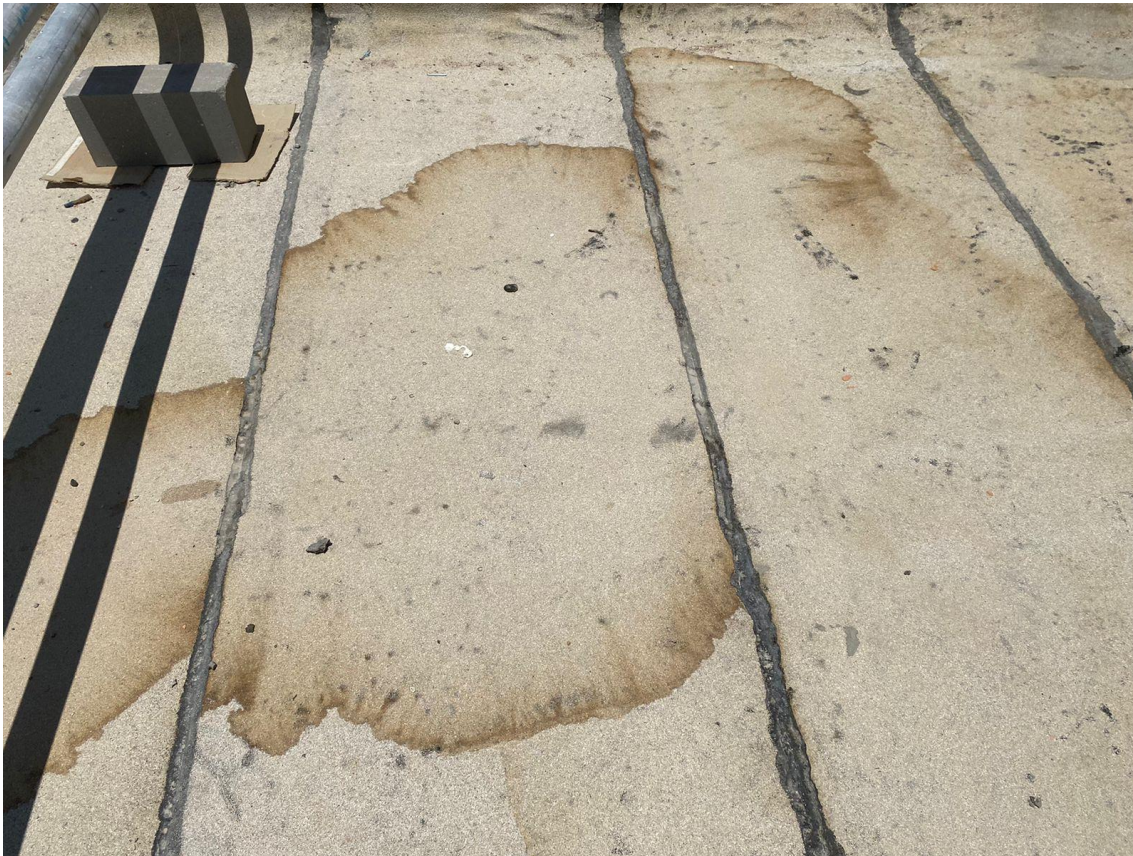
(Figure: 11)

4	The team inspected the waterproofing at the roof of the multi-purpose hall and observed that the Contractor conducted the required repair for the concrete layer and the waterproofing membrane as discussed before.
5	The team inspected the executed wall tiles at the wet area and notes were given to the Contractor.
6	The team inspected the waterproofing membrane at the roof and observed air voids under the membrane in some parts. The Contractor was requested to replace defected areas.
7	The team observed that there is some waving in the plastering and painting of the corridors walls and ceilings. The Contractor was requested to rectify.
8	The team inspected the status of laboratories and the delivered furniture for those laboratories.
9	The team observed black spots on the granite cladding of the staircases and requested the Contractor to replace.

The team inspected the waterproofing membrane at the roof and observed air voids under the membrane in some parts. The Contractor was requested to replace defected areas

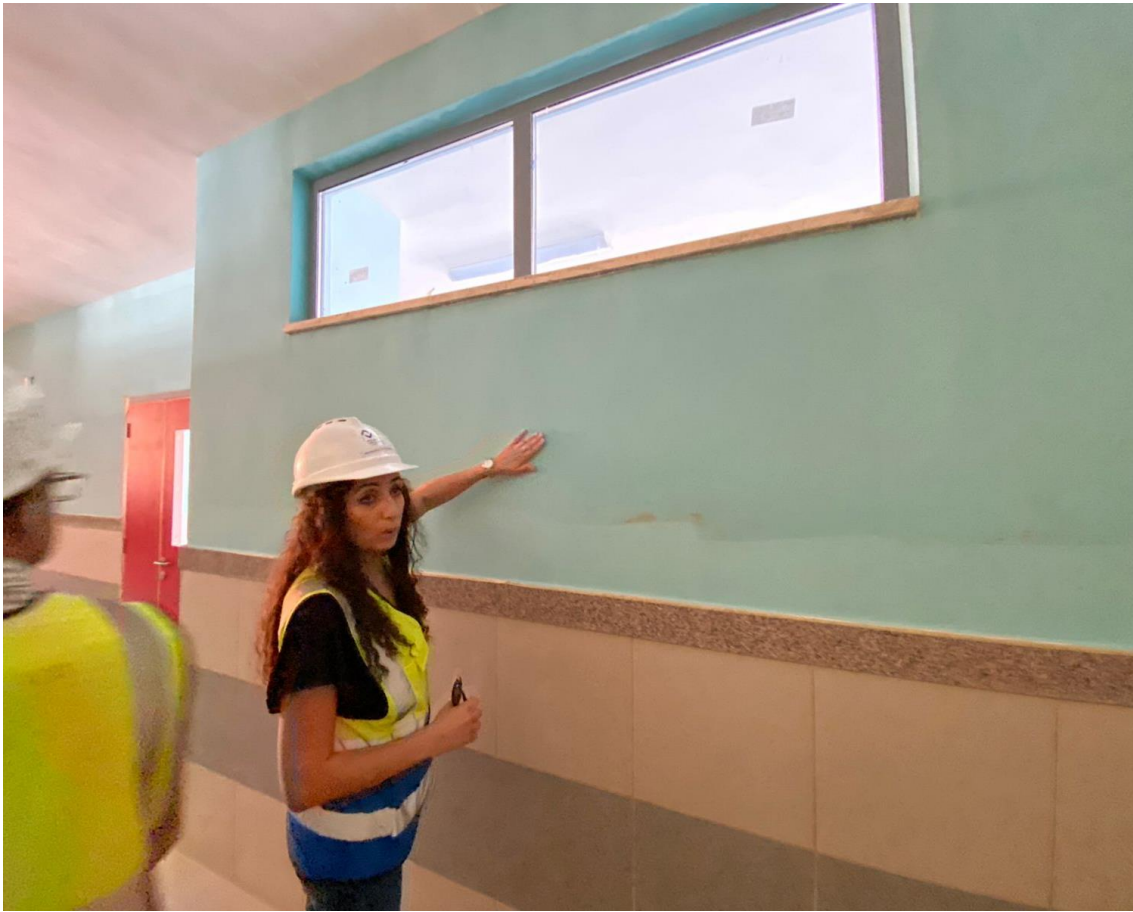
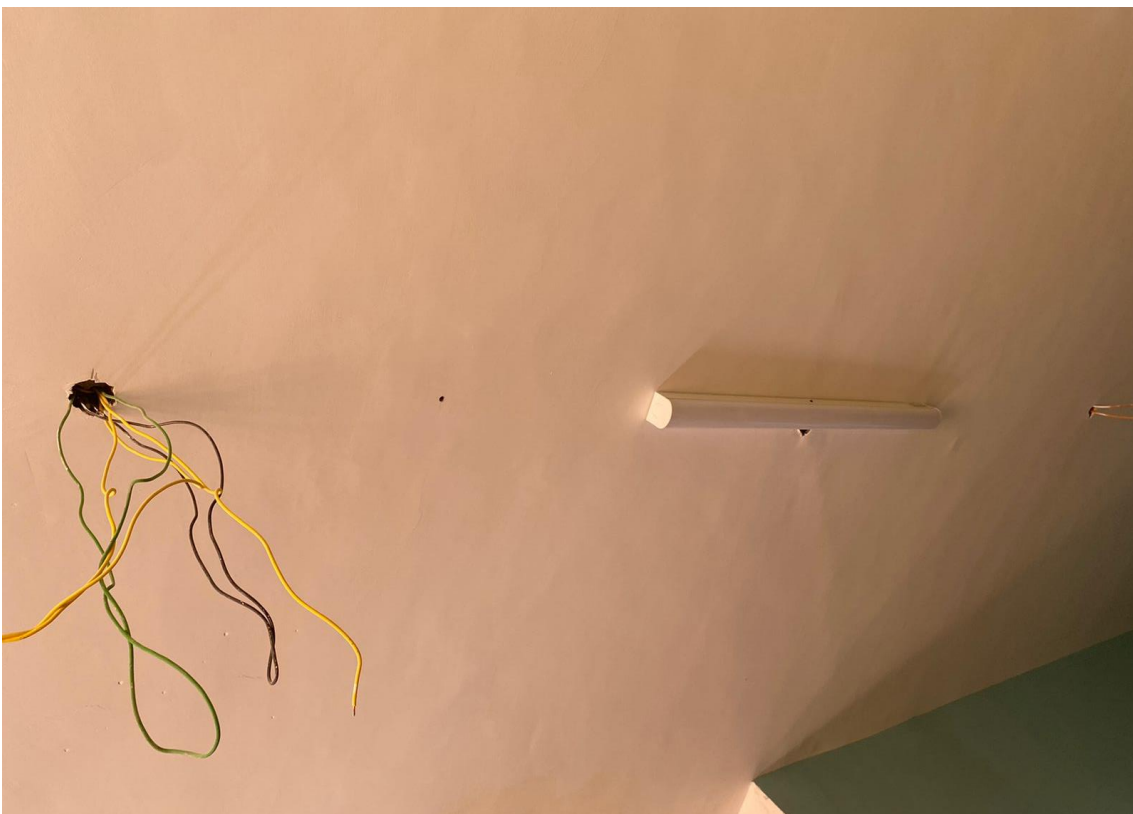
The team observed that there is some waving in the plastering and painting at the corridors and ceilings along with openings at the ceiling. The Contractor was requested to rectify waving and close these openings

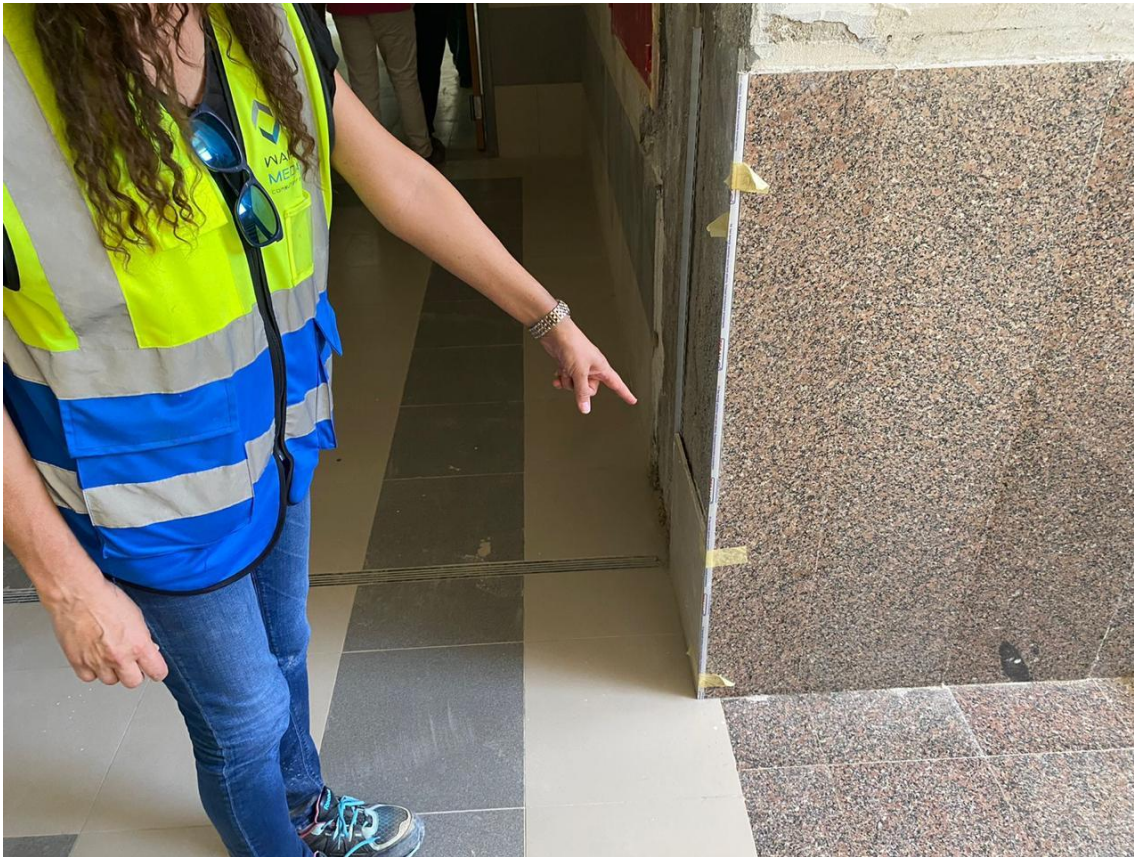
(Figure: 15)

The team observed black spots on the granite cladding of the staircases and requested the Contractor to replace

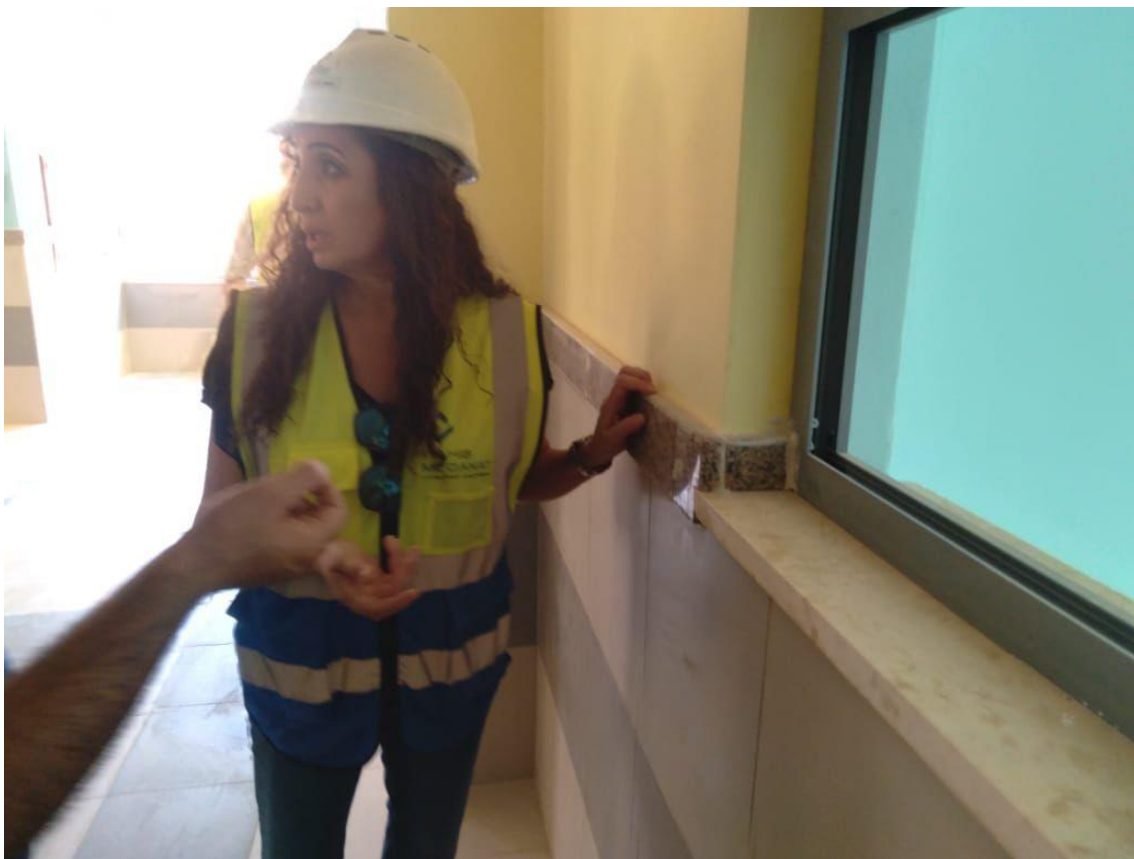
(Figure: 16)

The team Inspected the relation between granite coping and the window sill at the corridor

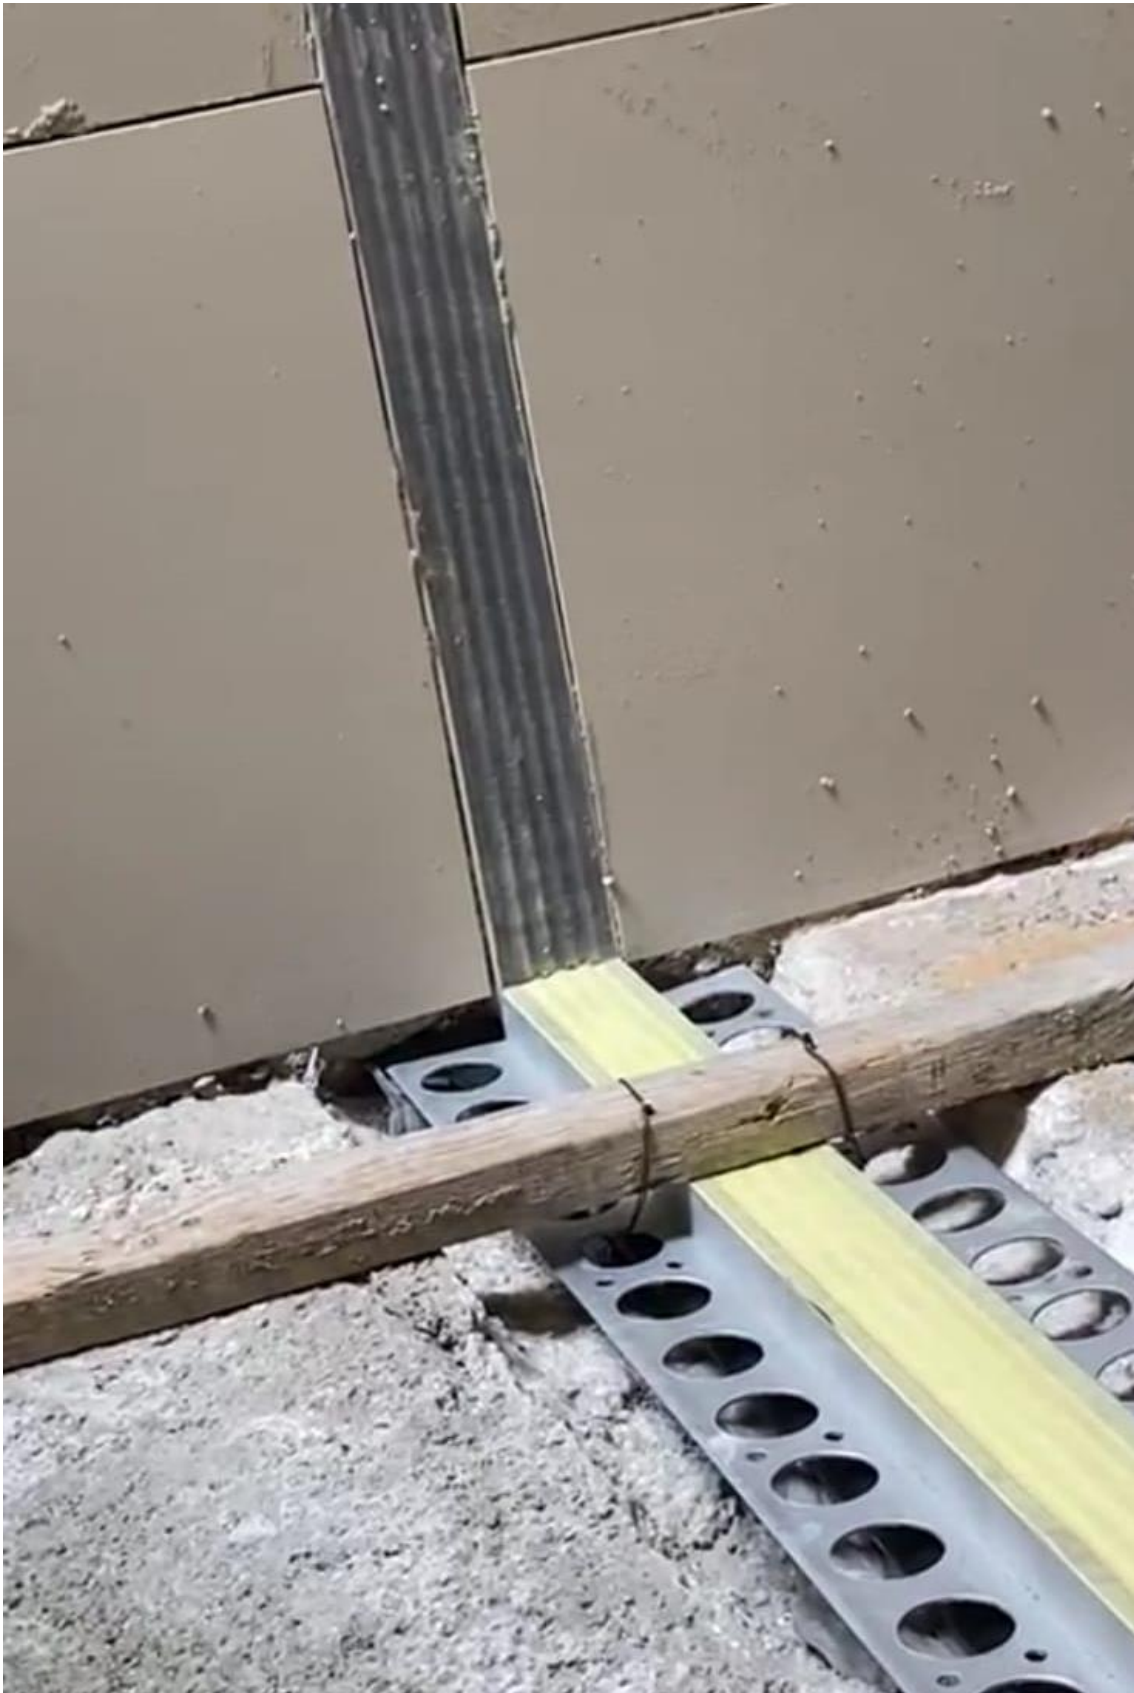
(Figure: 17)

The team inspected the execution of the expansion joint according to the previously agreed upon solution

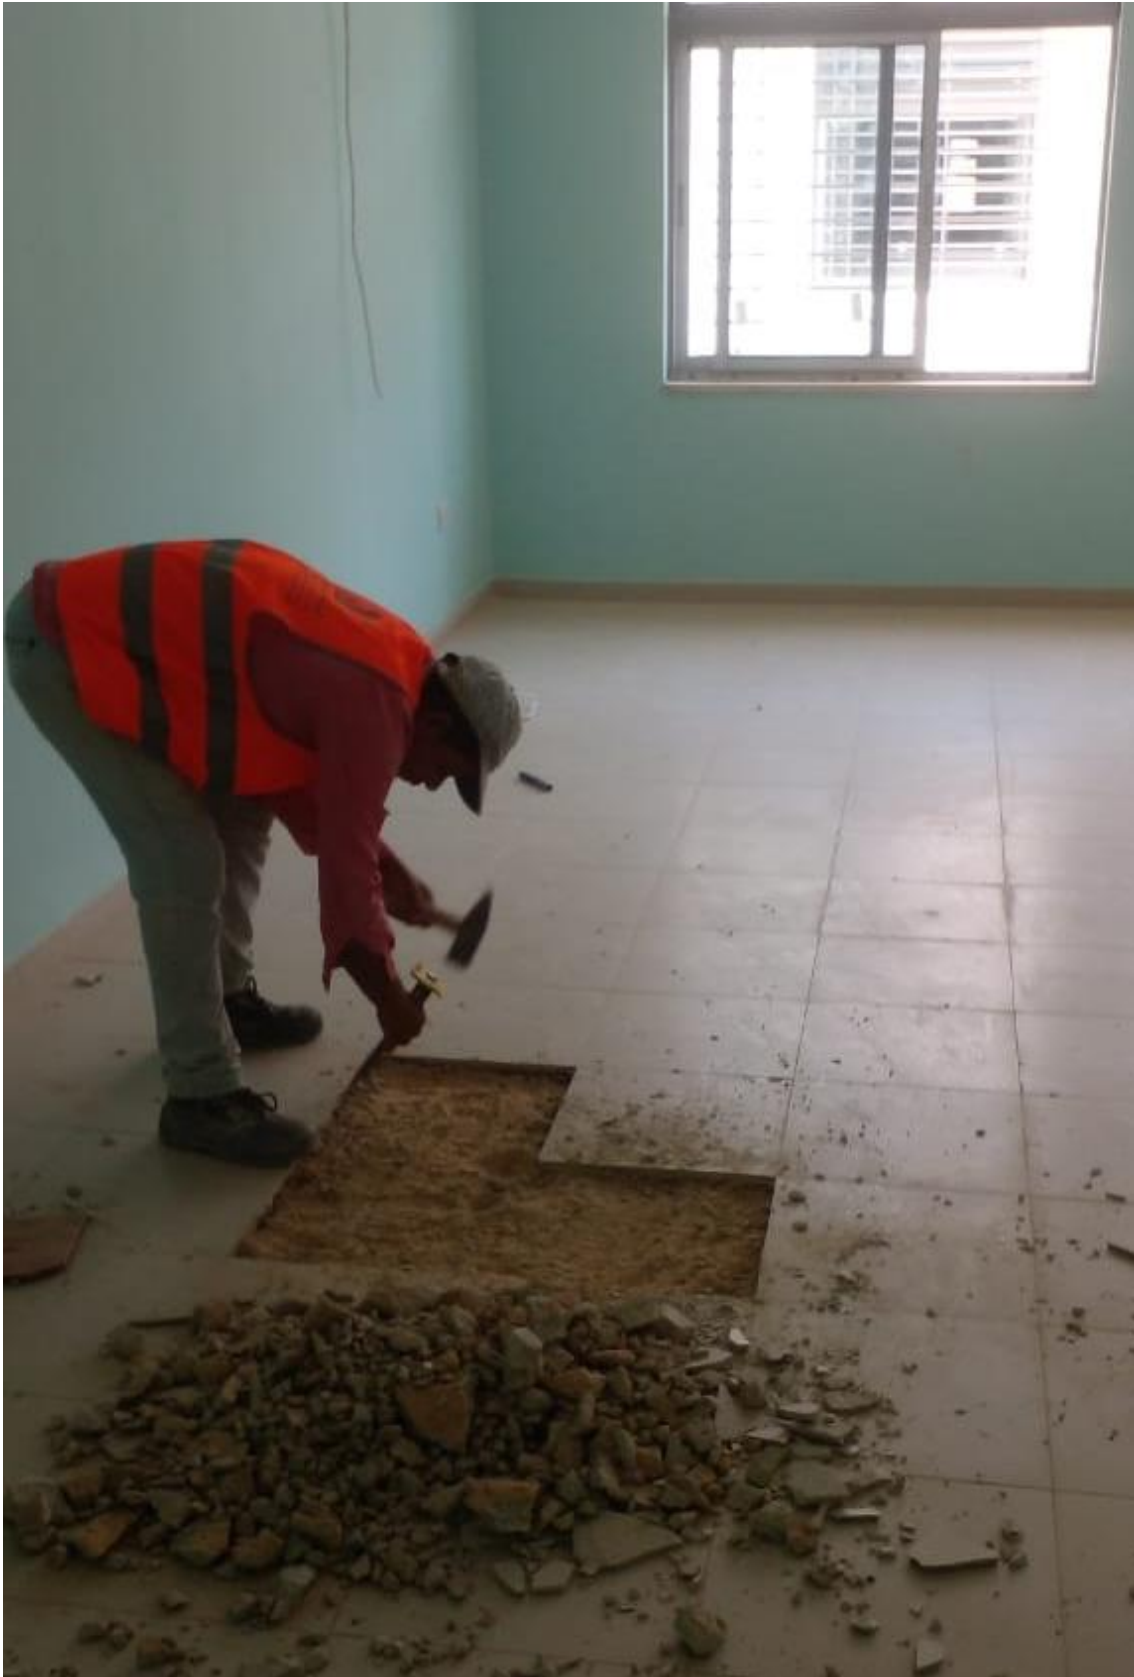
(Figure: 18)

The team observed that the Contractor started replacing defected porcelain floor tiles

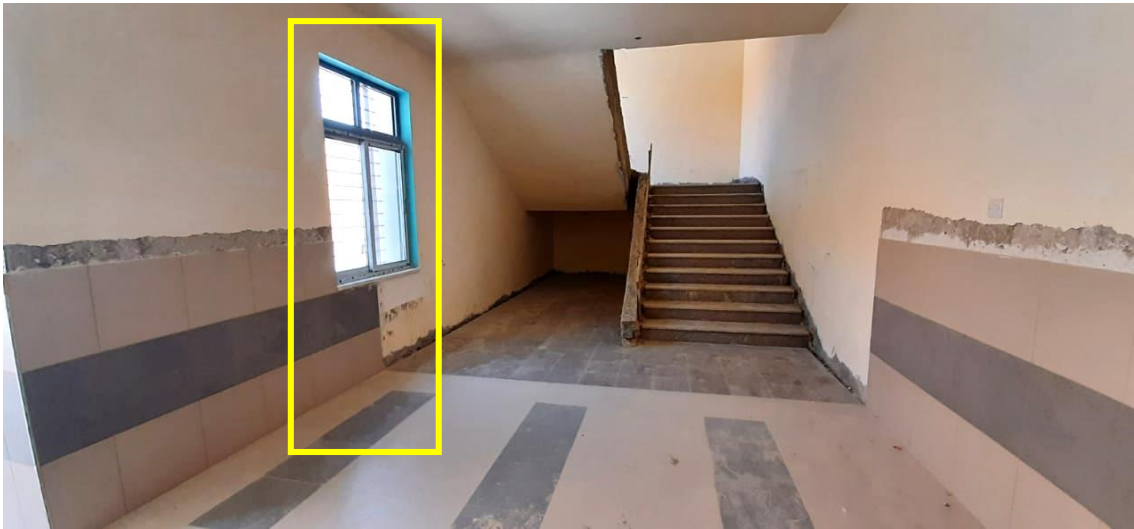
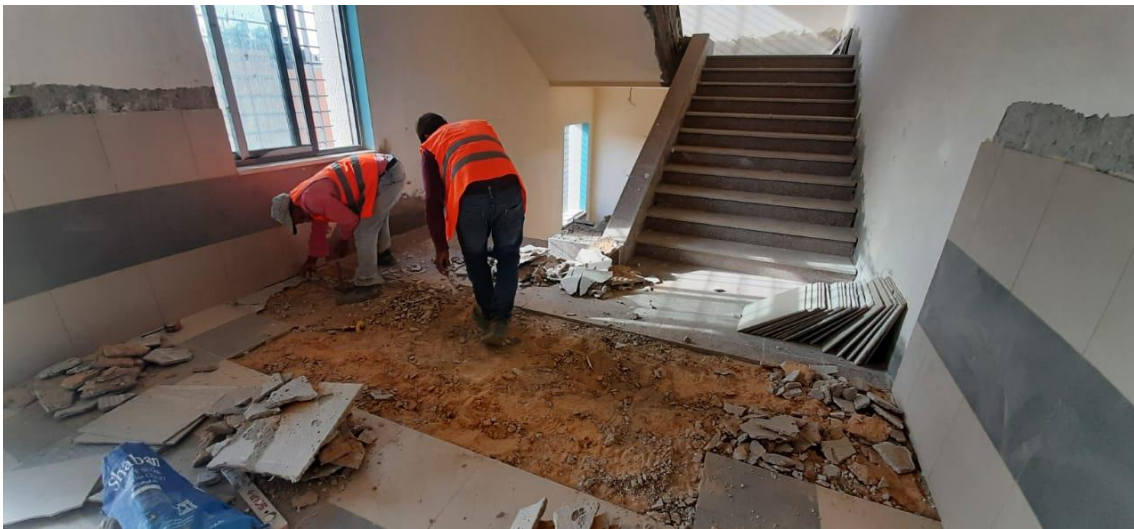
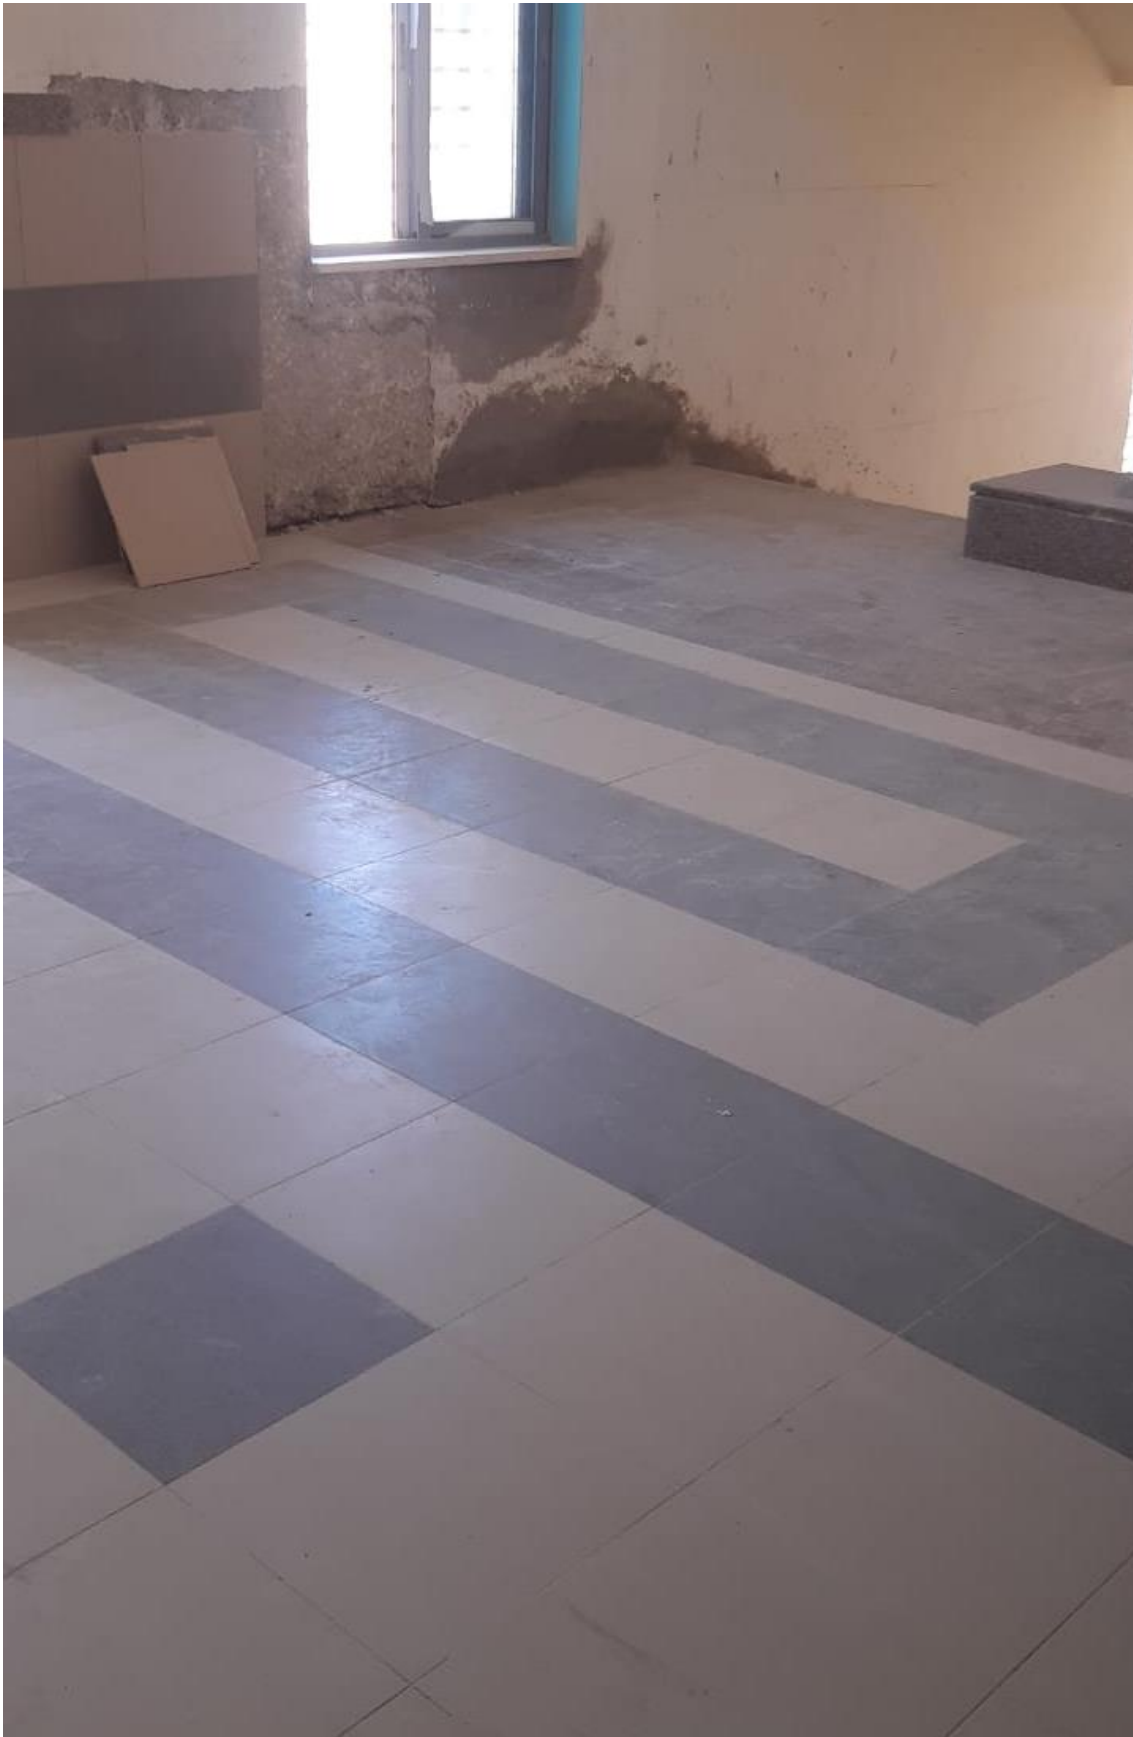
The team previously instructed the Contractor to limit the porcelain tiles of the corridor to the nearest side of the window where the granite floor tiles and cladding shall start and The Contractor started with rectification
