Consultant	Wahib Medanat Consultant Engineer	Rep No.	11-16072022
Contractor	Derar Saraireh & Sons for Engineering & Contracting	Tender No.	(11/2019/USAID/SKEP/3/S) Schools for a Knowledge Economy Project (SKEP) - Phase (3) Package (1, 2)
Site Name	Um Al Dananir Basic Mixed School- Al Balqa	Day/ Date	Sat. 16/07/2022
Duration of Project	450 Calendar Days	Total Project Budget	9,789,417.840 JD

### Visit Notes

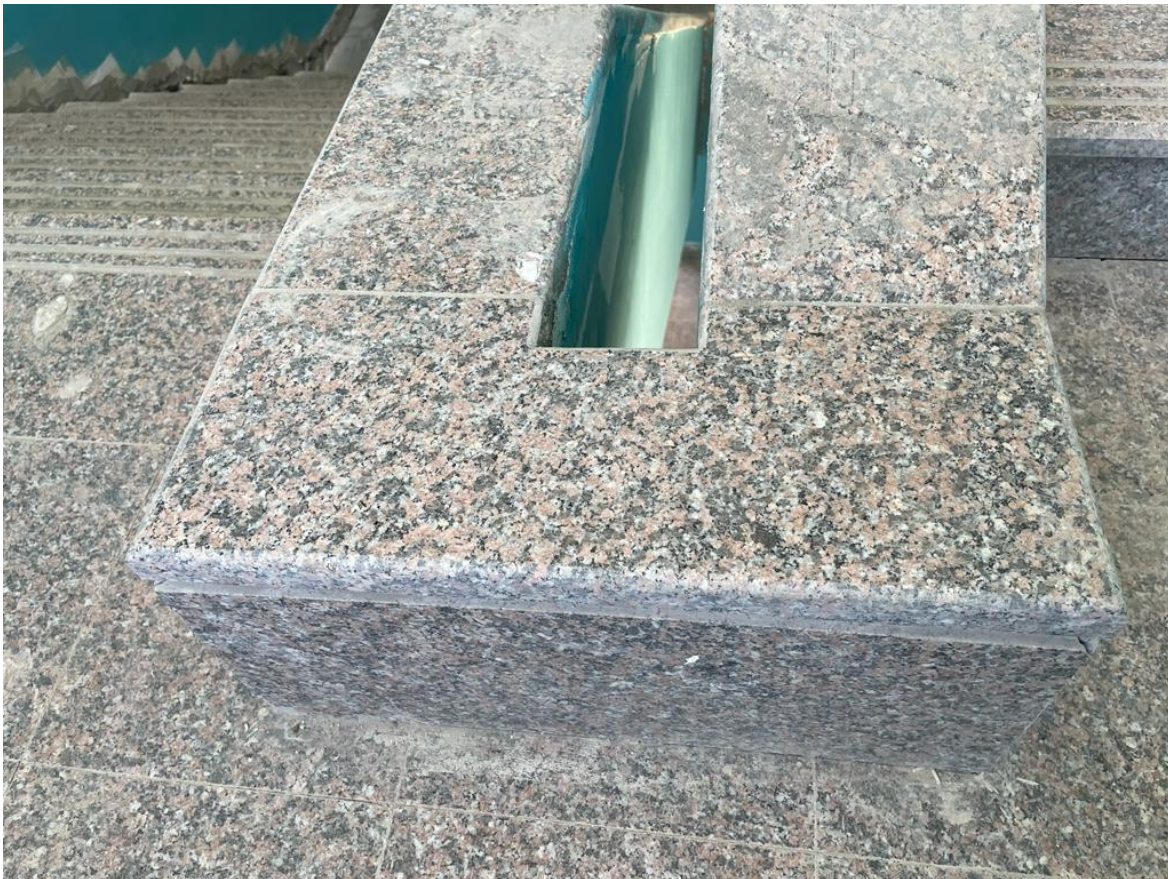
*(figure:05)*

The team previously inspected the granite at the staircase parapet and requested the Contractor to remove small pieces and replace by one piece

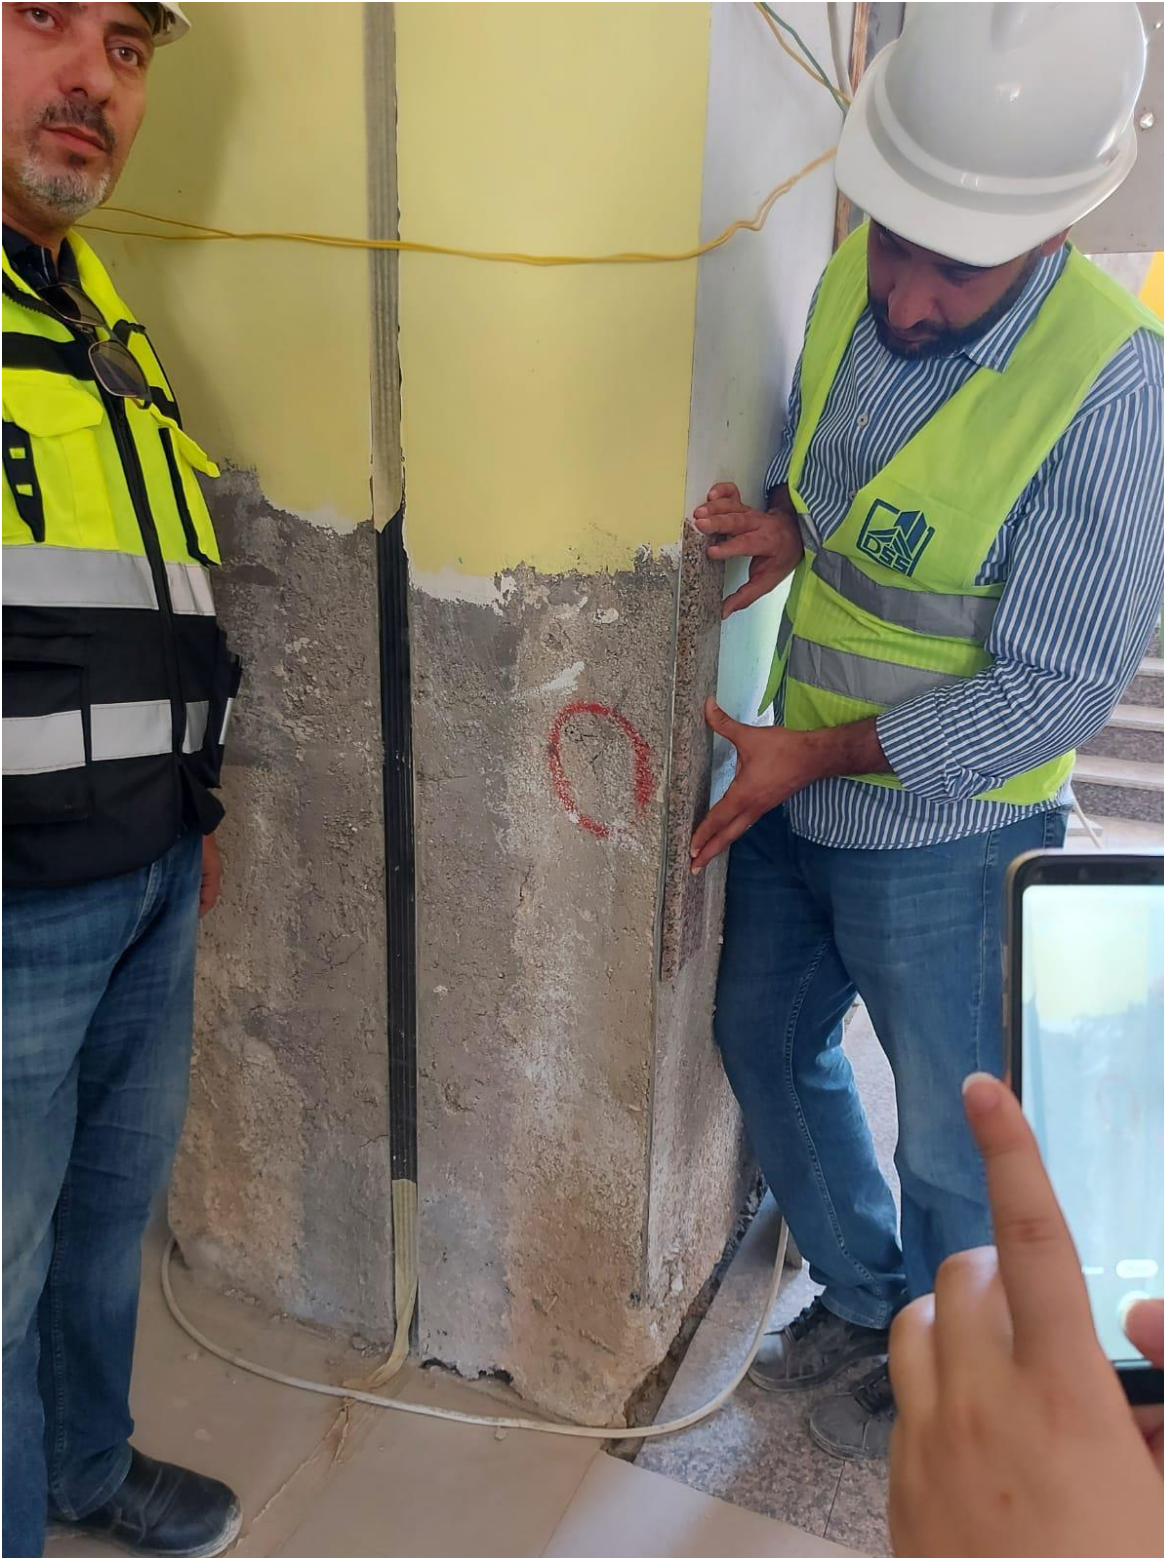
(figure:08)

The team had previously discussed with the Contractor the connection point between the porcelain cladding at the corridors and the granite cladding at the entrance for the purpose of separating the entrance and the kindergarten area

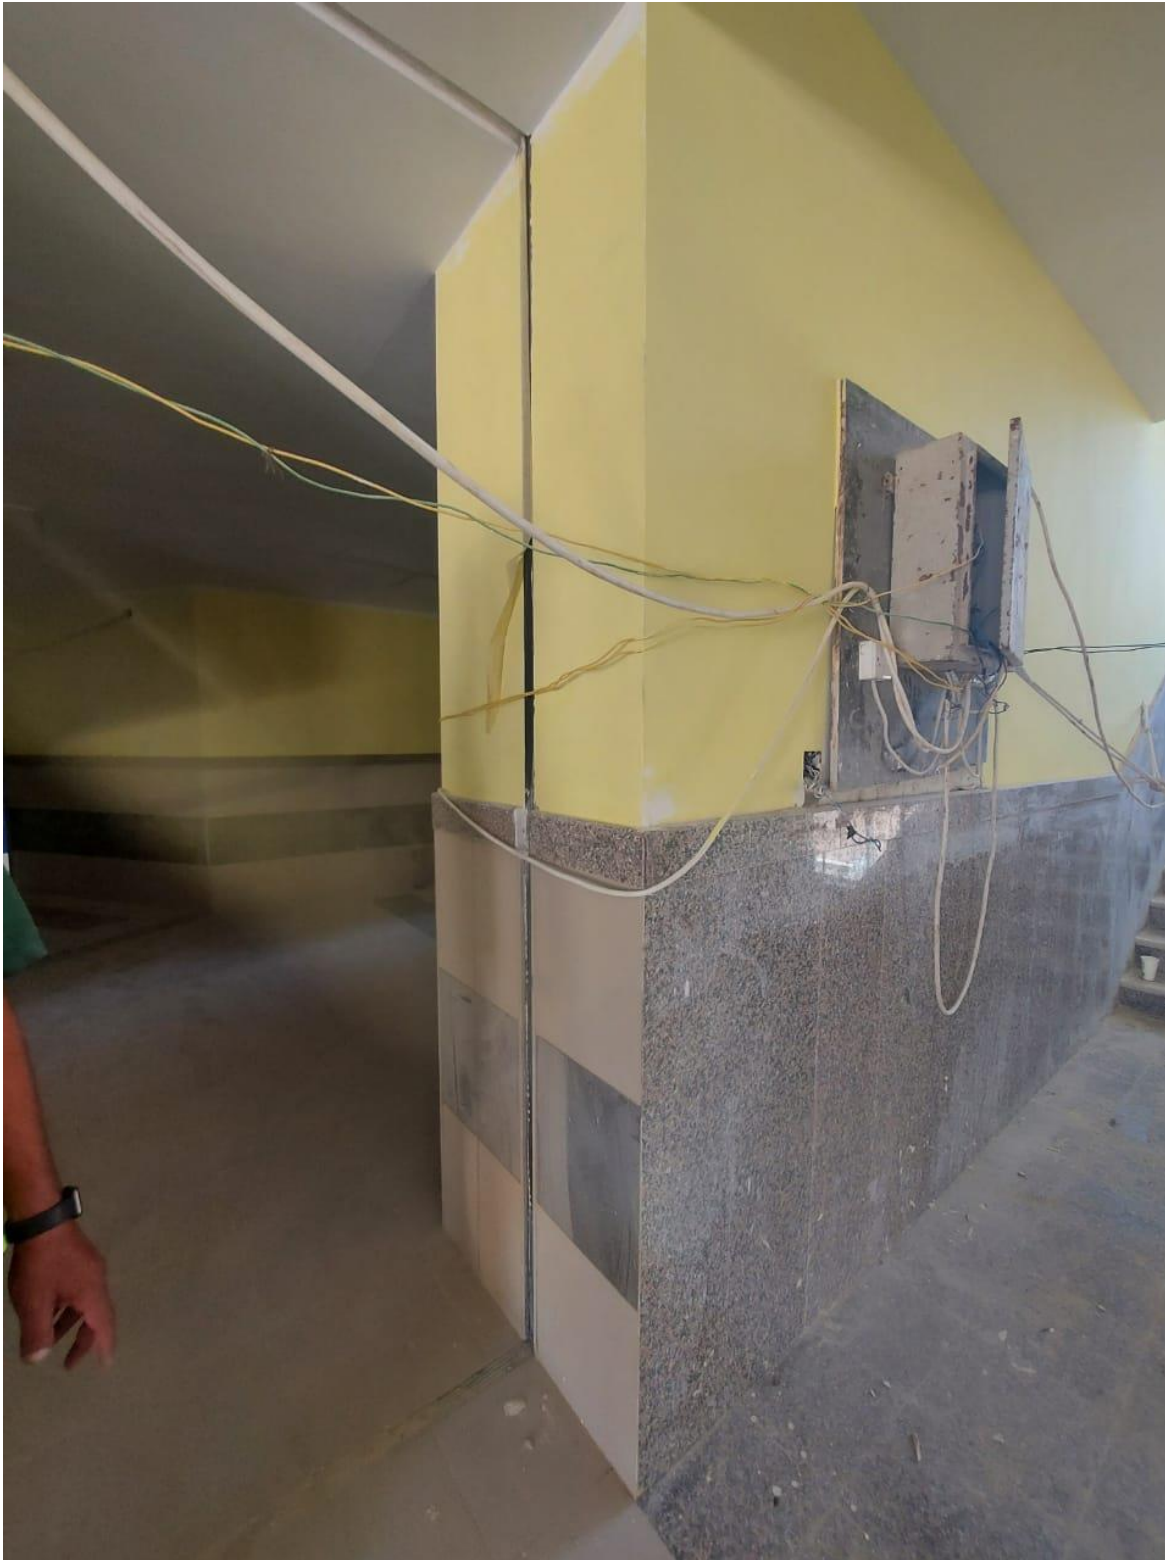
(figure:10)

The Contractor executed the works according to the instructions

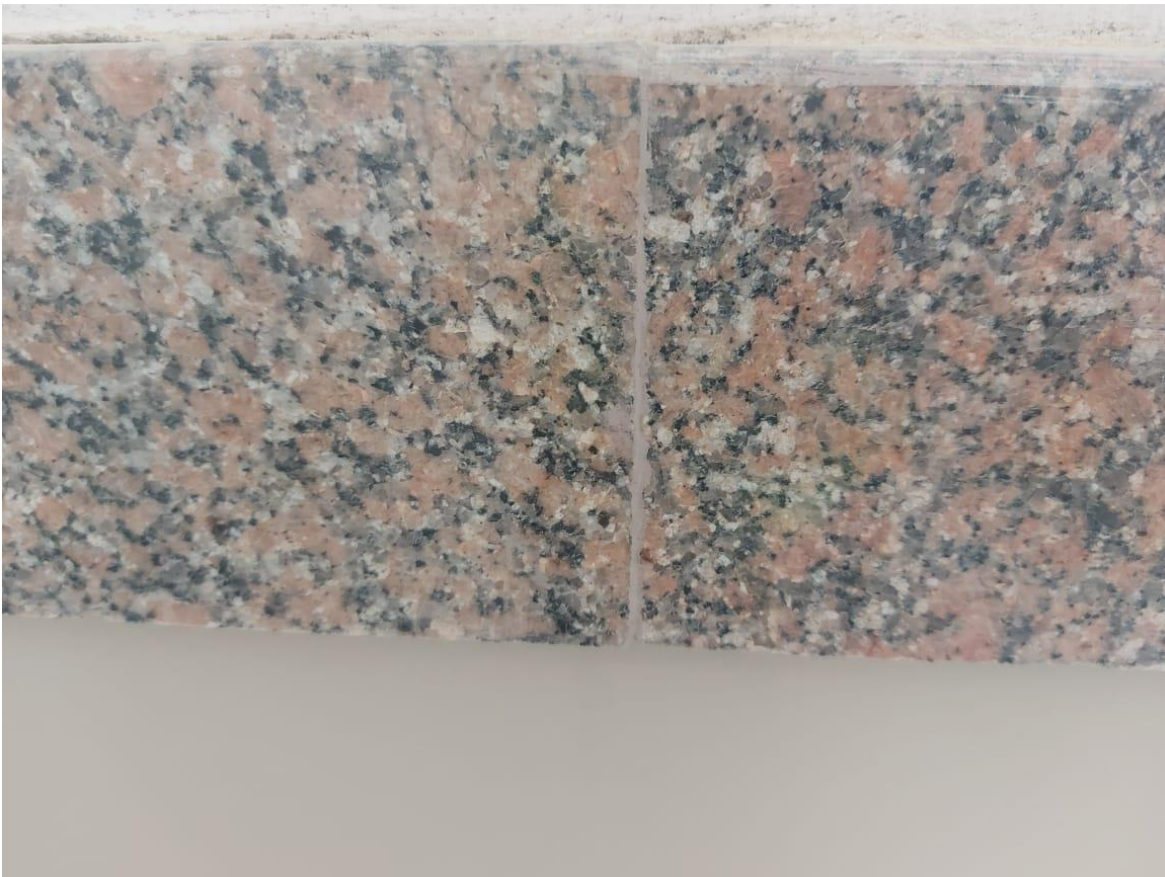
*(figure:12)*

The team observed using red grout for granite coping at the corridors which does not comply with the approved grout in relation to color.

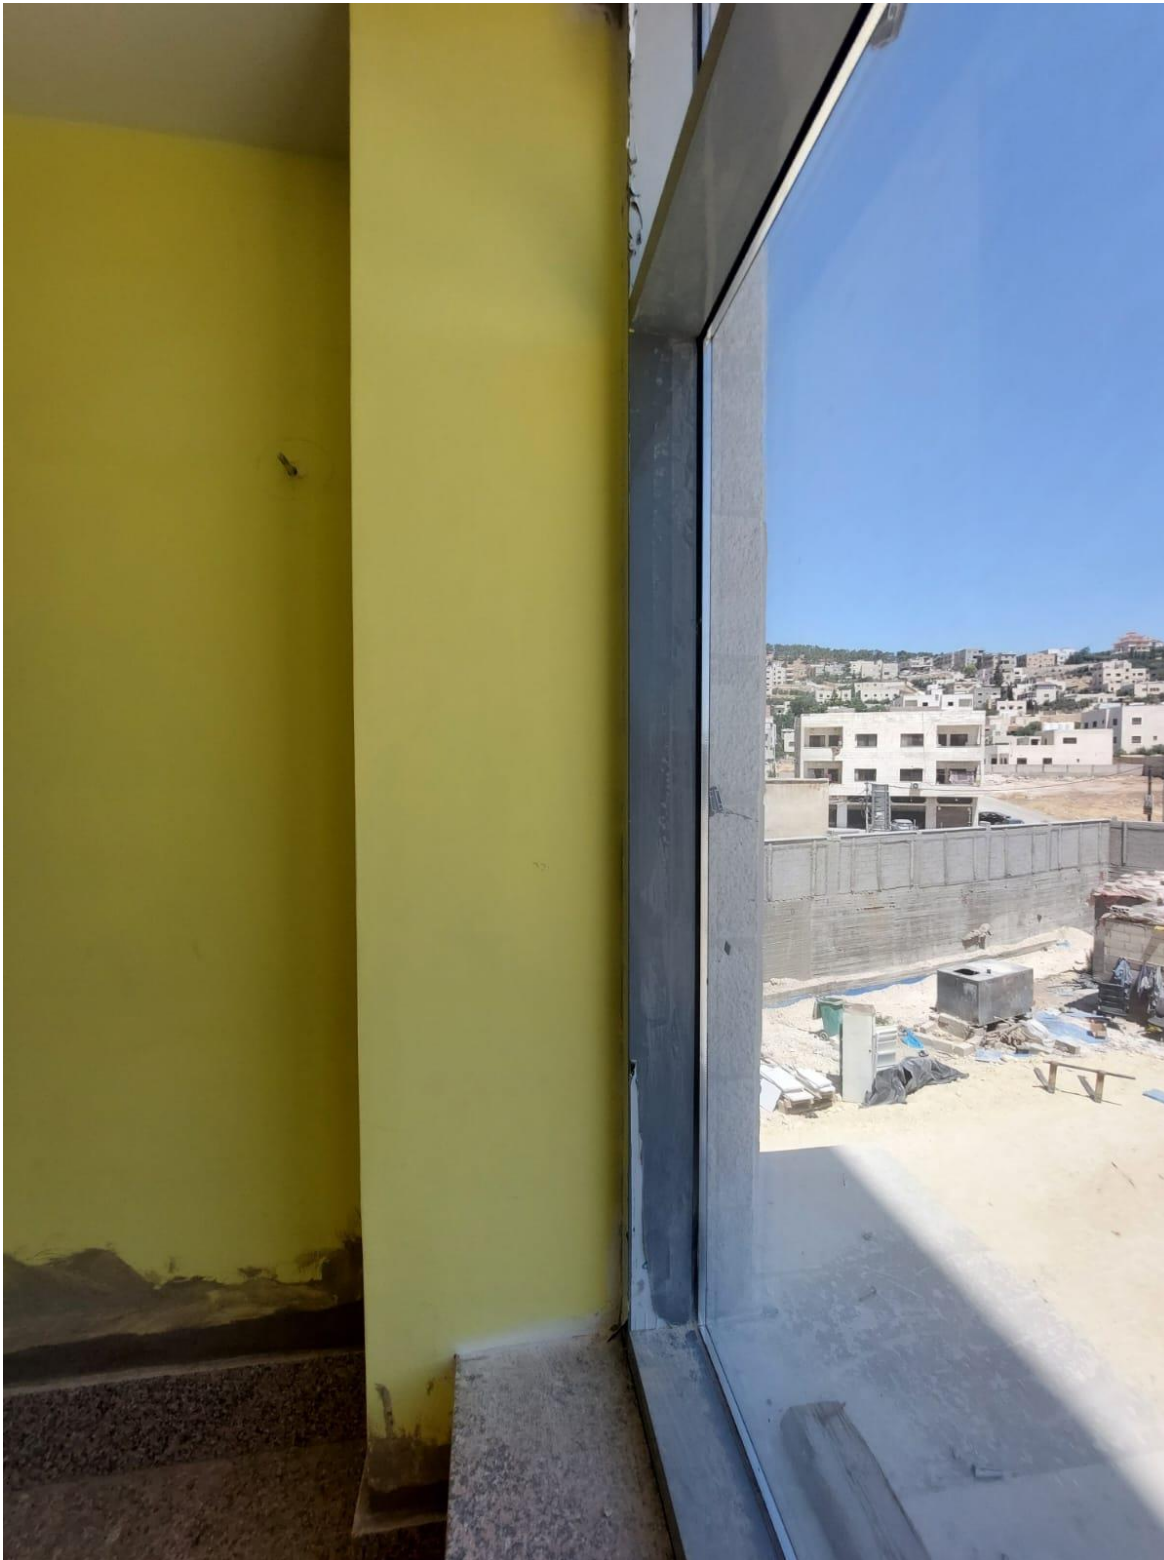
*(figure:14)*

3	The team inspected the executed curtain wall at the staircase façade and observed variations regarding the fixation points, relation with the built stones at the window jambs and the window sills as well. The team requested the Contractor to check and dismantle the sections at the whole façade which are fixed incorrectly and rectify other works if needed in coordination with the supervision team. The relation between stone at the jambs, window sills, internal plastering and aluminum curtain walls should be corrected. The Contractor has made the necessary rectifications.
4	The team observed that the Contractor has removed the red grout used at the granite coping and replaced it with the approved grouting.
5	The team inspected the installed aluminum windows and observed that the installation is correct in relation to the stone, window sills and aluminum sections.
6	The team observed that the Contractor has not yet rectified broken edges window sills and instructed the Contractor to make the necessary rectification.

The team inspected the executed curtain wall at the staircase façade and observed variations regarding the fixation points, relation with the built stones at the window jambs and the window sills as well. The team requested the Contractor to check and dismantle the sections at the whole façade which are fixed incorrectly and rectify other works if needed in coordination with the supervision team

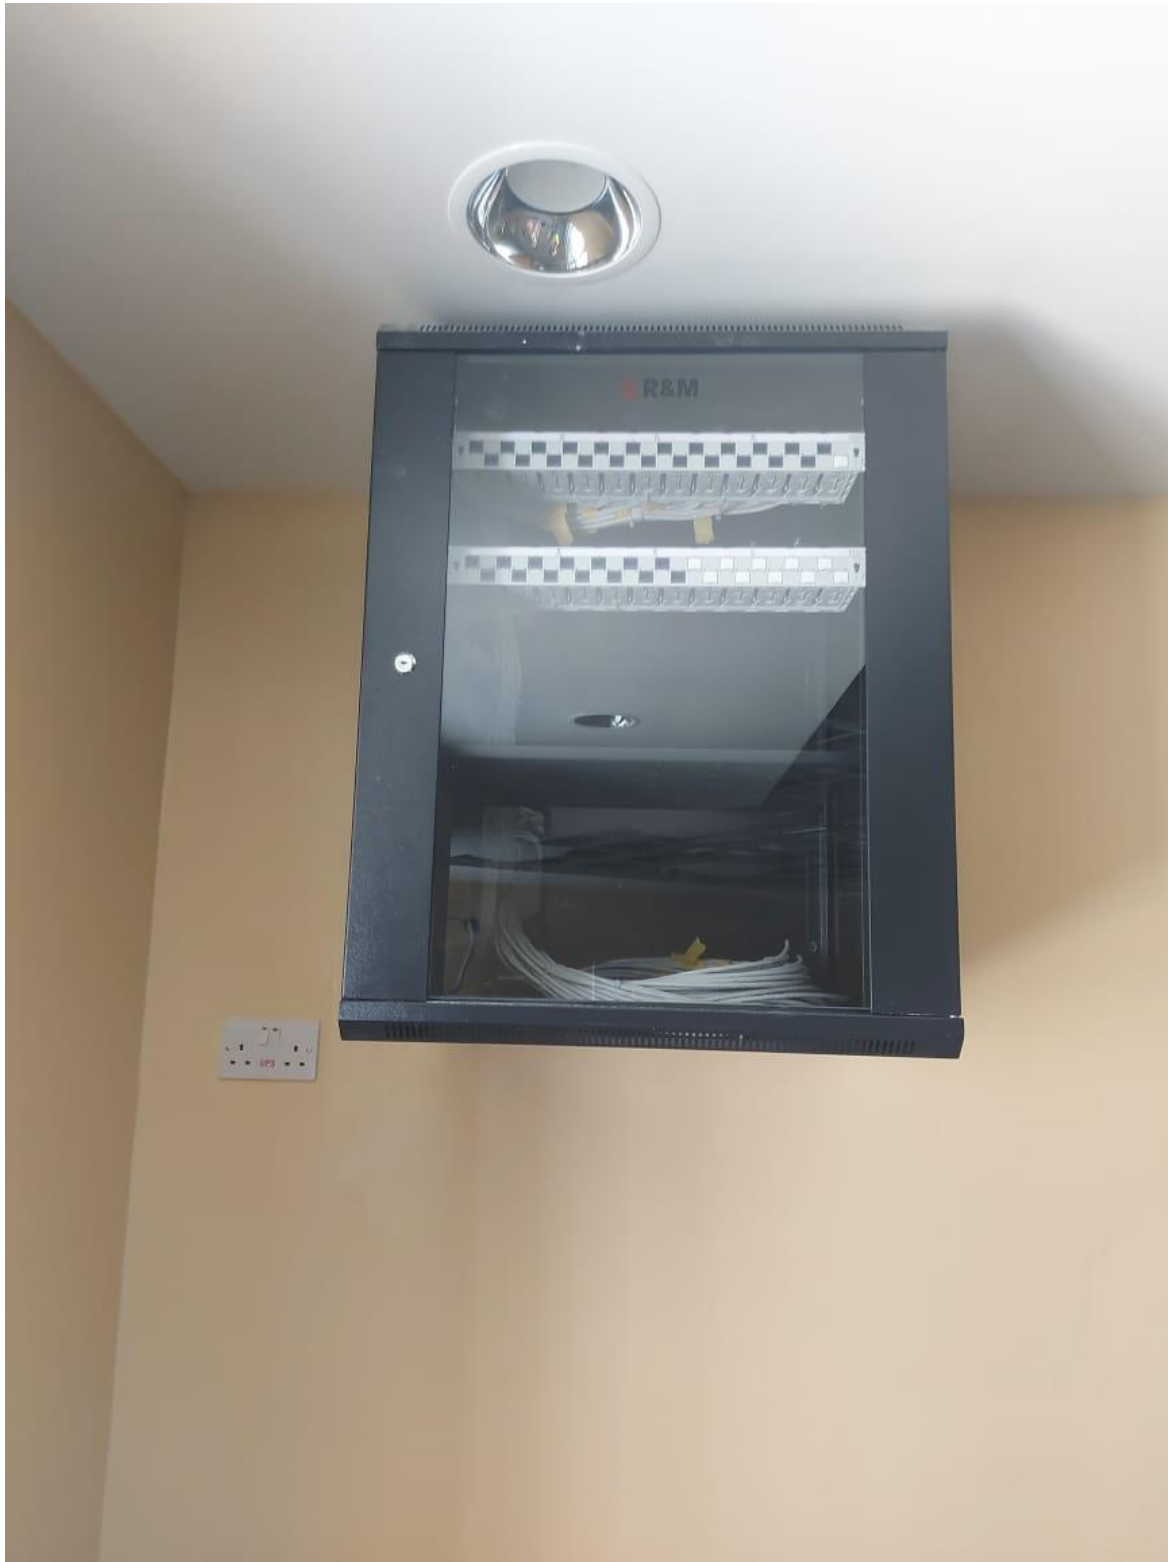
(figure:16)

7	The team inspected through the electrical engineer the patch panel for the "Data System" and rejected it due to observed damages occurred during the installation. The Contractor was requested to completely replace the cabinet and reassemble the patch panel without causing any damages. The Contractor has fixed the damages as required.

The team inspected through the electrical engineer the patch panel for the "Data System" and rejected it due to observed damages occurred during the installation. The Contractor was requested to completely replace the cabinet and reassemble the patch panel without causing any damages
