Quality Control Report

Consultant **Wahib Medanat** Consultant Engineers
Site Name **Um Al Dananir Basic Mixed - Balqa**
Package **Package 1**
Contractor **Derar Saraireh & Sons for Engineering & Contracting**
Tender No. **1/2020/USAID/SKEP/3/1**

Rep No. **QC-11 18**
Date **16 / 04 / 2022**

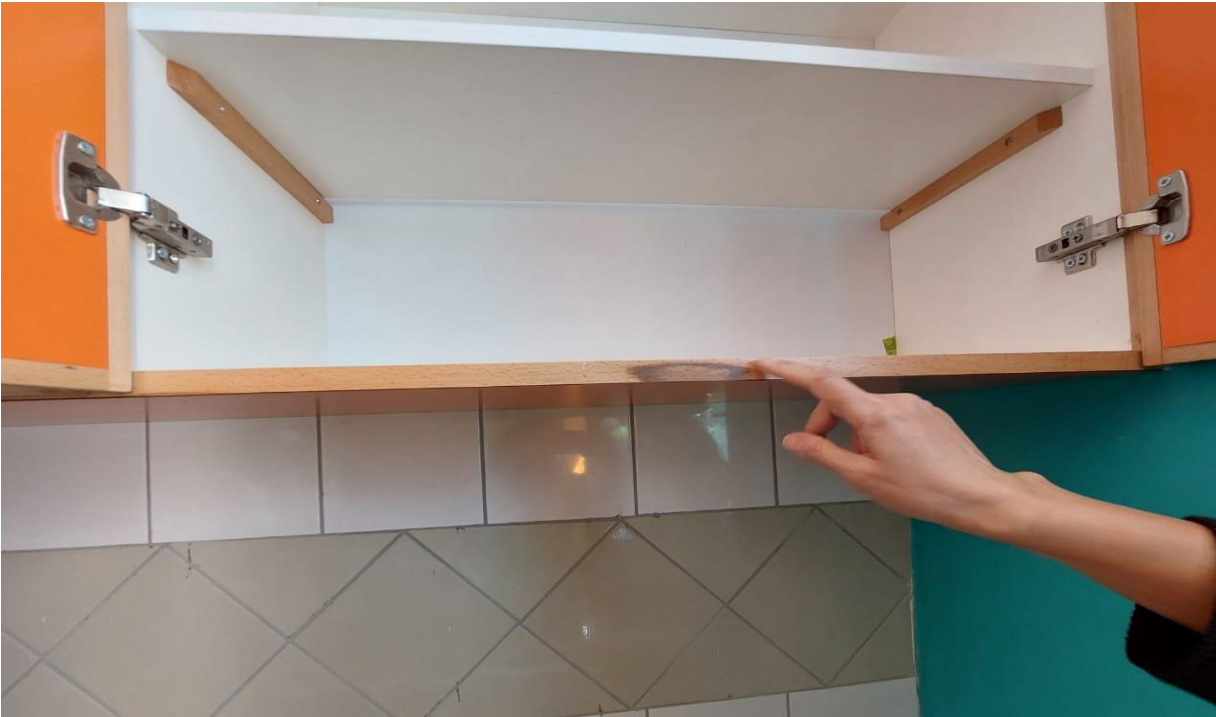
Defected cabinets

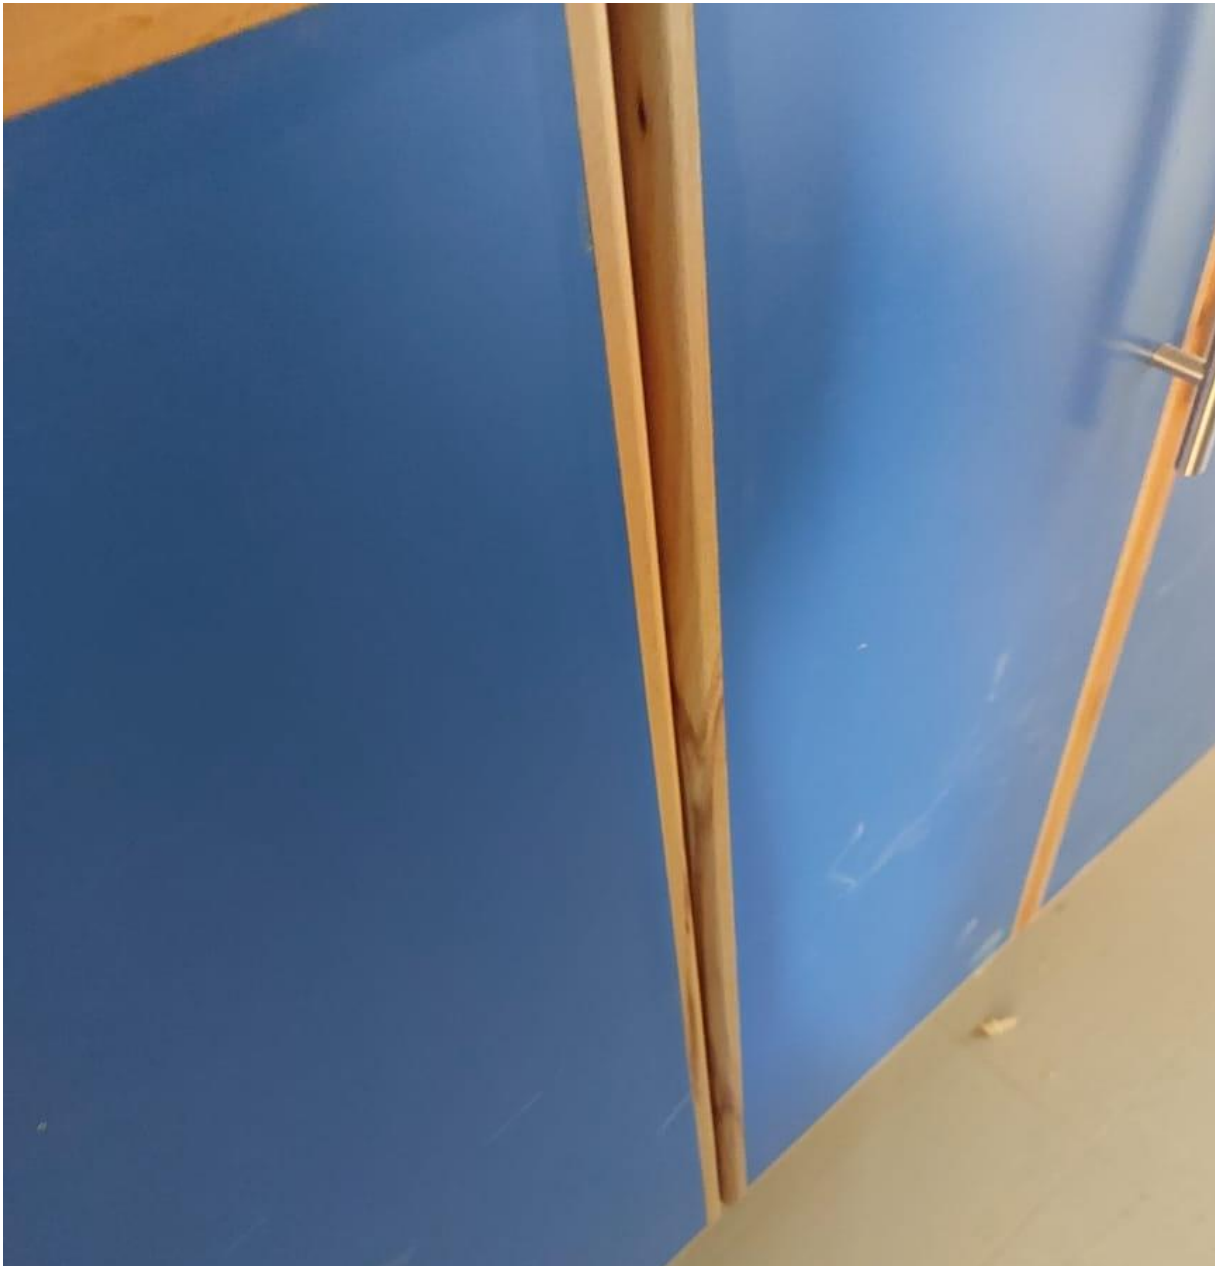
Defected cabinets

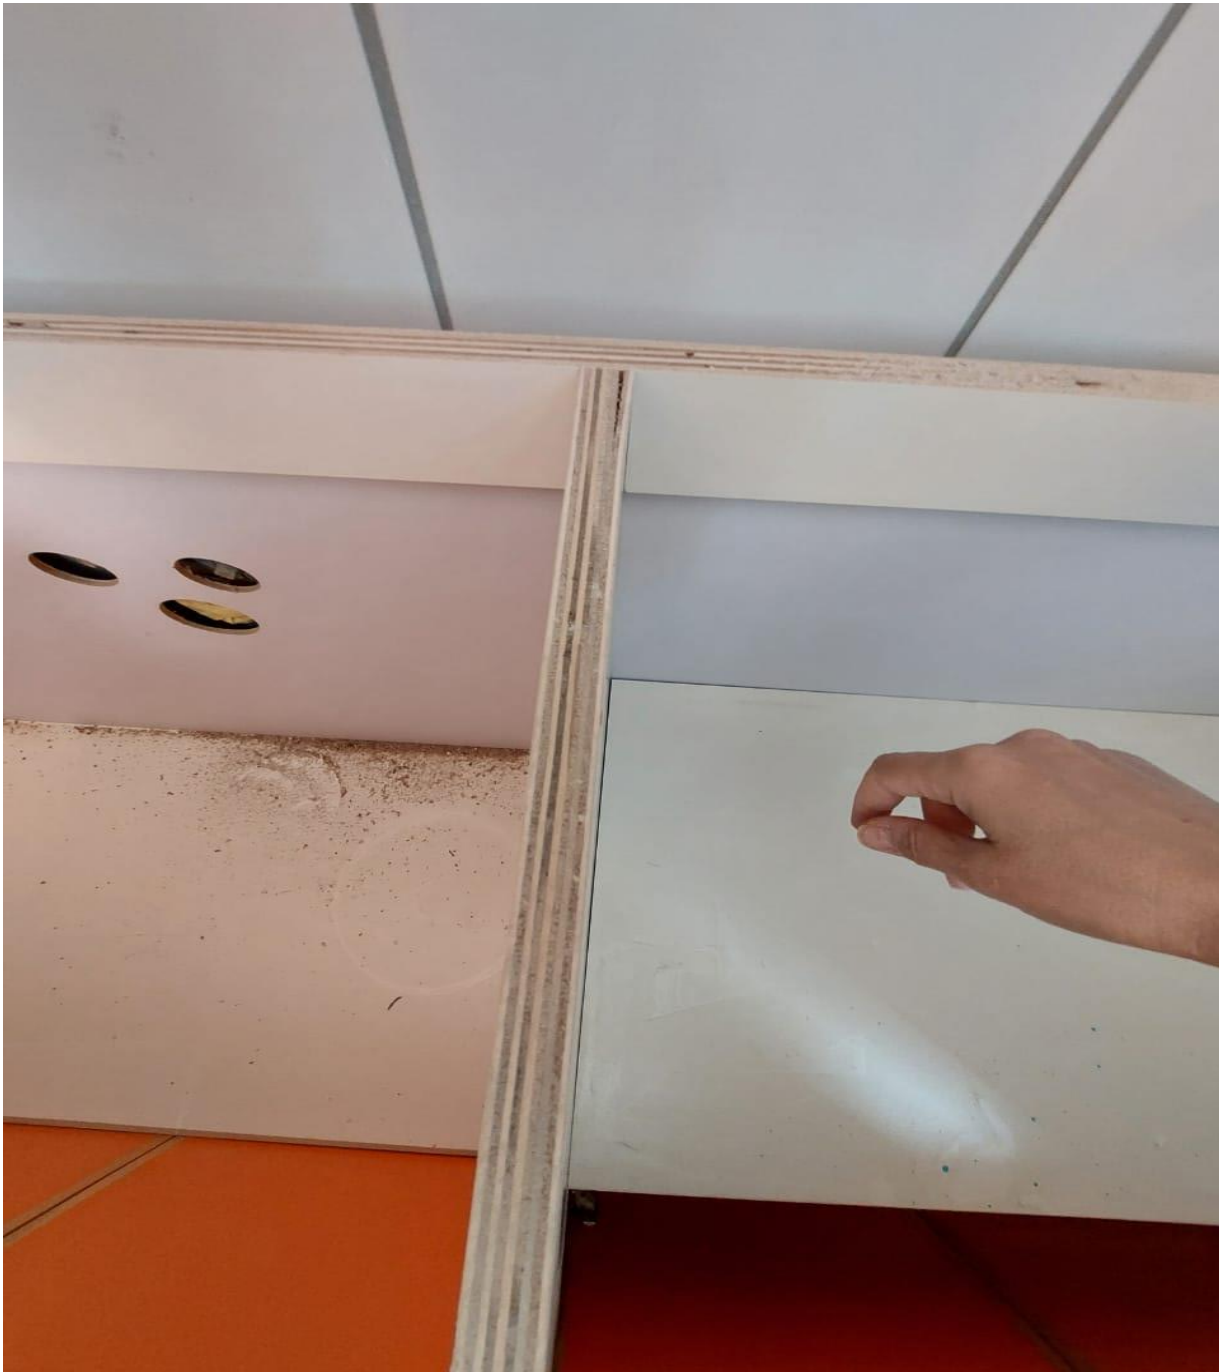
Defected cabinets

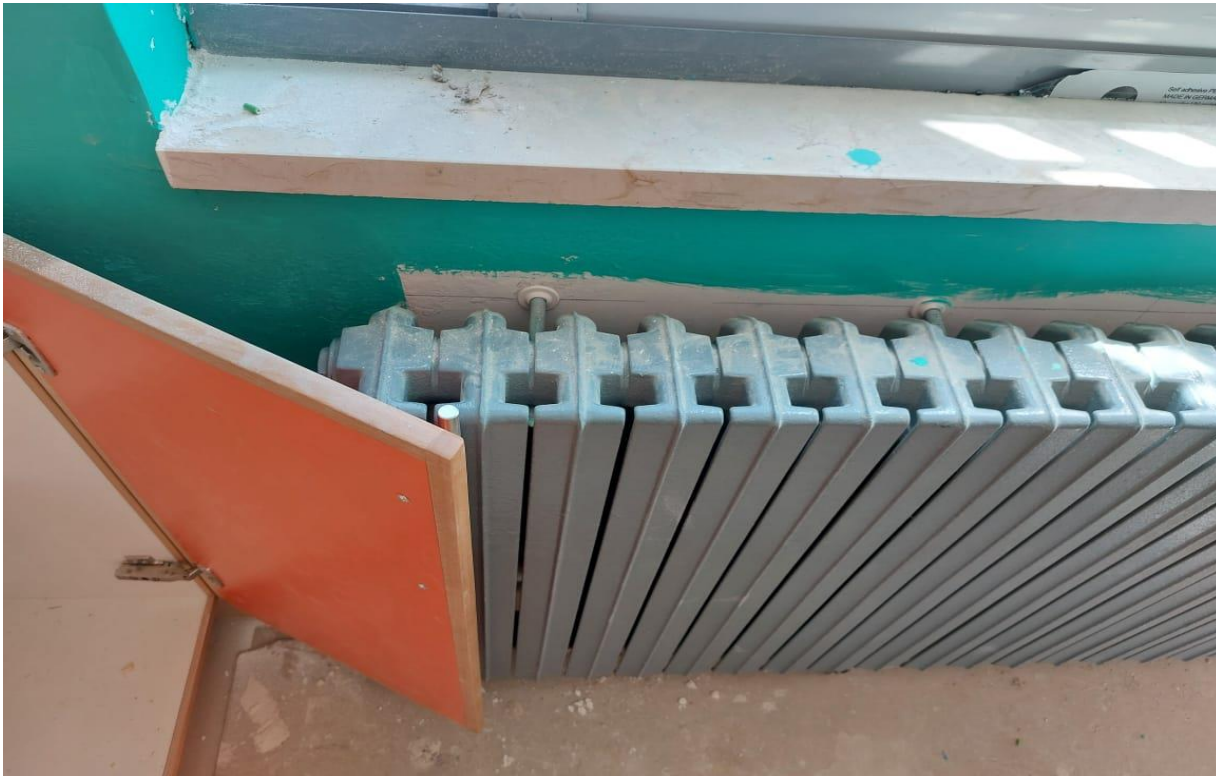
Not complete opening

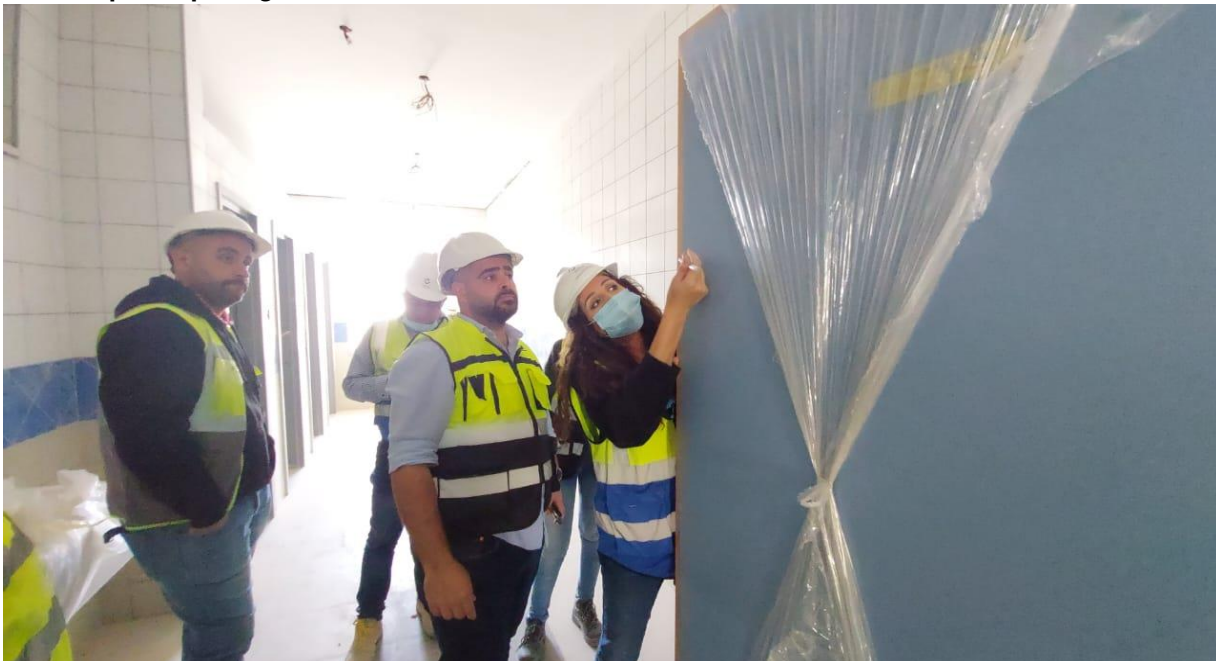
Unprotected door leafs

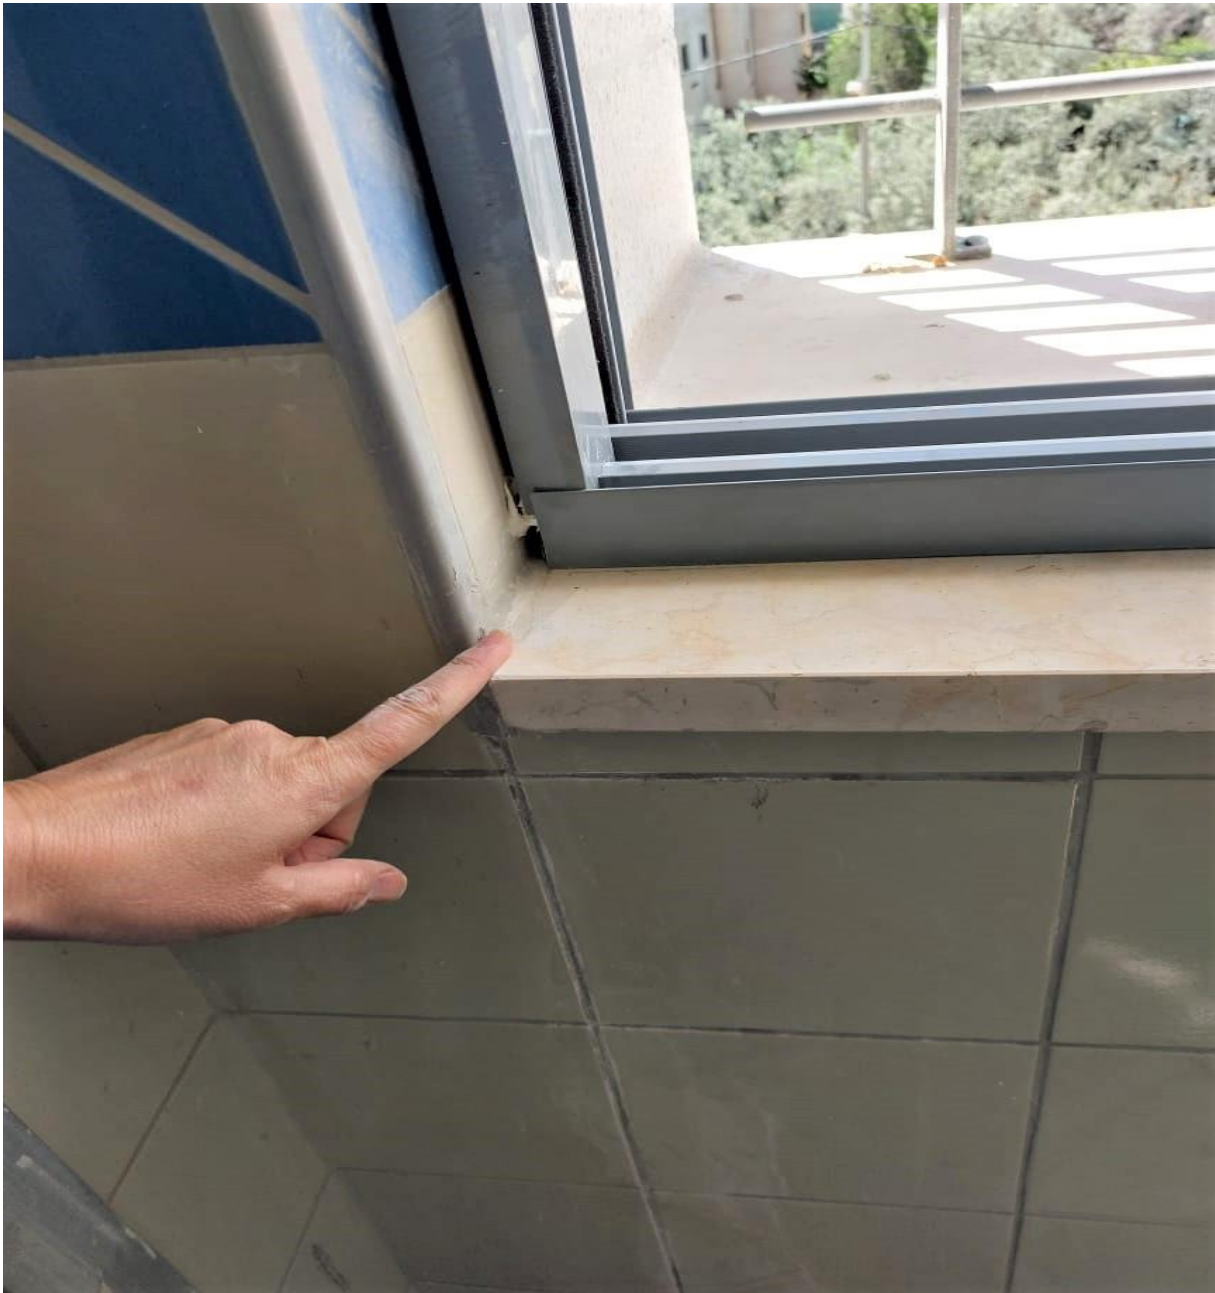
Wrong dimension of aluminum sections

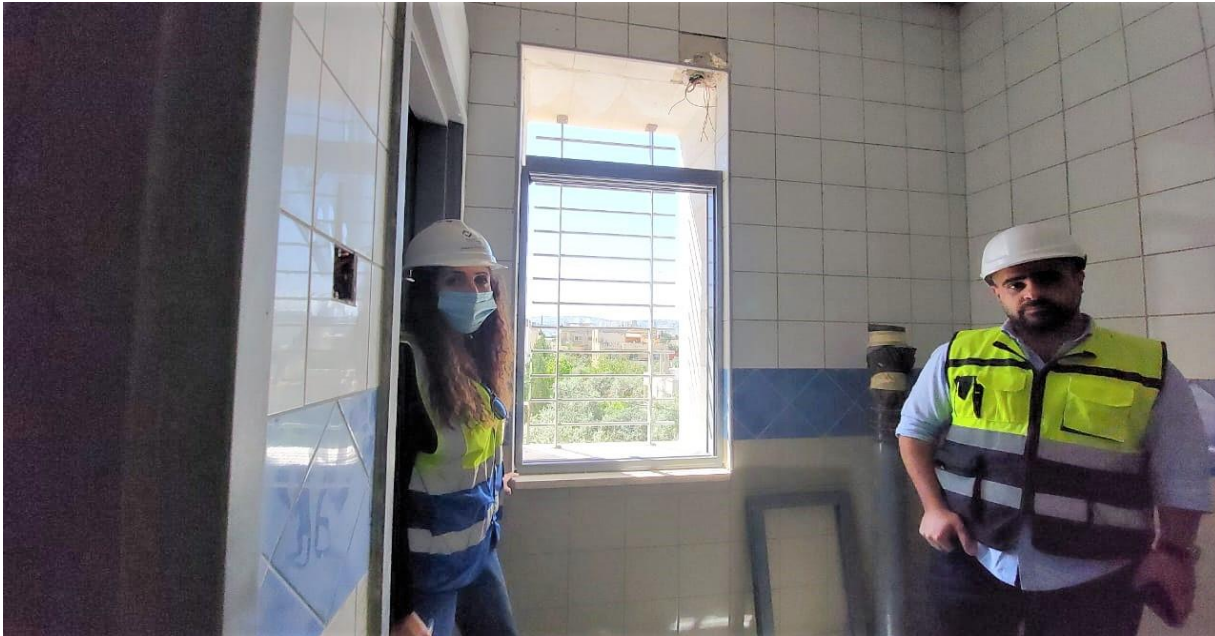
Wrong dimension of aluminum sections

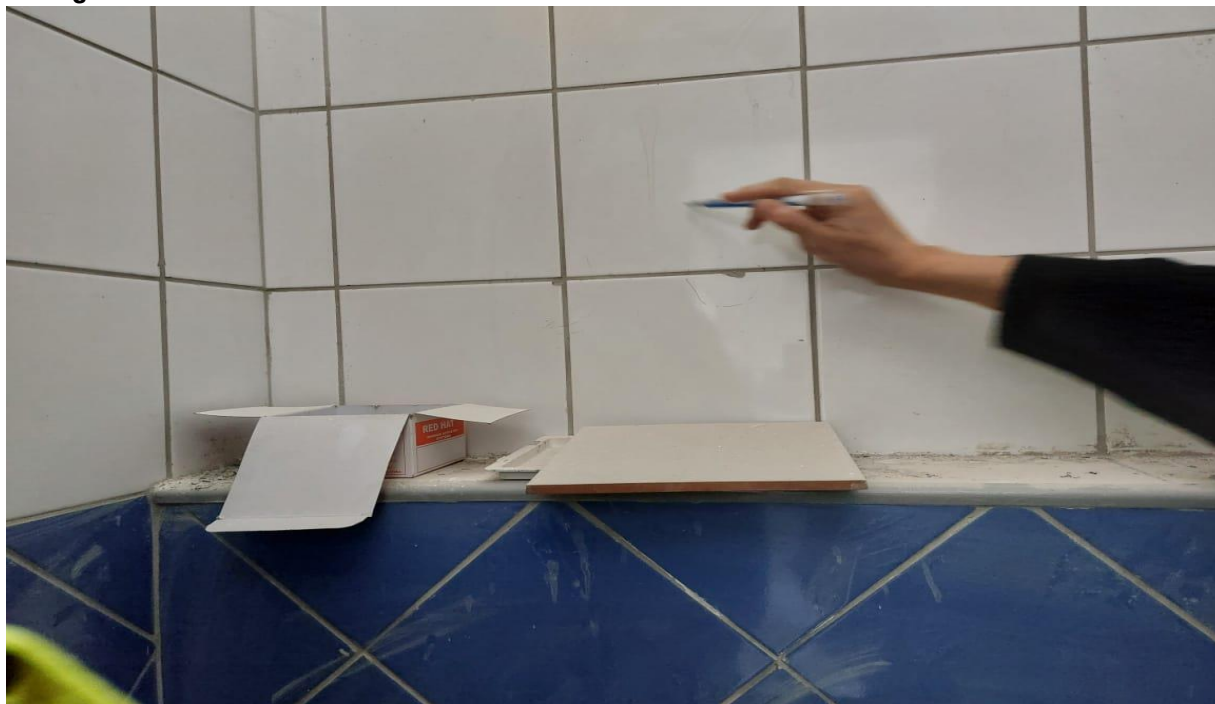
Broken ceramic tiles

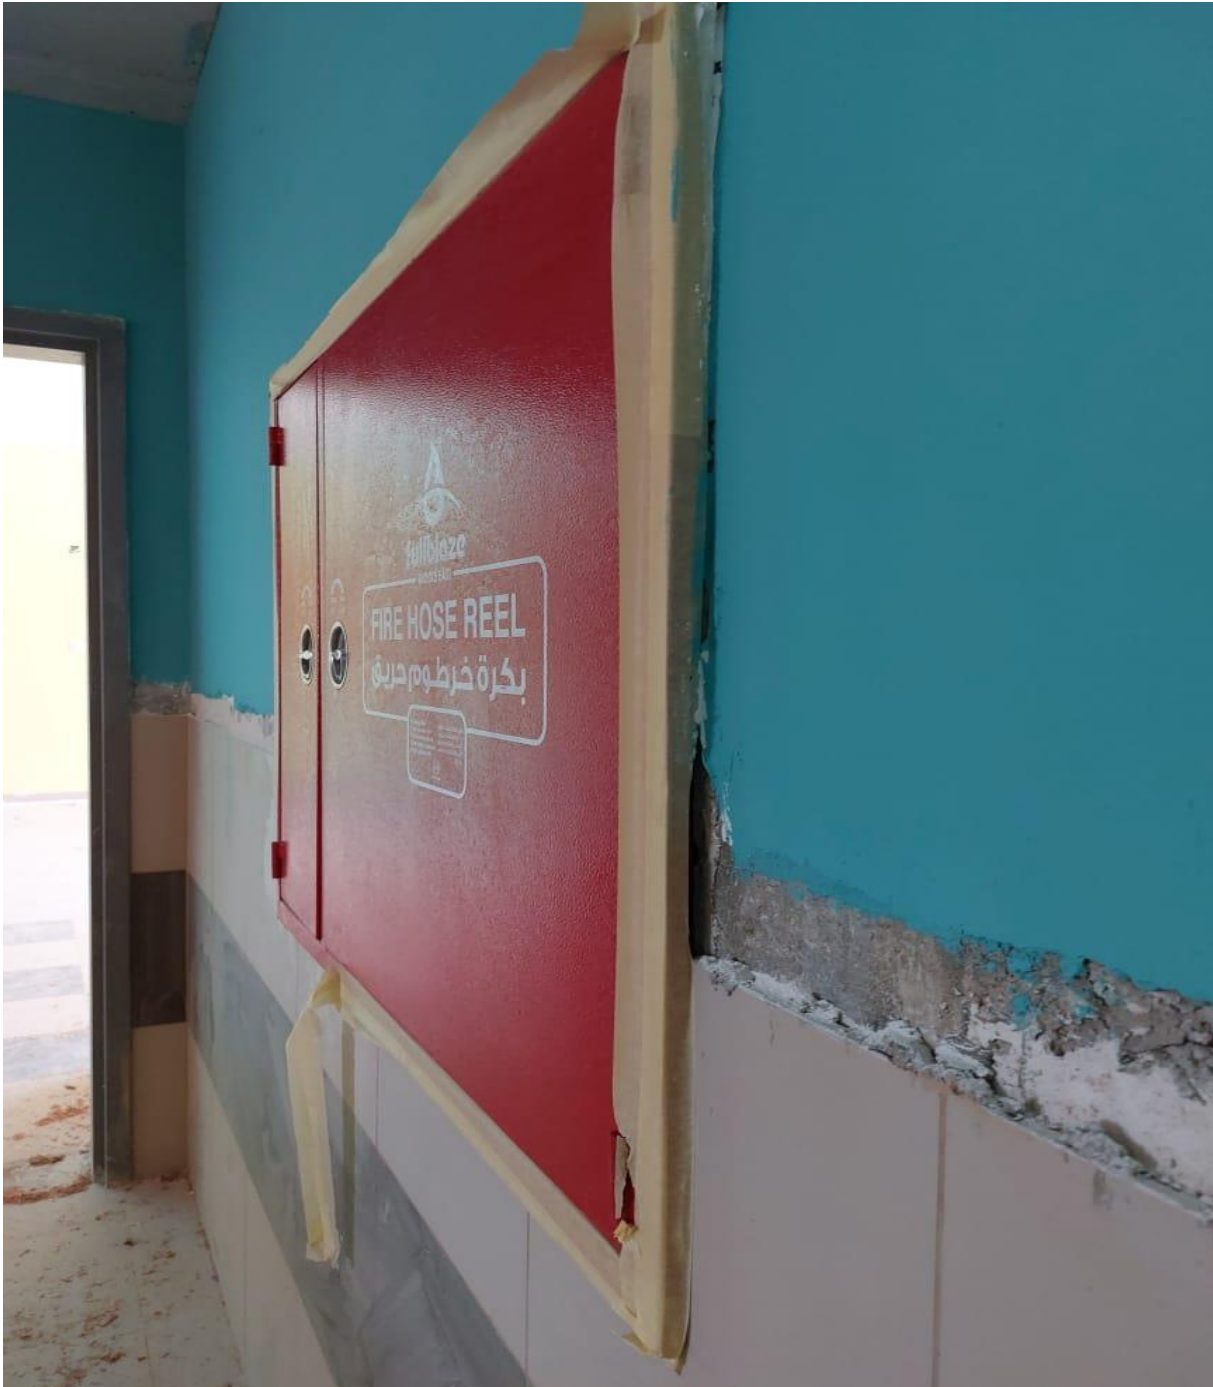
Gaps between the cabinet frame and the wall

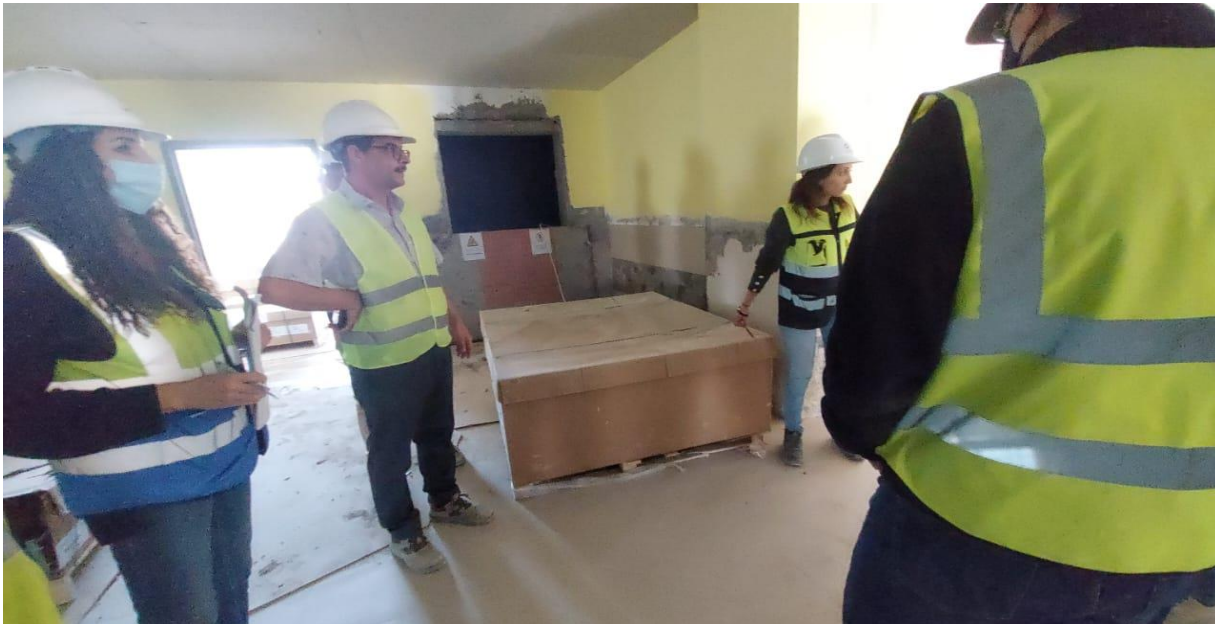
Inappropriate storage for the elevator equipment
