# Site Visit Report Form

# FTR 277 HSE

Program (JSEP or SKEP):	SKEP	PHASE: III	PACKAGE: 1			
School Name:	Al Khansa' Basio	: Mixed School				
Supervisory Engineer (SE) Name:	Wahib Medanat Consultant Engineers					
Construction Contractor (CC):	Derar Saraireh	& Sons for Engir	neering and Contracting			
Date and Time of Field Trip:	Mar 24 <sup>th</sup> , 2021					
Date of Report:	Mar 30 <sup>th</sup> , 2021					
Weather During Visit:	Dusty 22°					
Report Submitted By:	Odai Tawalbeh

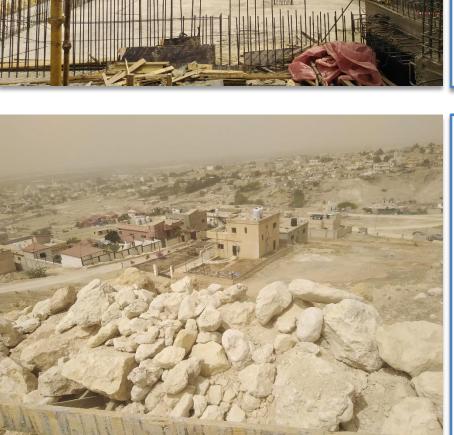
### Figure #2:

Unsupported deep excavation walls, as well as unguarded and protruding steel reinforcement bars.

**Action Required**

No corrective action from the contractor side has	Immediate action required. All the on-site protruding					
					been taken regarding the unguarded and protruding	steel reinforcement bars must be guarded with safety					
Concrete R/F Starter Bar	Y		3/24/2021	3	steel reinforcement bars were observed on site during	mushroom caps to prevent impalement.					OPEN
					the previous inspections.						
Occupational Health, Hygiene Conditions		N	3/24/2021	7			+				
Fire Prevention		N	3/24/2021	7							
Housekeeping Standards		N	3/24/2021	7				+			
Materials Storage			2/2//2021	_	Not all materials are properly stored at the site.	More attention required. All materials and equipment					
	Ŷ		3/24/2021	5		must be stored correctly at the site.					
Welfare Facilities		N	3/24/2021	7							
PPE		Ν	3/24/2021	7							
			Total H&S %	58%					Total CA %		
			Action Status		NEEDS IMPROV.			4	Action Status	6	
Environmental Regulations	Y	N N/A	<u> </u>				۲N	I N/A
