SKEP III Home Office Support Site Visit Report

Consultant	Wahib Medanat Consultant Engineer	Rep No.	21-09082021
Contractor	Dijlah Establishment Constr. Contracting	Tender No.	(11/2019/USAID/SKEP/3/S) Schools for a Knowledge Economy Project (SKEP) - Phase (3) Package (1, 2)
Site Name	Hay Al Iskan Basic Mixed School- Jerash	Day/ Date	Mon. 09/08/2021
Duration of Project	450 Calendar Days	Total Project Budget	8,314,983.735 JD

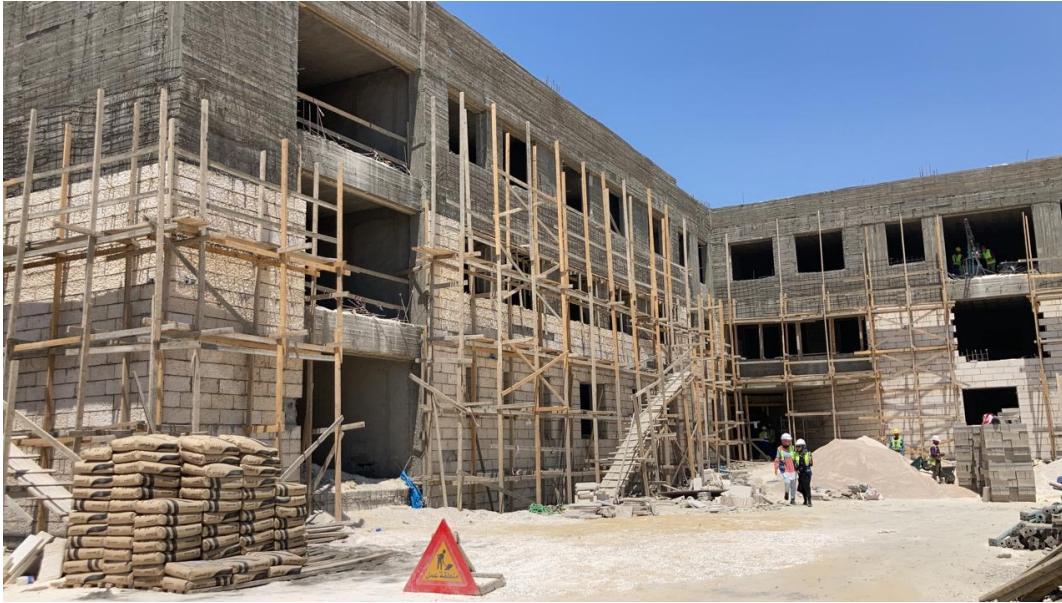
General view of the completed second floor casting (the last slab)

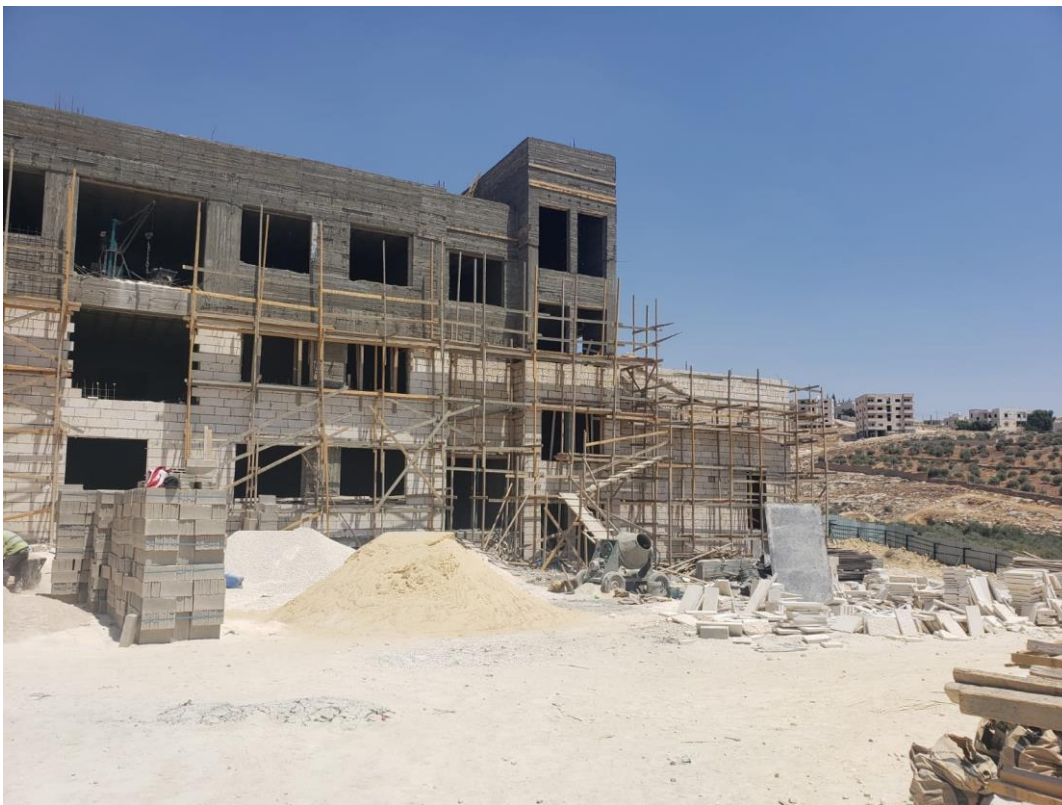
The Contractor is continuing in removing the defected stones to replace them with stones complying with the approved sample. Special zone at the site was identified to sort out the stones and discard the rejected stones. Stone building is still progressing

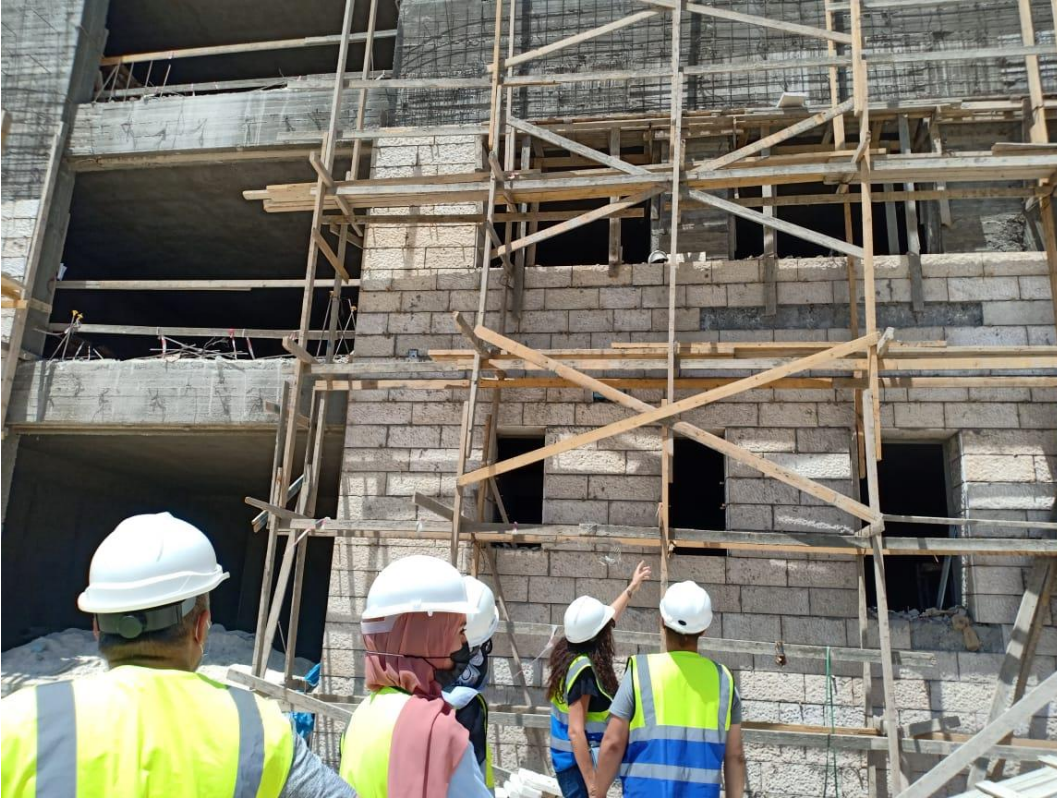
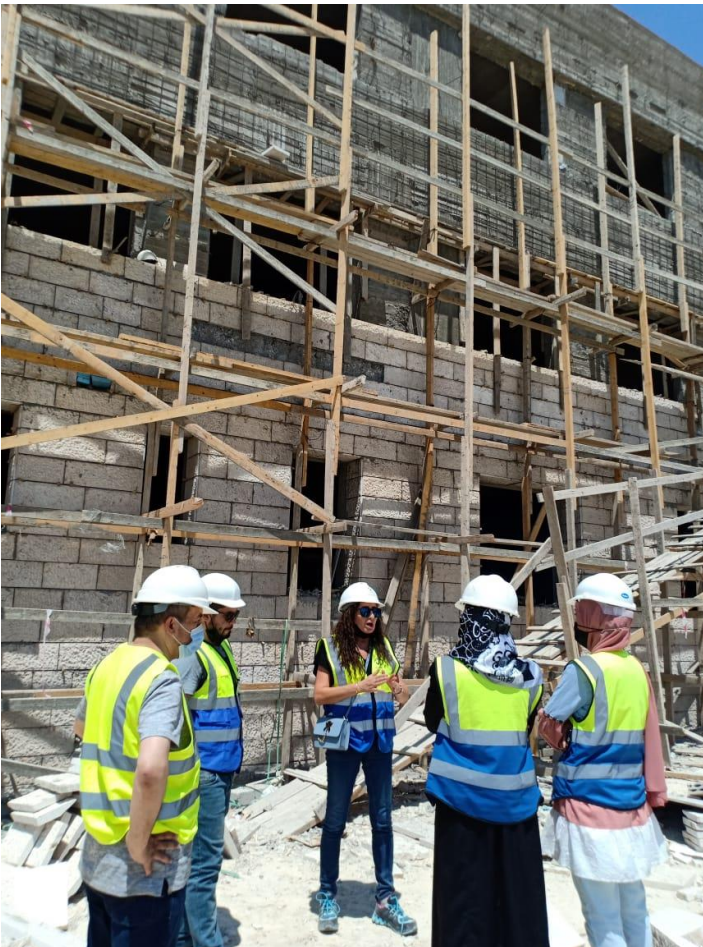
Remarks have been observed on the built stone on the facades and a discussion was made

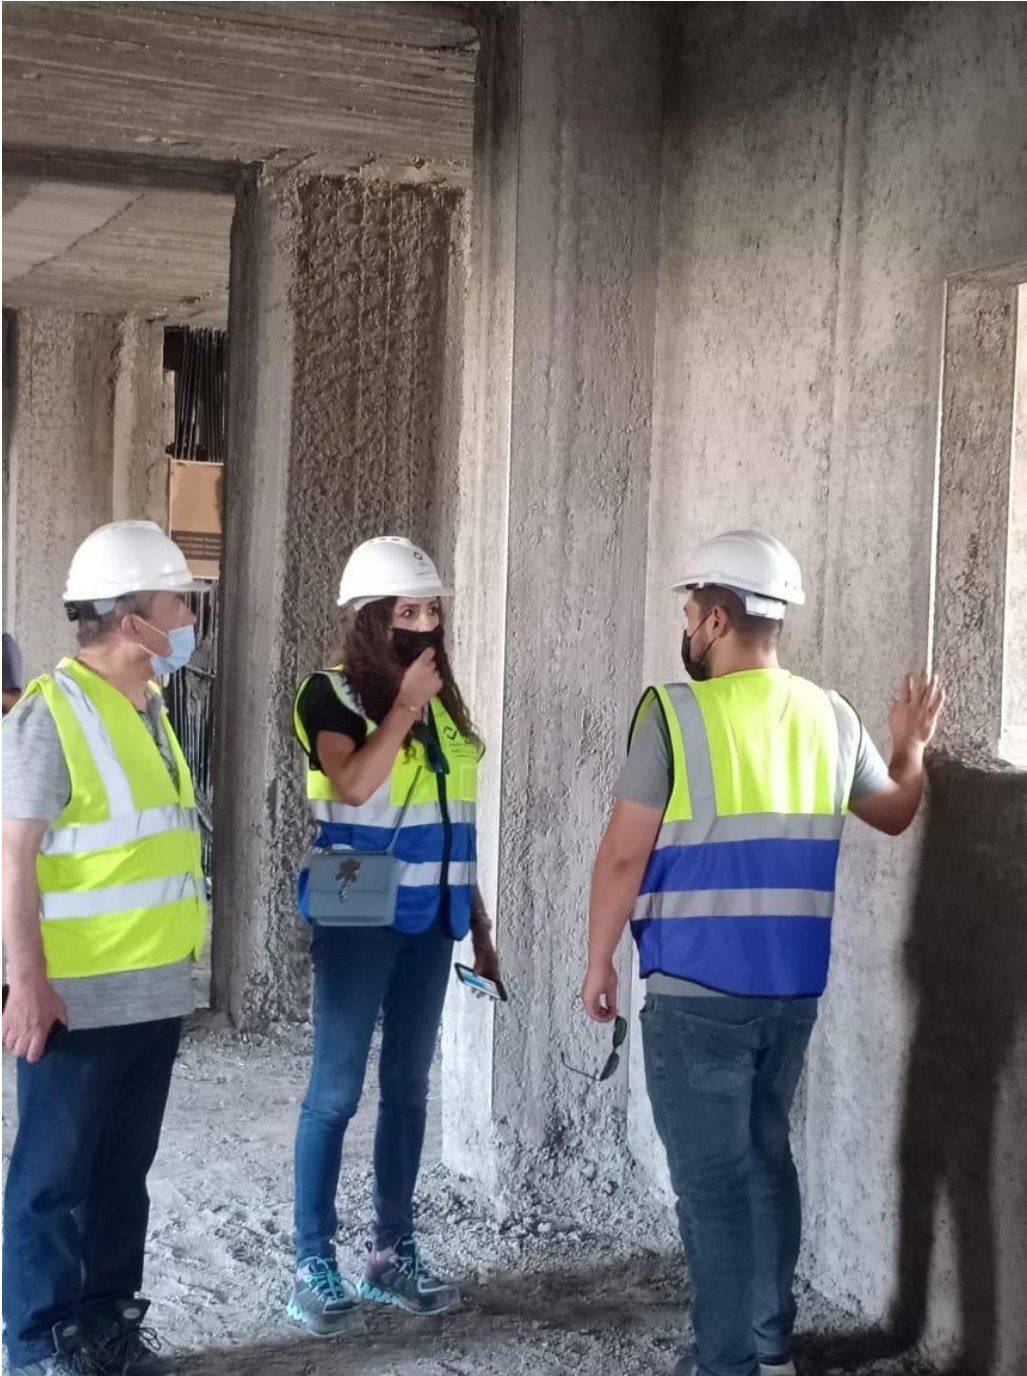
Plastering beads are used for windows' edges

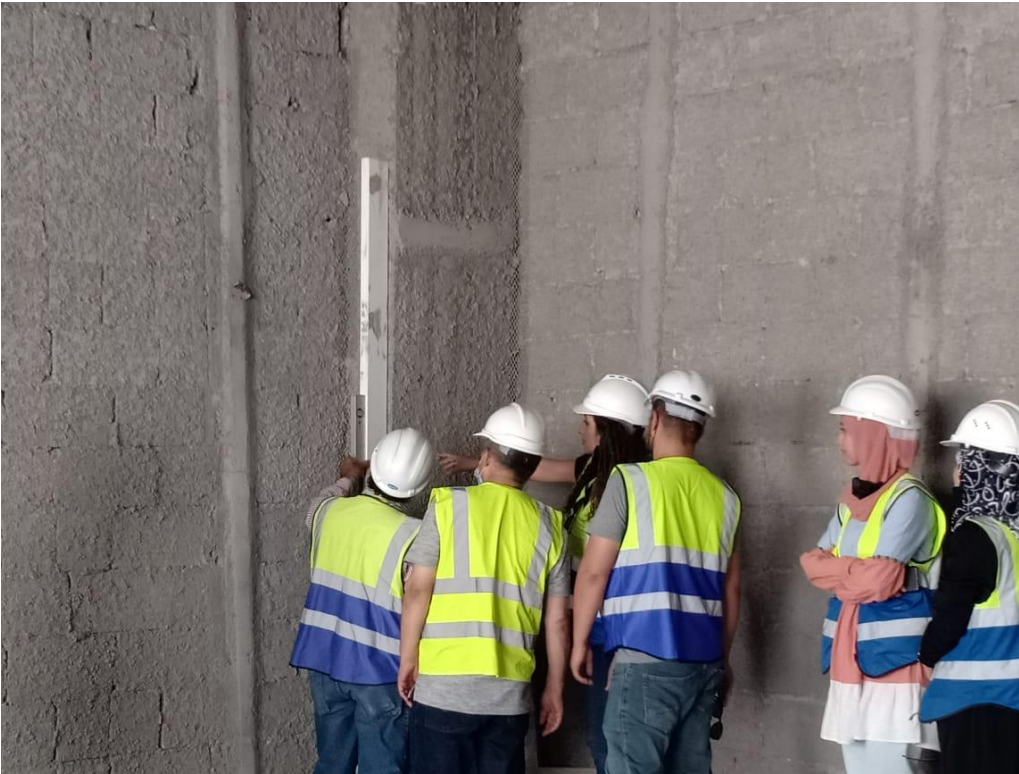
The Consultant observed a minor defect in the verticality of one column and instructed the

No.	Description
1	The Consultant observed a minor defect in the verticality of one column and instructed the Contractor to rectify at the plastering stage with the follow up of the Consultant's site staff.
2	The Contractor is continuing in removing the defected stones to replace them with stones complying with the approved sample. Special zone at the site was identified to sort out the stones and discard the rejected stones. Stone building is still progressing.

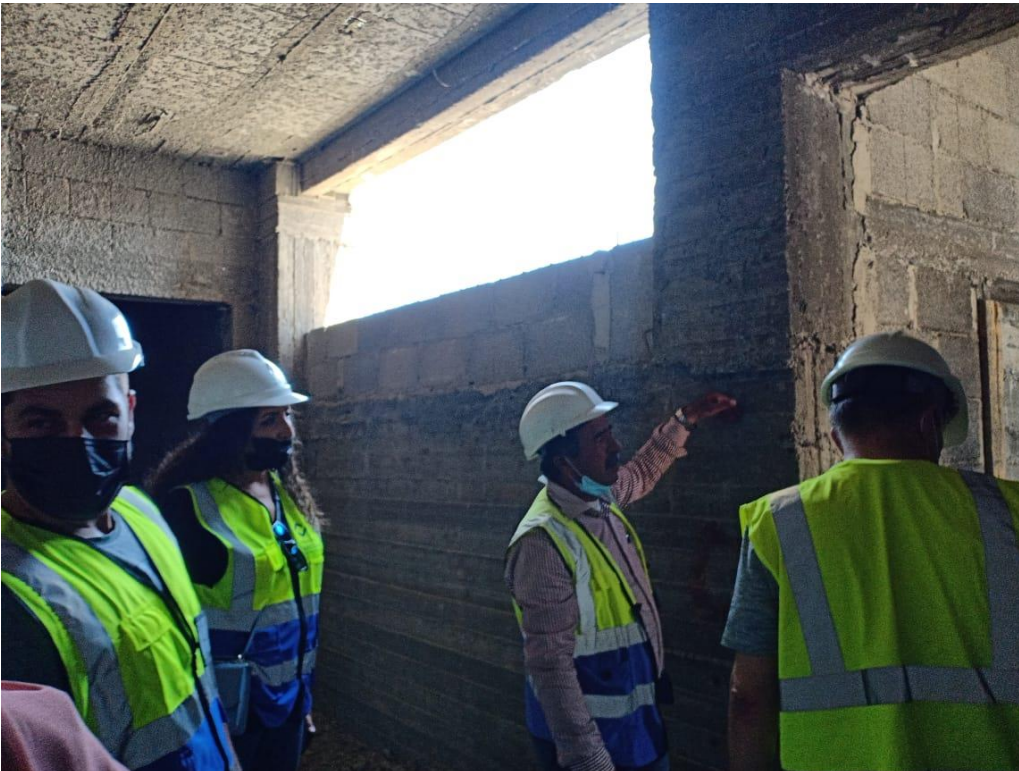
The Consultant observed prominence in one of the internal walls in the first floor- staircase entrance. The prominence came due to the drop beam there. The Contractor was requested to cast concrete strip adjacent to cancel the prominence

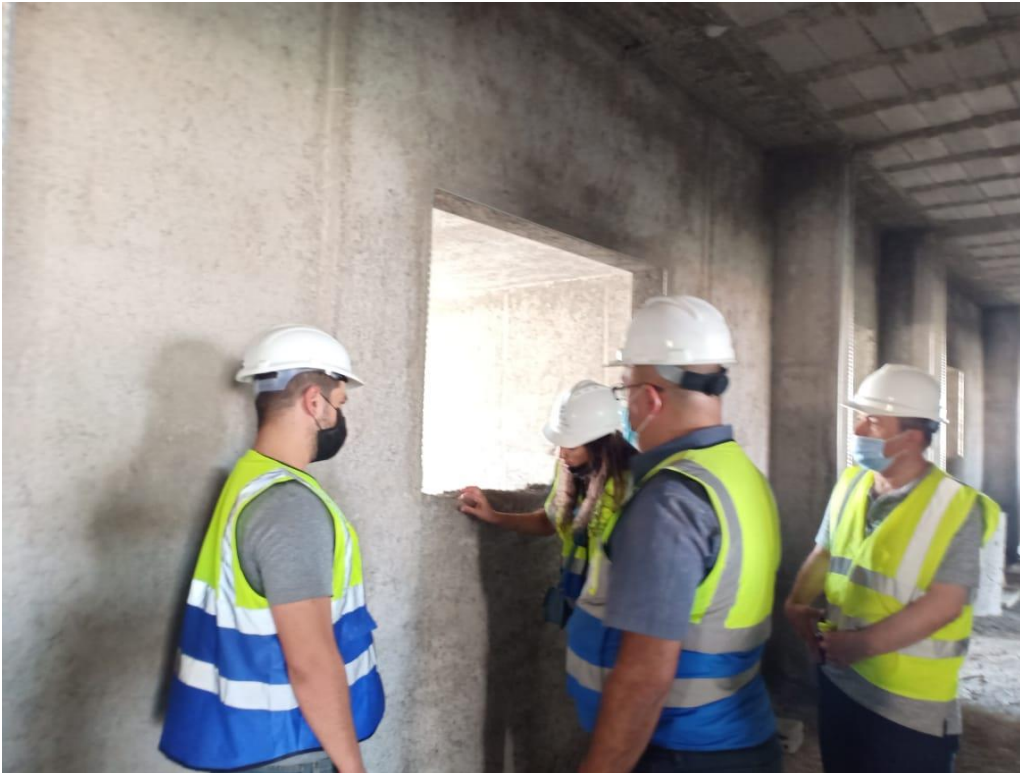
Arch. Suhair explained to the Contractor the relation between the porcelain cladding, granite coping, window sill and the door jamb

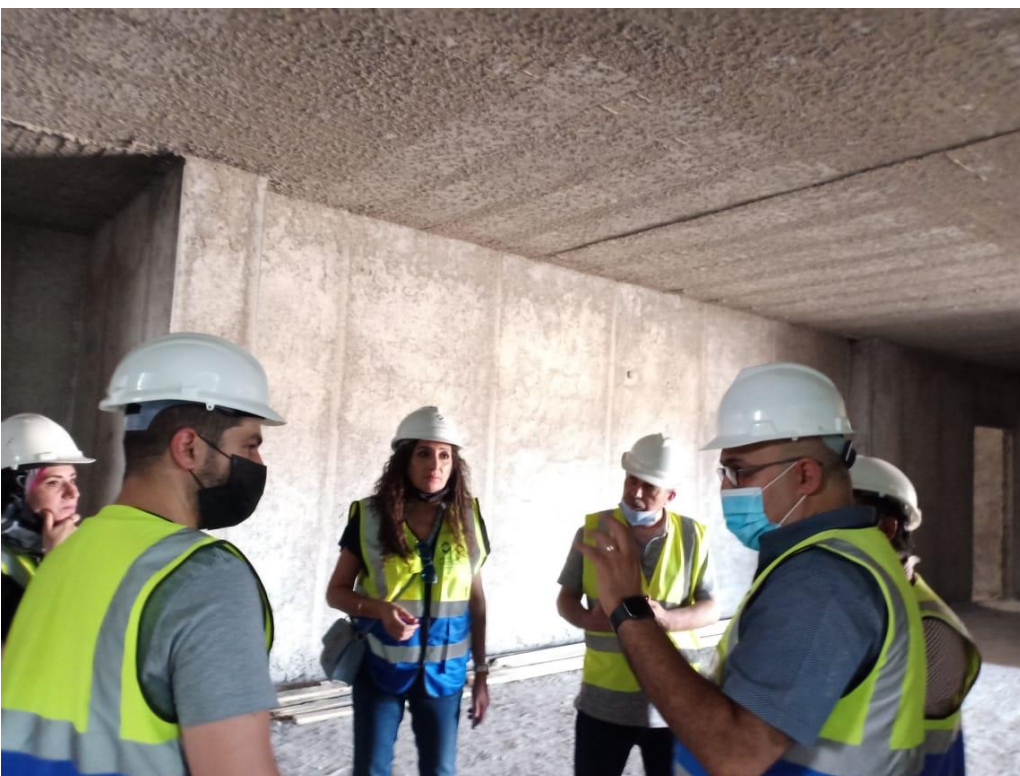
Observing plastering work and remarks were given

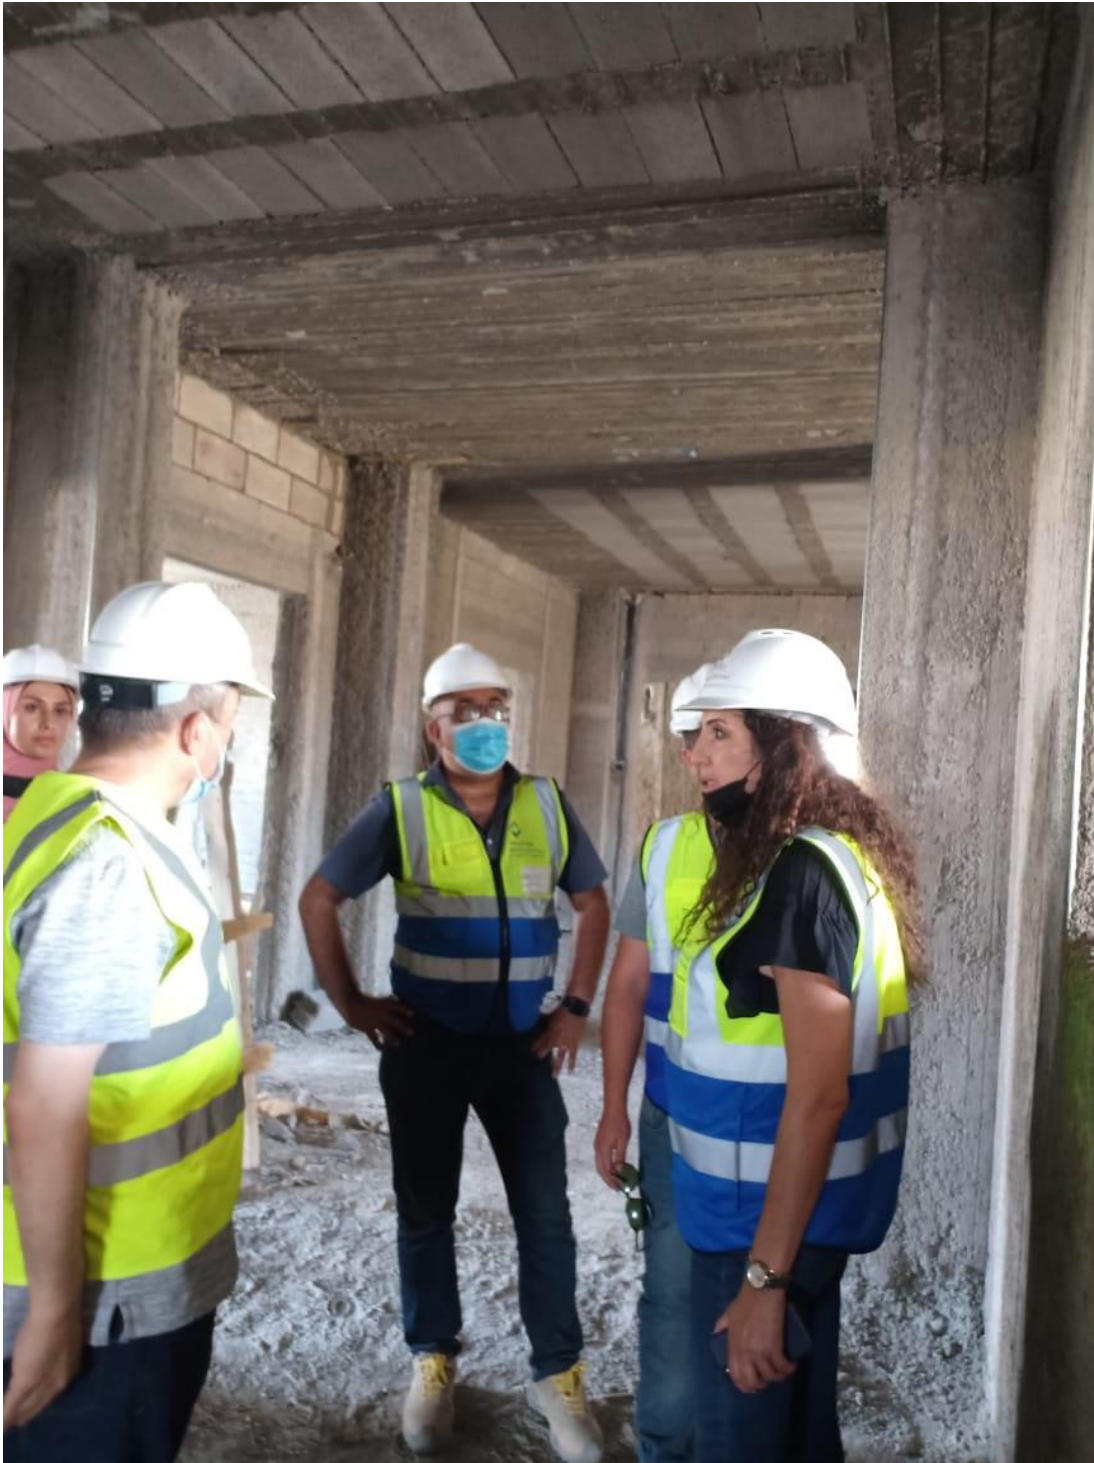
The Consultant advised the Contractor to submit workshop drawings for heating pipes under slab for Engineer review as MPWH approval is still under process and discussing the false ceiling design ideas for corridors

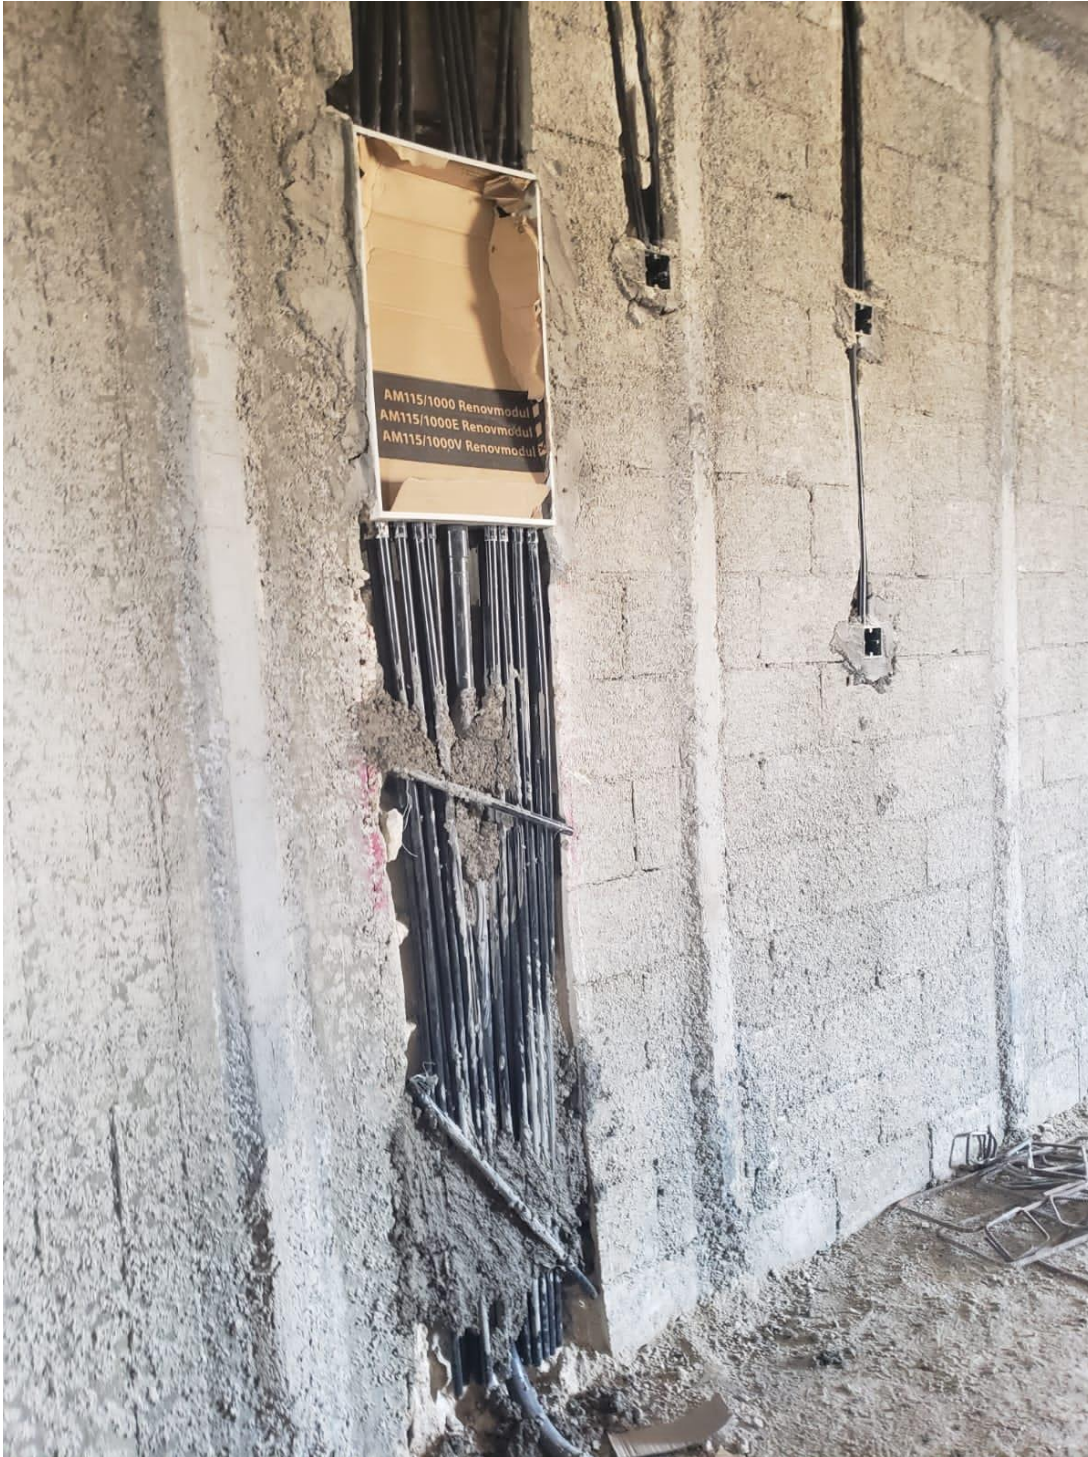
The Consultant observed that the Contractor abide by the contract's requirement regarding the saw cut in the block wall for the MEP first fix
