**Construction Management of the Jordan School Expansion Project (JSEP)
and the Schools for a Knowledge Economy Project (SKEP)**

Site Visit Report Form

FTR #266 HSE

Program (JSEP or SKEP): SKEP **PHASE:** III **PACKAGE:** I
School Name: Al Khansa' Basic Mixed School
Supervisory Engineer (SE) Name: Wahib Madanat Consultant Engineers
Construction Contractor (CC) Name: Derar Saraireh & Sons for Engineering and Contracting
Date and Time of Field Trip: March 10, 2021 – 10:15 AM
Date of Report: March 13, 2021
Weather During Visit: Sunny – 24°
Report Submitted By: "Odai Tawalbeh" and "Adnan Cobein"

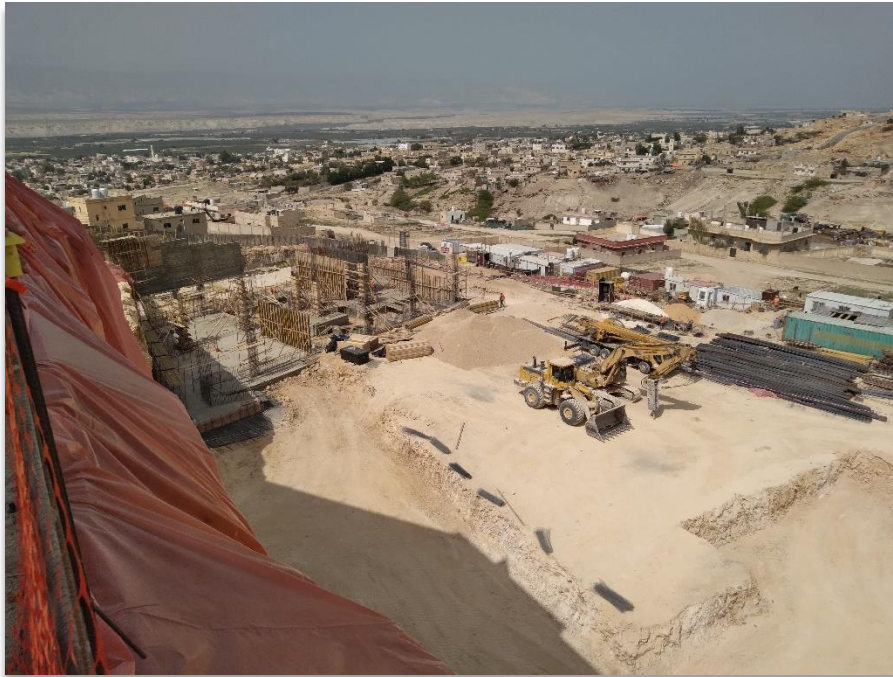
Figure 2: Overview of the Ongoing Works in the Project

Figure #2: The project consists of 23 classrooms and four KGs from KG2 to 10th grades and will host 928 students. With an internal area of 6600 sqm, and an external area of 3800 sqm.

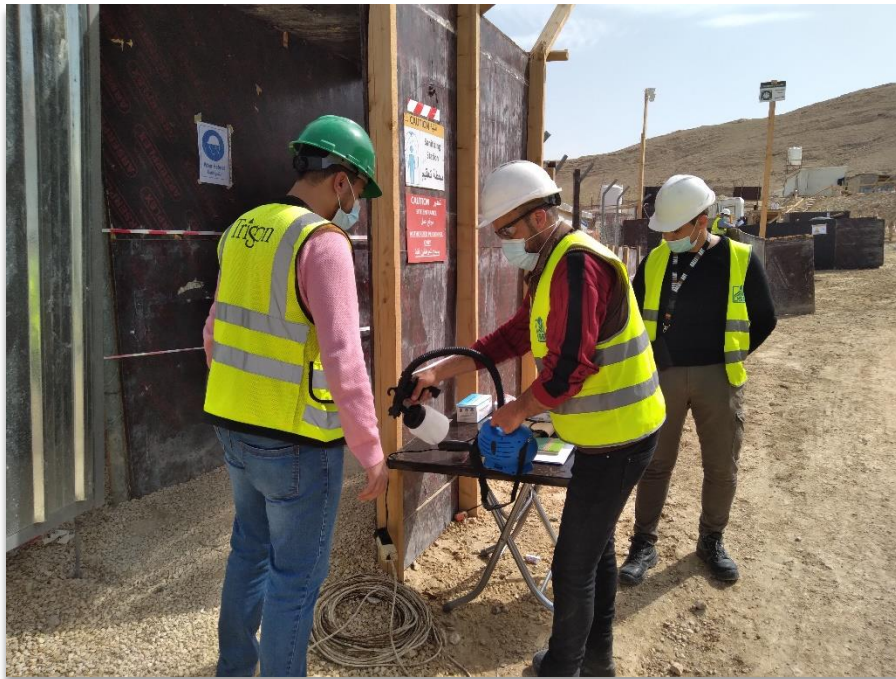
Figure 4: Compliance With COVID-19 MOL Measures

Figure #4: Adequate Hygiene stations were secured in the workplace at the entrances and exits.

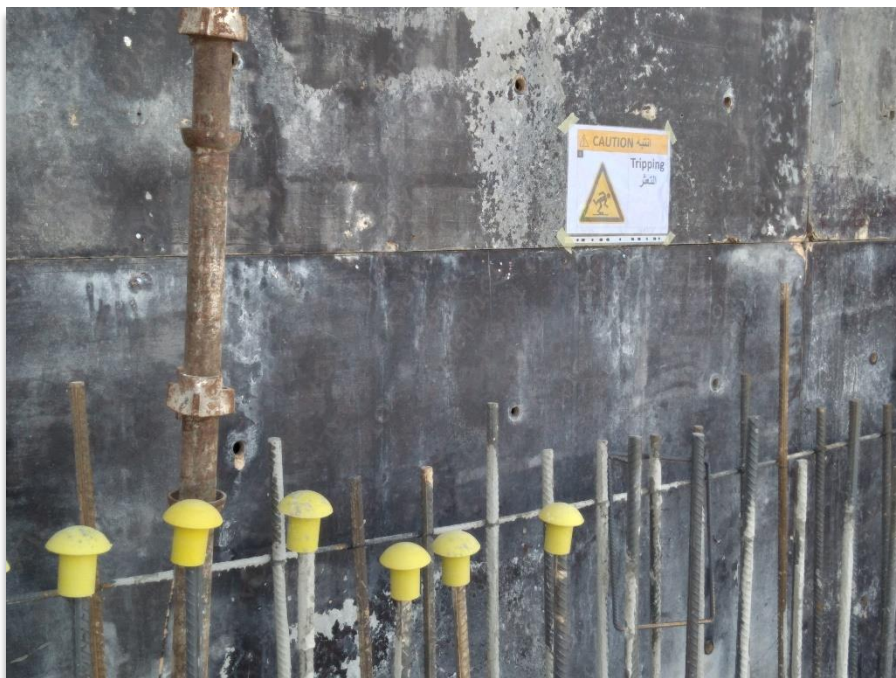
Figure 5: Steel Reinforcement Bars

Figure #5: Safety Mushroom Caps were provided, but sporadic throughout the site. It's recommended to guard all Protruding Steel Reinforcement Bars with these caps at all project sites to prevent Impalement.

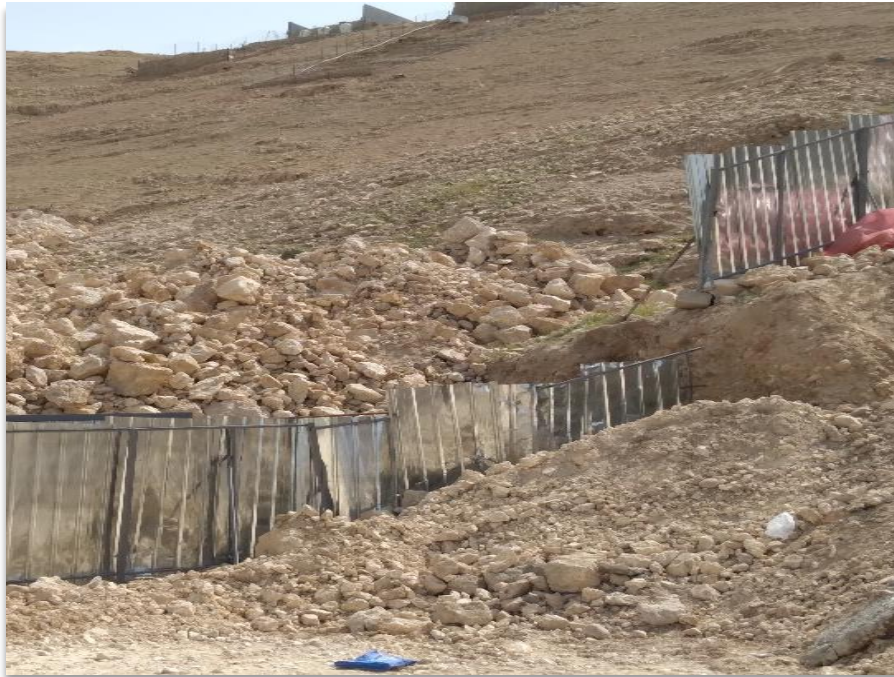
Figure 6: Site Fencing

Figure #6: The damaged Temporary Site Fencing must be promptly repaired along site perimeter, and the assigned Contractor must ensure that all Site Excavations are properly protected against Collapse.

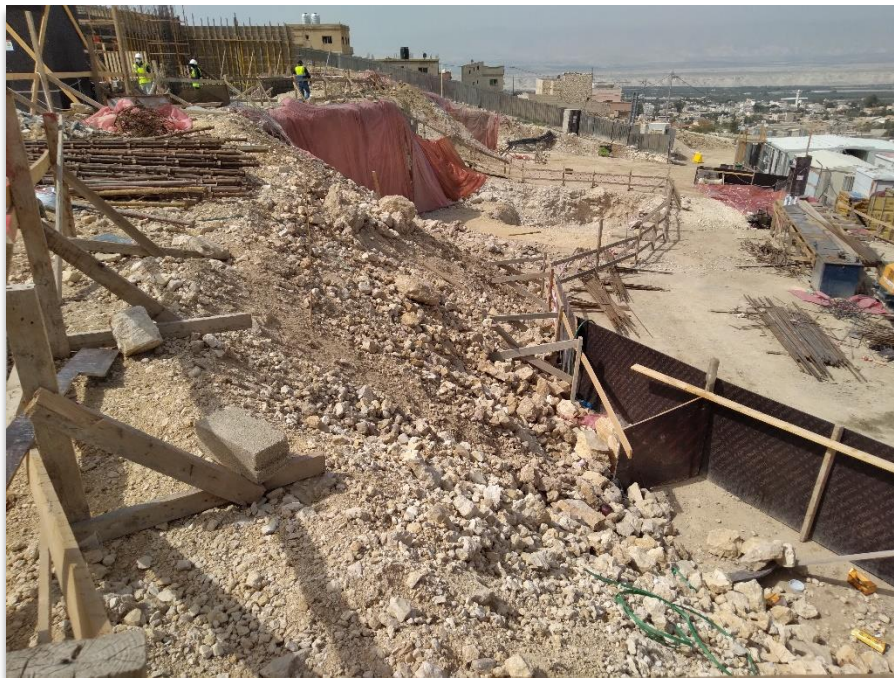
Figure 7: Site Excavations

Figure #7: The assigned Contractor must ensure that all Site Excavations are properly protected against Collapse and Soil Sliding.

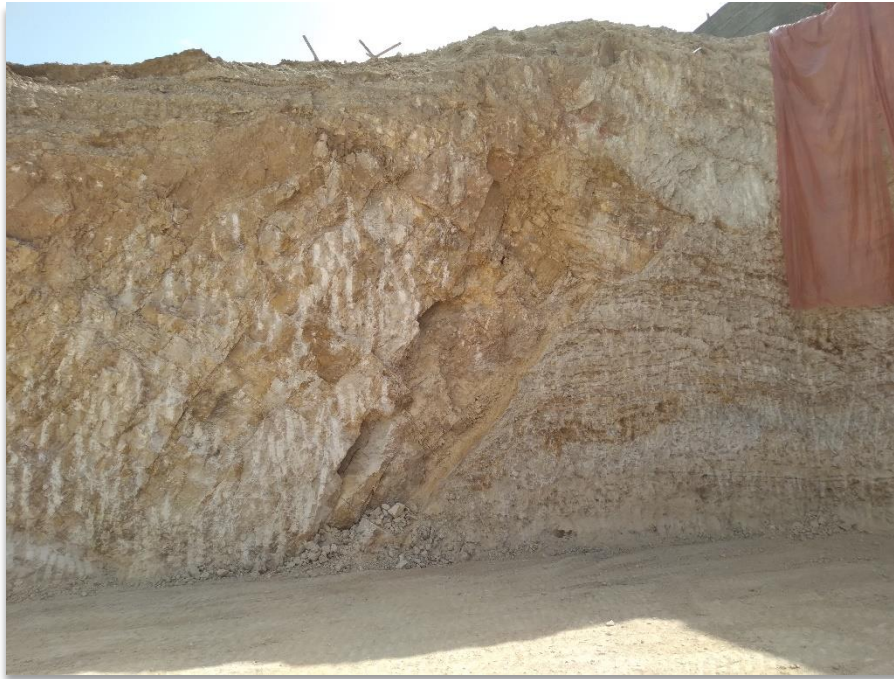
Figure 8: Deep Excavation Walls

Figure #8: Failure to provide the necessary support systems (such as Shoring) for Deep Excavation Walls on site to prevent Collapse and Movement of Soil and Foundations.

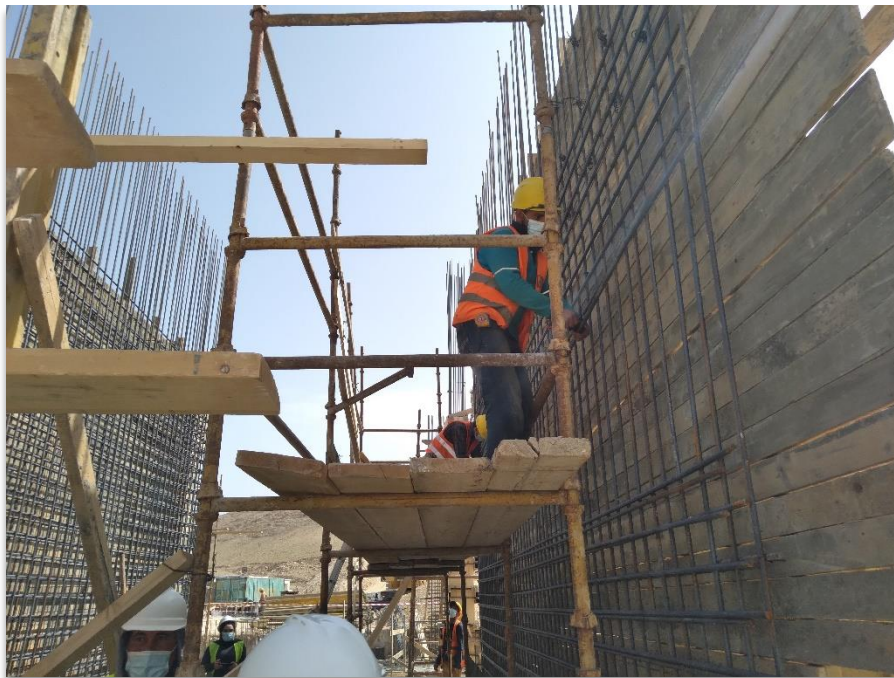
Figure 9: Scaffolding Safety

Figure #9: Handrails and Mid-rails were provided for the on-site Scaffolds, and Scaffold Platforms were Fully Planked.

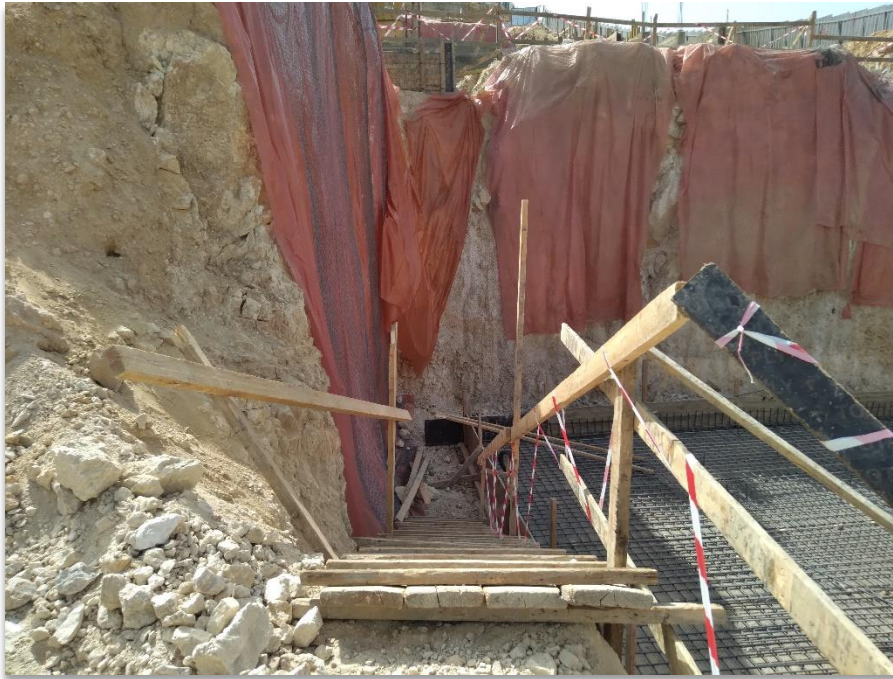
Figure 10: Site Excavations and Access Ramps

Figure #10: Access Ramps for Deep Excavations must be properly secured to prevent Falling Hazards, and Shoring Required.

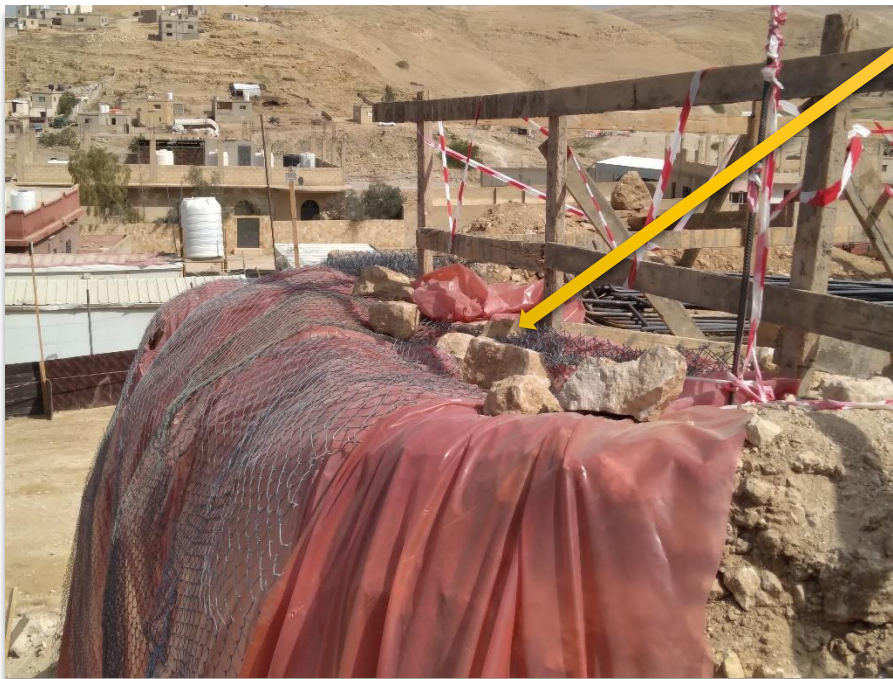
Figure 11: Falling Object Hazards

Figure #11: Deep Excavations with Falling Object Hazards.

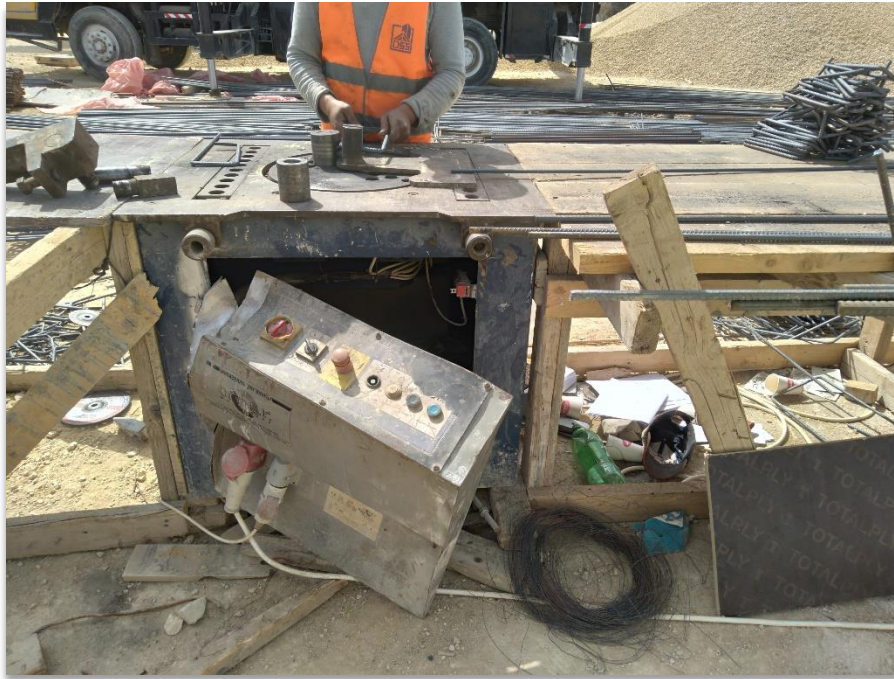
Figure 12: Unsafe Control Panel for Rebar Bending Machine

Figure #12: An unsafe Control Panel of the Rebar Bending Machine that were observed in the Rebar Shop on site.

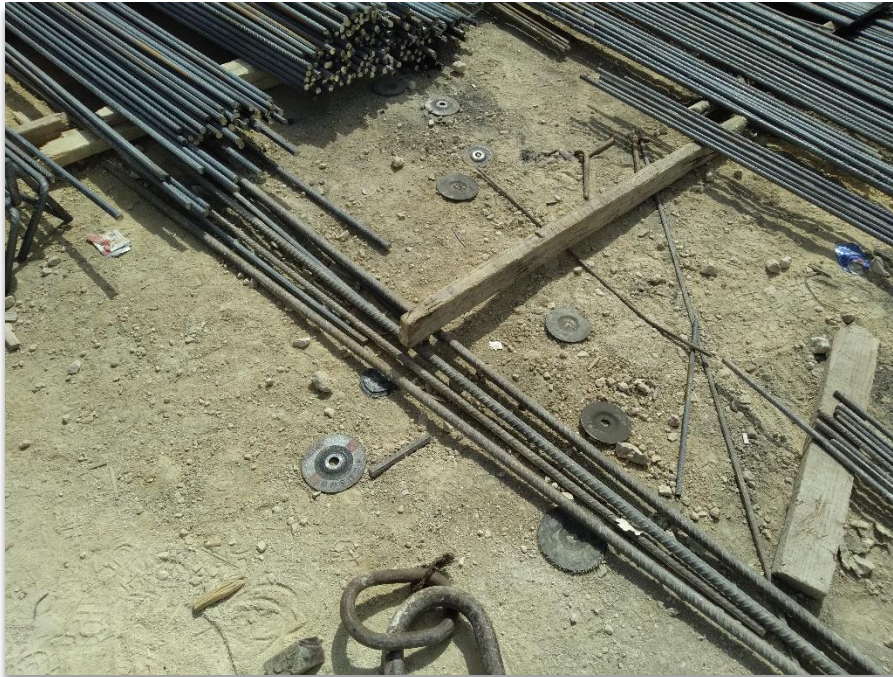
Figure 14: Housekeeping Standards

- Materials and equipment have been stored at the edge of steep slope in an extremely scary condition ; and
 - Poor housekeeping standards, nails have not been removed from lumbers that already stored on site as well as the grinding wheels have been left on the ground in an unsafe condition.
2. For more information about HSE status at the site, please see the attached Trigon HSE Field Trip Report later in this form.
 3. For more information about Contractor’s compliance with the COVID-19 MOL Measures, please see the attached JSEP and SKEP H&S Activities According to the Ministry of Labor (MOL) Working Procedures for Safety (Construction Projects) later in this form.

Figure #14: Poor Housekeeping Standards, Grinding Wheels left on the ground in an unsafe condition.

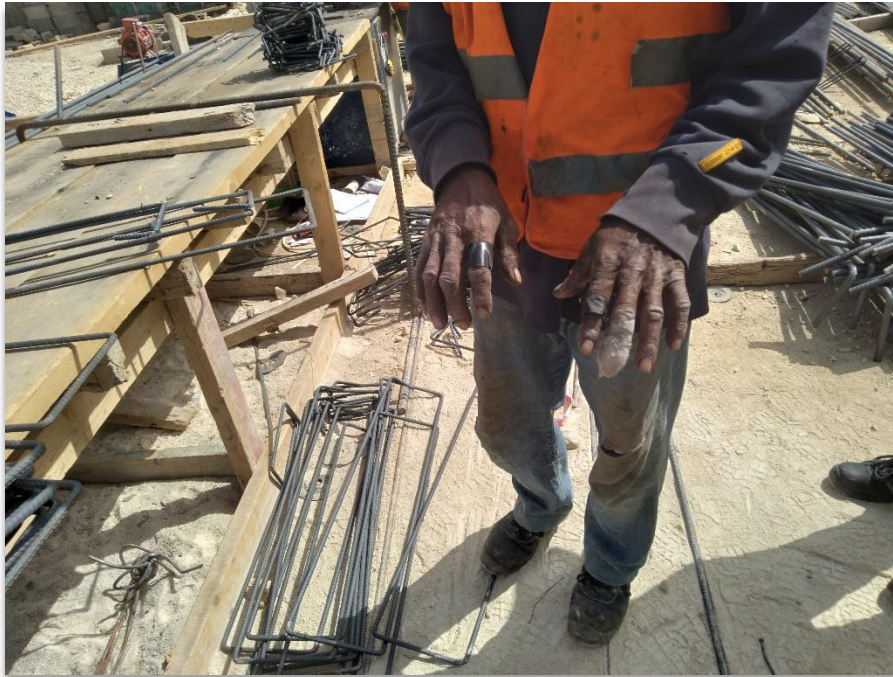
Figure 16: Mandatory Safety Requirements – PPE

Figure #16: Failure to provide workers with Gloves on site, It's the Contractor responsibility to make sure that all site personnel have been provided with proper PPE for the task including Gloves. Immediate Action Required.

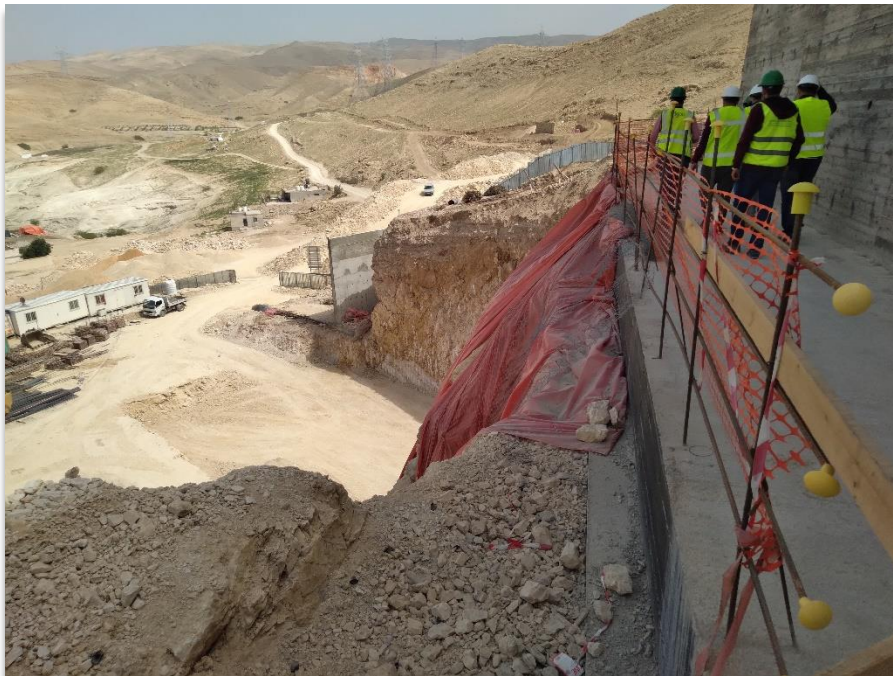
Figure 17: Edge Protection

Figure #17: Substandard Edge Protection, the Contractor using Steel Reinforcement Bars as Handrail System. Temporary Leading-Edge Protection System Required.
