**Construction Management of the Jordan School Expansion Project (JSEP)  
and the Schools for a Knowledge Economy Project (SKEP)**

**Site Visit Report Form**

**FTR #253 HSE**

**Program (JSEP or SKEP):** SKEP                      **PHASE: III**                      **PACKAGE: I**  
**School Name:** Al Khansa' Basic Mixed School  
**Supervisory Engineer (SE):** Wahib Medanat Consultant Engineers (Medanat)  
**Construction Contractor (CC):** Derar Saraireh & Son  
**Date and Time of Field Trip:** January 25, 2021 11:15 AM  
**Date of Report:** January 31, 2021  
**Weather During Visit:** Sunny  
**Report Submitted By:** Trigon's HSE Engineer, Odai Tawalbeh

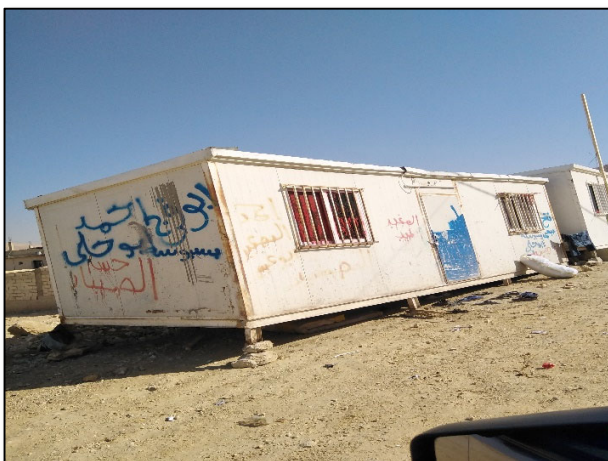
**Figure #4: Unsafe Contractor Office Trailers, fixed on unstable objects.** Photo credit: Odai Tawalbeh, 1/25/2021

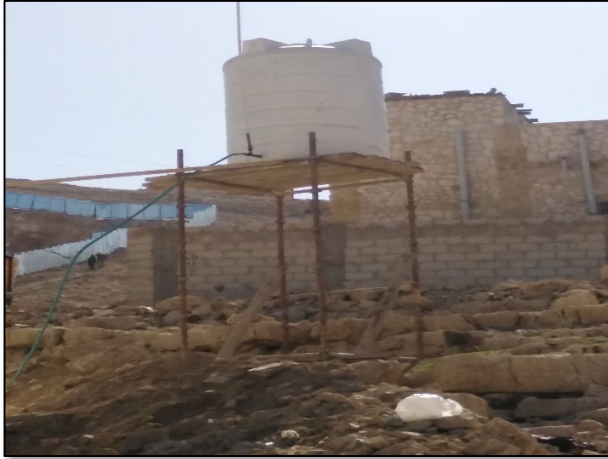
**Figure #5:** A Water Tank Placed on Unsafe Scaffold. Photo credit: Odai Tawalbeh, 1/25/2021

Scaffolding, Temporary Works	Y		1/25/2021	3	A water tank was observed on an unsafe scaffold on site.	All scaffolds on site should be provided with handrails for side protection, and each scaffold should be erected on a level ground.						
Ladders, Stepladders		N	1/25/2021	7								
Electrical	Y		1/25/2021	3	The roof of temporary electrical room was not properly protected from the rain, it will be a real hazard if rainstorm hit the site.	This item must be promptly addressed by the responsible party.						
Working At Height			N/A	1/25/2021								
Lifting Ops.			N/A	1/25/2021								
Hand Tools, Powered Tools, Heavy Powered Equip.	Y		1/25/2021	3	An excavator was observed at the edge of an unbelievable slope in an extremely scary conditions; Gravel road for site equipment and vehicles with no any means of barriers and warning signs; and No ongoing maintenance program for tools and equipment on site.	The Excavator has been moved out of place. However, an effective training on safe work practices should be provided to all heavy equipment operators on site to prevent the recurrence of such unsafe conditions. Moreover, the assigned Contractor must: (1) Provide safe access for heavy equipment and vehicles on site; (2) Implement an ongoing maintenance program for all tools and equipment; (3) Keep maintenance and repair logs; (4) Install adequate onsite signs, lights, and devices; and (5) Train heavy equipment operators in proper operating procedures. REMEMBER: Working with tools and heavy equipment is a major hazard on site. Injuries can result from equipment hitting or running over personnel so, effective safety measures are required.

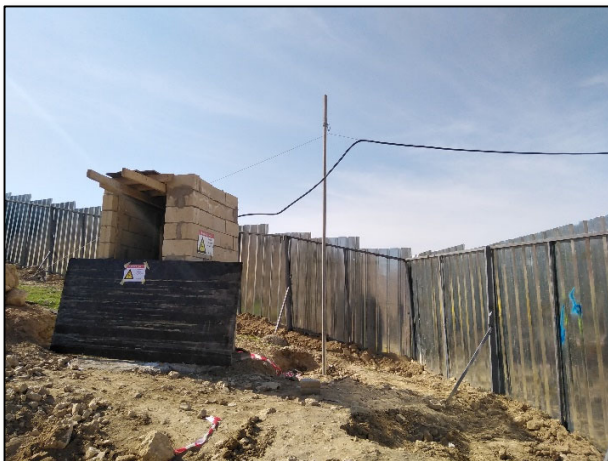
**Figure #6:** The Roof of Temporary Electrical Room was Not Properly Protected from the Rain, It will be A Real Hazard if Rainstorm Hit the Site. Photo credit: Odai Tawalbeh, 1/25/2021

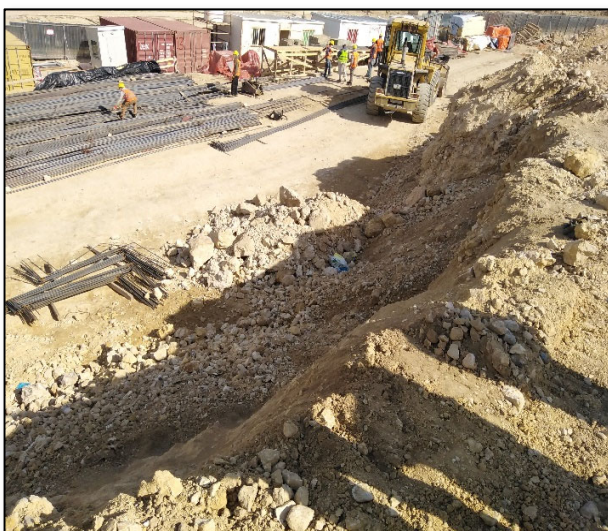
**Figure #7:** Movement of Heavy Equipment very close to the Excavated Portion and Lack of Lateral Support may lead to the Collapse of Soil and Rocks from the top of the Slope towards the Site Offices, which may result in Serious Injuries. We've already recommended the assigned Contractor to install an additional temporary support along the site offices and the immediate corrective action has been taken by the next day of our site visit. Accordingly, we will arrange another field trip ASAP to re-inspect the site and ensure that the required support is effective. Photo credit: Odai Tawalbeh, 1/25/2021

Excavation, Backfilling	Y		1/25/2021	3	The project is located in A Mountain Region and there are many risks associated with collapsing soil and rocks, in addition to the insufficient warning signs of deep excavations and the ineffectiveness of the existing barriers in controlling risks on site.	We've already recommended both Construction Contractor and Supervisory Engineer to take some urgent Engineering Controls that could reduce the risk associated with the collapse of soil & rocks as much as possible by installing an additional temporary barriers along the site offices to isolate them from surrounding hazards. The immediate corrective action had been taken from the Contractor side. However, the assigned Contractor still needs to submit a Method statement and Risk Assessments and Engineering Controls to the Supervisory Engineer for approval as well as to provide the site with an effective temporary railing system & proper warning signs along the deep excavations on site. Moreover, a suitably qualified persons (for example, experienced geotechnical and civil engineers) must be engaged to assess ground conditions and determine the appropriate shoring system for the site (if required) according to Soil Test Result.

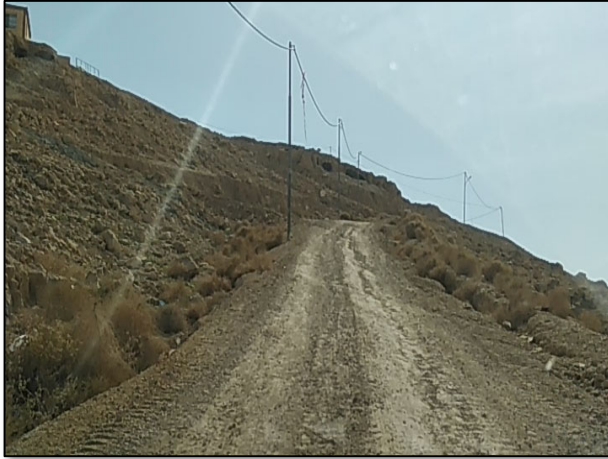
**Figure #8:** Gravel Road for Site Equipment & Vehicles – No Barriers, Warning Tapes, Warning Signs and Speed Limit Signs were observed along the road leading to the site. Photo credit: Odai Tawalbeh, 1/25/2021

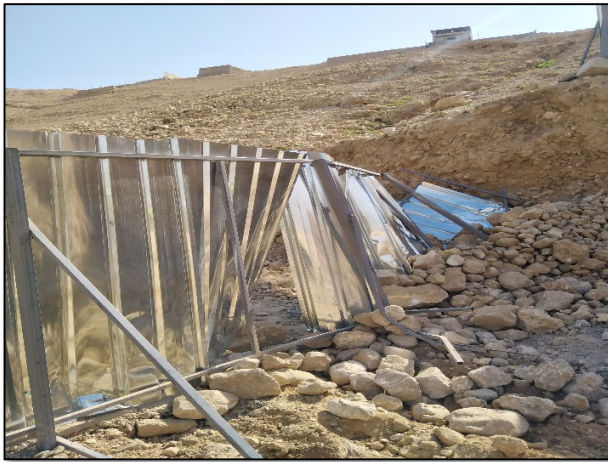
**Figure #9:** Part of the Temporary fencing was Damaged as a result of Collapsing Soil & Rocks near it on Site. Photo credit: Odai Tawalbeh, 1/25/2021

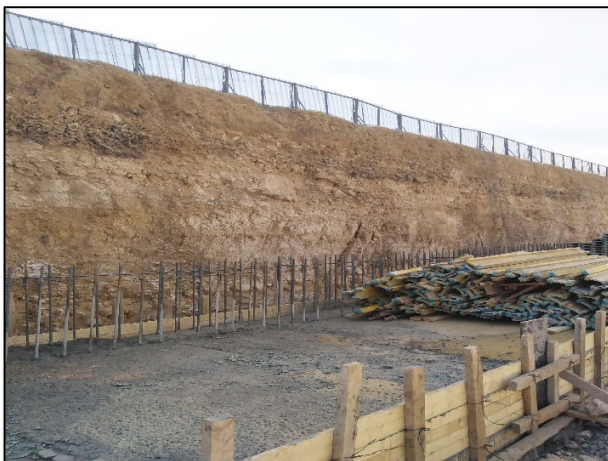
**Figure #10:** Rockfall Protection Steel Wire Mesh has been installed, however, a competent person experienced in excavation work must inspect this area to assess whether this support is sufficient or not. Photo credit: Odai Tawalbeh, 1/25/2021

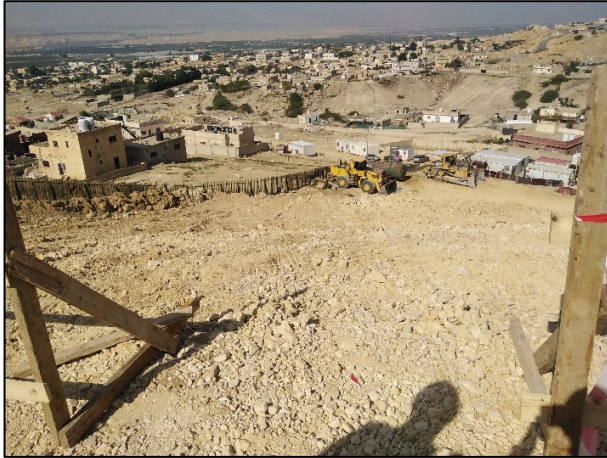
**Figure #11:** An Effective Guardrail Edge Protection System should be Installed on Site. Photo credit: Odai Tawalbeh, 1/25/2021

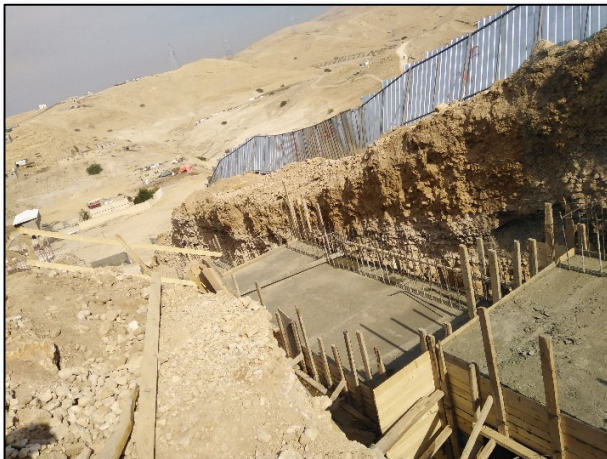
**Figure #12:** Lack of Lateral Support for Deep Excavations, Risk of Collapse, Serious Injuries. The area was closed by the Contractor, however, a competent person experienced in excavation work must inspect this dangerous area to assess ground conditions and determines the appropriate shoring system for the site, according to Soil Test Results. Photo credit: Odai Tawalbeh, 1/25/2021

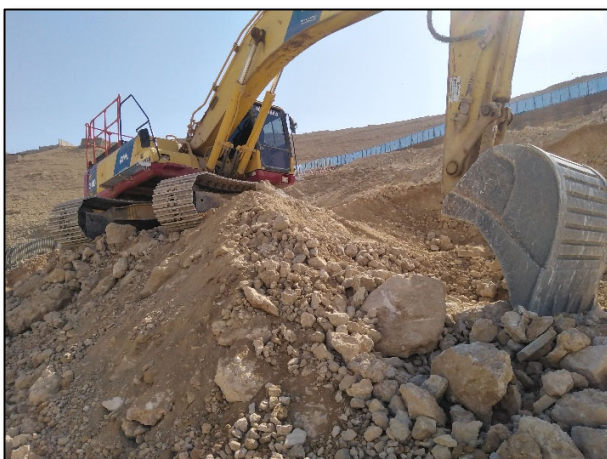
**Figure #13:** This Excavator Located at the Edge of An Unbelievable Slope in An Extremely Scary Conditions. Immediate Corrective Action had been Taken. However, **REMEMBER:** Precautions Must ALWAYS Be Taken in Mountain Regions, **AND** Operators Really Need To Develop A Feel For The Controls When Digging On A Slope. Photo credit: Odai Tawalbeh, 1/25/2021
