**Construction Management of the Jordan School Expansion Project (JSEP)
and the Schools for a Knowledge Economy Project (SKEP)**

Site Visit Report Form

FTR # QR 280

Program (JSEP or SKEP): SKEP **PHASE:** III **PACKAGE:** 2
School Name: Thahr Al Sarow Basic Boys School
Supervisory Engineer (SE) Name: Wahib Medanat
Construction Contractor (CC) Name: Dijlah Contracting Co.
Date and Time of Field Trip: Feb 9,2021 12:30 PM
Date of Report: Feb 11,2021
Weather During Visit: Sunny
Report Submitted By: Osama Obeid & Mohammad Sami Ali-Ahmad

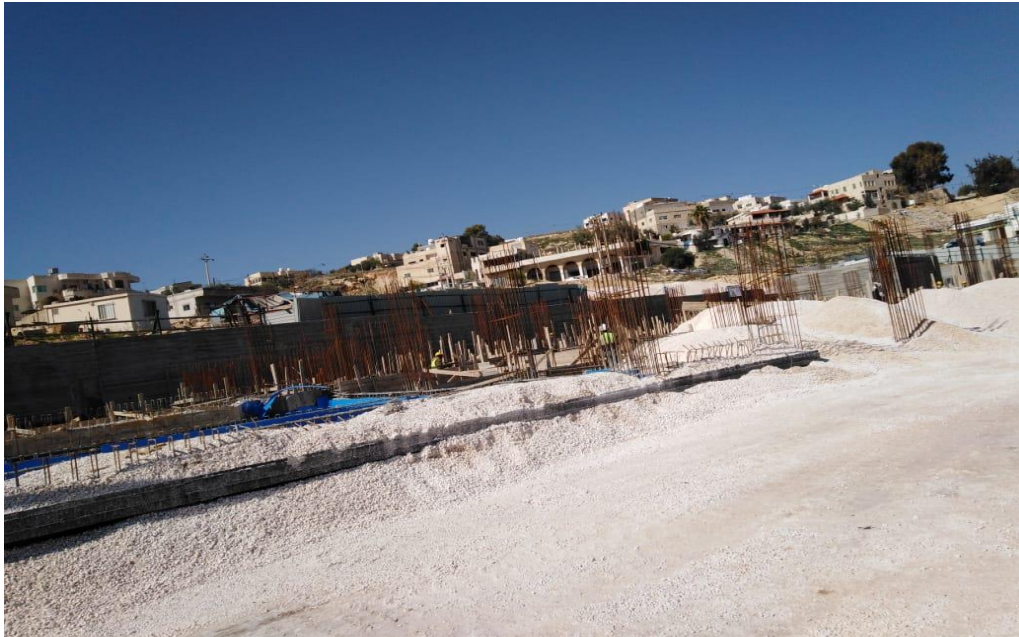
FIGURE #02:

The Project consists of five floor building, in addition to other site works. The project internal area is 4615 m². And external area is 2827 m² Backfilling materials and preparation works before casting the SOG

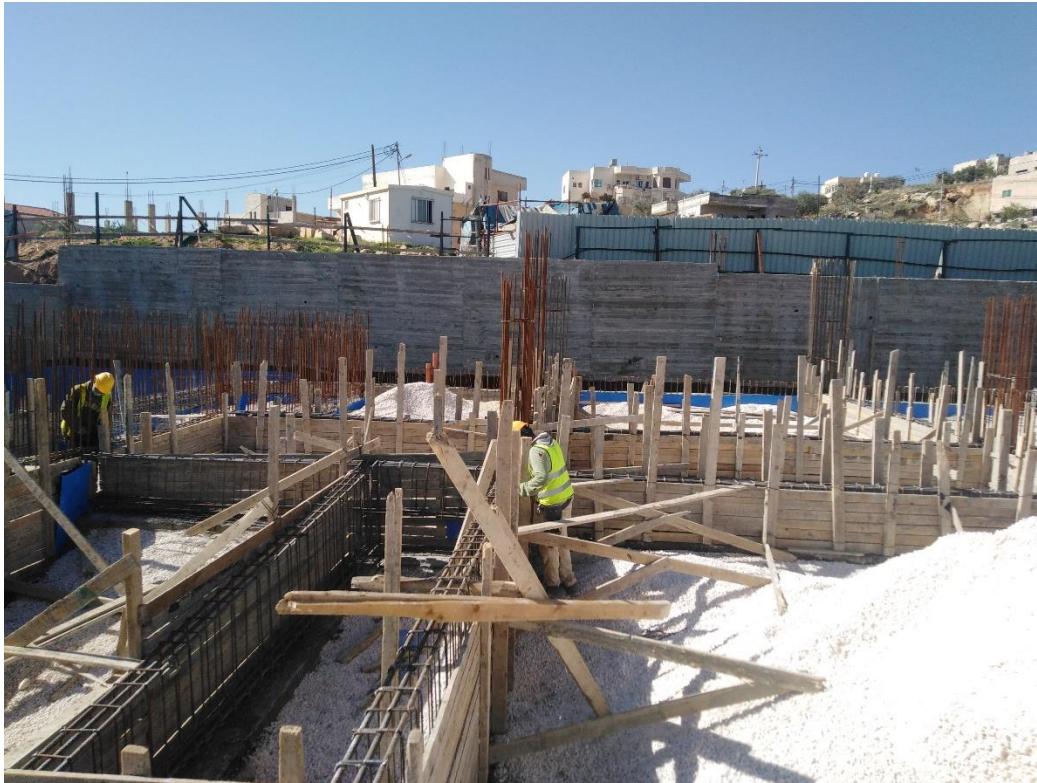
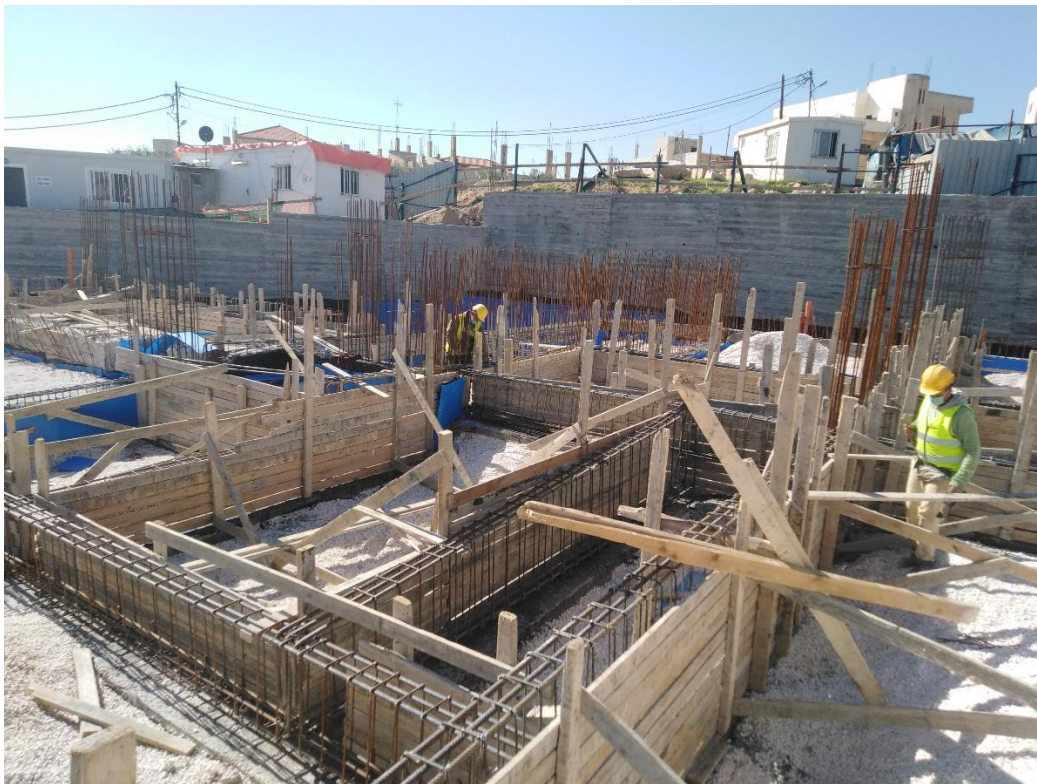
FIGURE #04&05:

Foundations of the proposed building is completed and insulated. Preparation works (backfill and ground beams) for casting the S.O.G is ongoing

- Foundations of the proposed building is completed and insulated with bitumen coat and Carton Sheets
- Ground Beams on process
- Backfilling materials and preparation works before casting the SOG
- Ground beams and preparation works for casting the S.O.G are ongoing
- The construction of west side of the boundary wall adjacent to Antiquities land is completed
- 90% of the east-side of boundary wall is completed
- The Construction of east-side-of the boundary wall adjacent to road is not started yet (see below-other issue)
- Steel bars are uncovered and exposed to weather and could lead to be rusty

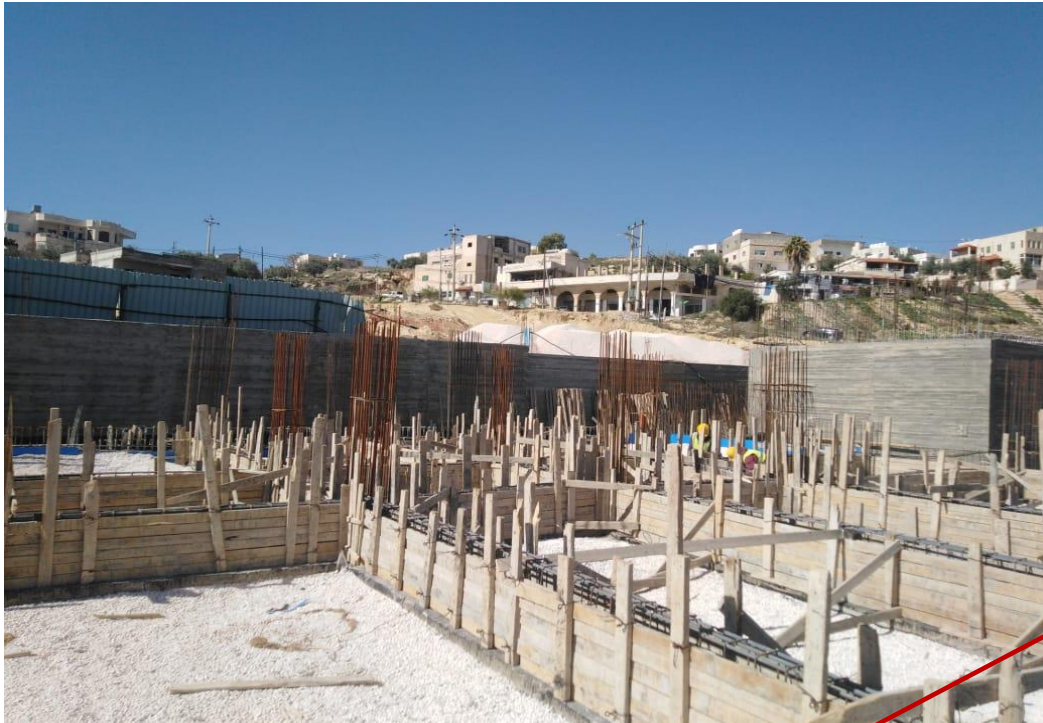
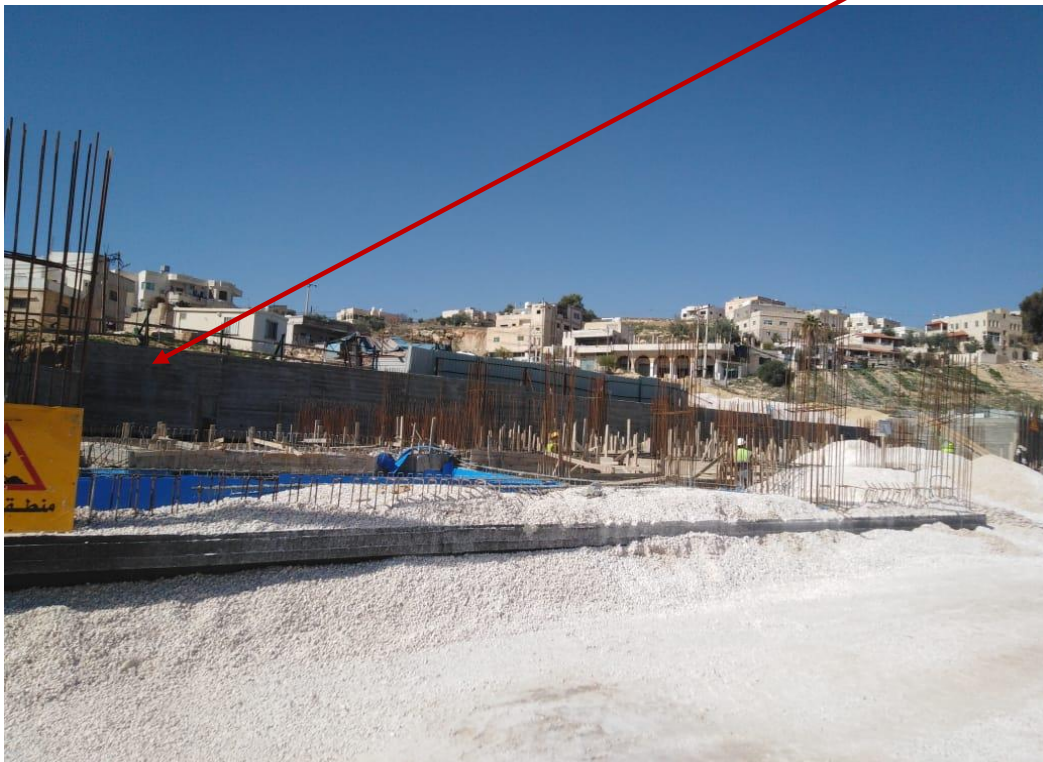
FIGURE #06 & 07

The backfilling along the boundary wall adjacent to the antiquities land is ongoing but slowly because the Contractor needs a permission from the Antiquities Department at site in order to let the machines and equipments pass the land to unload the backfill materials.

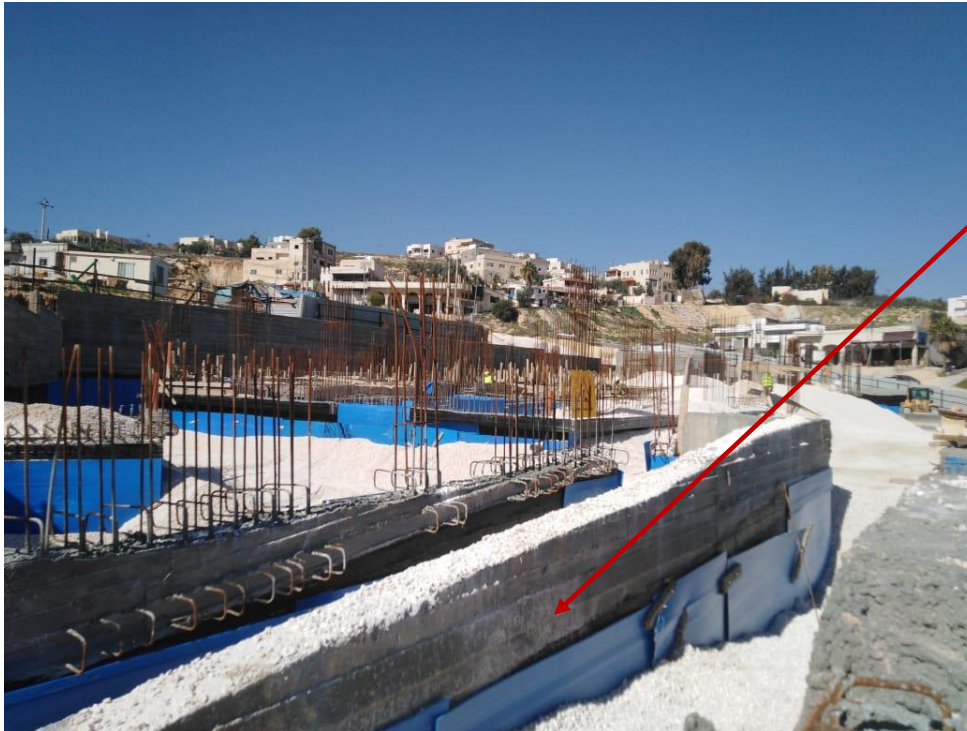
FIGURE #08

The ground beams and walls under slab on grade is ongoing

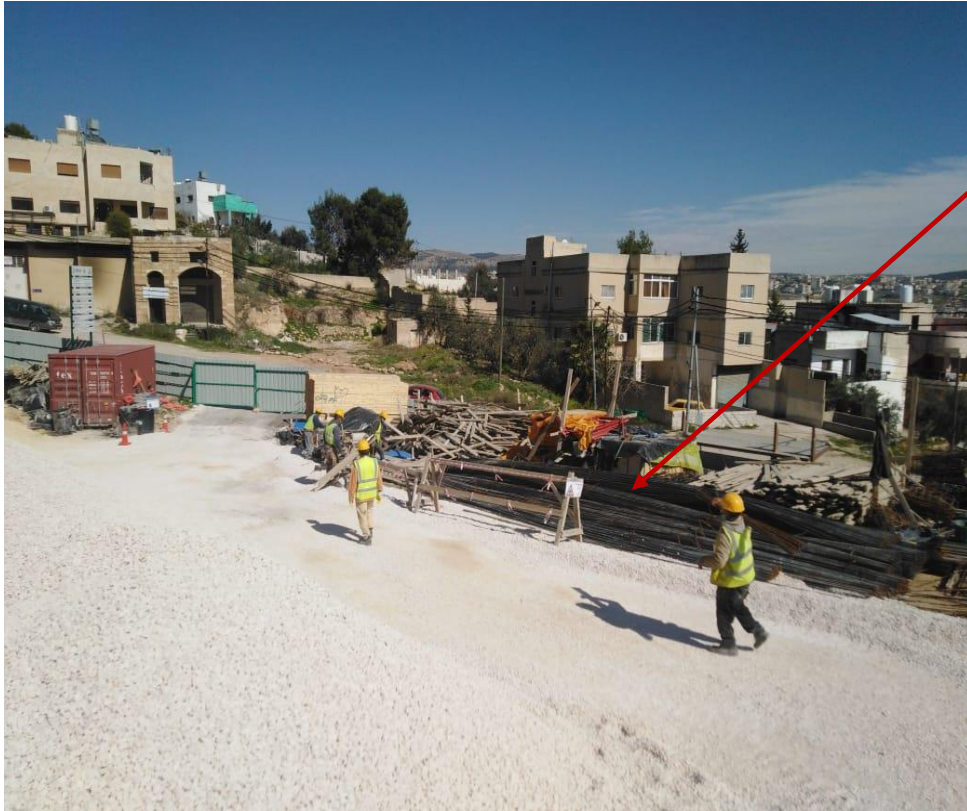
FIGURE #07:

Uncovered steel bars, bars must be covered well in order to avoid rust

#	Task / Activity	Observations (Y/N)	Findings	Recommendations / Corrective Actions
A. Excavation				
B. Backfilling				
C. SubStructural, Concrete, Foundations				
1	Steel Bar	Y	Uncovered steel bars	Steel bars must be covered well to avoid rust
2	Footings			
3	Ground beams			
4	Tie beams			
5	Column neck			
6	Column			
7	waterproofing(Insulation)			
8	Slab on grade
