Site Visit Report Form

Program (JSEP or SKEP): SKEP III Package I
School Name: Al Khansa'a Basic Mixed School
Supervisory Engineer (SE) Name: Medanat Consultant Engineers
Construction Contractor (CC): Derar Al Saraireh & Sons
Date and Time of Field Trip: Mar 24th, 2021
Date of Report: Mar 28th, 2021
Weather During Visit: Dusty 22°
Report Submitted By: Abedalaziz Abu Wandu

The new School will be a 6454 sq.m 5-storey building and will consist of 24 classrooms, 4 KGs and 1 for special need. The school will service up to 928 Students, starting from KG2 to 10th grade

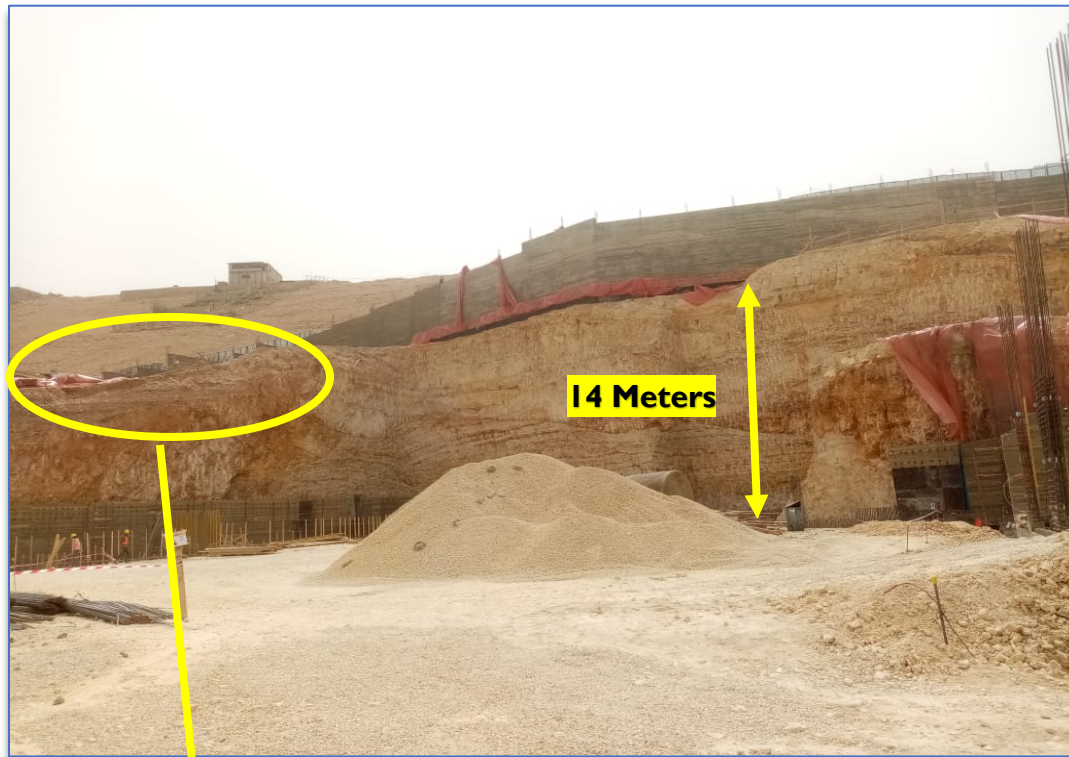
Figure 3: External Boundary Wall and proposed Shoring System

External boundary wall is constructed. After the excavation was done, an almost 14-16 meters height of solid rocks were exposed. The geotechnical lab recommendation was that a shoring system is needed to protect the construction site. According to the design a shearing wall that will cover the exposed side of the excavation will be constructed. This wall goes up to the 4th floor. The circled area is loose rocks and soil.

1. Site is well gated and secured;
2. All workers had a full PPE gear on;
3. Sides of the cliff excavation shall be protected at all times,
4. Unacceptable dispose of excess concrete in the adjacent lands.

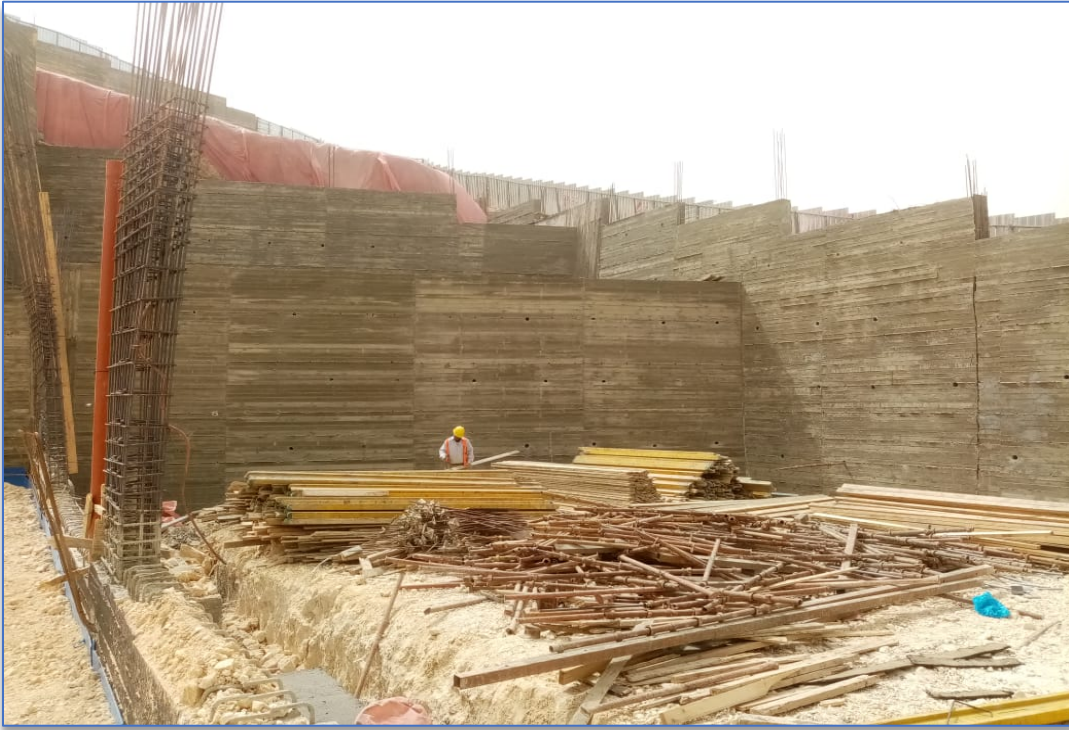
Figure 5: Finished Retaining & External walls

The Executed retaining and external works looked perfectly done with no segregations observed.

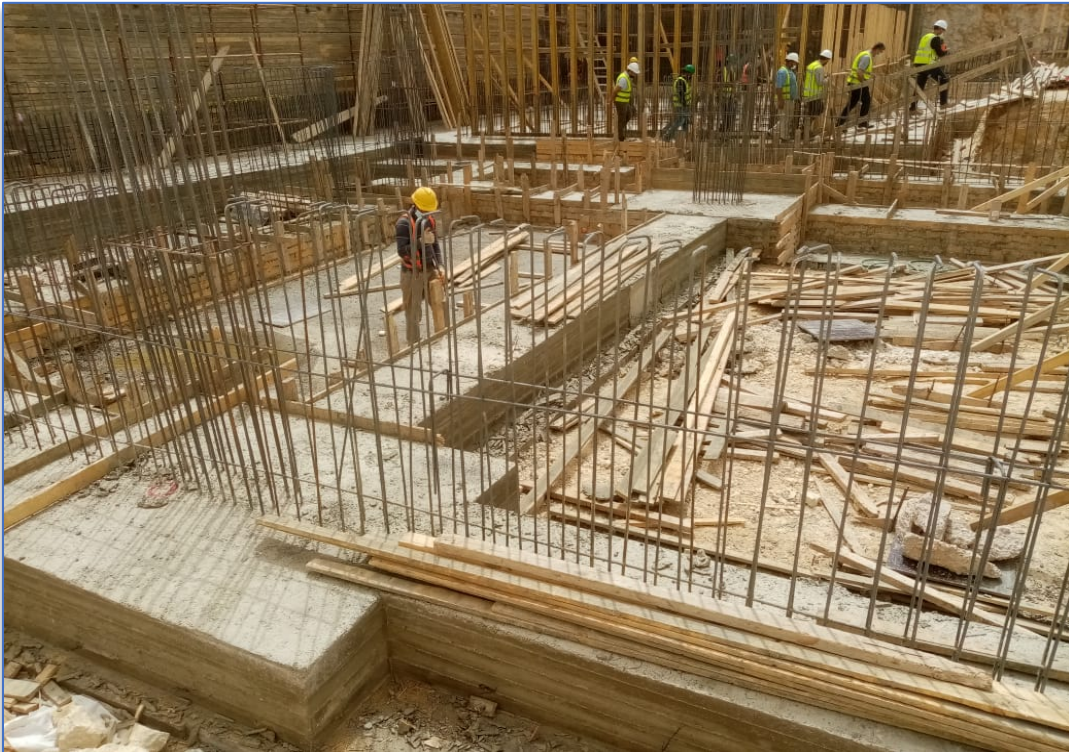
Figure 6: Dismantling Formwork

Dismantling framework of tie beams, quality seem to be as per specifications with no defects found.

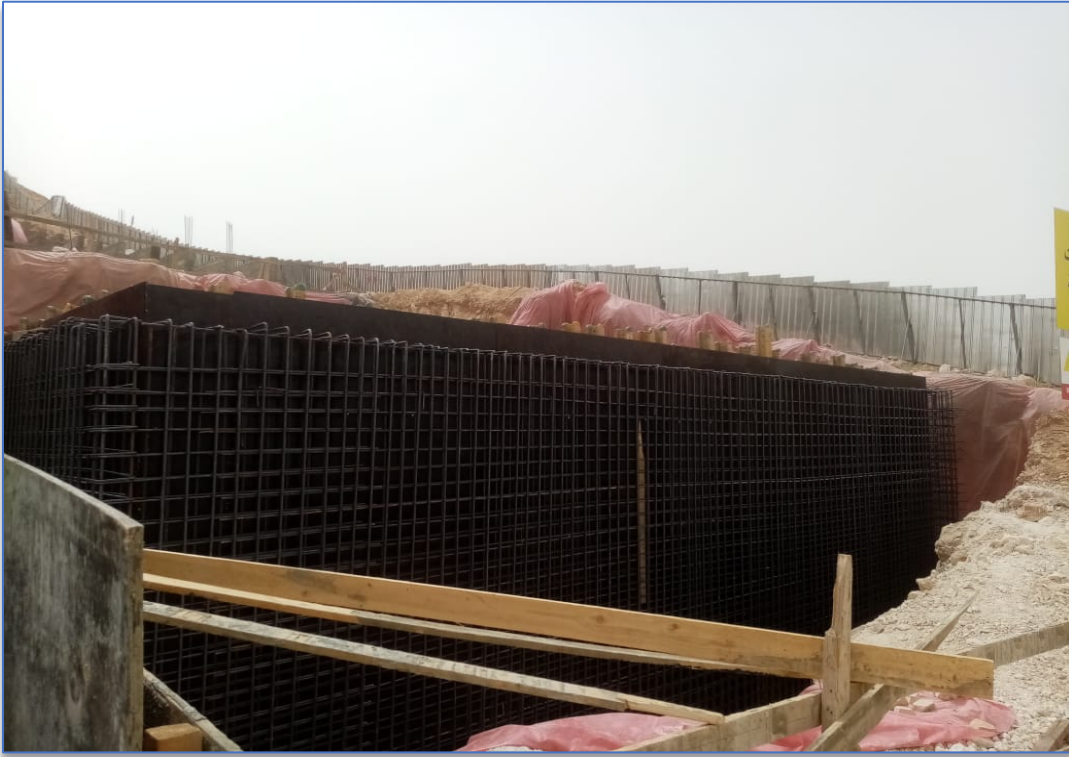
Figure 7: Water Tank

Preparing framework and reinforcement steel of the Water Tank

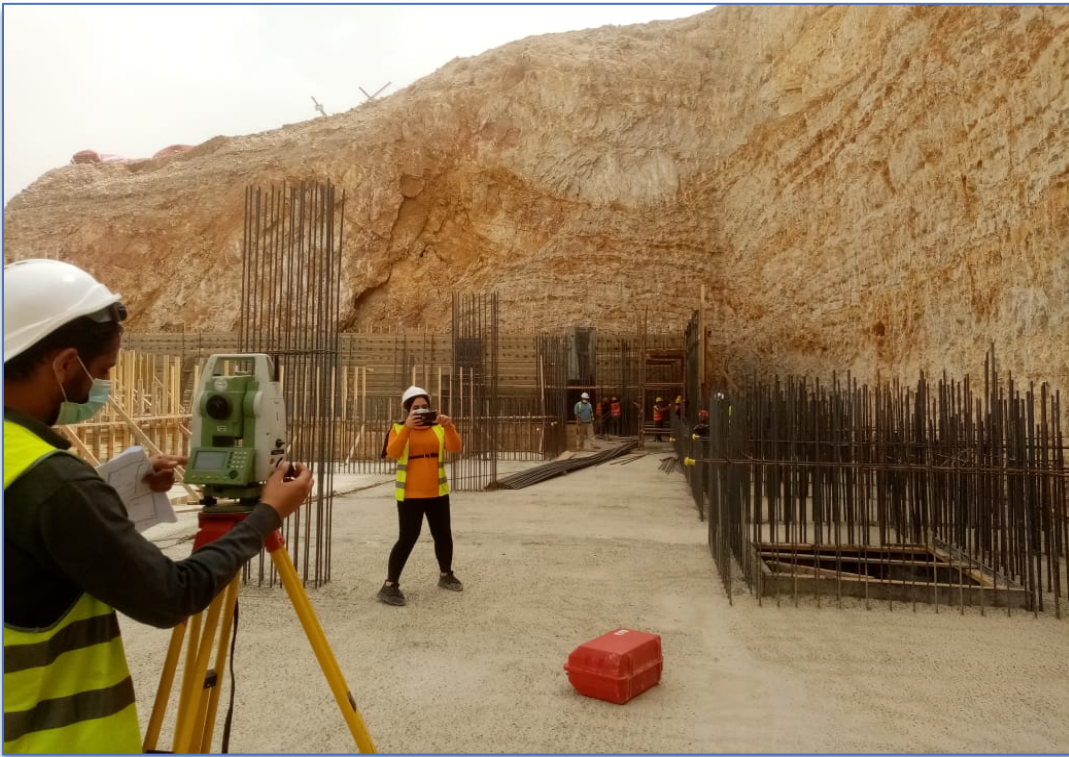
Figure 8: Site Leveling

Site leveling and framework for the 12M height Shear wall

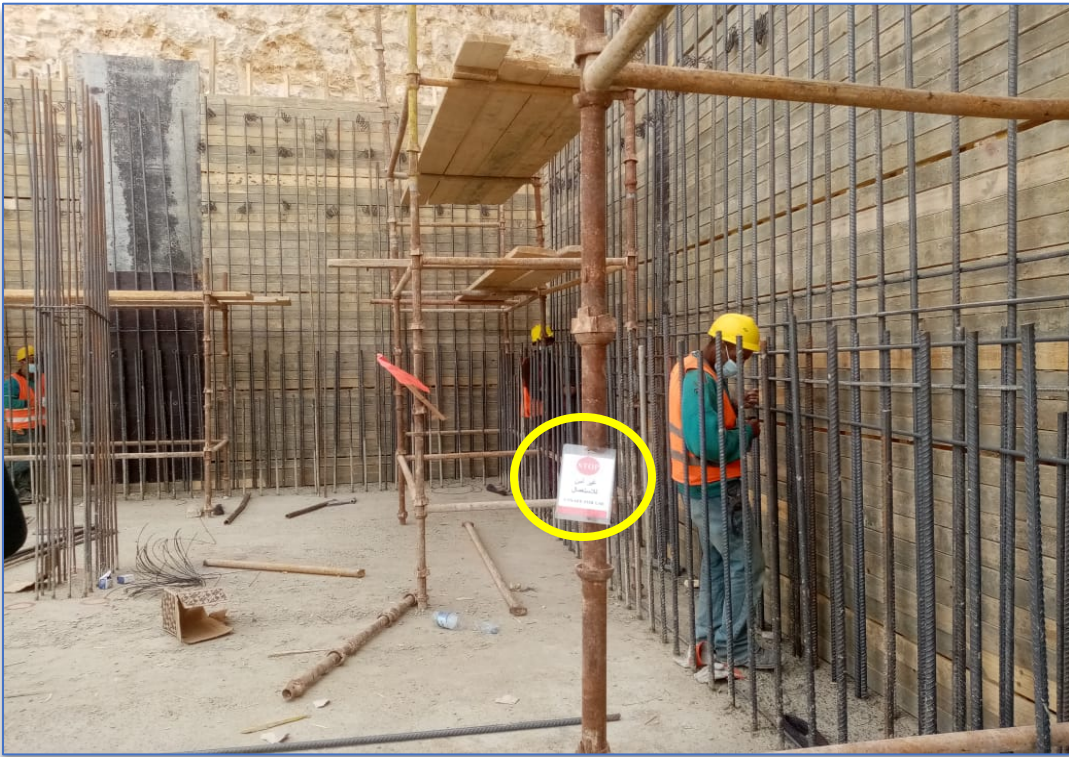
Figure 9: Lockout/Tagout sign

Good safety procedure. A Lockout/Tagout sign was installed on the scaffolding to prevent workers from using the scaffolding.

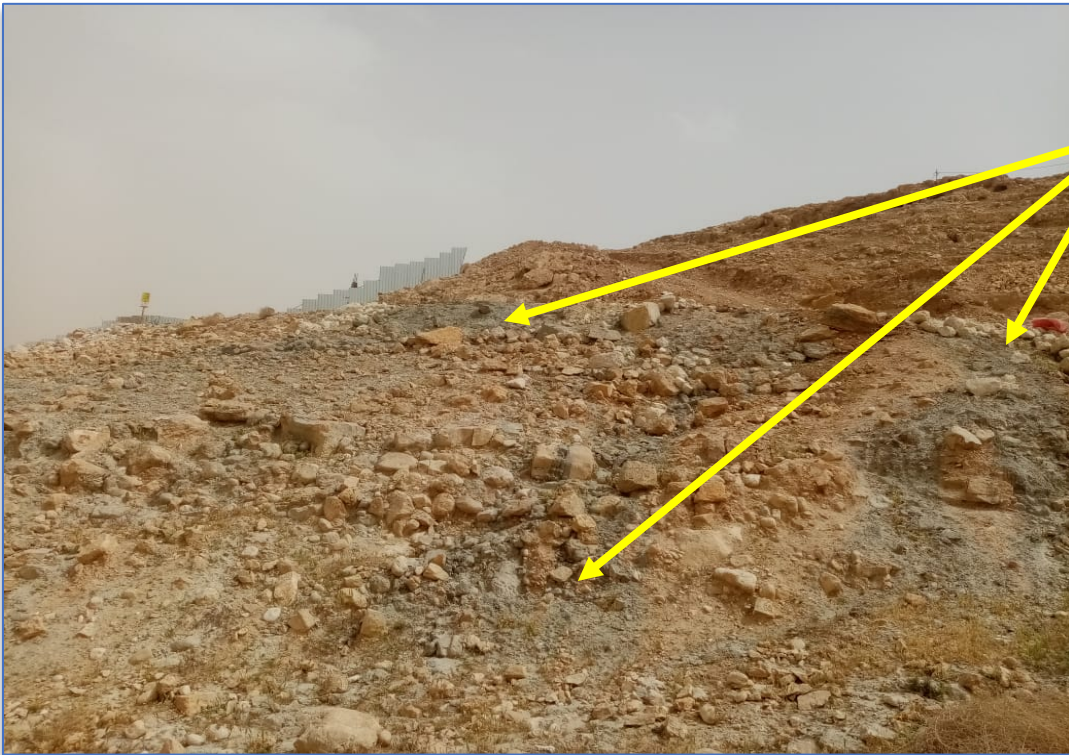
Unacceptable dispose of excess concrete
