Consultant	Wahib Medanat Consultant Engineer	Rep No.	11-24012022
Contractor	Derar Saraireh & Sons for Engineering & Contracting	Tender No.	(11/2019/USAID/SKEP/3/S) Schools for a Knowledge Economy Project (SKEP) - Phase (3) Package (1, 2)
Site Name	Um Al Dananir Basic Mixed School- Al Balqa	Day/ Date	Mon. 24/01/2022
Duration of Project	450 Calendar Days	Total Project Budget	9,789,417.840 JD

Visit Notes

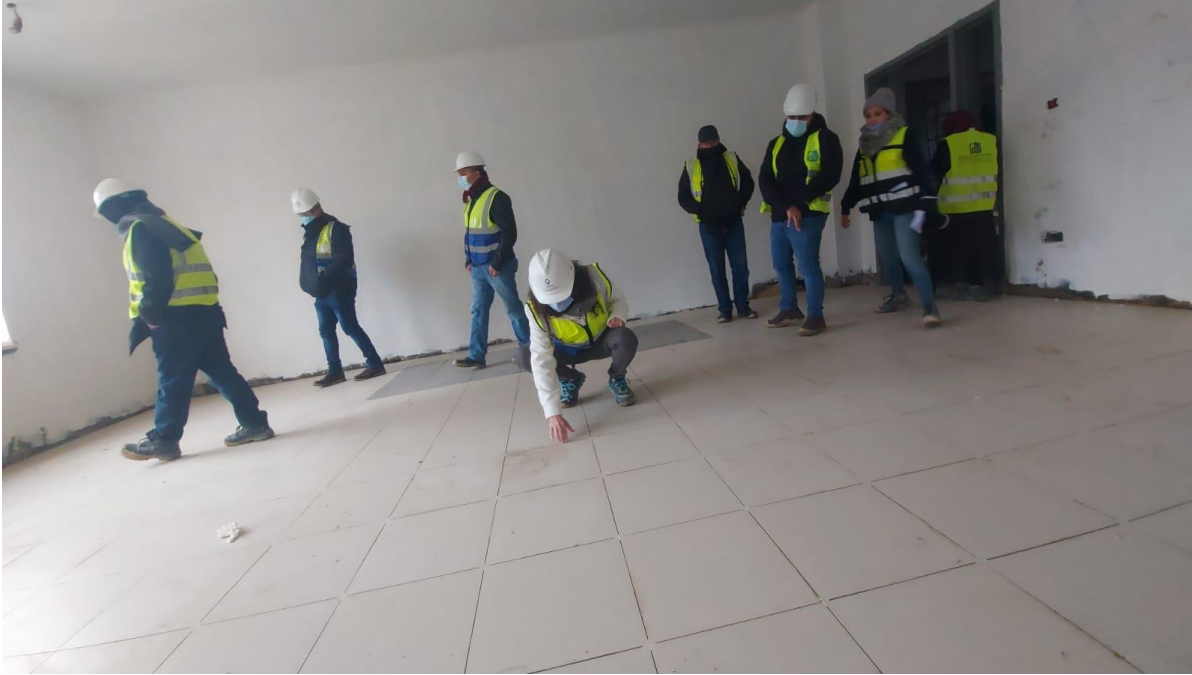
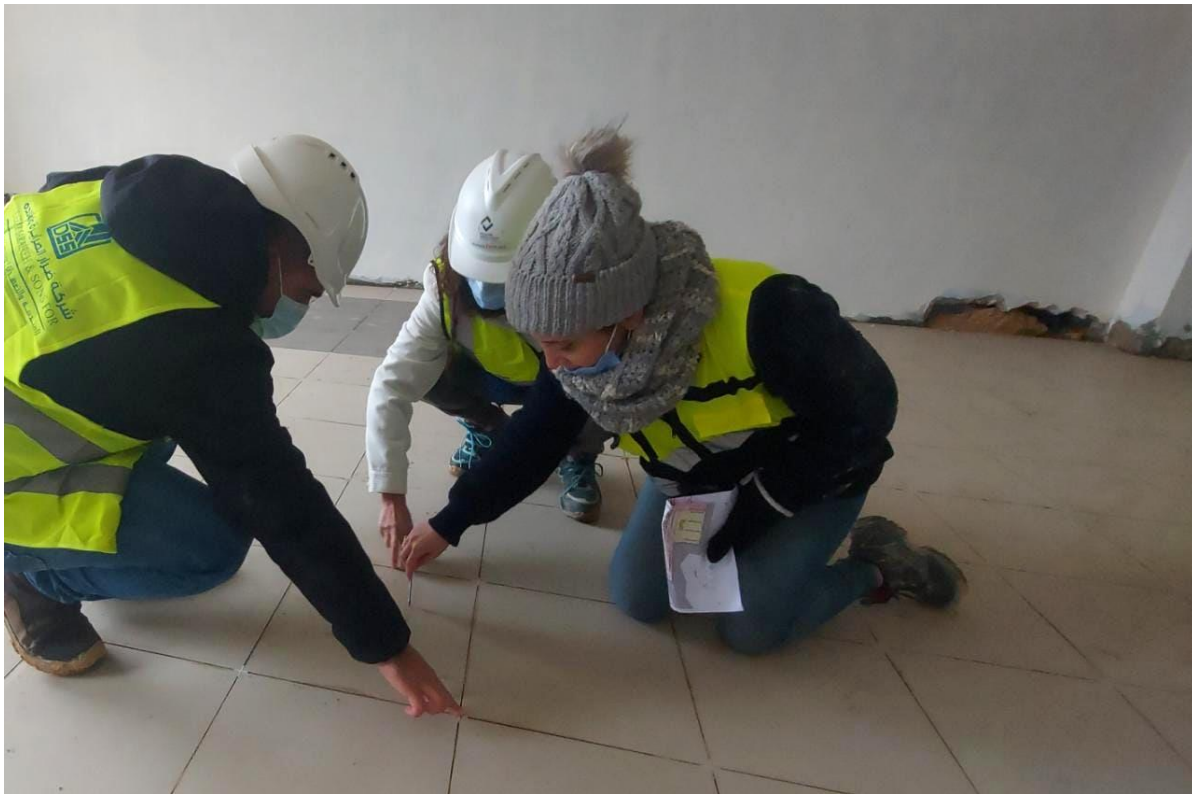
(figure:03 & 04)

The supervision team conducted general check on the executed porcelain floor tiles and observed minor tiles with teething or uneven. The Contractor was instructed to replace

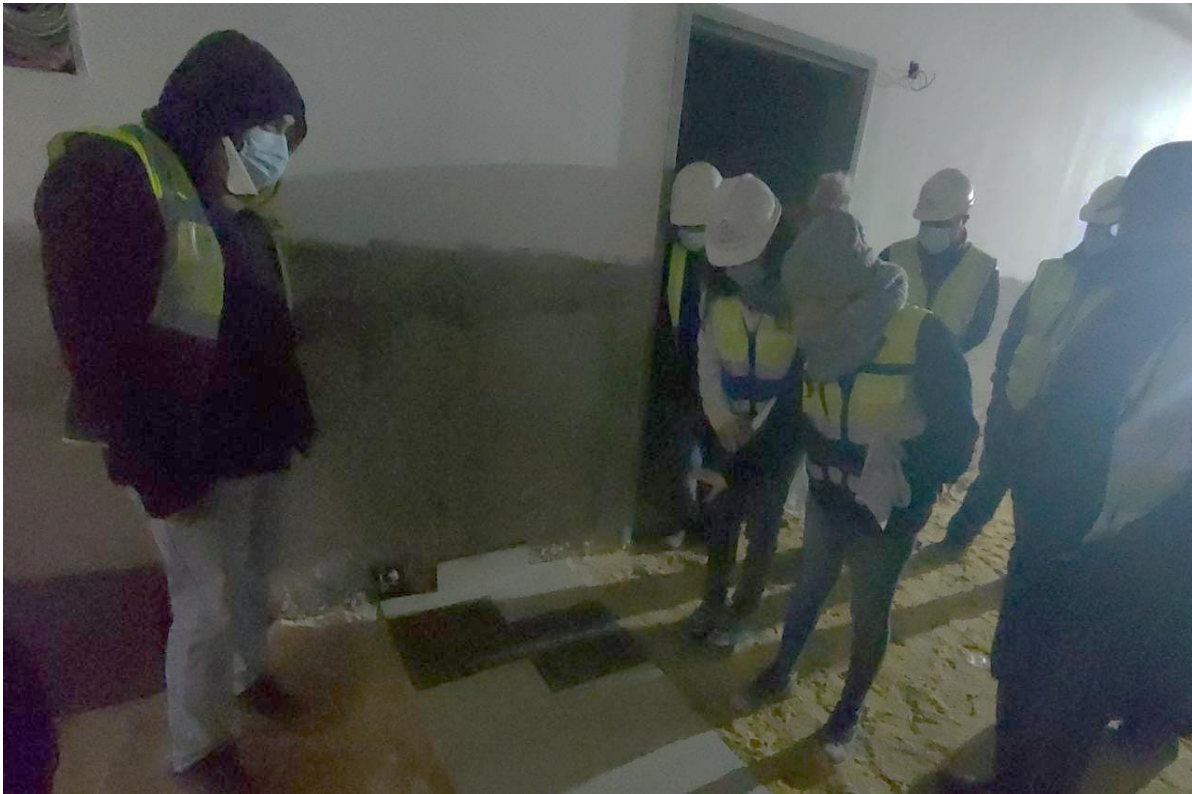
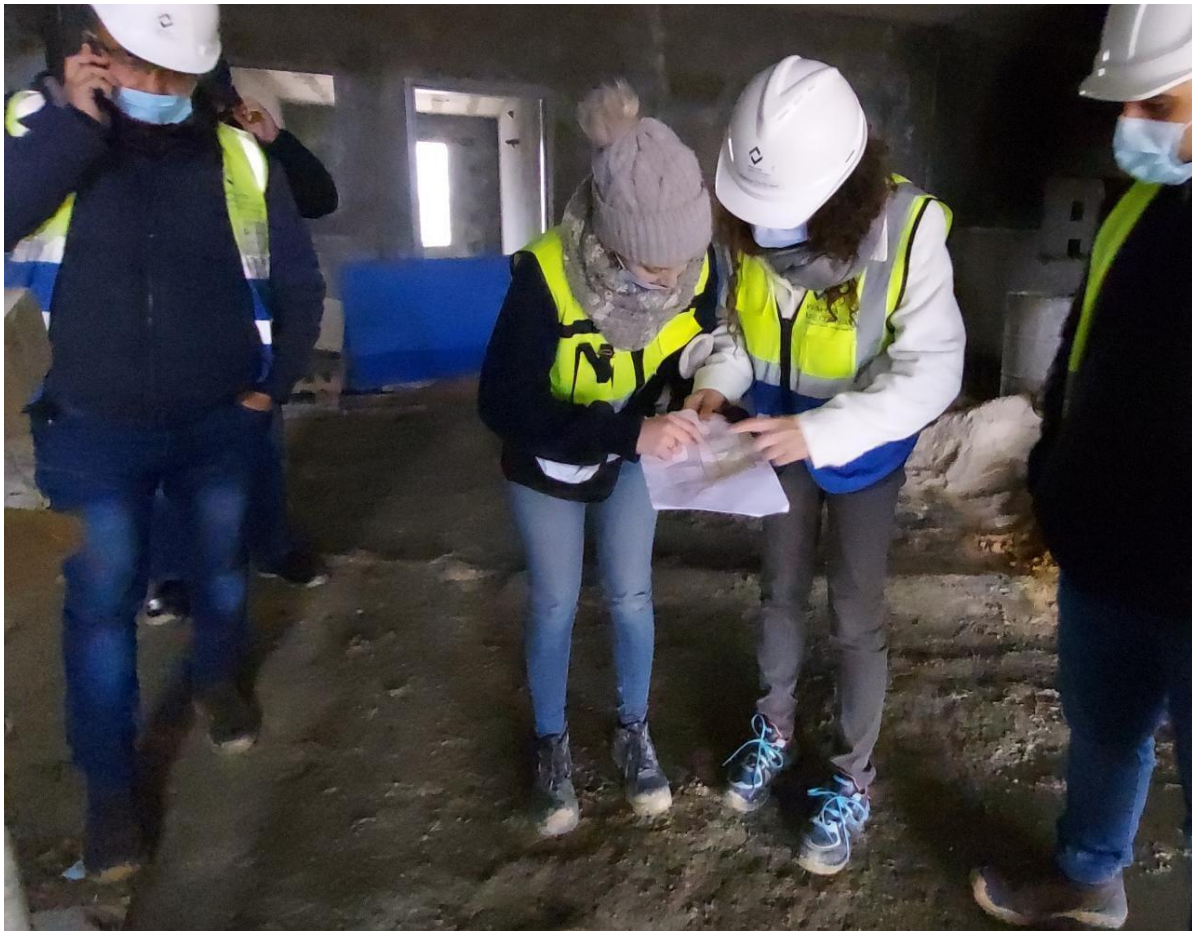
(figure:05 & 06)

The supervision team discussed with the Contractor the pattern of tiling in corridors where two colors of tiles are required. It was agreed that the Contractor will prepare revised sketches showing the distribution of the two colors in the corridors and number of rooms

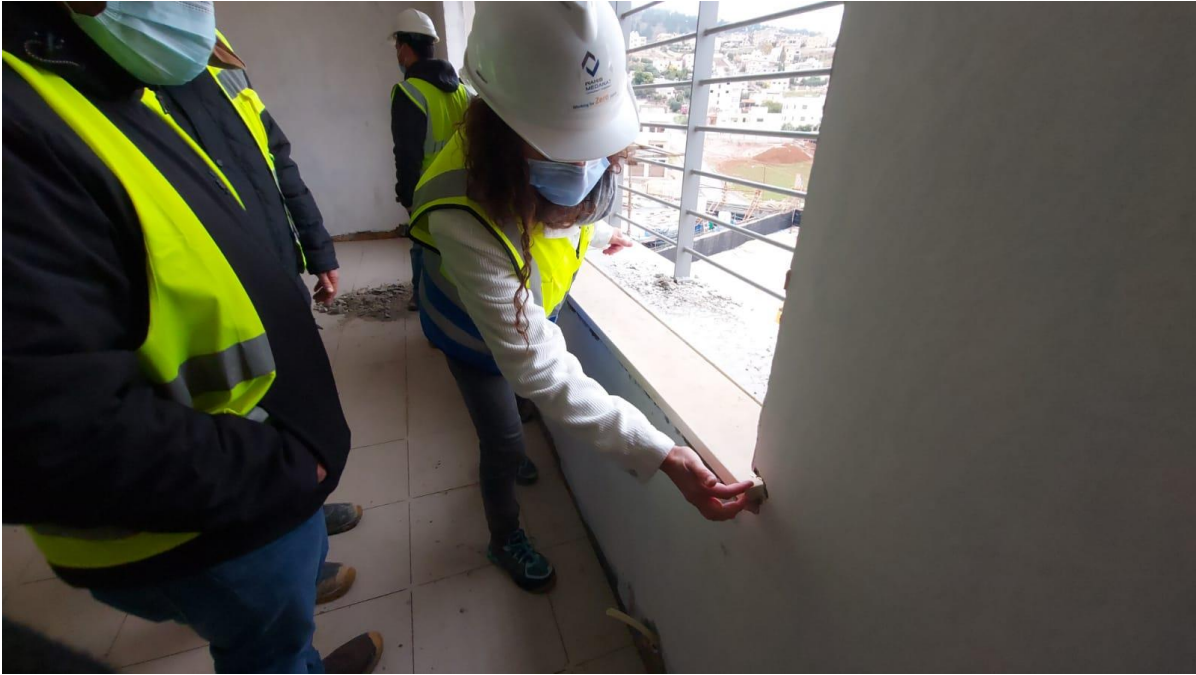
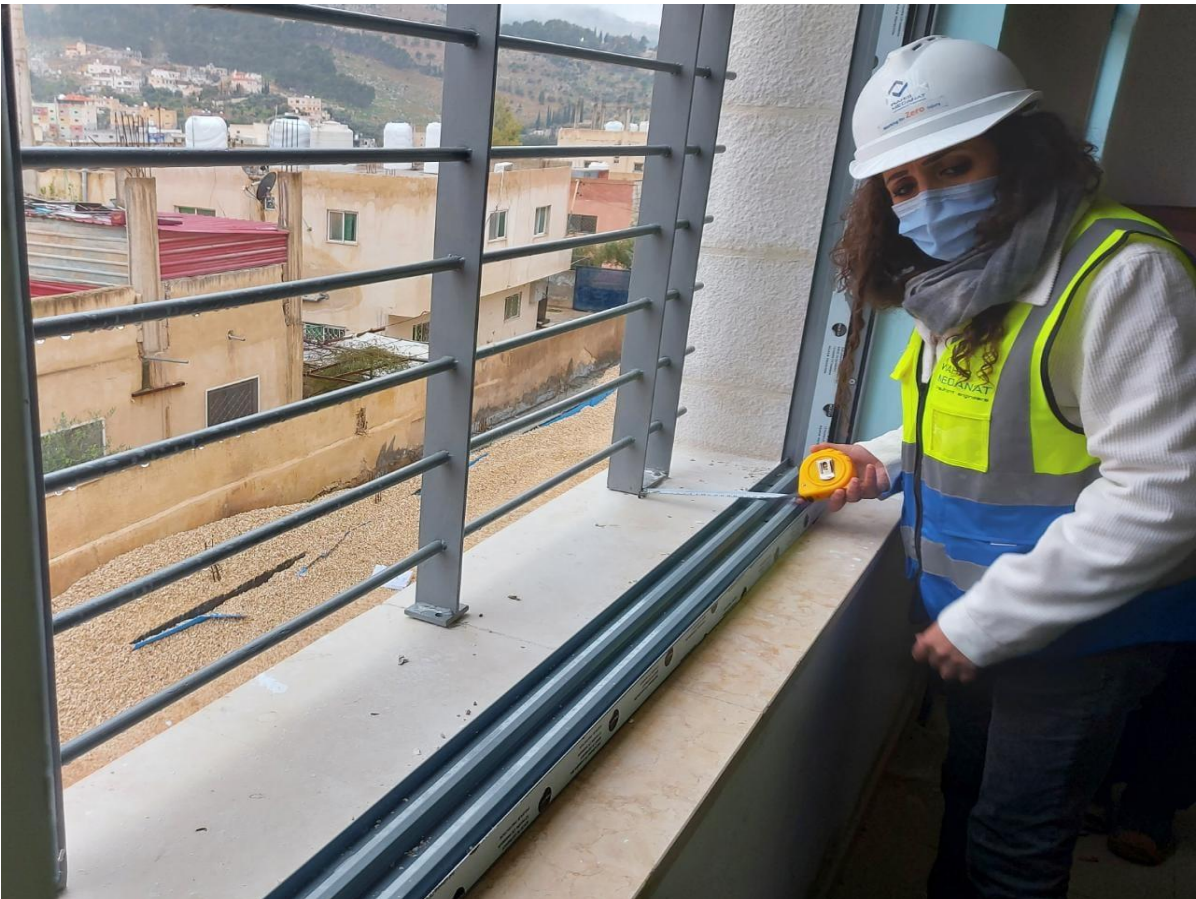
(figure:07 & 08)

The supervision team inspected the installed sample of steel protection screen and the aluminum frame for windows and observed that all dimensions comply with the design drawings

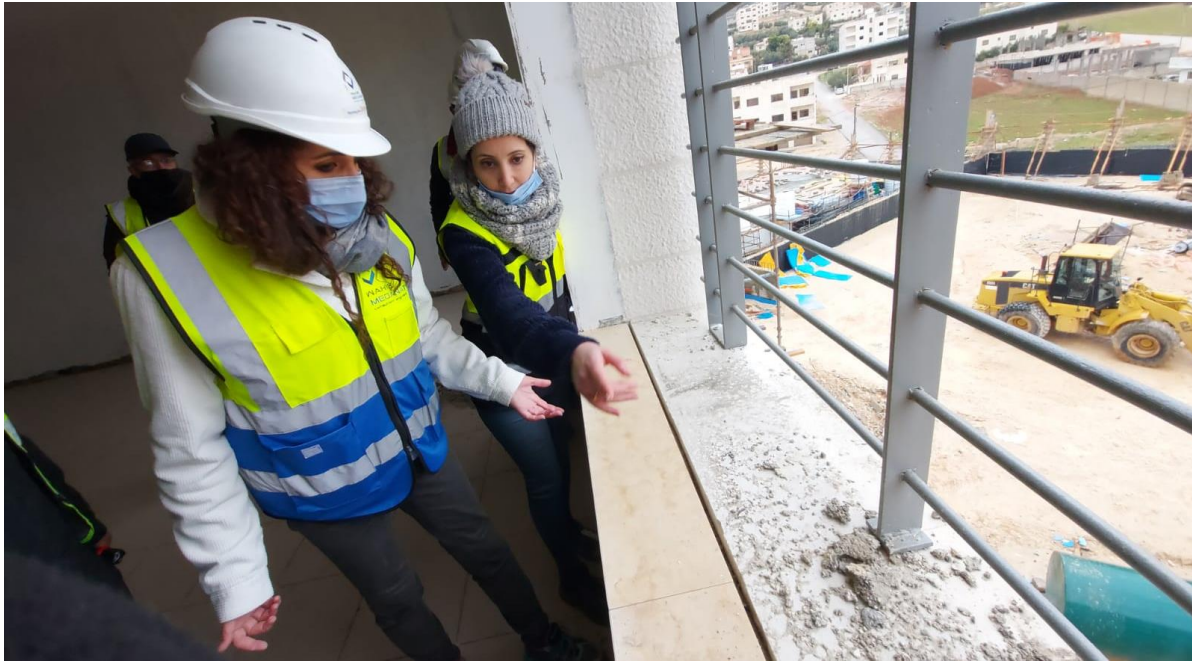
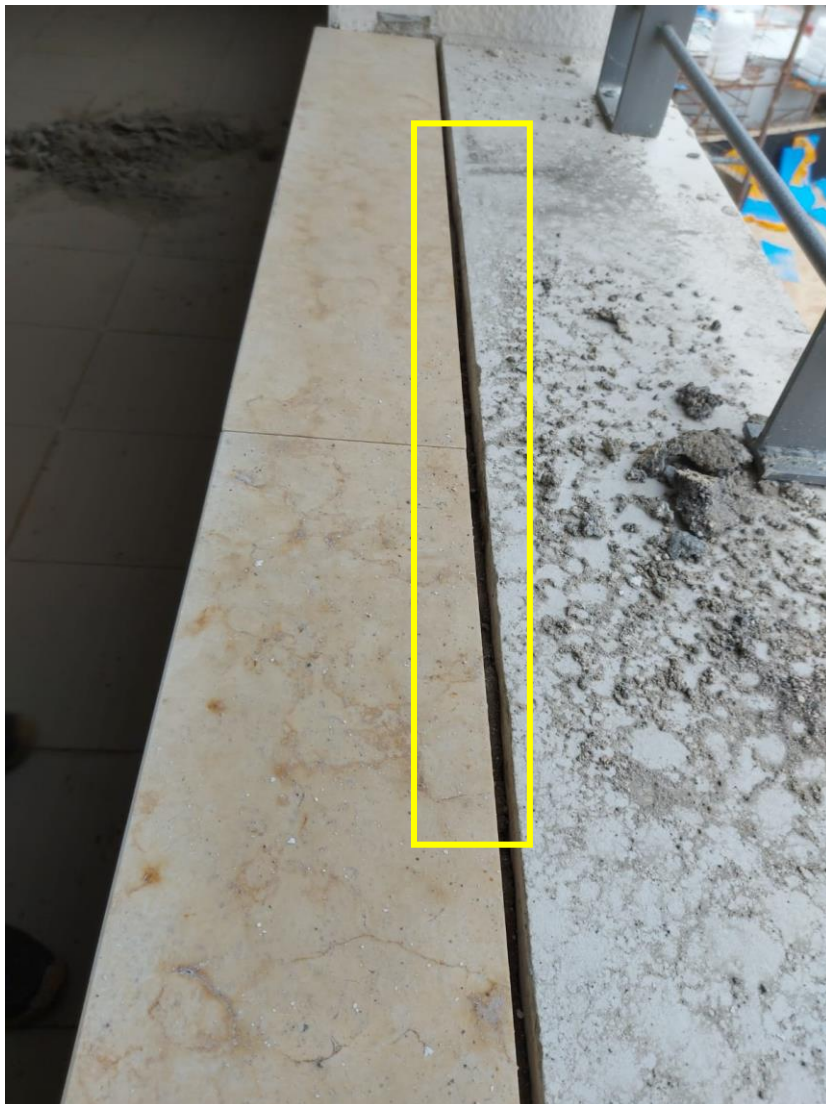
(figure:09 & 10)

The supervision team observed that the gap between the inside sill (marble) and the outer sill (stone) of windows is wider than required. The Contractor was requested to rectify and comply with the maximum allowed gap width as per specification (not more than 1 cm)

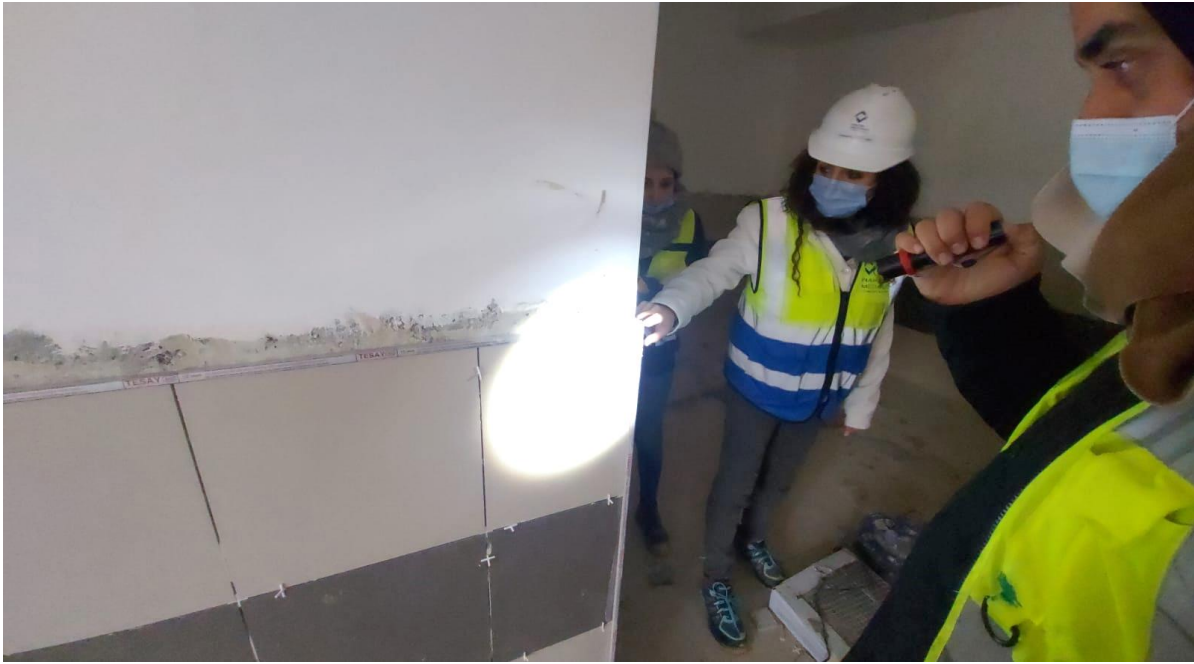
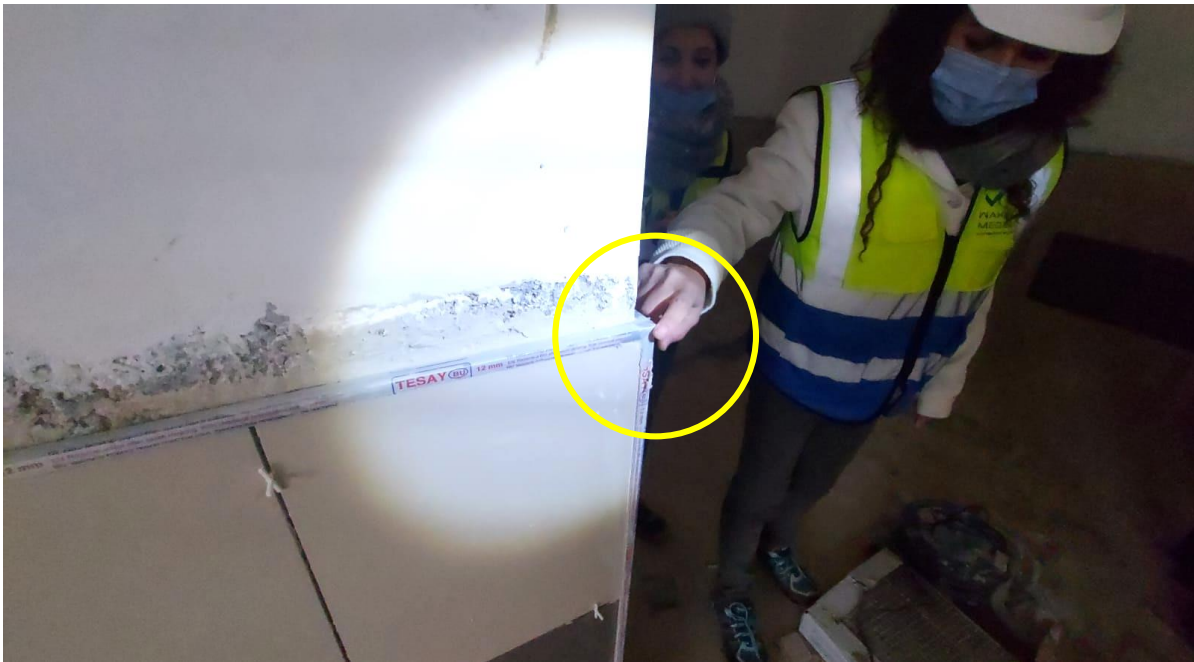
(figure:11 & 12)

The supervision team inspected the installation of beads for the porcelain wall tiles and insured its acceptable quality and installation

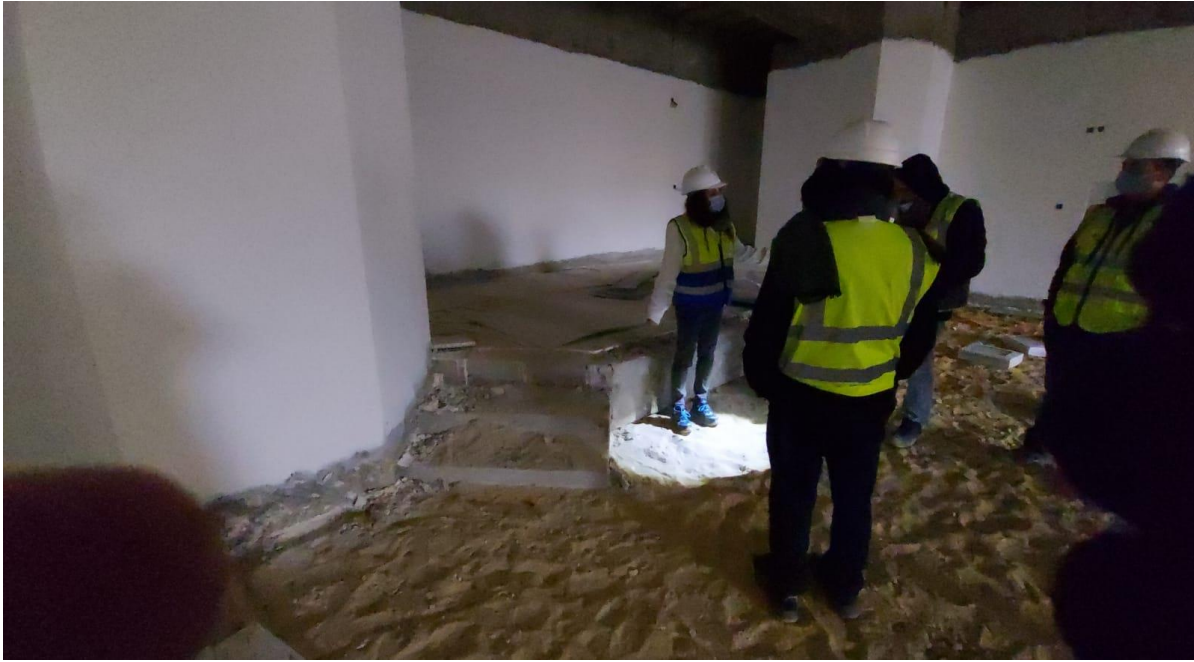
(figure:13)

The supervision team inspected the starting of tiling work at the multi-purpose hall
