**Construction Management of the Jordan School Expansion Project (JSEP)
and the Schools for a Knowledge Economy Project (SKEP)**

Site Visit Report Form

FTR # QR 316

Program (JSEP or SKEP): SKEP **PHASE:** III **PACKAGE:** I
School Name: Um Al Dananir Basic Mixed School
Supervisory Engineer (SE) Name: Wahib Medanat Consultant Engineers
Construction Contractor (CC) Name: Darar Sararieh Co.
Date and Time of Field Trip: March 28, 2021 9:30 AM
Date of Report: March 29, 2021
Weather During Visit Sunny 9 °
Report Submitted By: Osama Obeid and Talid Hamdan.

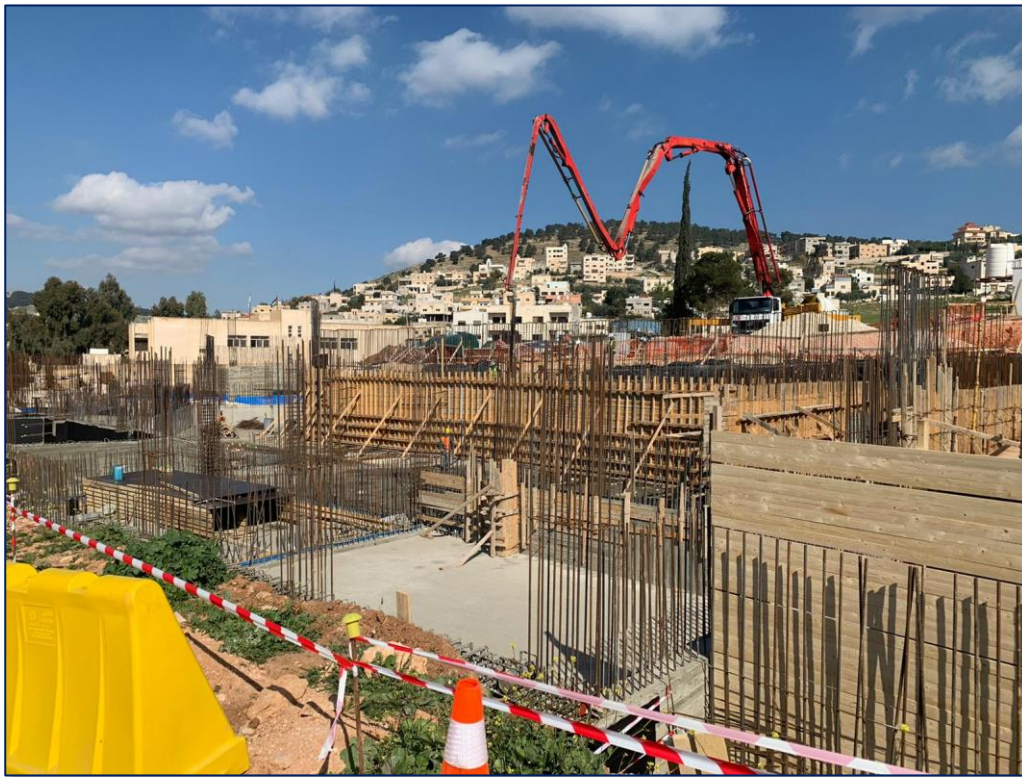
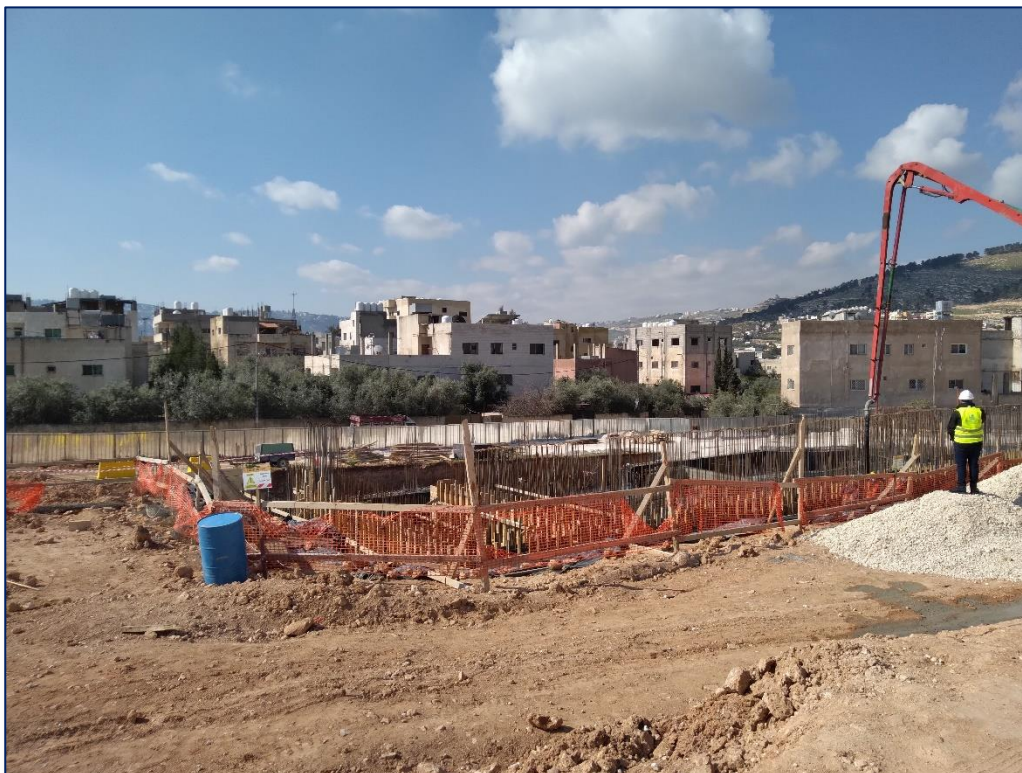
FIGURE #02& 03:

The project consists of five floors building, with a total approximate area of 5420 sq.m, in addition to site works. The project will contain a KG on the ground floor, a playground, an exercise area and a basketball court.

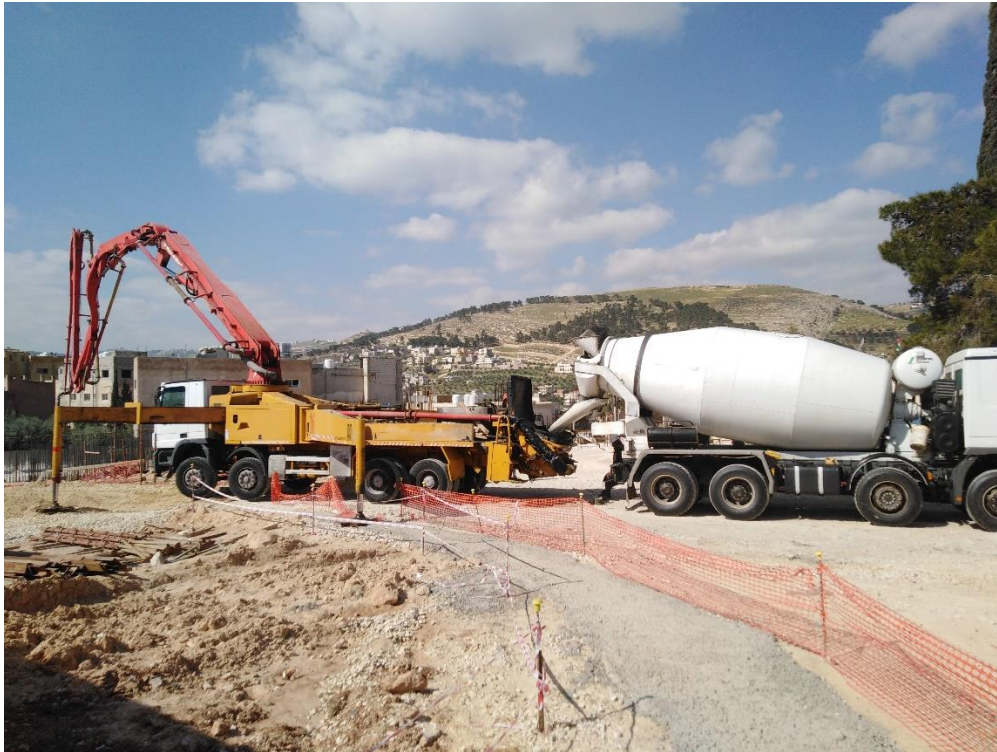
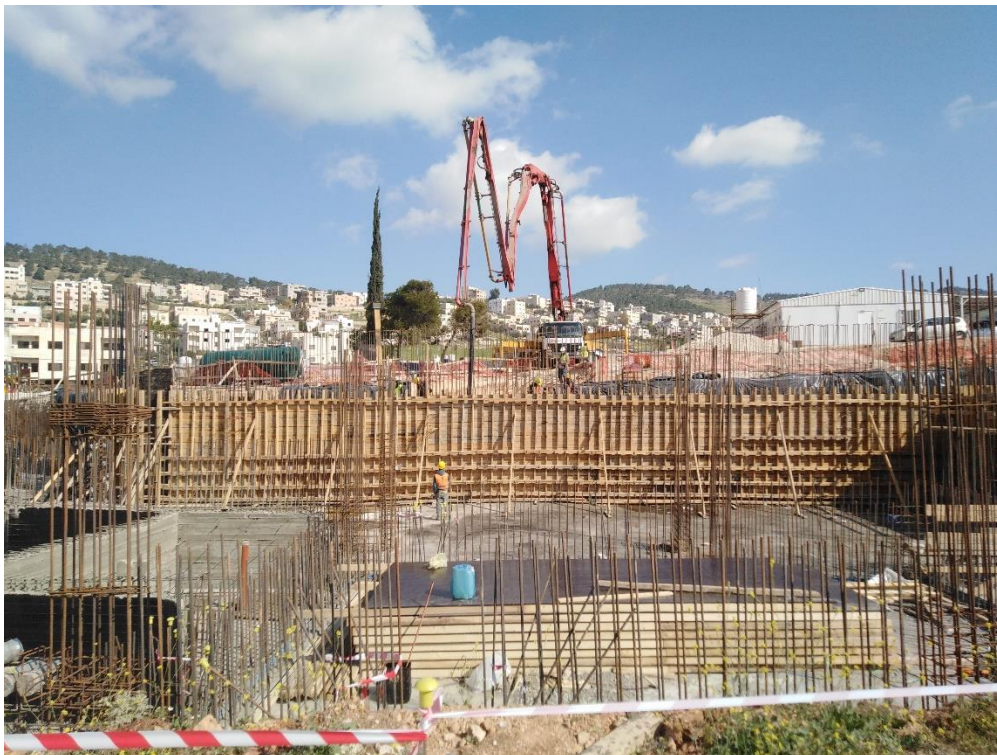
FIGURE #04 &05:

- Casting the basement walls is ongoing
- Insulation works is ongoing
- Erecting formwork is ongoing
- De-shuttering works is ongoing
- Backfilling works is ongoing.

During casting the
basement walls

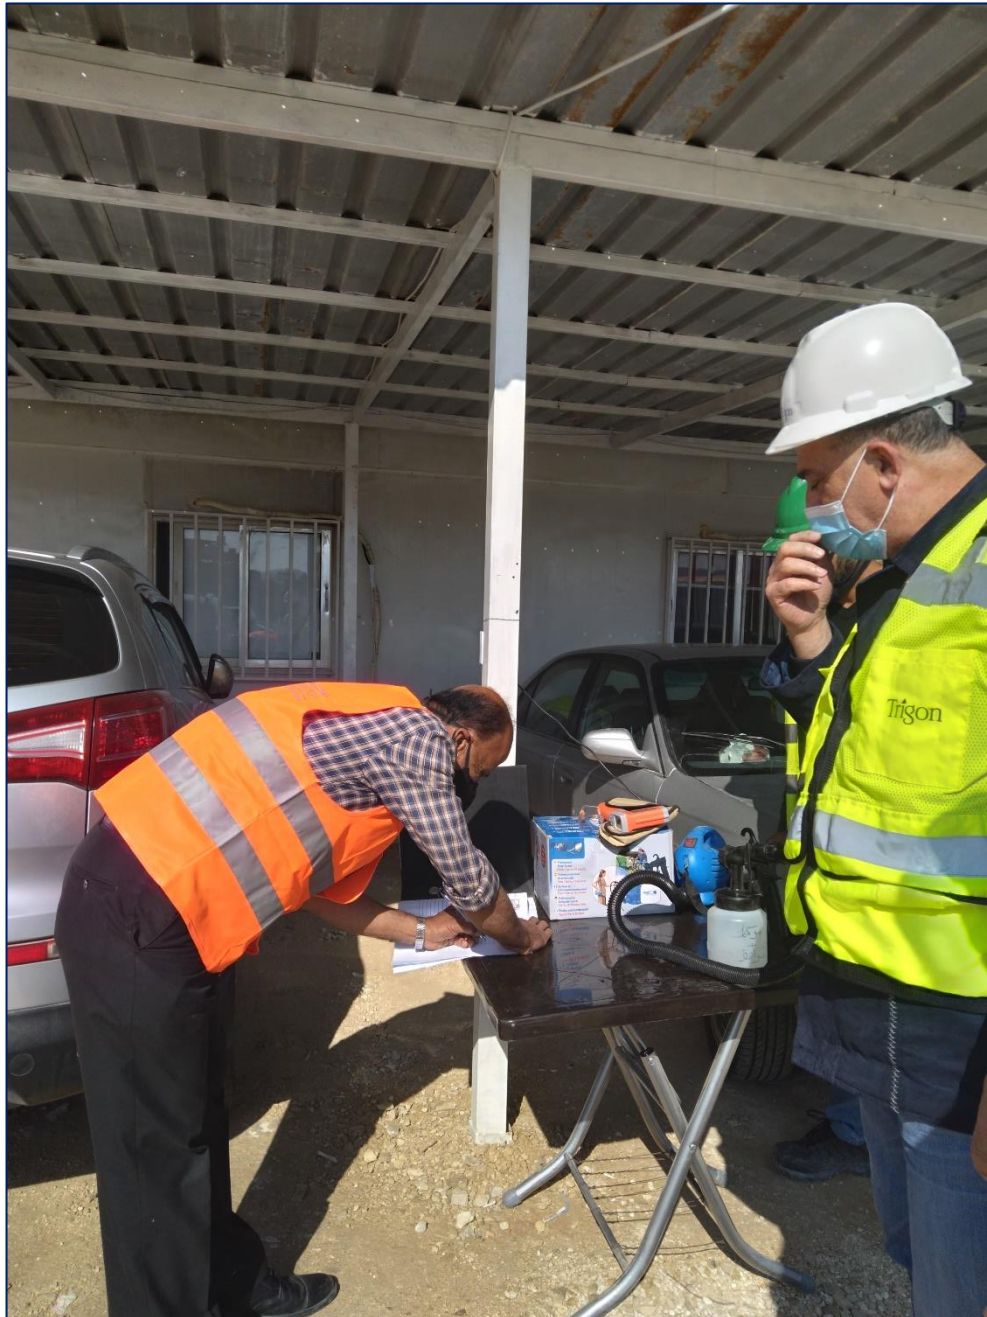
FIGURE #06:

- Good construction site security.
- Health and safety signs were used on site.
- Good Housekeeping on site.
- Hygiene, visitors' log station and disinfection stations were available on site.

Hygiene, and visitors' log station on site.

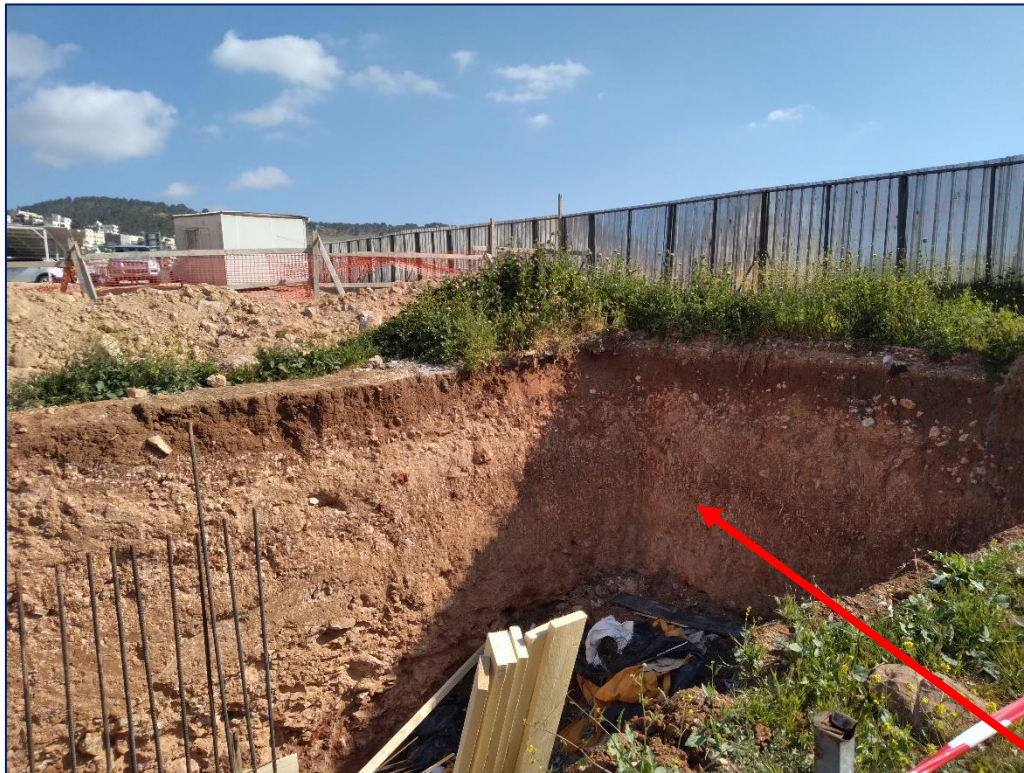
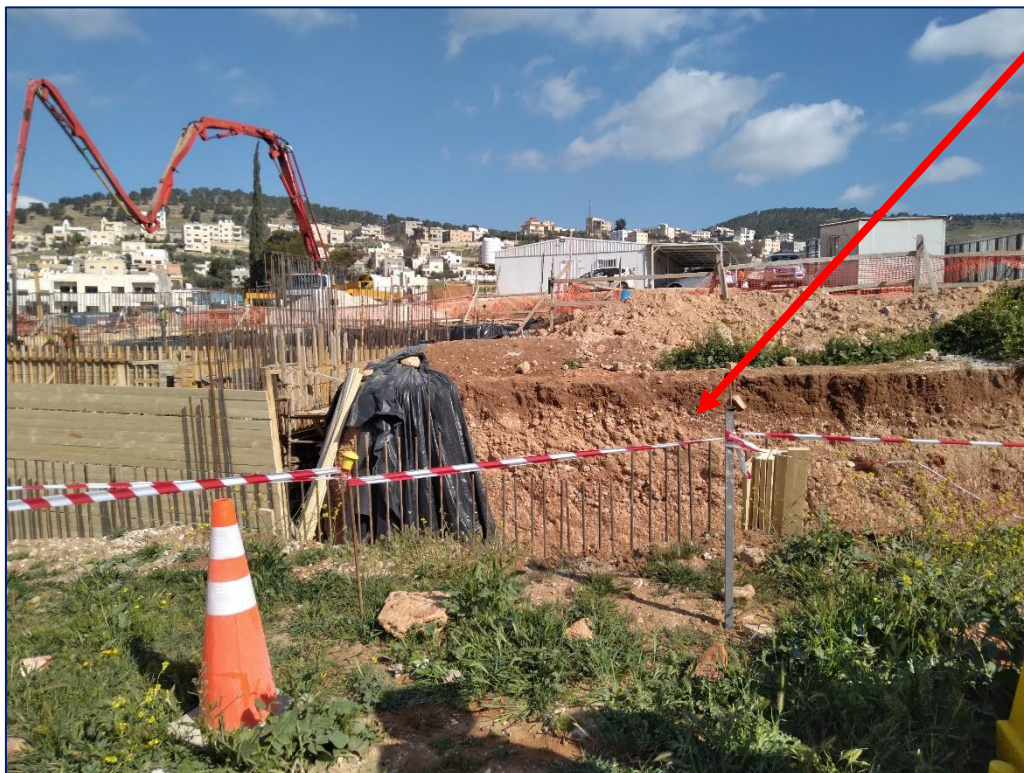
- Possibility of soil sliding.

FIGURE #07& 08:
Possibility of soil sliding, it is recommended to protect the area.

#	Task / Activity	Observations (Y/N)	Findings	Recommendations / Corrective Actions
A. Excavation				
			Possibility of soil sliding	Should protect the area

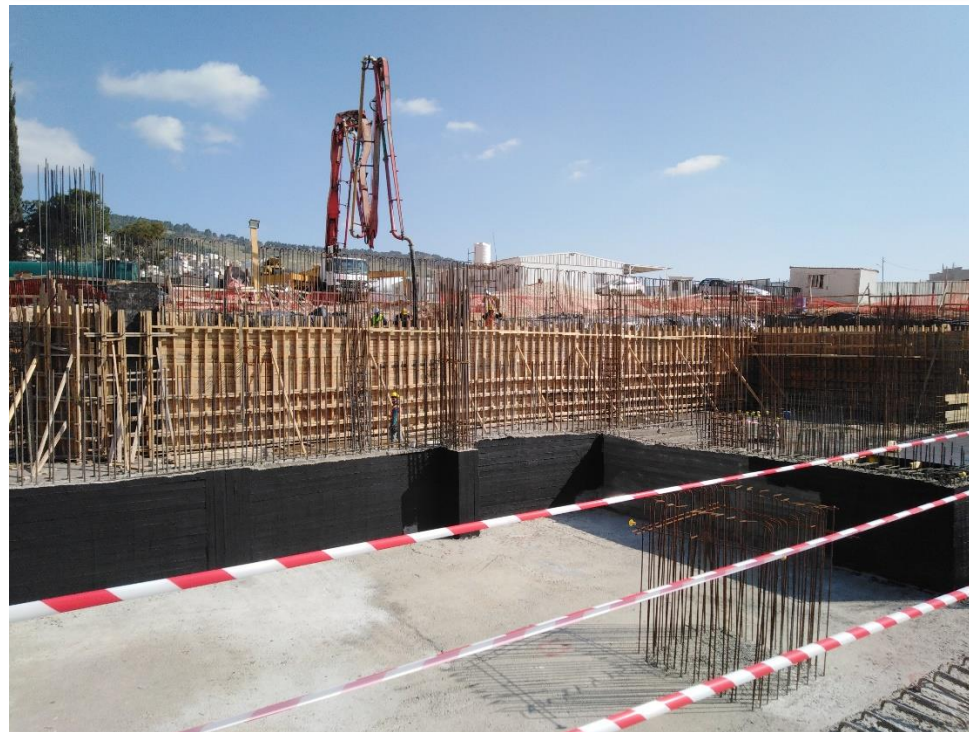
FIGURE #07& 08:

Backfilling works is ongoing.

Insulation works is ongoing

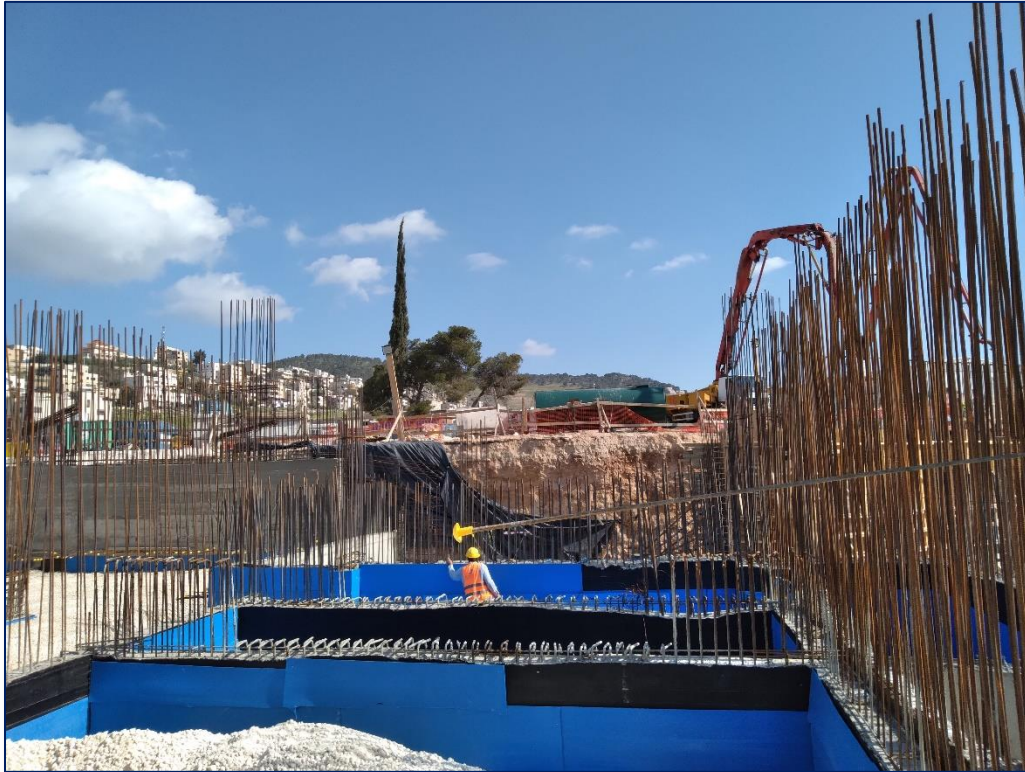
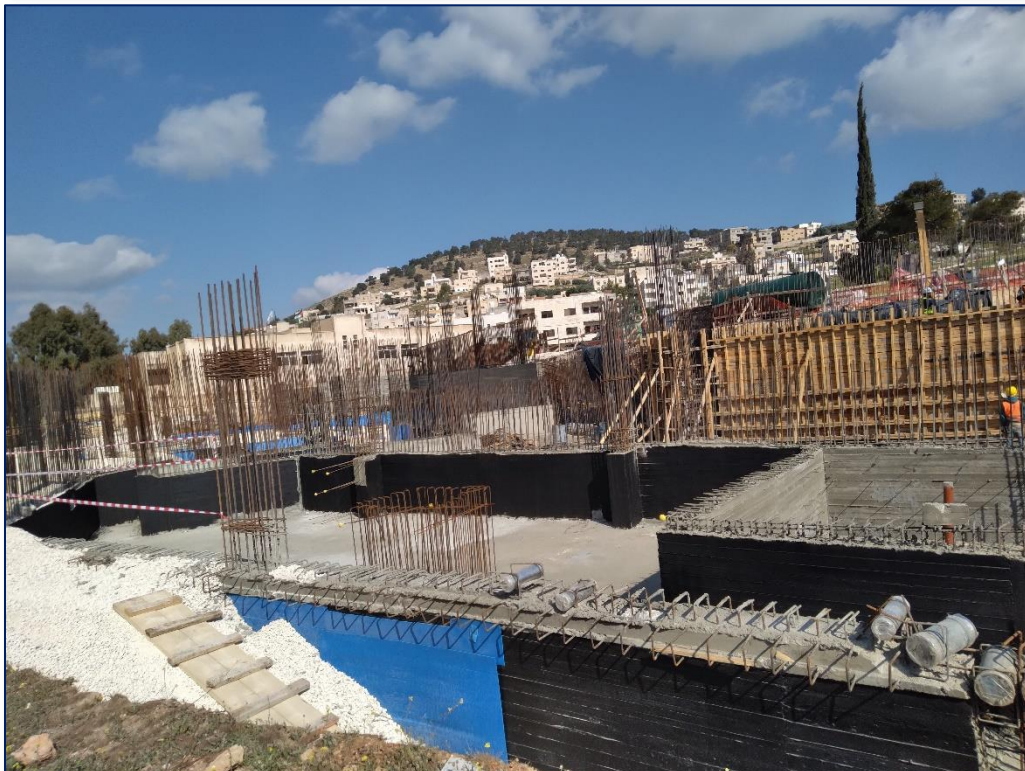
FIGURE #09& 10:
Backfilling works is ongoing.
Insulation works is ongoing.
*Photos credit: Talid Hamdan
March 28th, 2021*

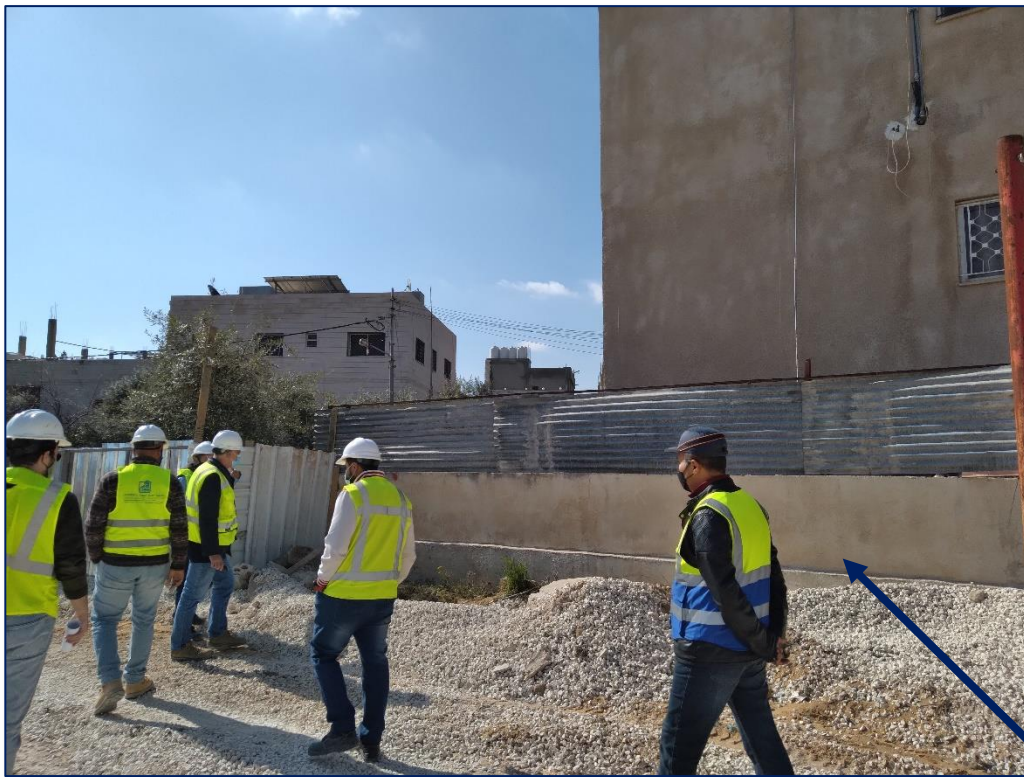
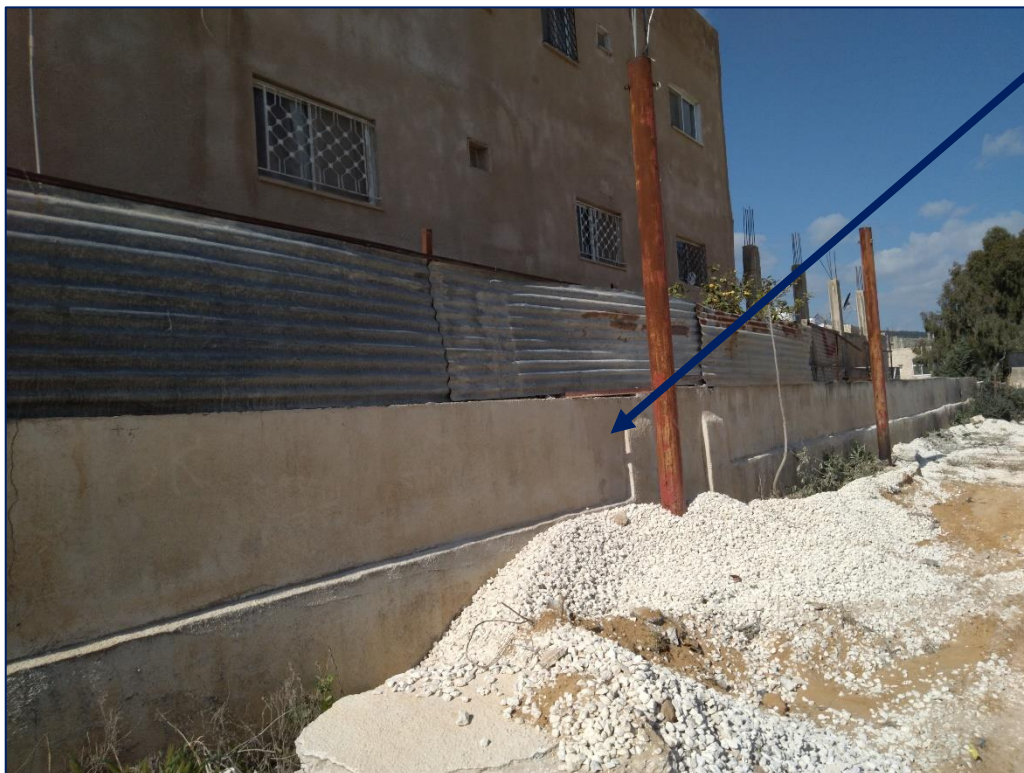
FIGURE #11 & 12:

- There is encroachment of neighbor wall toward the school boundary plot.
- There is encroachment of the existing street toward the school land and this will affect the construction of the eastern boundary wall, boundary wall, guard room, R/F concrete water tank, transformer's room and parking lot)
- According to Municipality organizational site plan, there is an existing street
- There is contradiction between the municipality site plan and project site plan must be resolved

There is encroachment of neighbor wall toward the school boundary plot.

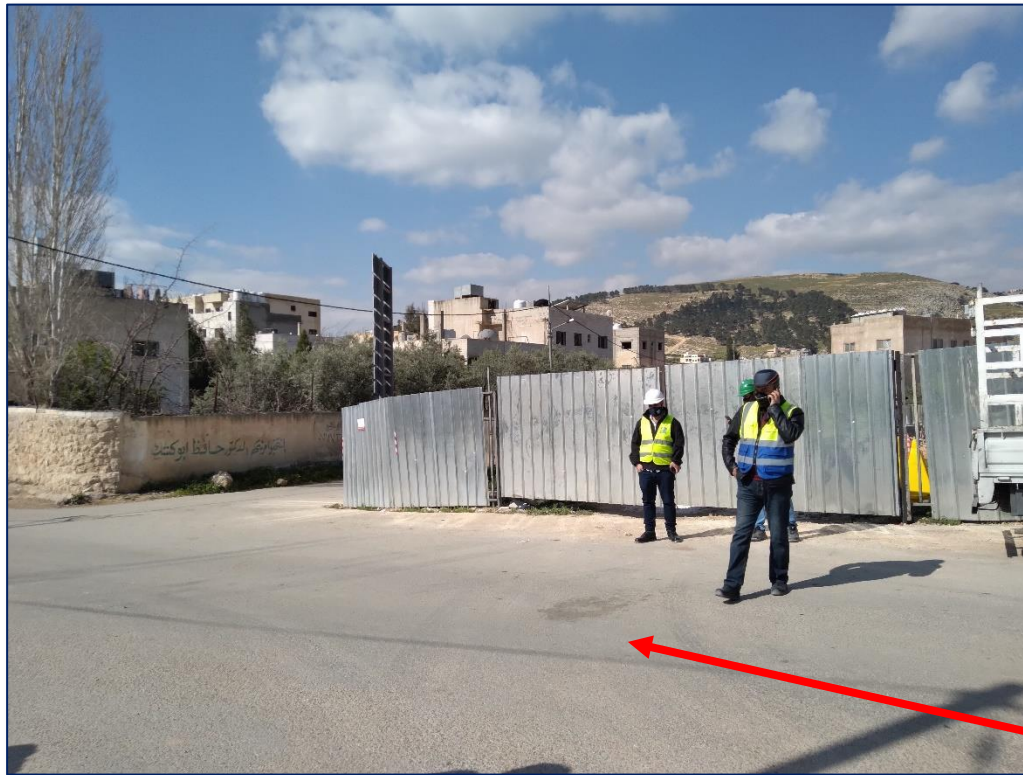
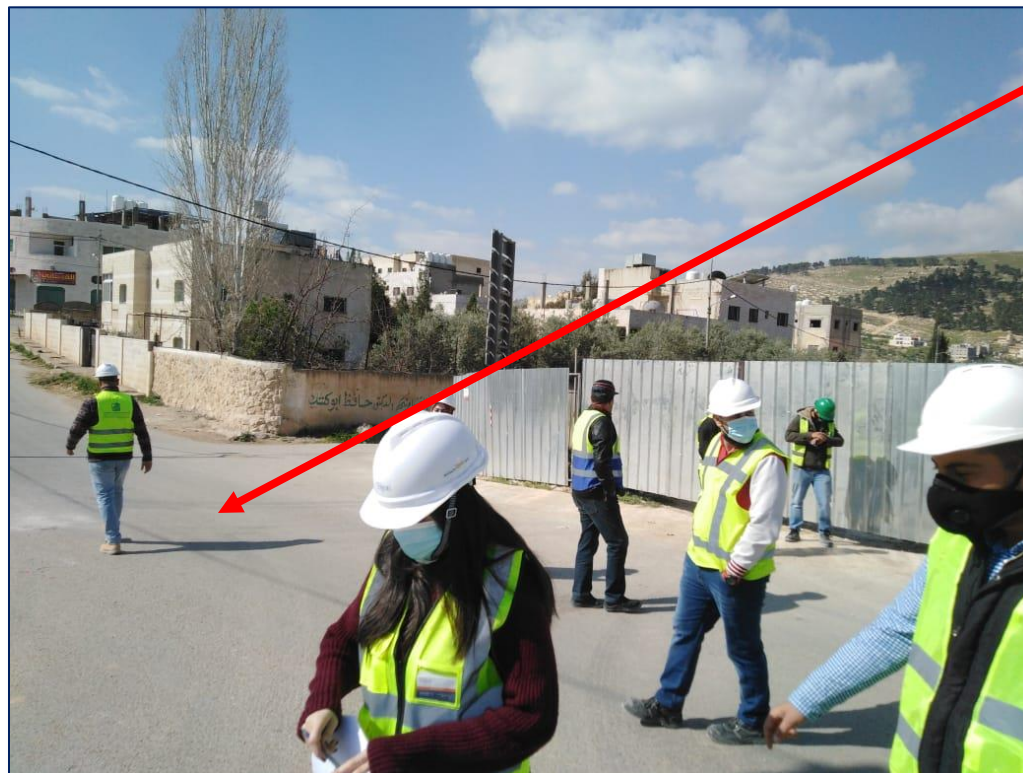
FIGURE #13& 14:

There is encroachment of the existing street toward the school land and this will affect the construction of the eastern boundary wall, the guard house, the harvesting rainwater tank and the transformer's location.

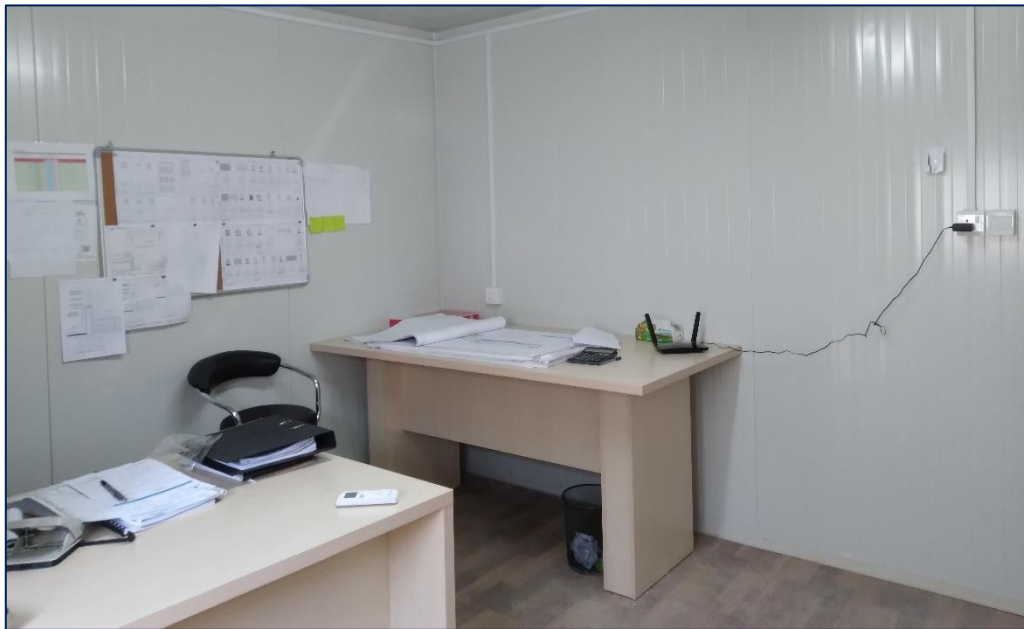
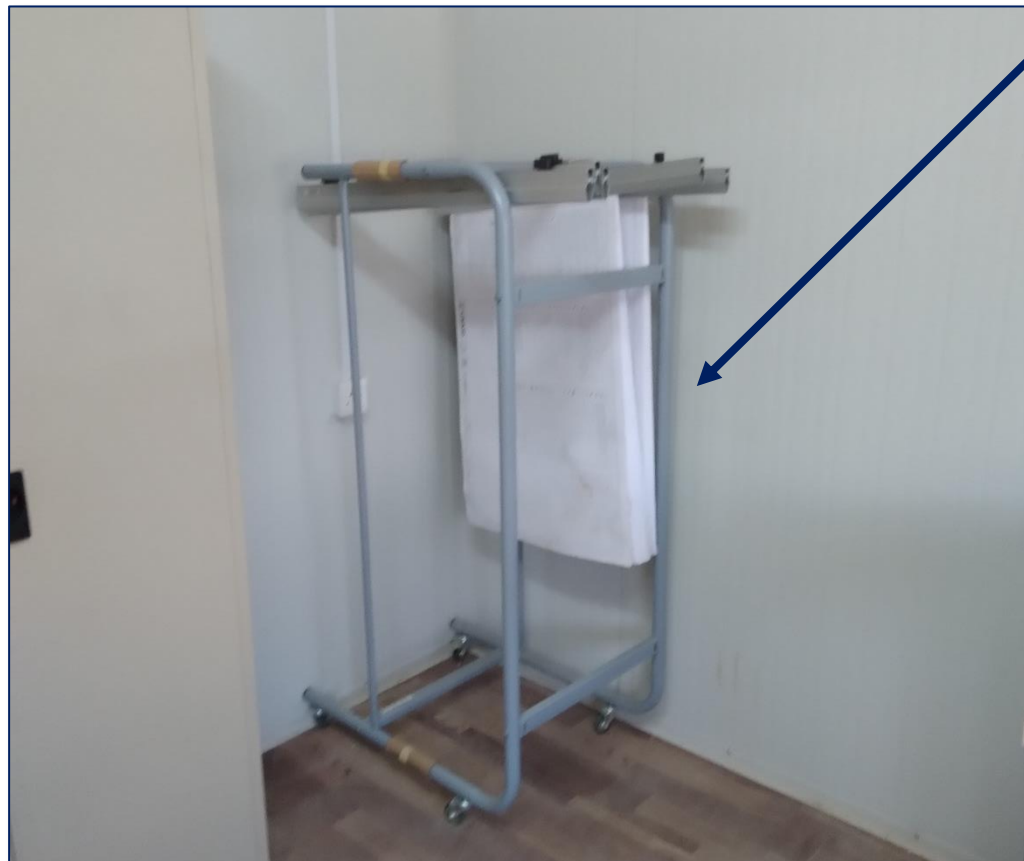
- Available and well documented.
- Engineer's offices were very organized and the offices' entry was tiled.

FIGURE #16& 17:
Neat offices and organized drawings.
