Site Visit Report Form

FTR # QR 330

Program (JSEP or SKEP): SKEP PHASE: ||| PACKAGE: 2

School Name: Jumana Bint Abi Taleb Basic Mixed School

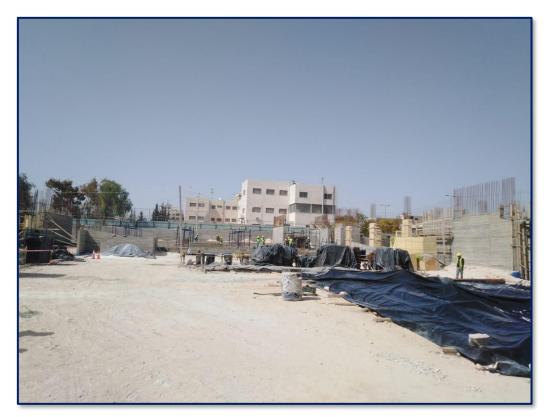
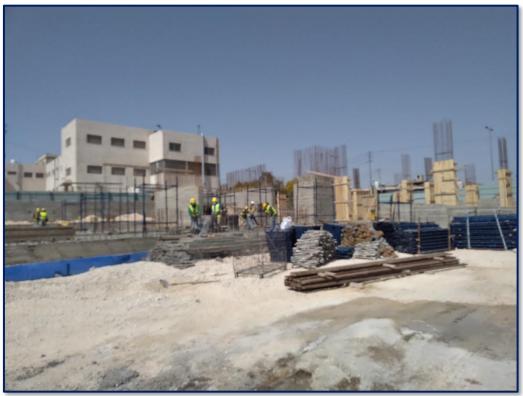
FIGURE #02& 03:

The project consists of a five floors building, in addition to other site works. The project has an internal area of 5460.0 m² and external area of 5529.0 m².

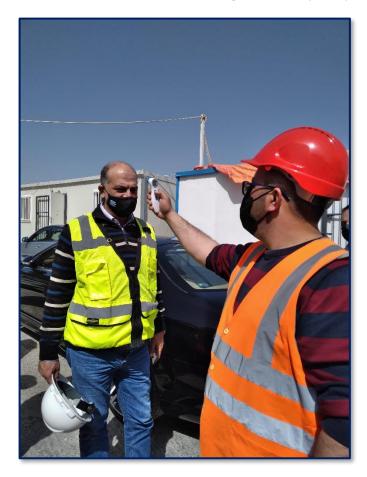
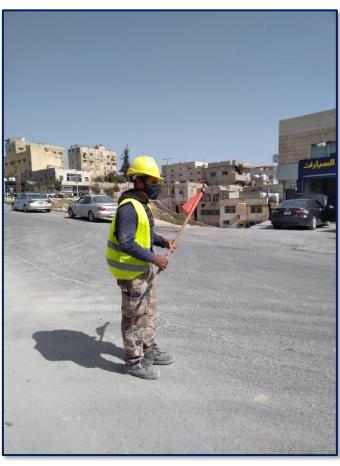
FIGURE #04& 05:

Covid-19 hygiene stations and visitor's log are available on site.

Flagman at site fostering safety and managing the flow of cars coming into the work zone

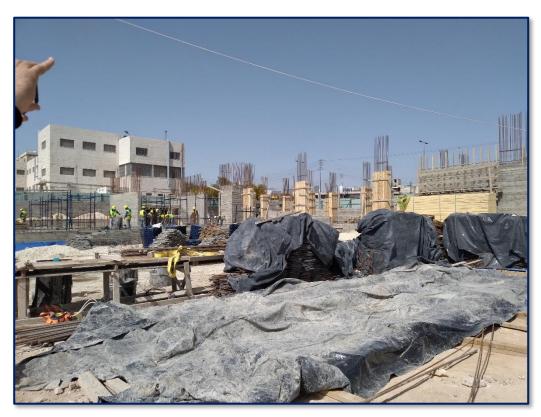
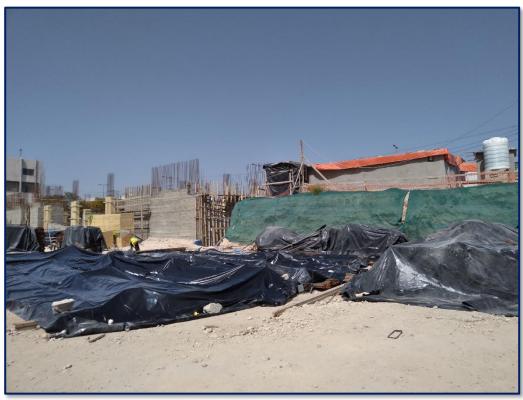
FIGURE #06& 07:

Construction materials are stacked and stored safely.

Access and egress routes are clear.

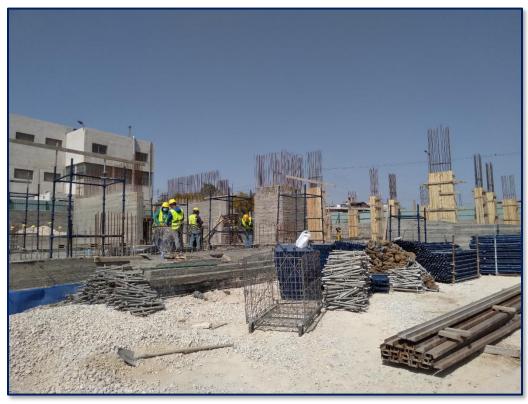
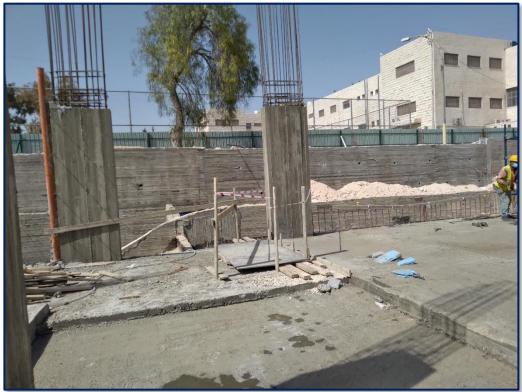
FIGURE #08& 09:

Cast in place SOG works are done and ground column works are ongoing.

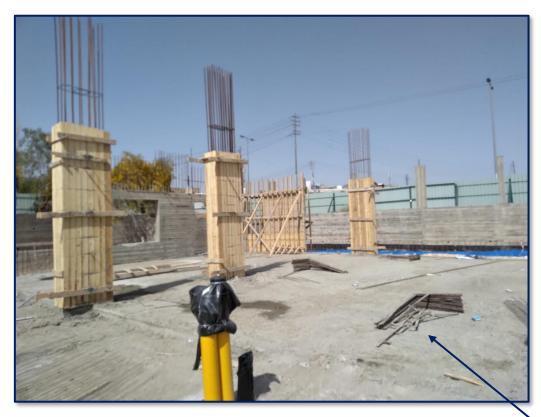
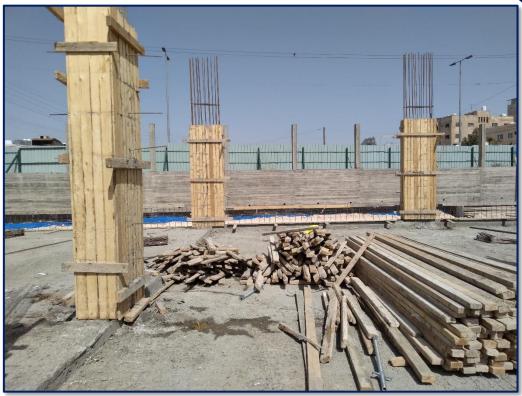
FIGURE #10& 11:

De-shuttering of columns formwork is ongoing,

Used materials are gathered on site in a neat manner.

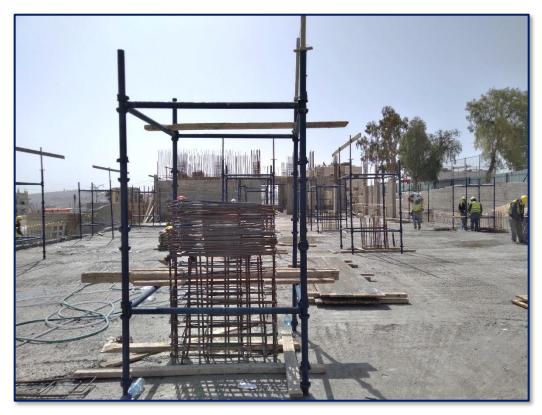
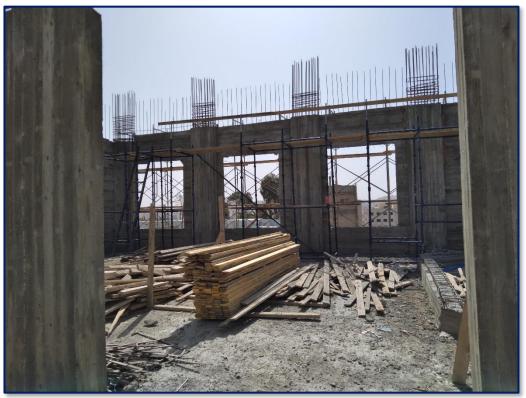
FIGURE #12& 13:

Ladder frame scaffolding is used as a safety measure.

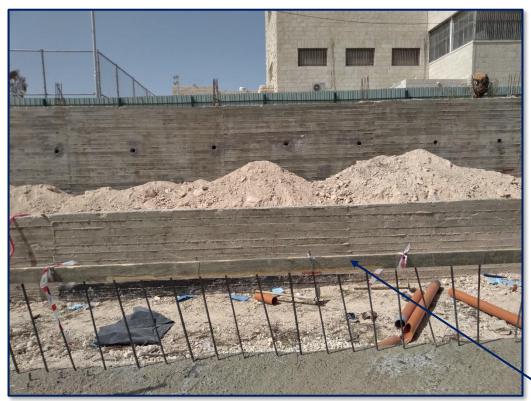
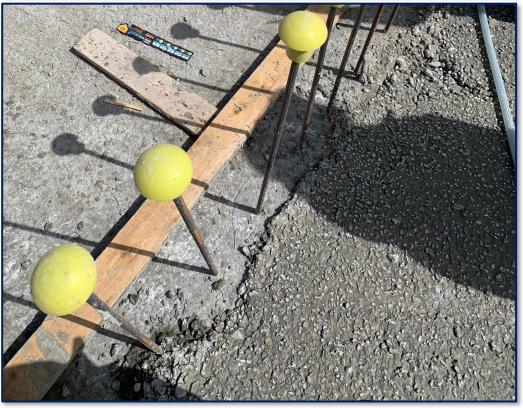
FIGURE #16& 17:

The height of a handrail above the floor, shall be between 900mm and 1100mm.

Using mushroom caps for protection from exposed rebars.

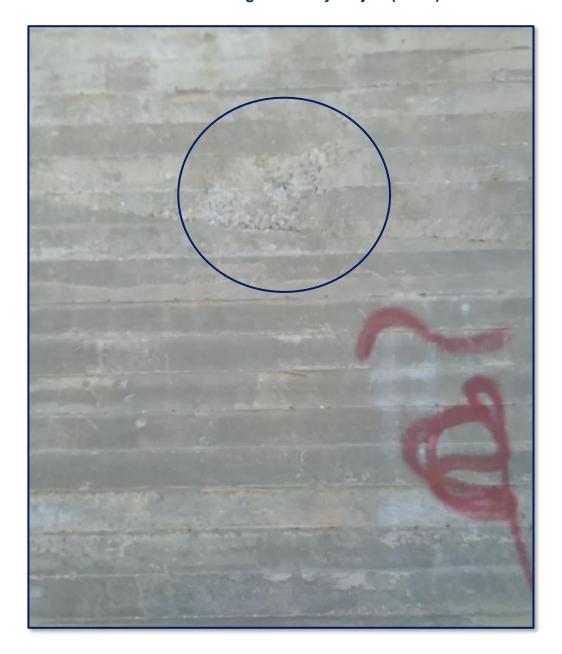
FIGURE #18:

- Stair's risers and treads are hand drawn on site to make sure the measurements are right.
- Good workmanship for concrete works was noticed (only a small spot of concrete roughness was observed that needs treatment)

Untreated roughness in concrete seen on the school's wall.

0.0	ackining				
c. s	ubStructural, Concrete,Foundations				
1	Steel Bar				
2	Footings				
3	Ground beams				
4	Tie beams				
5	Column neck				
6	Column				
7	waterproofing(Insulation)				
	Slab on grade				
	uperStructural, Concrete,Masonry works				
1	Columns		Concrete roughness was noticed	It is recommended to treat the roughness	
2	Beams		<u> </u>	<u> </u>	
3	Slabs				
			Stairs risers and treads are hand drawn on site to make sure the		
	Stairs		measurements are right.		
5	Roof				
	Hollow Concrete Block (internal)				
7	Hollow Concrete Block (external)				
8	C-Channel				
9	Clading Natural Stones				
10	Electrical conuits/ sleeves				
	Mechnical pipes/sleeves				
	ivil Works		A		
1	Access /Gates		Access and egress routes are clear.		
2	Doors Wooden Doors				
3	Aluminum Windows				
4	Authinalli Williaows				
_	Distanta di anti (lata ana al)				
	Plastering (Internal)				
6	Plastering (External)				
7 8	Wall Paint Ceiling Paint
