Site Visit Report Form

FTR #252 HSE

School Name: Khadija Bint Khwailed Basic Mixed School

Date and Time of Field Trip: January 25, 2021 10:30 AM

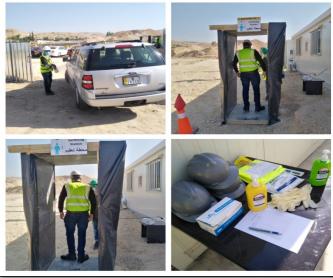
Figure #2: Adequate disinfection stations for personnel and vehicles were secured in the workplace at the entrances and exits. Photo credit: Odai Tawalbeh, 1/25/2021

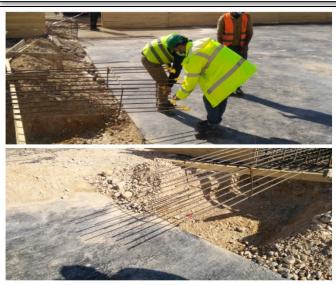
Figure #3: A protruding steel reinforcement bars that were observed on site along with the corrective action taken immediately from the contractor side by providing all steel bars with safety mushroom caps. Photo credit: Odai Tawalbeh, 1/25/2021

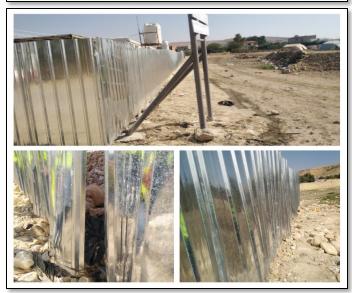
Figure #4: No safety signs along fences on site as well as a part of fences were damaged due to the accumulation of excavation materials near them on site. Photo credit: Odai Tawalbeh, 1/25/2021

adequate safety signs should be posted along fences					
HSE Signage	Υ		1/25/2021	4		on site so as to guide workers and local residents. In					
						addition, all signs should be written in a language					
		1	1								
						that everyone understands.					
					Dangerous Condition: A weak boundary wall of the

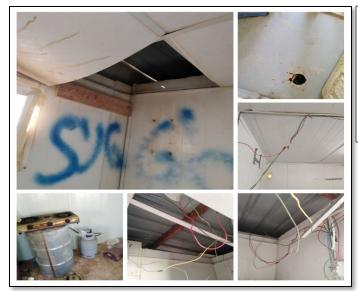
Figure #5: Unsafe (damaged) workers trailers that were observed on site; Hanging and exposed electrical wiring; Dirty Gas Stove stained while cooking; and Gas stove cylinder that was observed in a poorly ventilated room. Photo credit: Odai Tawalbeh, 1/25/2021

Poor public protection at the site.	All areas that were noted on this inspection must be					
Public Protection	Υ		1/25/2021	3		corrected and all systems should meet site					
						compliance protocol.					
Concrete R/F Starter Bar		N	1/25/2021	7							
Occupational Harlin Harton Conditions	v		1/25/2021	_	Dirty Gas Stove stained while cooking was observed	The Gas Stove must be removed and replaced by a					
Occupational Health, Hygiene Conditions	Ĭ		1/25/2021	3	inside the workers' trailer on site.	new one.					
					Gas stove cylinder that was observed in a poorly	In addition to the above, keep the cylinder away					
					ventilated room inside the workers' trailer on site.	from heat and direct sunlight or anything that could					
Fire Prevention			1/25/2021	3		cause a fire where practicable. It must be kept in a					
Fire Prevention	'		1/23/2021	3		well ventilated area (preferably in a cage outside) to

reduce the risks associated with leakage.					
			1/25/2021		Poor housekeeping standards on site.	High-quality housekeeping standards must be taken.	\vdash				
Housekeeping Standards	Y		1/25/2021	4							
Materials Storage	V		1/25/2021	4	Piles of excavated materials were accumulated into	Excavated materials must not be accumulated near					
	1		1/25/2021	4	inappropriate area near fences on site.	fences on site.					
Welfare Facilities	Υ		1/25/2021	3	Unsafe workers trailers that were observed on site.	Maintenance Required.					
PPE		N	1/25/2021	7							
			Total H&S %	46%			Т		Total CA %	0%	
			Action Status	3	At Risk		\vdash		Action Status	_	
Environmental Regulations	Y	N N/A					Υ	N N	A		
Waste Management		N	1/25/2021	7							,
Dust Management		N	1/25/2021	7							
Tracking / Transporting Waste		N	1/25/2021	7							
Runoff Discharge		N	1/25/2021	7							
Noise Nuisance		N	1/25/2021	7							
Air Pollution		N	1/25/2021	7

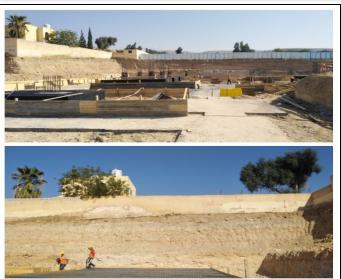
Figure #6: <u>Dangerous Condition</u>:
A weak boundary wall of the neighboring resedental building that already has no footings was observed on site; risk of collapse which could lead to the serious incident. Immediate Action Required.

-	that everyone understands. According to the contract specifications requires					
Excavation, Backfilling	Υ		1/25/2021	3	neighboring resedental building that already has no	According to the contract specifications requires shoring or some other form of protection. This item					
Excavation, Backfilling	Υ		1/25/2021	3	-	According to the contract specifications requires shoring or some other form of protection. This item must be addressed immediately by the responsible					
Excavation, Backfilling	Υ		1/25/2021	3	neighboring resedental building that already has no footings was observed on site; risk of collapse which	According to the contract specifications requires shoring or some other form of protection. This item					
Excavation, Backfilling Scaffolding, Temporary Works	Υ	N	1/25/2021	3	neighboring resedental building that already has no footings was observed on site; risk of collapse which	According to the contract specifications requires shoring or some other form of protection. This item must be addressed immediately by the responsible

Y	N N		3 7 7	neighboring resedental building that already has no footings was observed on site; risk of collapse which	According to the contract specifications requires shoring or some other form of protection. This item must be addressed immediately by the responsible					
Scaffolding, Temporary Works	Y	_	1/25/2021	7 7	neighboring resedental building that already has no footings was observed on site; risk of collapse which	According to the contract specifications requires shoring or some other form of protection. This item must be addressed immediately by the responsible					
Scaffolding, Temporary Works Ladders, Stepladders	Y	_	1/25/2021	7 7	neighboring resedental building that already has no footings was observed on site; risk of collapse which could lead to the serious incident. A utility pole with substandard protection was	According to the contract specifications requires shoring or some other form of protection. This item must be addressed immediately by the responsible party as we do consider this serious.

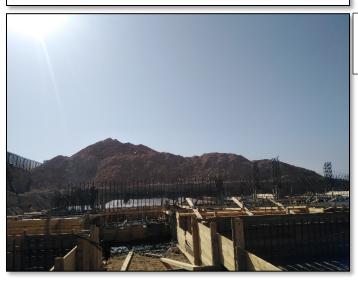
Figure #7: Excavation materials that were accumulated near fences on site. Photo credit: Odai Tawalbeh, 1/25/2021
