SKEP III Home Office Support Site Visit Report

Consultant	Wahib Medanat Consultant Engineer	Rep No.	23-210872021
Contractor	Dijlah Establishment Constr. Contracting	Tender No.	(11/2019/USAID/SKEP/3/S) Schools for a Knowledge Economy Project (SKEP) - Phase (3) Package (1, 2)
Site Name	Jumana Bint Abit Taleb Basic Mixed School - Jerash	Day/ Date	Sat. 21/08/2021
Duration of Project	450 Calendar Days	Total Project Budget	8,314,983.735 JD

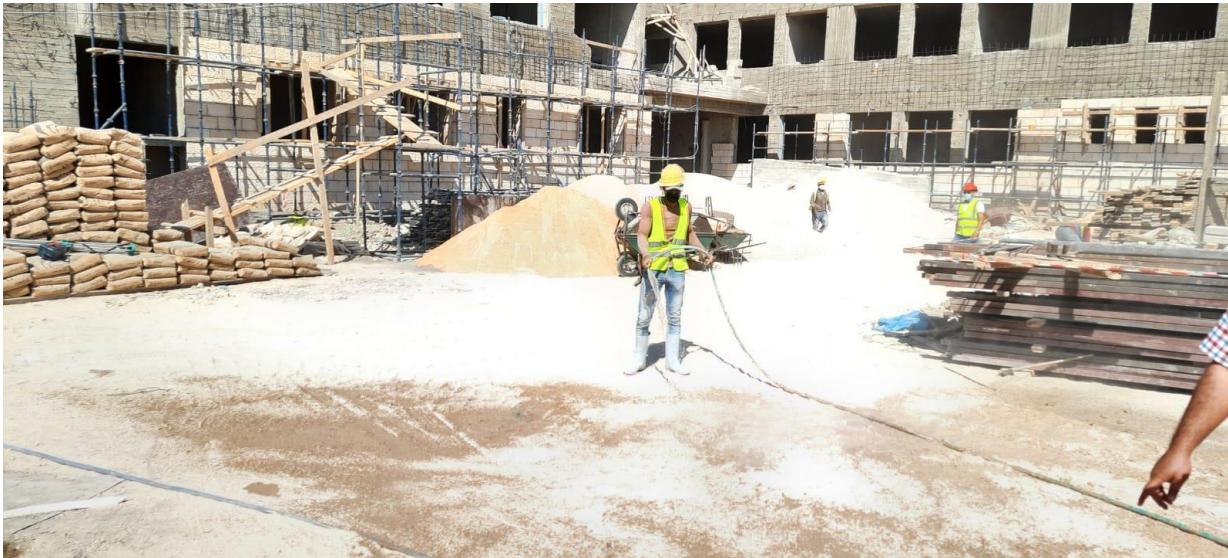
(Figure: 02)

Spraying water at the sand areas in the site for the purpose of dust control

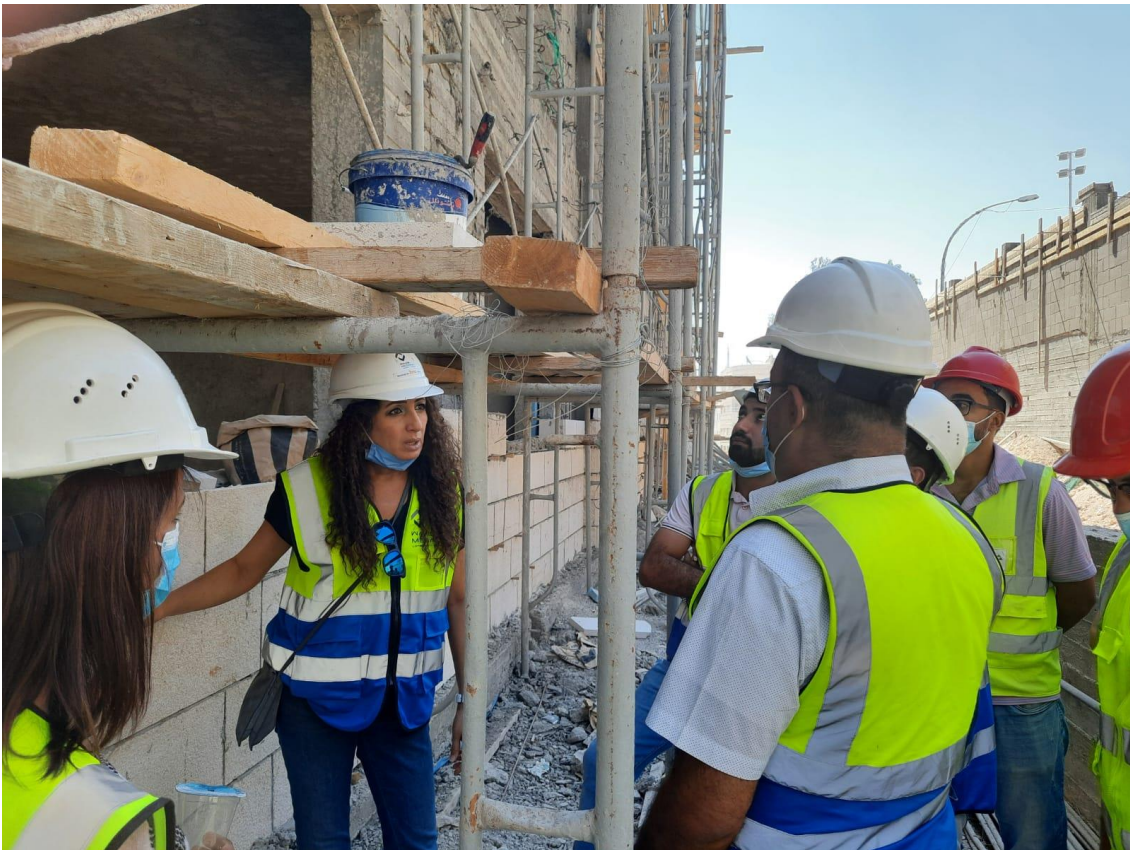
(Figure: 04)

The delivered stones to the site and the built stones as well were checked and the Consultant stressed on the compliance of stones to the approved samples

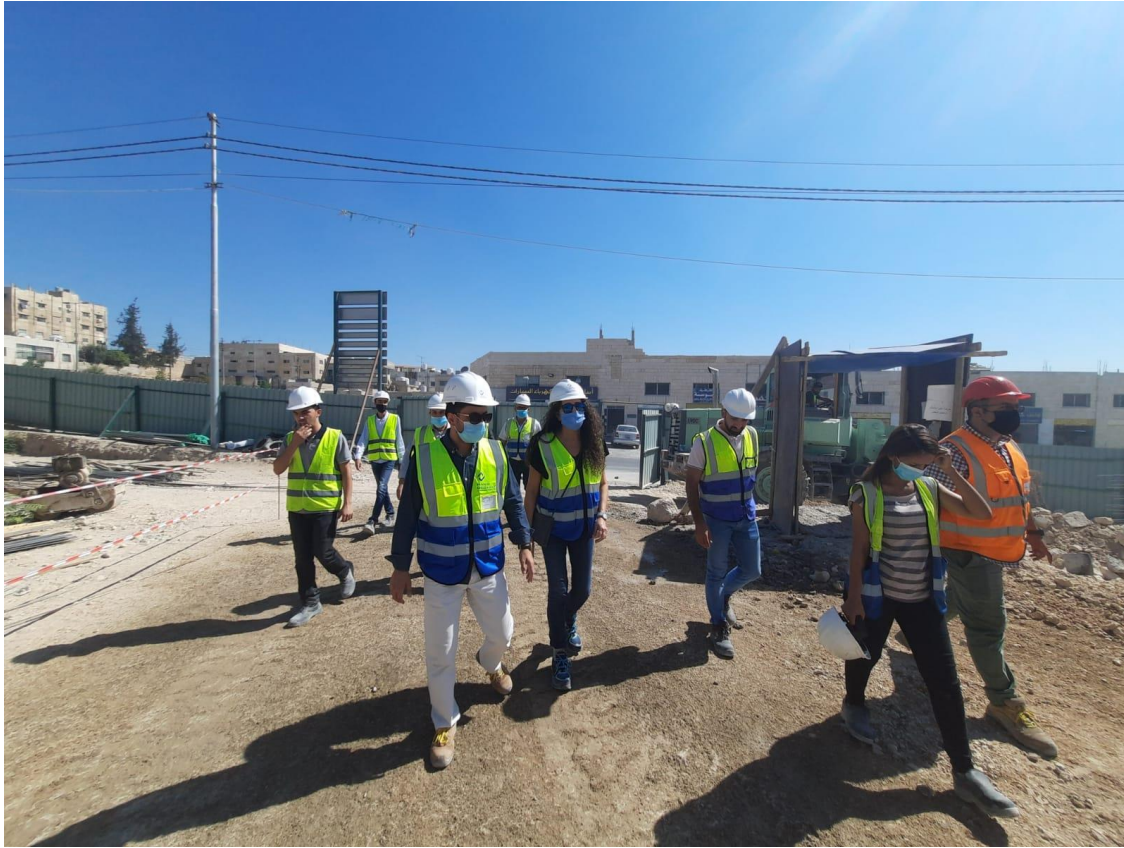
(Figure: 14)

A tour inside the site was conducted

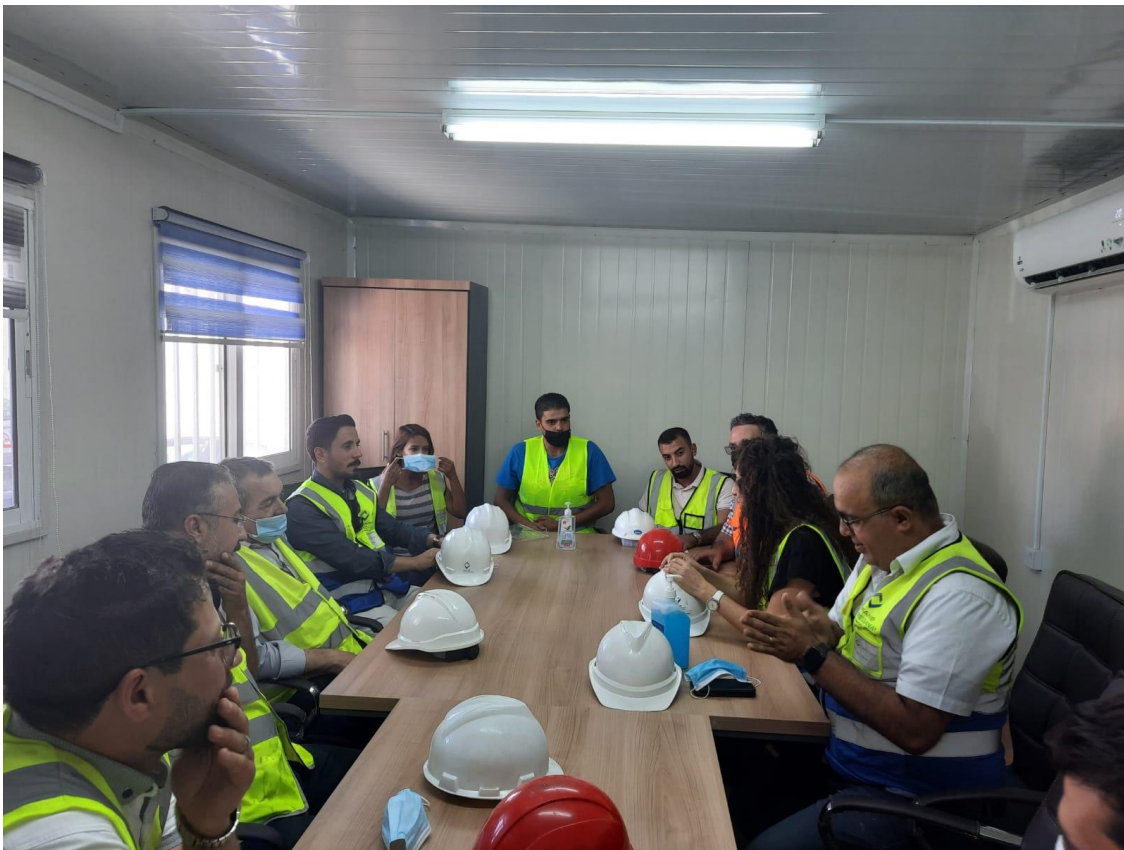
(Figure: 15)

a meeting was held to discuss monthly payments, stone work and mock-up rooms. The Consultant expressed concerns towards the Contractor's work progress and stressed on the necessity of him submitting his invoices with enough amounts to be able to proceed with work and avoid stoppages
