Consultant	Wahib Medanat Consultant Engineer	Rep No.	13-10112021
Contractor	Derar Saraireh & Sons for Engineering & Contracting	Tender No.	(11/2019/USAID/SKEP/3/S) Schools for a Knowledge Economy Project (SKEP) - Phase (3) Package (1, 2)
Site Name	Khadija Bint Khwailed Basic Mixed School- Shouna Janoubia	Day/ Date	Wed. 10/11/2021
Duration of Project	450 Calendar Days	Total Project Budget	9,789,417.840 JD

Visit Notes

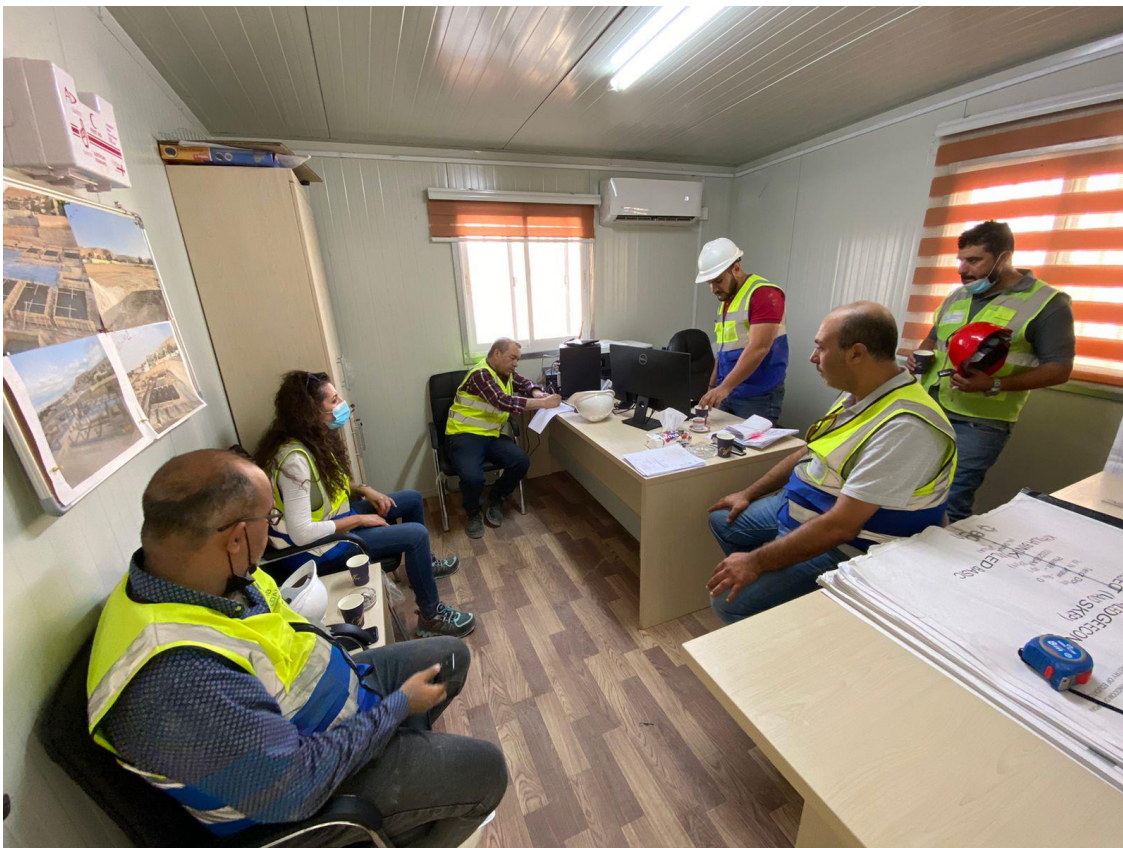
(Figure: 24)

A tour inside the site was conducted
