Consultant	Wahib Medanat Consultant Engineer	Rep No.	11-21082021
Contractor	Derar Saraireh & Sons for Engineering & Contracting	Tender No.	(11/2019/USAID/SKEP/3/S) Schools for a Knowledge Economy Project (SKEP) - Phase (3) Package (1, 2)
Site Name	Um Al Dananir Basic Mixed School- Al Balqa	Day/ Date	Sat. 21/08/2021
Duration of Project	450 Calendar Days	Total Project Budget	9,789,417.840 JD

Visit Notes

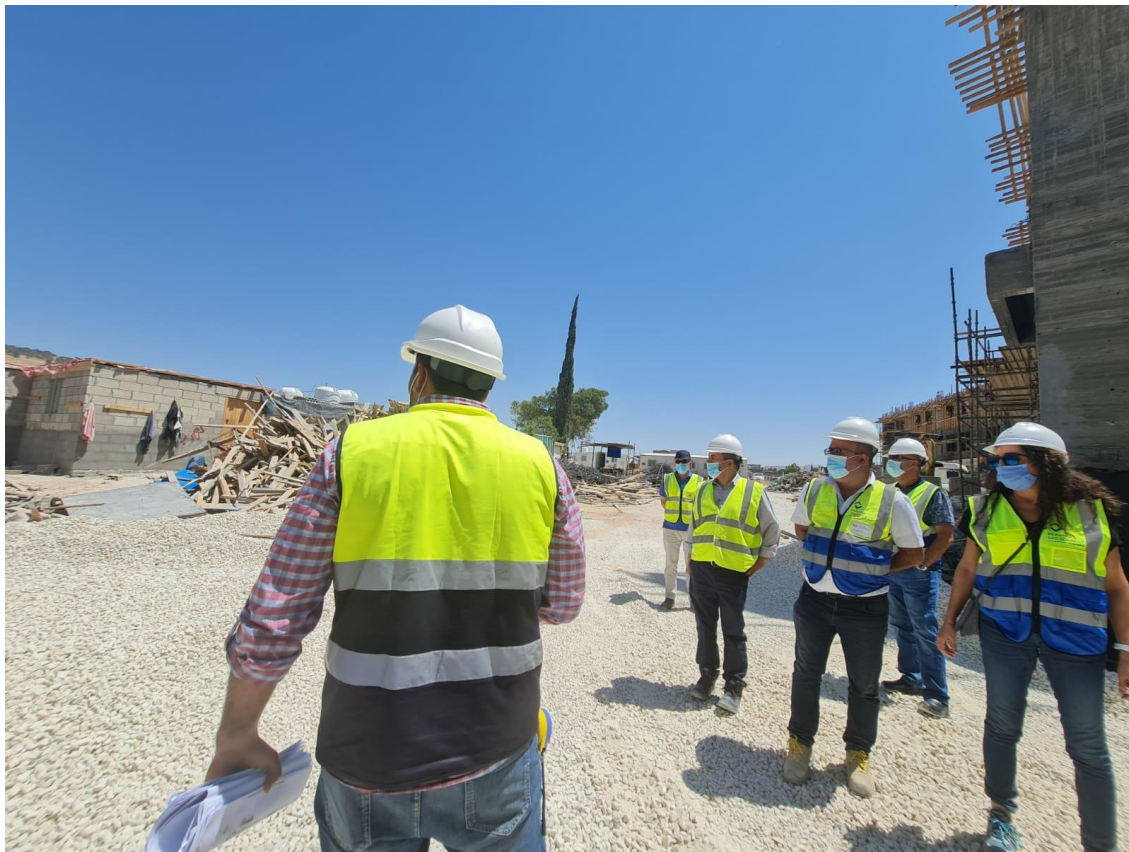
(Figure: 21)

A tour inside the site was Conducted

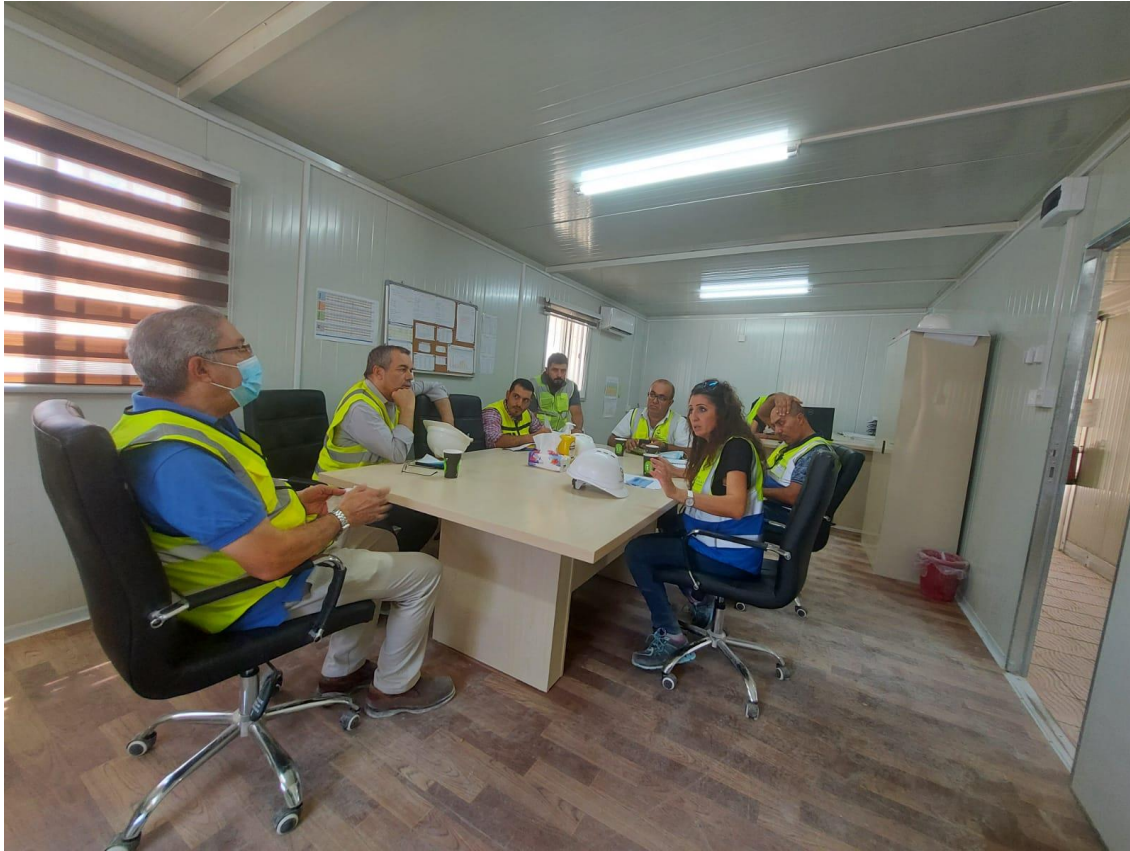
(Figure: 22)

After the site visit a meeting was held in the site offices in the presence of Engineer's representatives and Contractor's representatives to discuss work progress, quality and safety issues
