SKEP III Home Office Support Site Visit Report

Consultant	Wahib Medanat Consultant Engineer	Rep No.	22-27102021
Contractor	Dijlah Establishment Constr. Contracting	Tender No.	(11/2019/USAID/SKEP/3/S) Schools for a Knowledge Economy Project (SKEP) - Phase (3) Package (1, 2)
Site Name	Thahr Al Sarow Basic School for Boys- Jerash	Day/ Date	Wed. 27/10/2021
Duration of Project	450 Calendar Days	Total Project Budget	8,314,983.735 JD

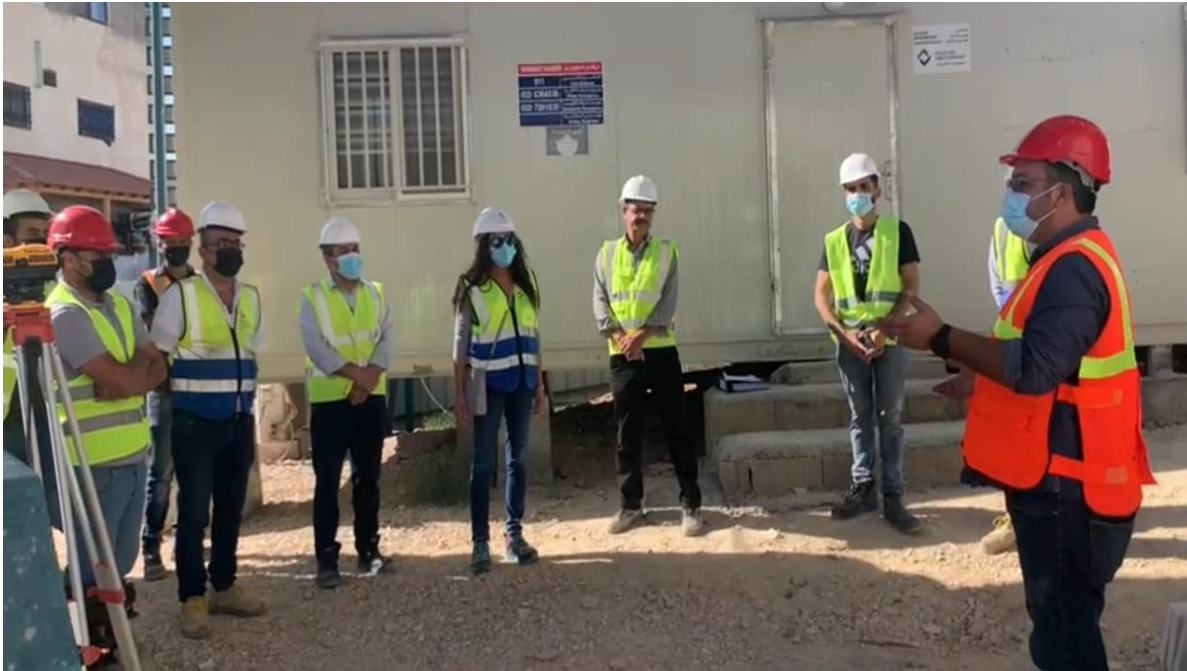
(Figure: 03)

The supervision safety officer conducted a session of toolbox to both site staff and visiting team focusing on the importance of wearing PPE in the site

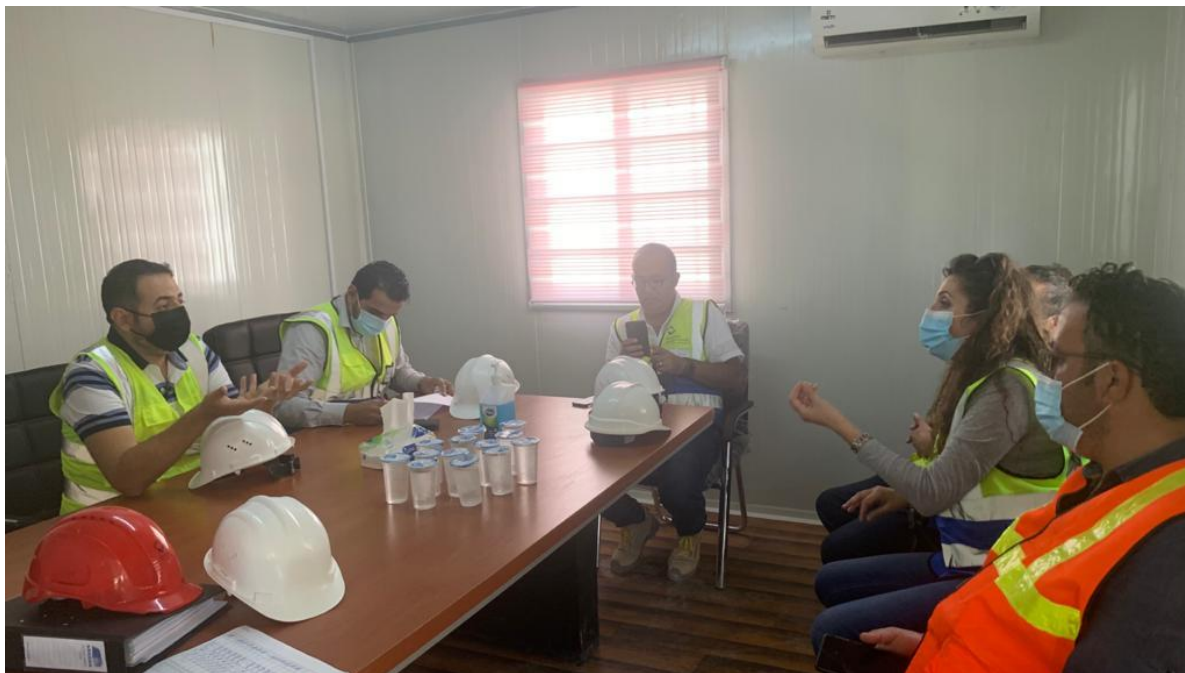
(Figure: 26)

After the site tour, a site meeting was held at the supervision staff offices
