SKEP III Home Office Support Site Visit Report

**WAHIB
MEDANAT**
consultant engineers

Consultant	Wahib Medanat Consultant Engineer	Rep No.	13-17102021
Contractor	Derar Saraireh & Sons for Engineering & Contracting	Tender No.	(11/2019/USAID/SKEP/3/S) Schools for a Knowledge Economy Project (SKEP) - Phase (3) Package (1, 2)
Site Name	Khadija Bint Khwailed Basic Mixed School- Shouna Janoubia	Day/ Date	Sun. 17/10/2021
Duration of Project	450 Calendar Days	Total Project Budget	9,789,417.840 JD

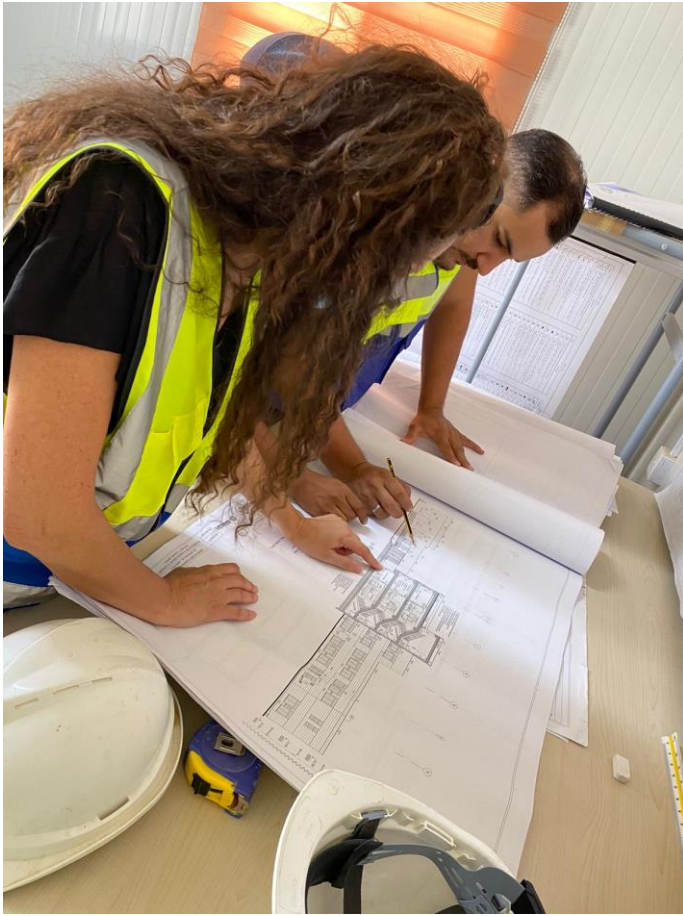
(Figure: 25)

At the end of the site visit, a meeting was held at the site offices to discuss the observations and the required actions with the Contractor
