### **Site Visit Report Form**

FTR # 259 QR

**School Name:** Thahr Al Sarow Basic School for Boys

Date and Time of Field Trip:January 6, 2021Date of Report:January 9, 2021Weather During Visit:Clear 19°Report Submitted By:Abedalaziz Abu

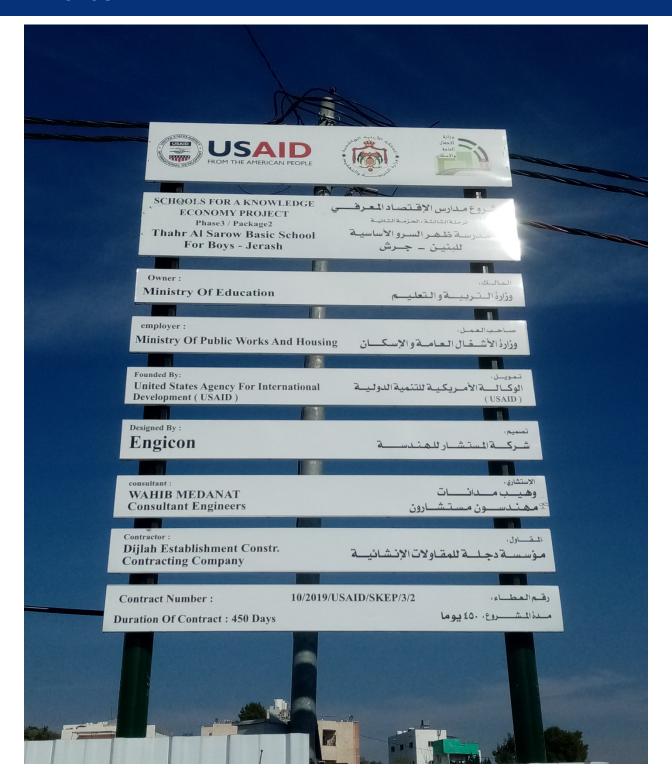
Electrical pole is located at the Construction site entrance and in the way of the Concrete pump trucks. It might cause a real danger if it was hit by the Concrete pump truck Boom

- 1. Some workers were observed not wearing full PPEs
- 2. Northern side of excavation and retaining wall execution needs to be closed before the forecasted rainy weather
- 3. Construction Contractor should be always aware of the Electricity Pole while pumping concrete
