SKEP III Home Office Support Site Visit Report

Consultant	Wahib Medanat Consultant Engineer	Rep No.	23-15012022
Contractor	Dijlah Establishment Constr. Contracting	Tender No.	(11/2019/USAID/SKEP/3/S) Schools for a Knowledge Economy Project (SKEP) - Phase (3) Package (1, 2)
Site Name	Jumana Bint Abit Taleb Basic Mixed School - Jerash	Day/ Date	Sat. 15/01/2022
Duration of Project	450 Calendar Days	Total Project Budget	8,314,983.735 JD

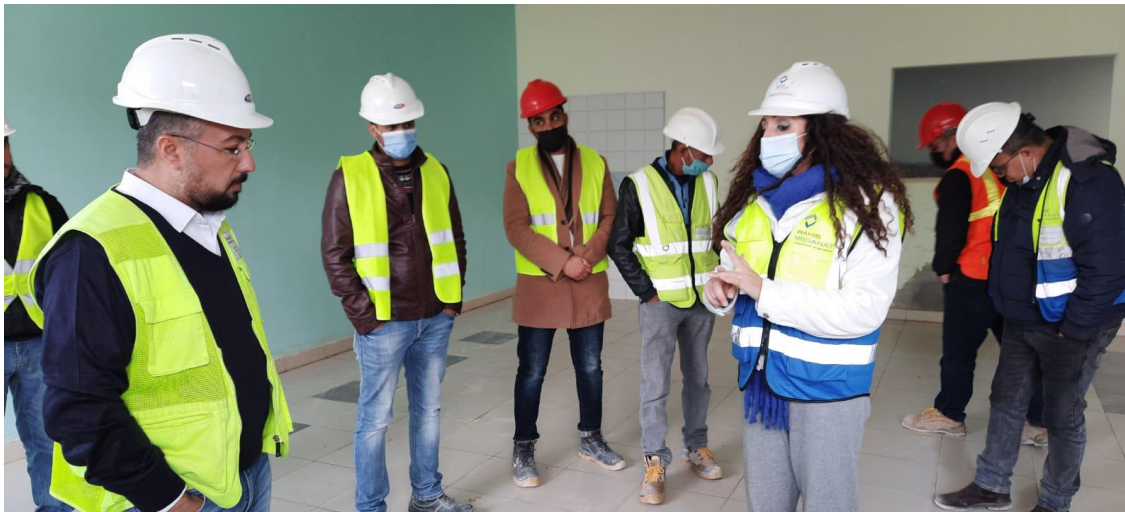
(Figure: 19)

Painting work was discussed with the Contractor

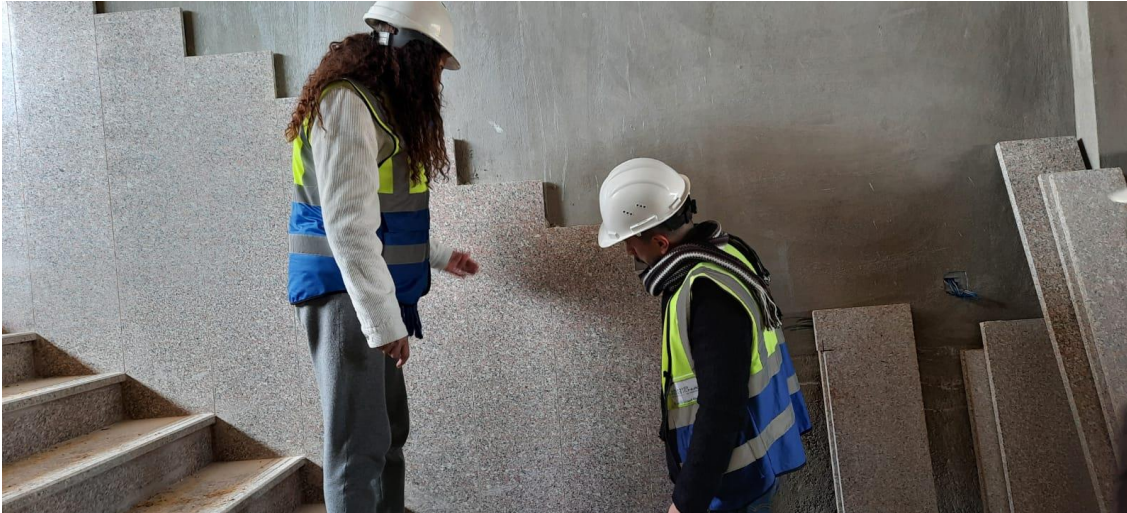
(Figure: 20)

The team observed that the Contractor has not removed the defected granite pieces for the staircases (wall granite and skirting). One of the major defects is that the cutting off is not done properly
