SKEP III Home Office Support Site Visit Report

Consultant	Wahib Medanat Consultant Engineer	Rep No.	22-23052022
Contractor	Dijlah Establishment Constr. Contracting	Tender No.	(11/2019/USAID/SKEP/3/S) Schools for a Knowledge Economy Project (SKEP) - Phase (3) Package (1, 2)
Site Name	Thahr Al Sarow Basic School for Boys- Jerash	Day/ Date	Mon. 23/05/2022
Duration of Project	450 Calendar Days	Total Project Budget	8,314,983.735 JD

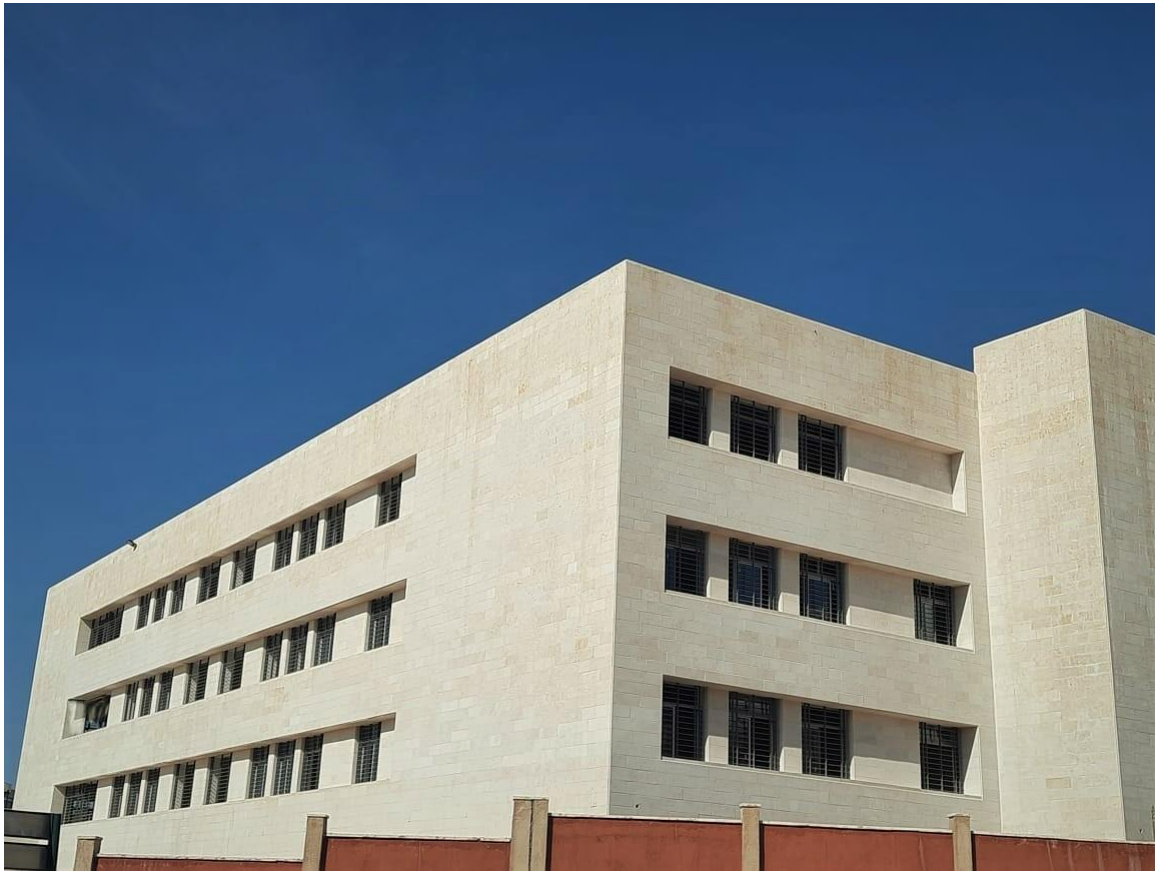
(Figure: 01)

General view of the project site

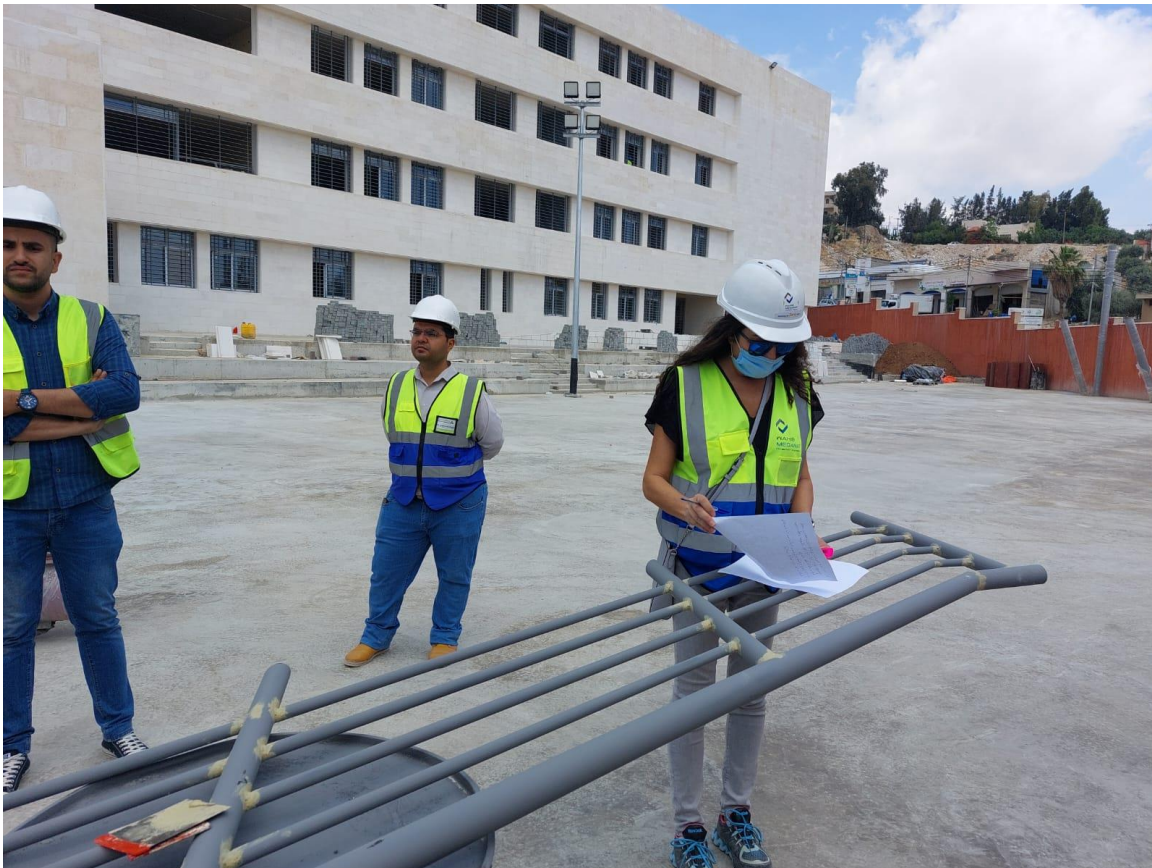
(Figure: 06)

The team observed defects in the handrails of the stairs and the executed paint for those handrails. The Contractor was requested to repair before installing
