Consultant	Wahib Medanat Consultant Engineer	Rep No.	13-11042022
Contractor	Derar Saraireh & Sons for Engineering & Contracting	Tender No.	(11/2019/USAID/SKEP/3/S) Schools for a Knowledge Economy Project (SKEP) - Phase (3) Package (1, 2)
Site Name	Khadija Bint Khwailed Basic Mixed School- Shouna Janoubia	Day/ Date	Mon. 11/04/2022
Duration of Project	450 Calendar Days	Total Project Budget	9,789,417.840 JD

### Visit Notes

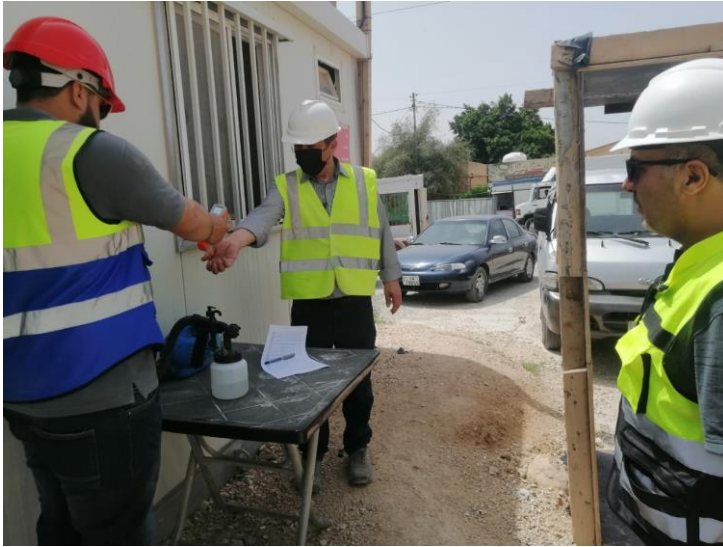
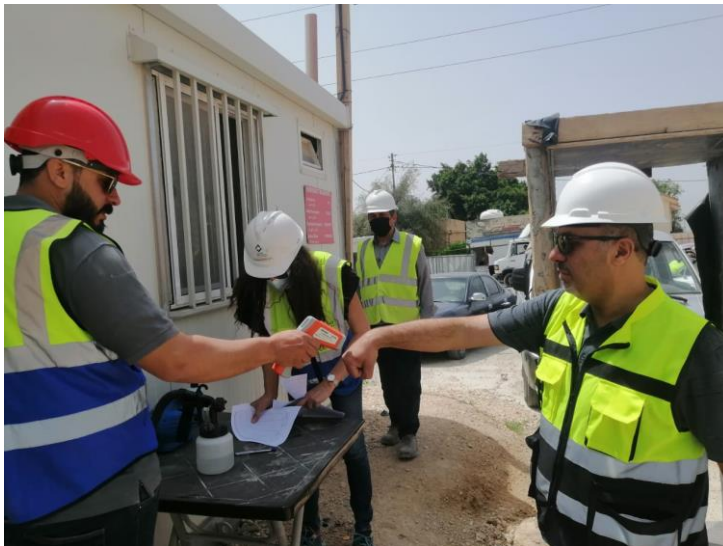
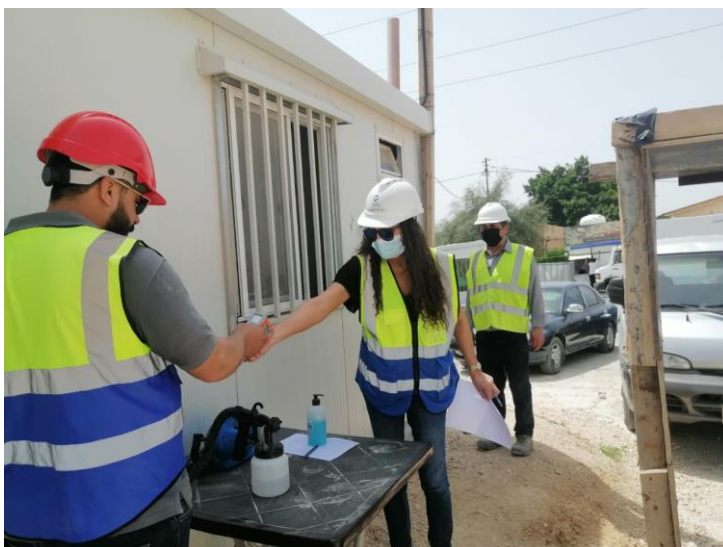
Temperature check, sterilization and signing visitors' attendance sheet at the entrance of the site, complying with Covid-19 Protocol

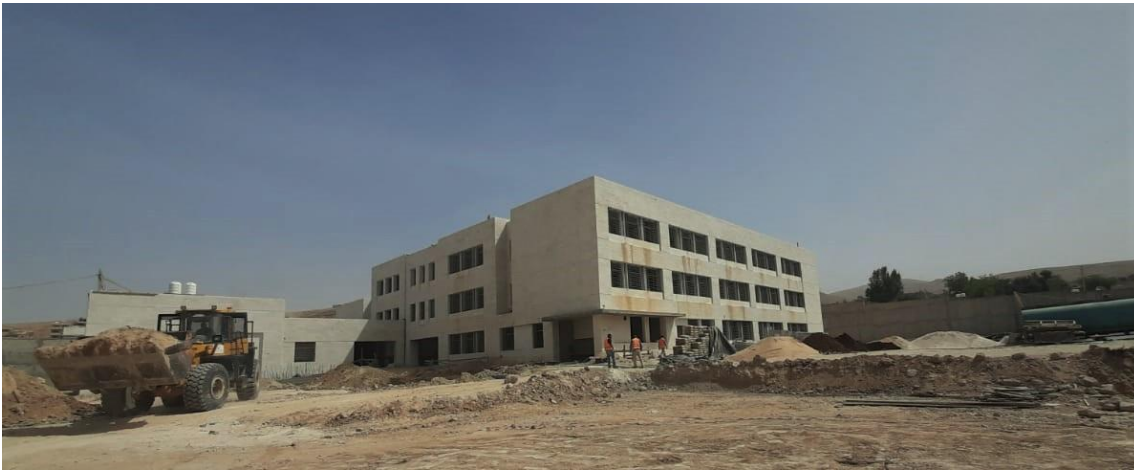
*(Figure: 01)*

General view  
of the project  
*(Figure: 01, 02, 03,  
04, 05 & 06)*
