Consultant	Wahib Medanat Consultant Engineer	Rep No.	13-16022022
Contractor	Derar Saraireh & Sons for Engineering & Contracting	Tender No.	(11/2019/USAID/SKEP/3/S) Schools for a Knowledge Economy Project (SKEP) - Phase (3) Package (1, 2)
Site Name	Khadija Bint Khwailed Basic Mixed School- Shouna Janoubia	Day/ Date	Wed. 16/02/2022
Duration of Project	450 Calendar Days	Total Project Budget	9,789,417.840 JD

Visit Notes

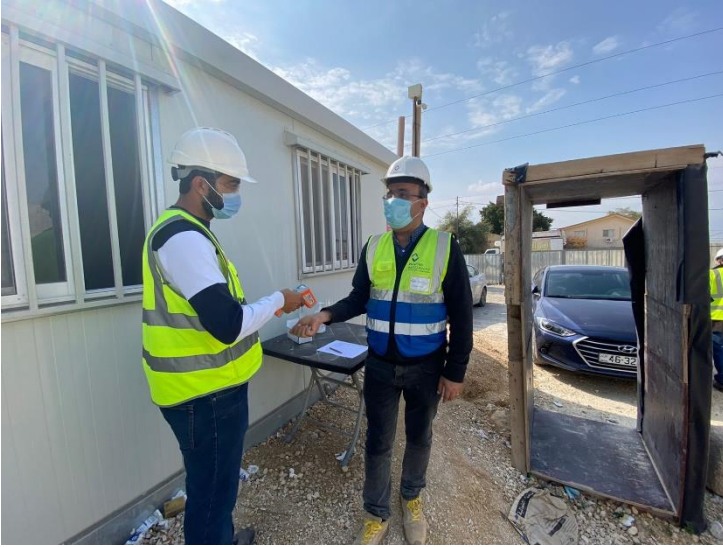
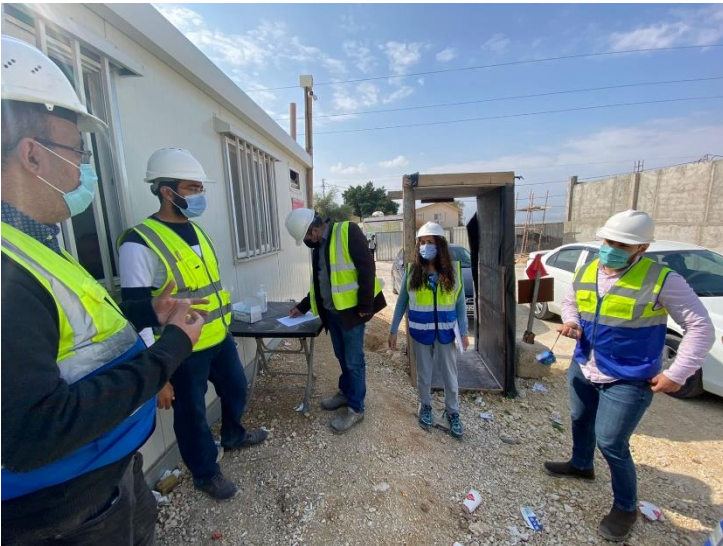
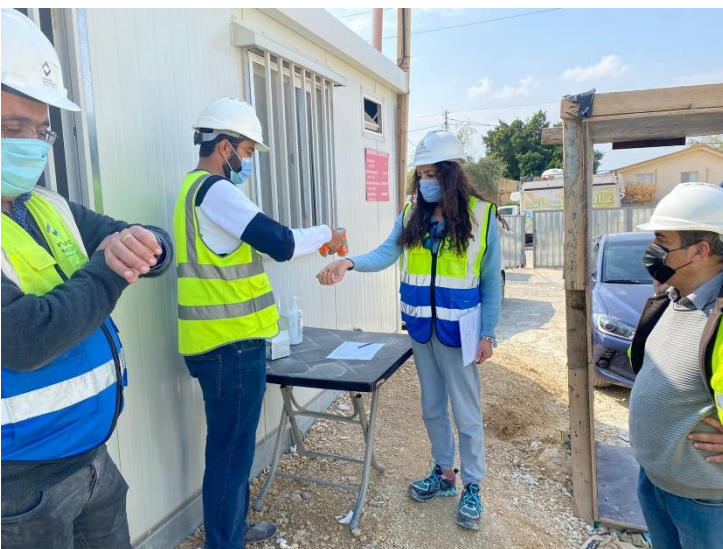
Temperature check, sterilization and signing visitors' attendance sheet at the entrance of the site, complying with Covid-19 Protocol

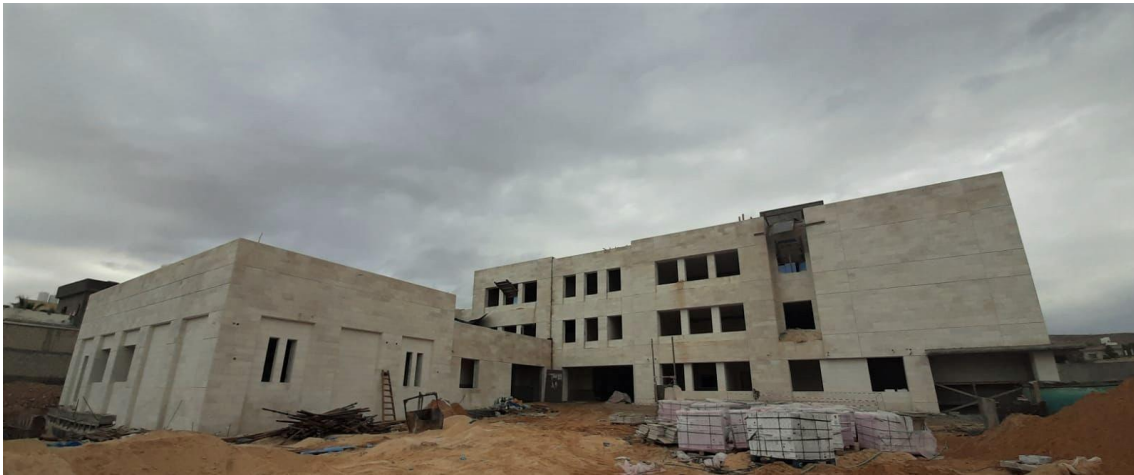
(Figure: 01)

General view
of the project
