School for Knowledge Economy Project (SKEP) Phase III – Package 1

Monthly Progress Report

No. 16

March, 2022

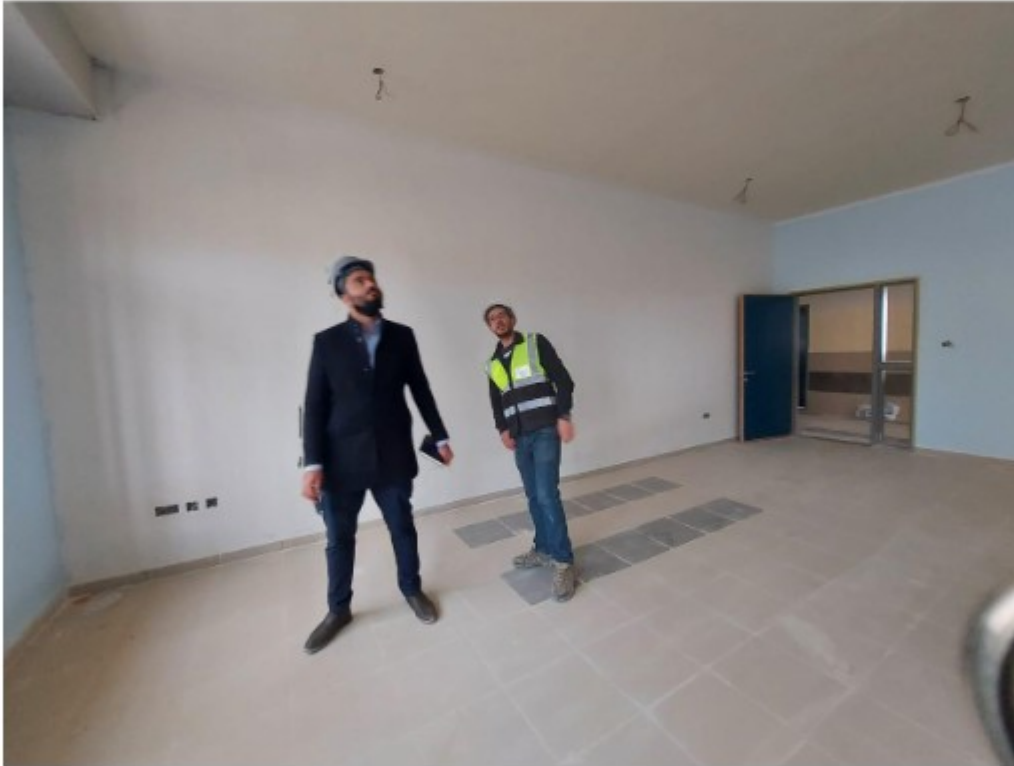
Inspecting insulation work

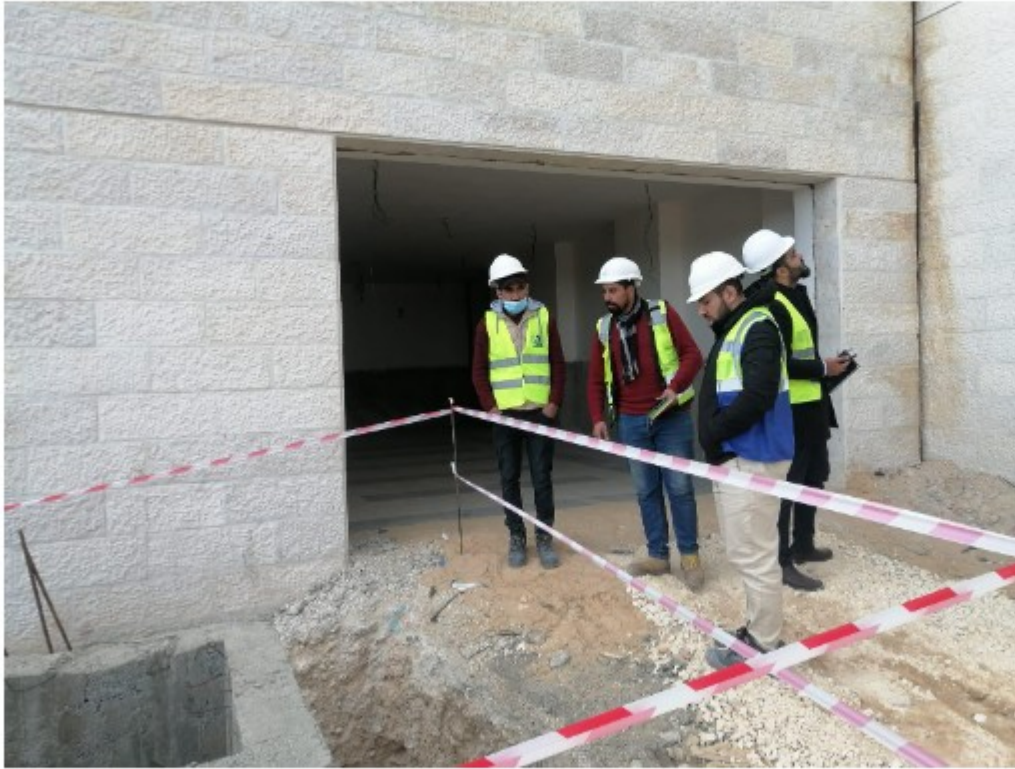
Eng. Odai instructing to put blocks or protection boards around the excavations to ensure the safety of labours

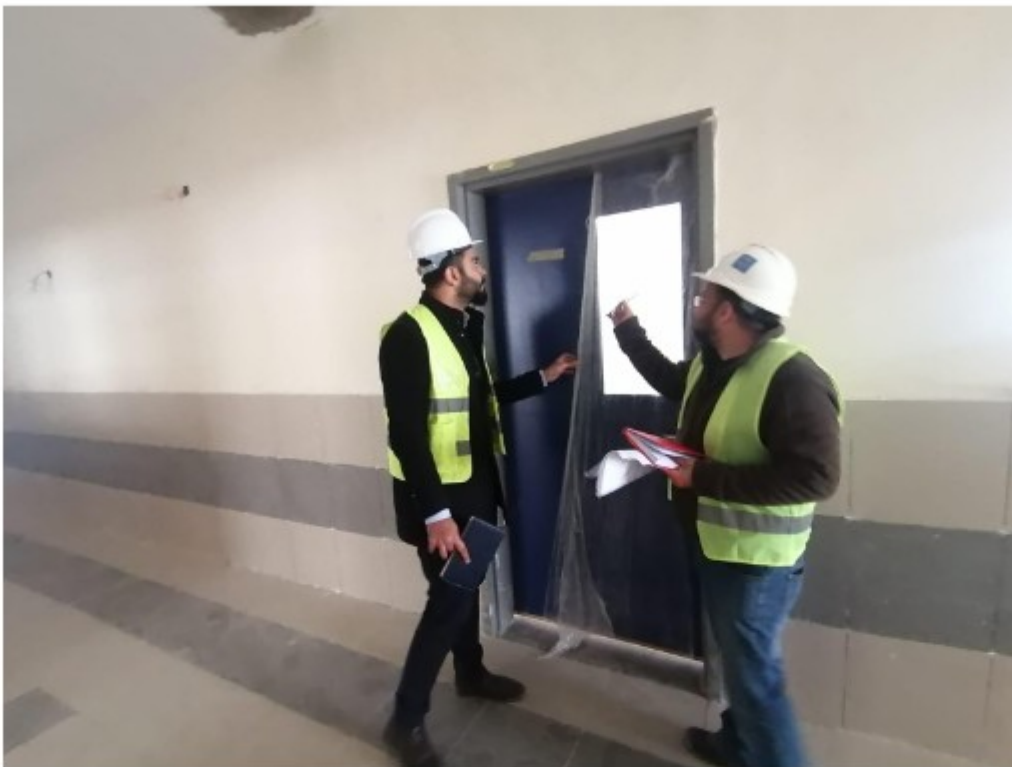
Inspecting wooden doors installation and recommending keeping them protected with the plastic covers

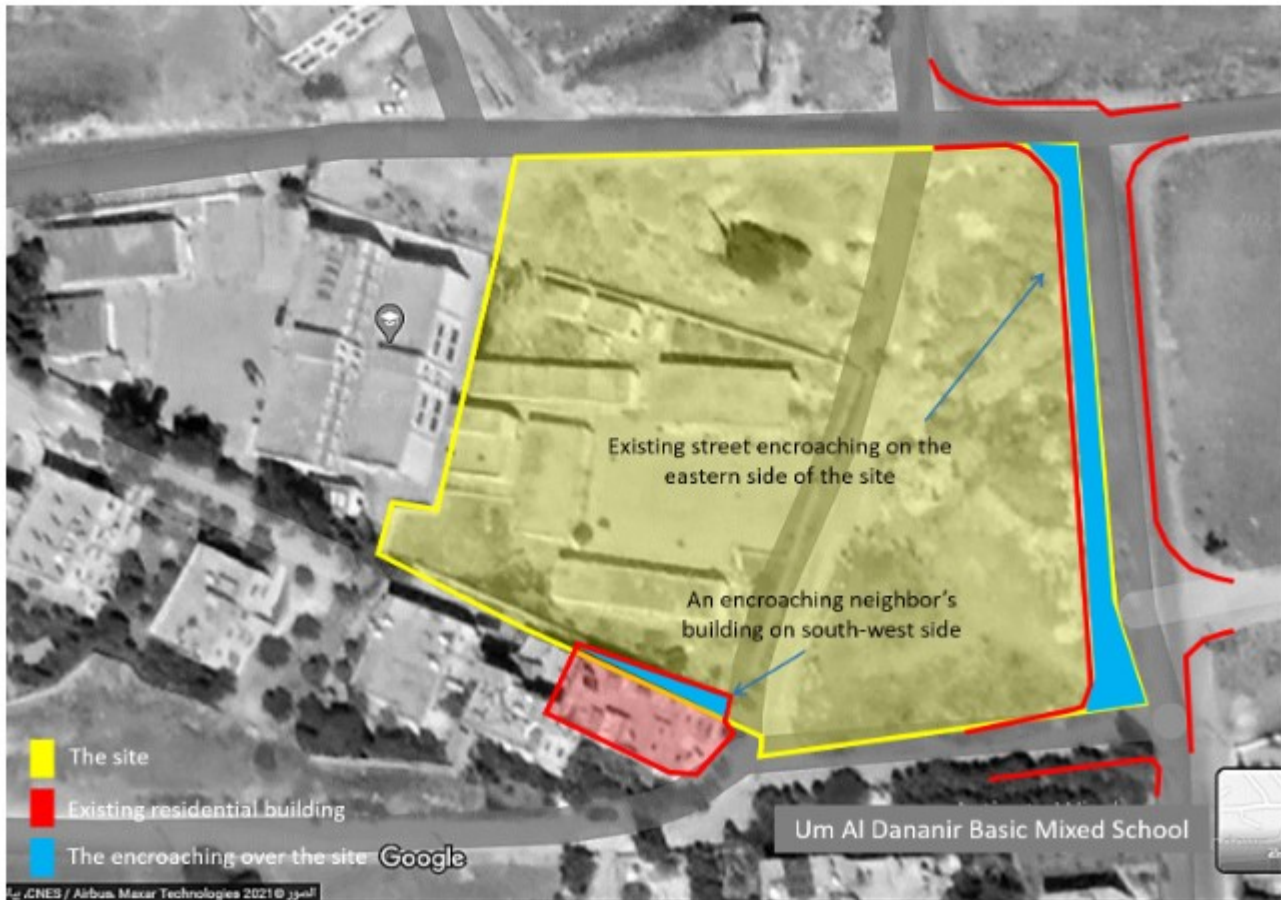
Figure 1. . Encroaching on the site boundary

SOLVED

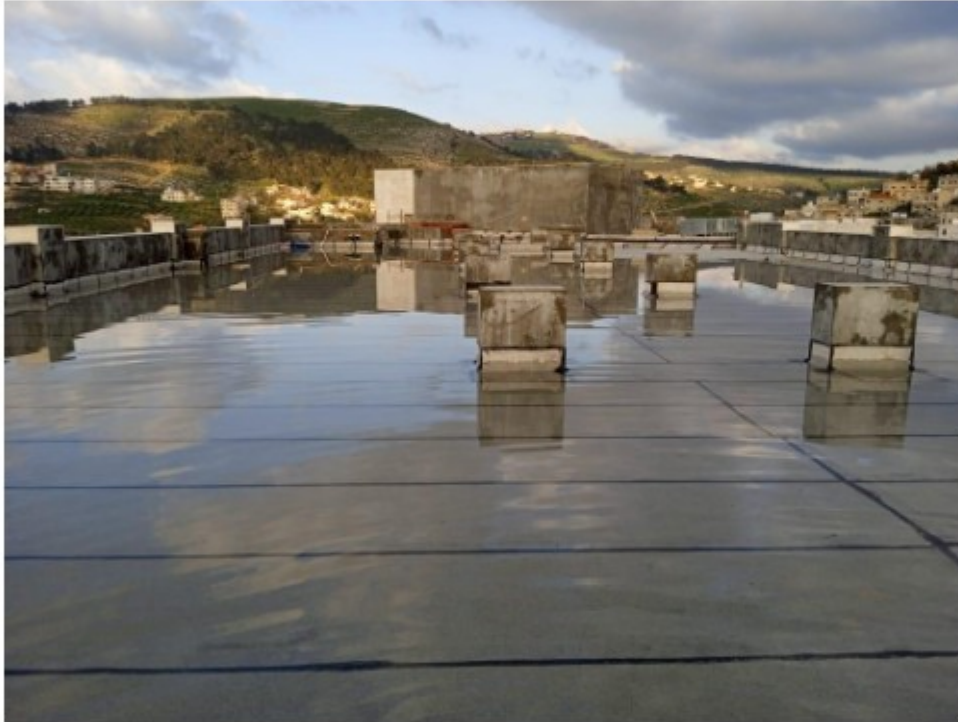
Water penetration test at the roof
