SKEP III Home Office Support Site Visit Report

Consultant	Wahib Medanat Consultant Engineer	Rep No.	22-22022022
Contractor	Dijlah Establishment Constr. Contracting	Tender No.	(11/2019/USAID/SKEP/3/S) Schools for a Knowledge Economy Project (SKEP) - Phase (3) Package (1, 2)
Site Name	Thahr Al Sarow Basic School for Boys- Jerash	Day/ Date	Tue. 22/02/2022
Duration of Project	450 Calendar Days	Total Project Budget	8,314,983.735 JD

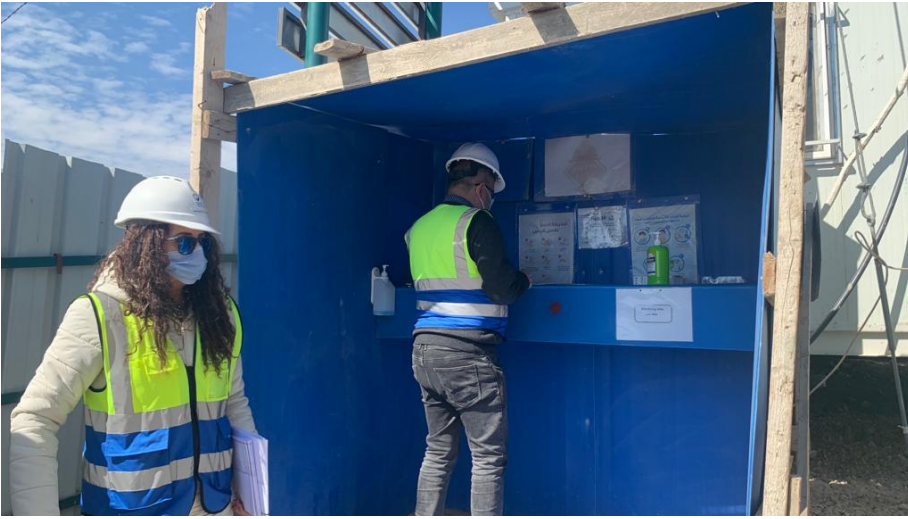
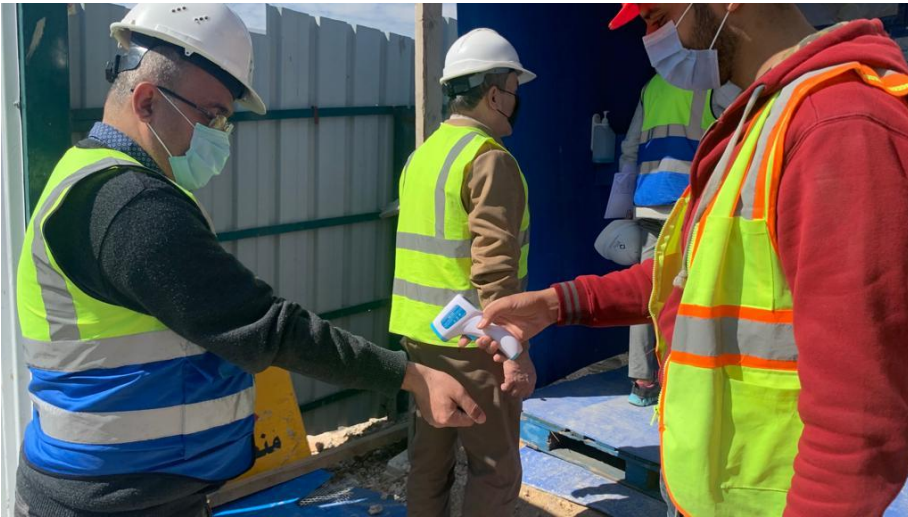
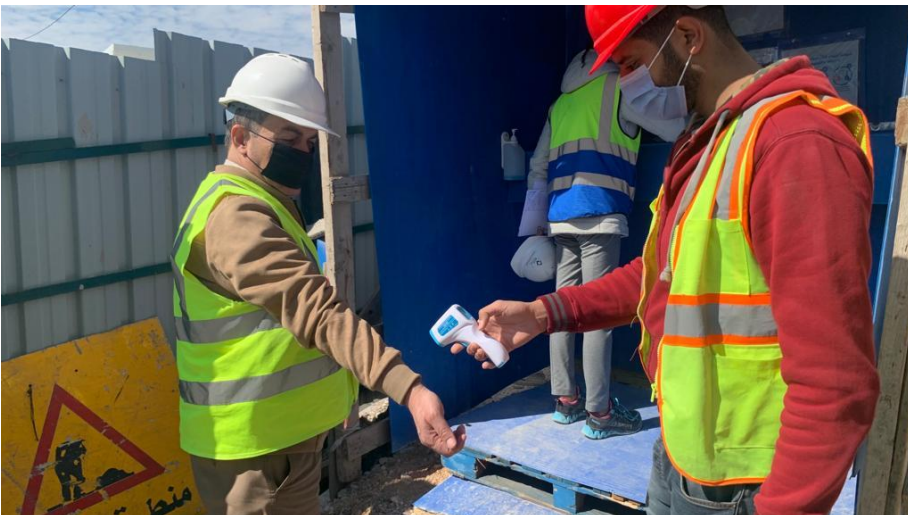
Temperature check, sterilization and signing visitors' attendance sheet at the entrance of the site, complying with Covid-19 Protocol

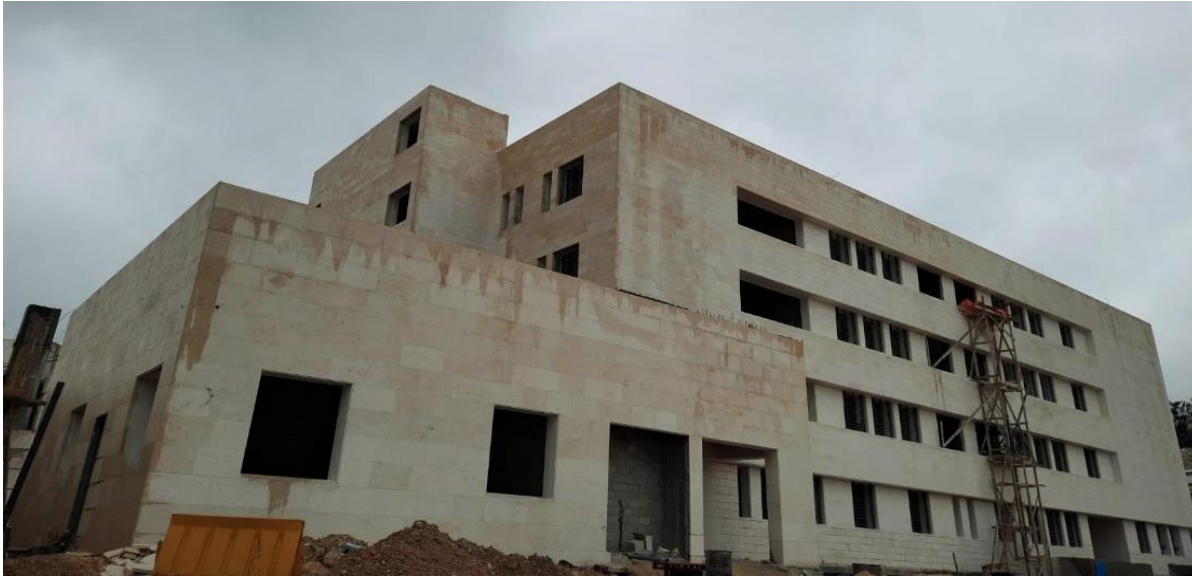
(Figure: 01)

General view
of the project
(Figure: 01, 02 & 03)

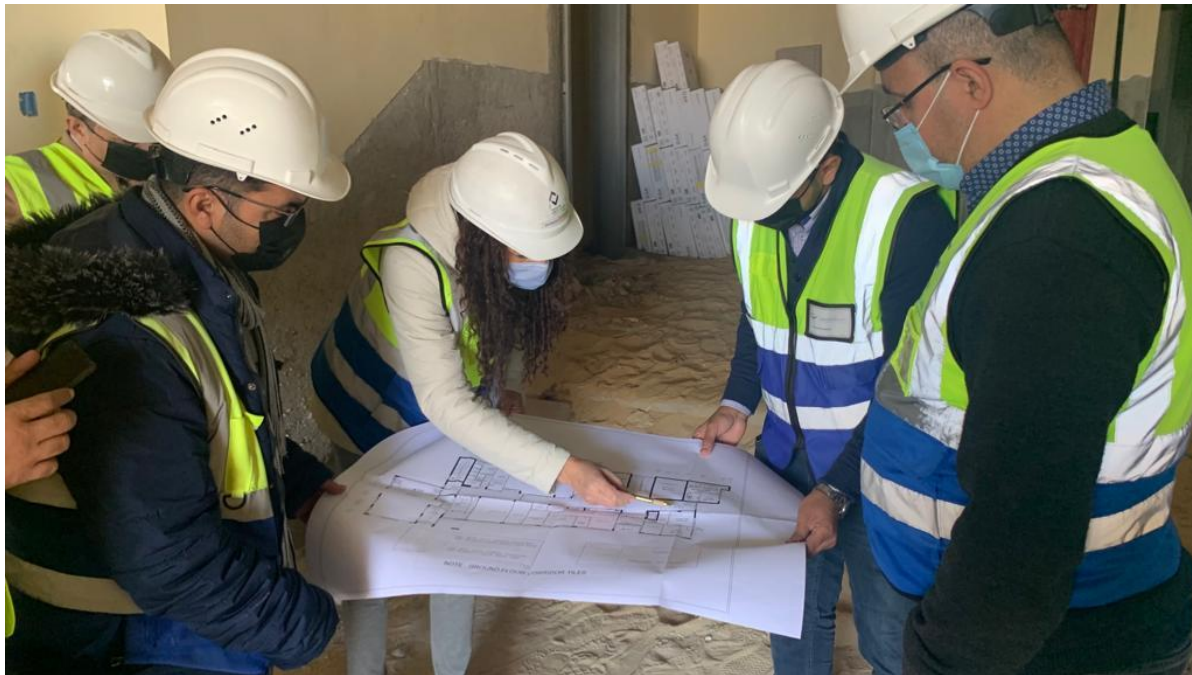
(Figure: 10)

The team inspected the executed stairs at the multi-purpose hall

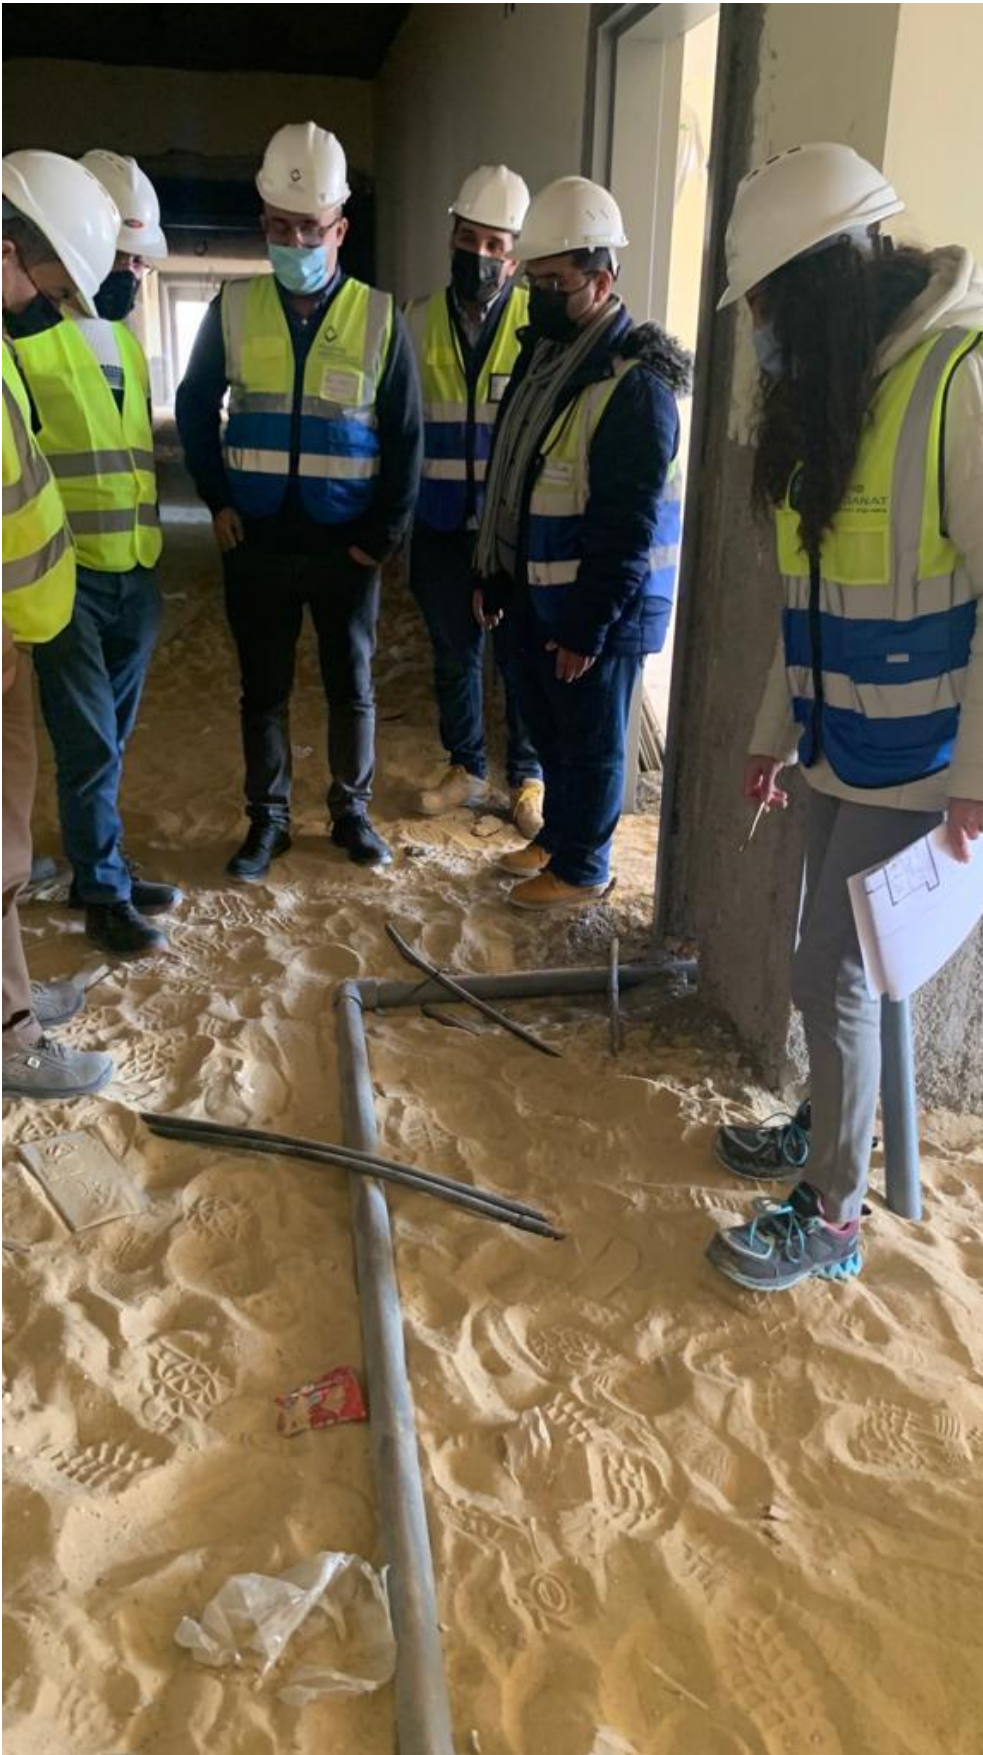
(Figure: 11)

The team discussed with the Contractor the correct implementation of the floor tiles workshop drawings in the ground floor, and reviewed several cases

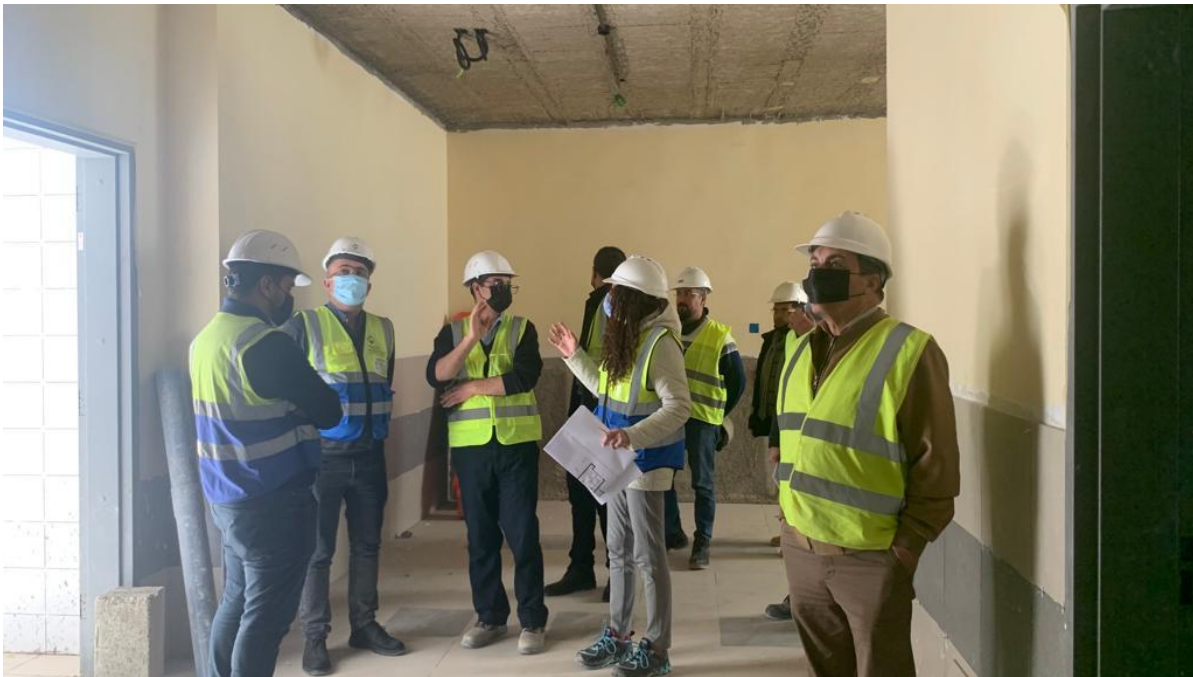
(Figure: 15)

The team observed defects in the steel protection screen

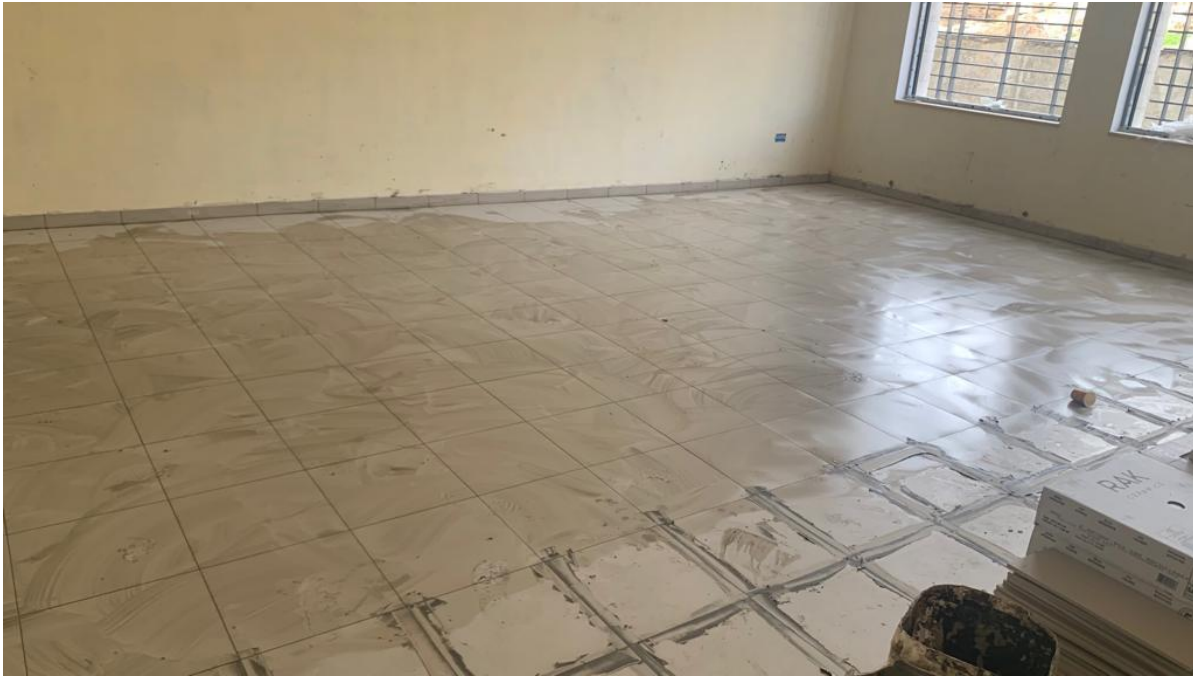
(Figure: 22)

The team inspected the installed porcelain floor tiles and observed teething at some areas and requested the Contractor to rectify

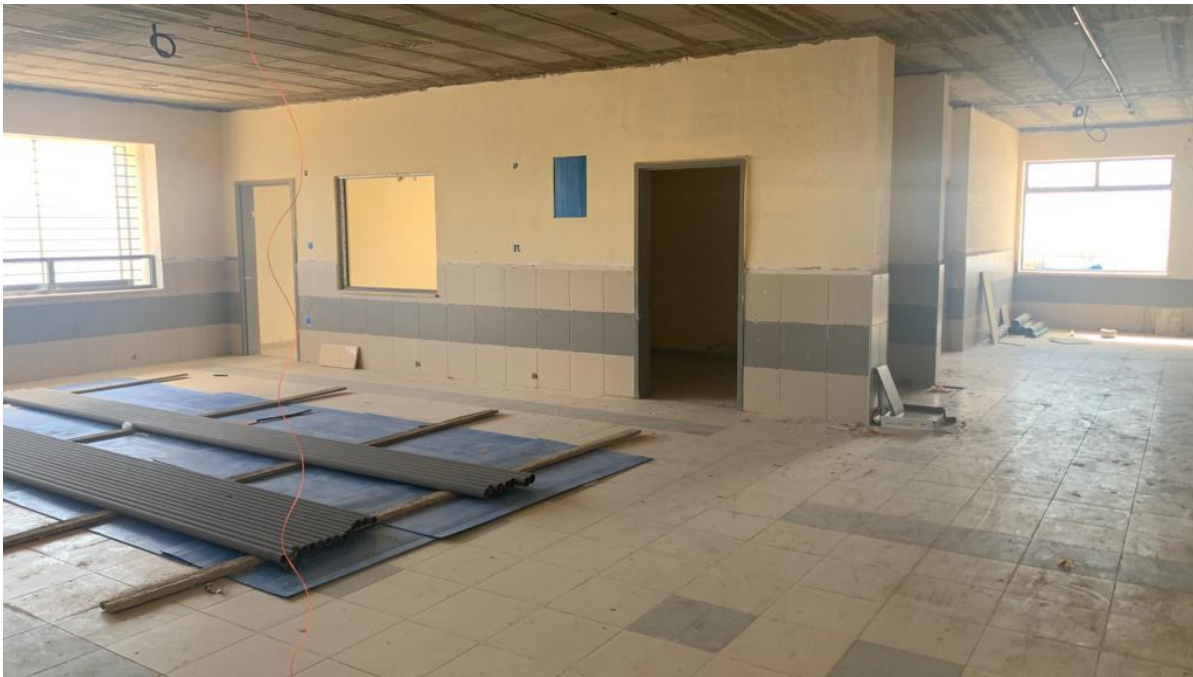
(Figure: 23)

The team inspected the progress made at applying grout and installing tiles

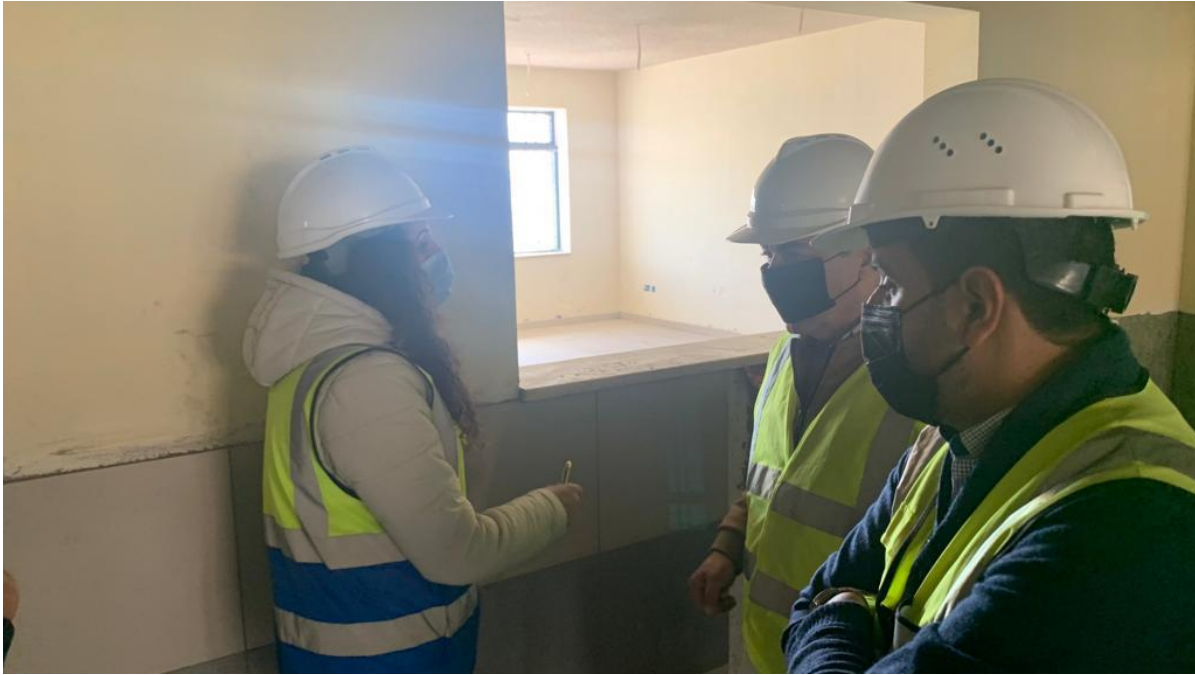
(Figure: 26)

The team observed that the Contractor has not rectified the granite cladding for staircases and the status has not changed regarding the cutting of the pieces

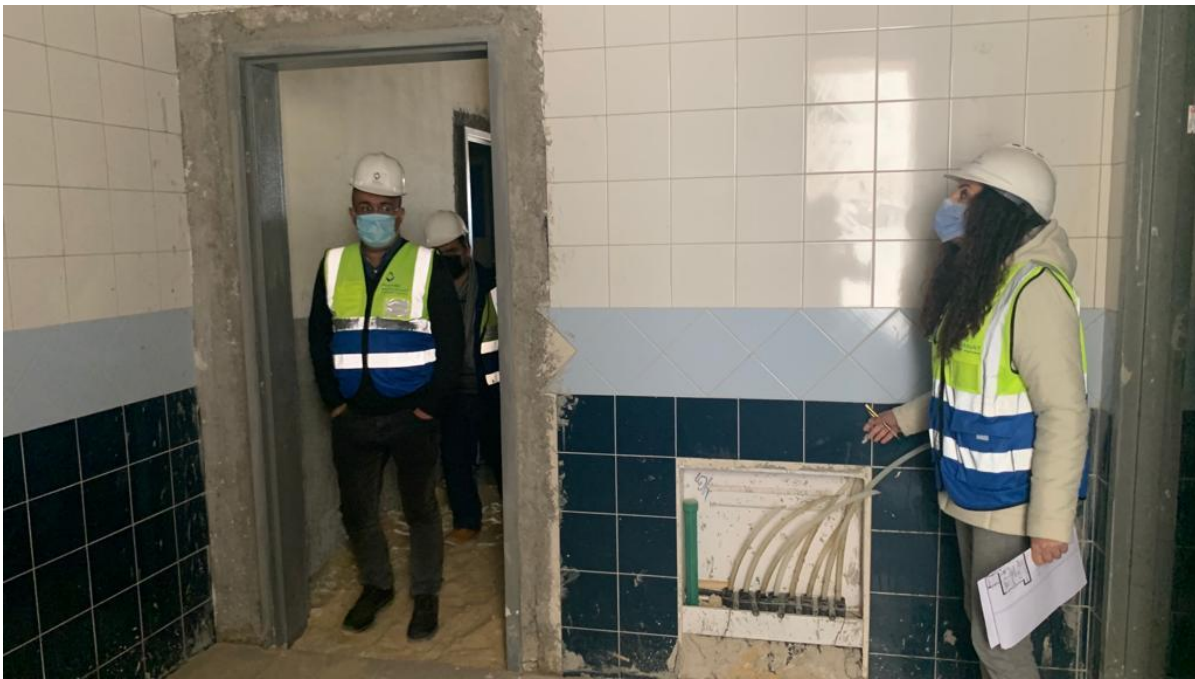
(Figure: 27)

The team inspected the tile cladding at corridors and the relation with the sills of internal windows and the height of lockers there
