# SKEP III Home Office Support Site Visit Report

Consultant	Wahib Medanat Consultant Engineer	Rep No.	22-06032022
Contractor	Dijlah Establishment Constr. Contracting	Tender No.	(11/2019/USAID/SKEP/3/S) Schools for a Knowledge Economy Project (SKEP) - Phase (3) Package (1, 2)
Site Name	Thahr Al Sarow Basic School for Boys- Jerash	Day/ Date	Sun. 06/03/2022
Duration of Project	450 Calendar Days	Total Project Budget	8,314,983.735 JD

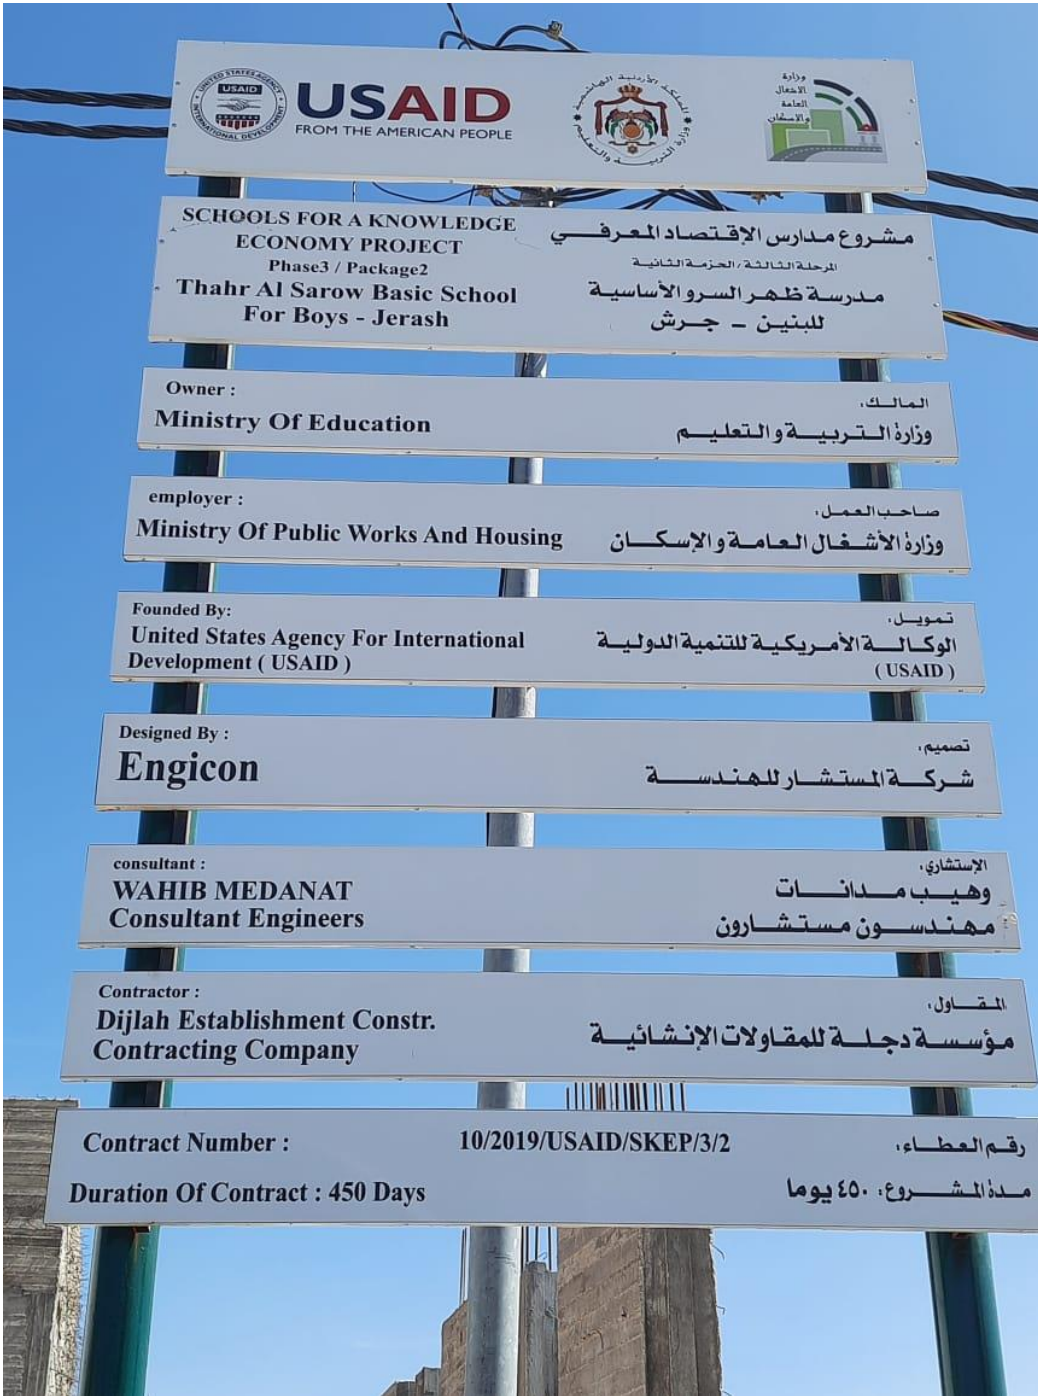
Project ID  
Sign on Site

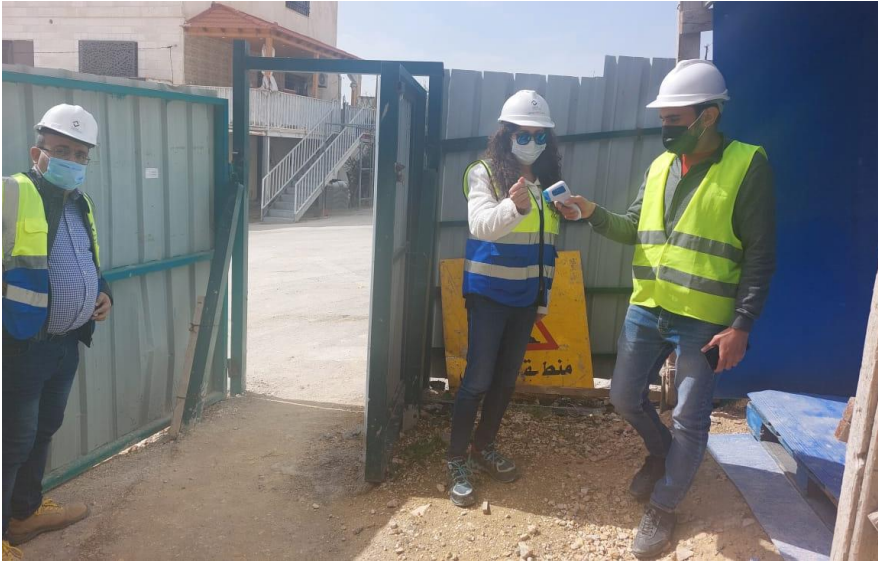
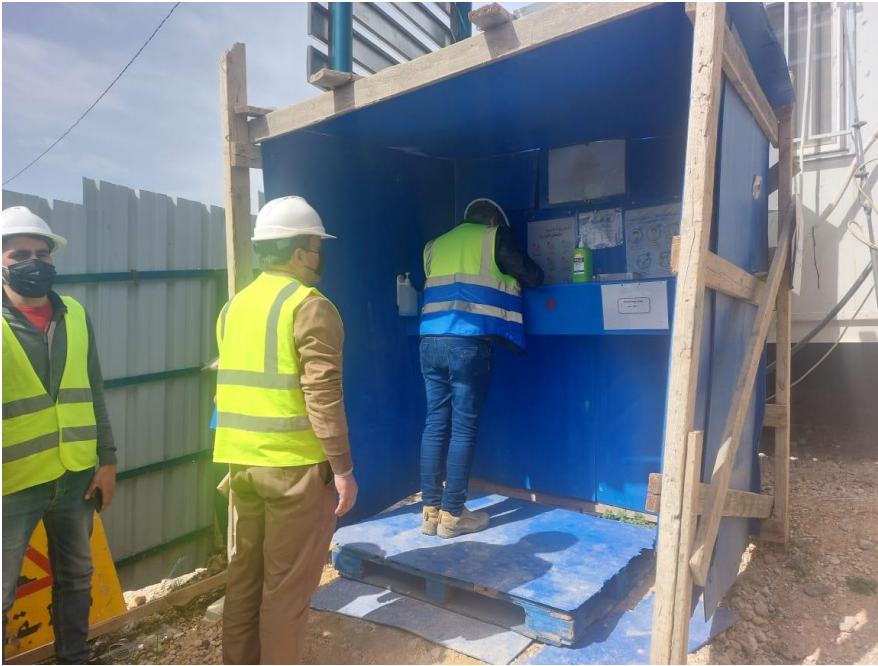
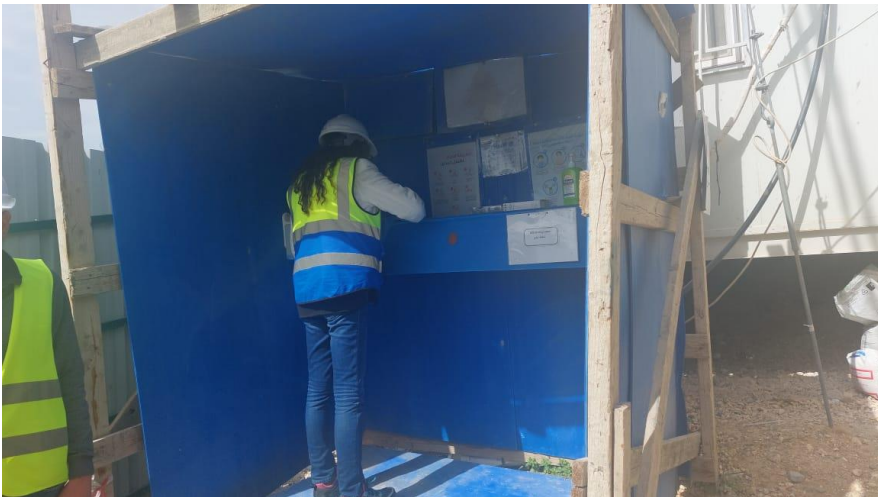
Temperature check, sterilization and signing visitors' attendance sheet at the entrance of the site, complying with Covid-19 Protocol
