SKEP III Home Office Support Site Visit Report

Consultant	Wahib Medanat Consultant Engineer	Rep No.	23-05062022
Contractor	Dijlah Establishment Constr. Contracting	Tender No.	(11/2019/USAID/SKEP/3/S) Schools for a Knowledge Economy Project (SKEP) - Phase (3) Package (1, 2)
Site Name	Jumana Bint Abit Taleb Basic Mixed School - Jerash	Day/ Date	Sun. 05/06/2022
Duration of Project	450 Calendar Days	Total Project Budget	8,314,983.735 JD

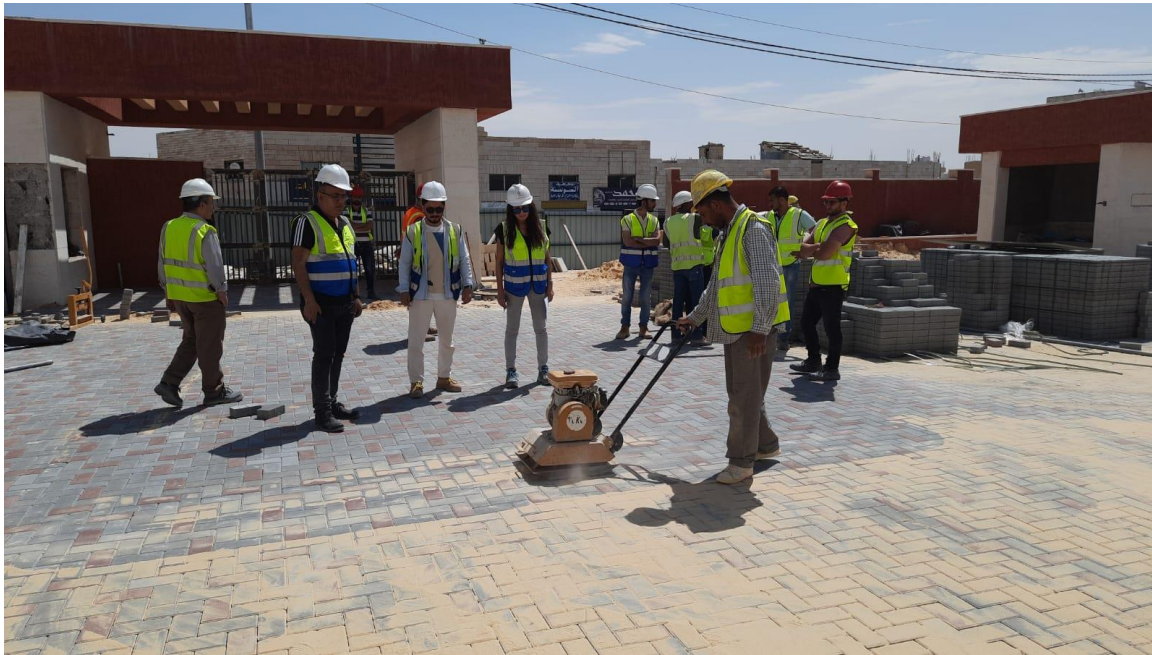
(Figure: 09)

The team observed the compaction process for interlocking tiles to adjust the levels as per requirements

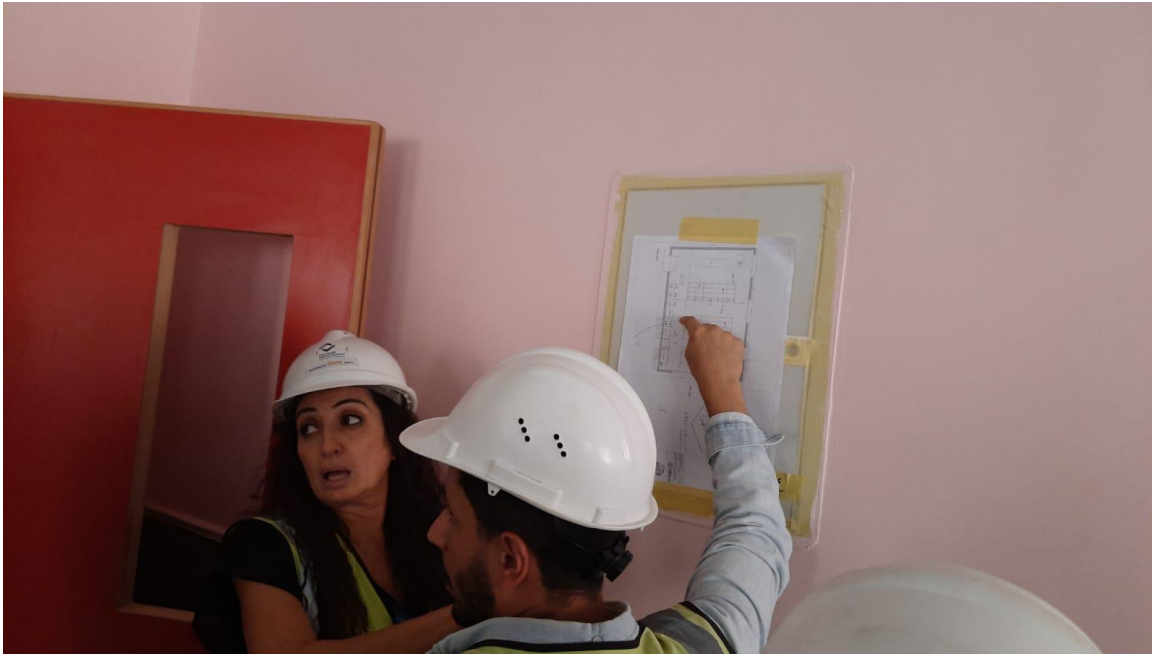
(Figure: 15)

The team observed the delivered laboratory furniture for the vocational laboratory, art room and labs by the manufacturer (Protech)
