# SKEP III Home Office Support Site Visit Report

Consultant	Wahib Medanat Consultant Engineer	Rep No.	13-25062022
Contractor	Derar Saraireh & Sons for Engineering & Contracting	Tender No.	(11/2019/USAID/SKEP/3/S) Schools for a Knowledge Economy Project (SKEP) - Phase (3) Package (1, 2)
Site Name	Khadija Bint Khwailed Basic Mixed School- Shouna Janoubia	Day/ Date	Sat. 25/06/2022
Duration of Project	450 Calendar Days	Total Project Budget	9,789,417.840 JD

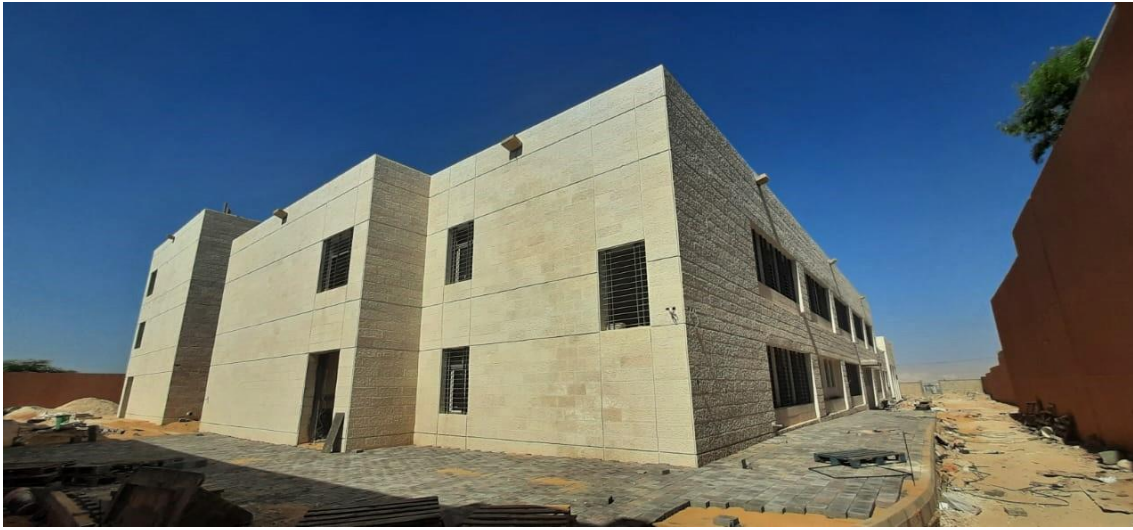
(Figure: 01)

General view  
of the project  
(Figure: 01, 02, 03,  
04, 05 & 06)
