Consultant	Wahib Medanat Consultant Engineer	Rep No.	23-23072022
Contractor	Dijlah Establishment Constr. Contracting	Tender No.	(11/2019/USAID/SKEP/3/S) Schools for a Knowledge Economy Project (SKEP) - Phase (3) Package (1, 2)
Site Name	Jumana Bint Abit Taleb Basic Mixed School - Jerash	Day/ Date	Sat. 23/07/2022
Duration of Project	450 Calendar Days	Total Project Budget	8,314,983.735 JD

Visit Notes

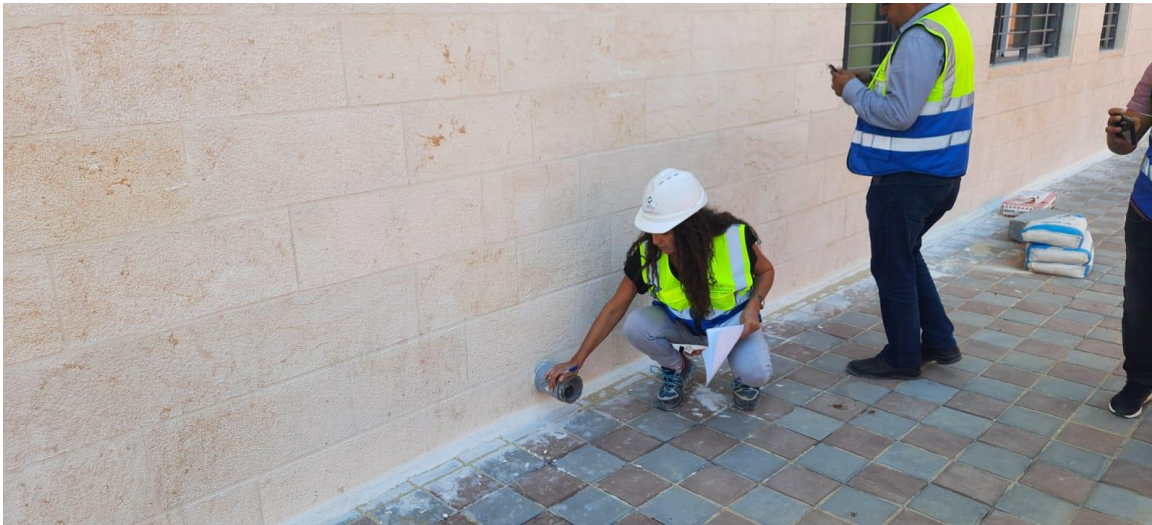
(Figure: 05)

Reduction of the protrusion in the rainwater drainage pipe and executing the slope for the water between the building facade and the sidewalk is required

No.	Description
17	The team requested the Contractor to reduce the protrusion in the rainwater drainage pipe and execute the required slope to direct the drained water to the sidewalk.
18	The team inspected the fire hose cabinets at the corridors, and observed that the protrusion of the cabinets from the wall is not fixed despite what was agreed upon in the previous visit. The Contractor was requested to rectify.
19	The team reminded the Contractor that all the hinged windows at the toilets shall open at 45 degree.
20	The team observed that the finishing work around the electrical sockets is done incorrectly. The Contractor was requested repair the said defects.
21	The team observed that parts of the installed laboratories' do not comply with the approved color scheme.

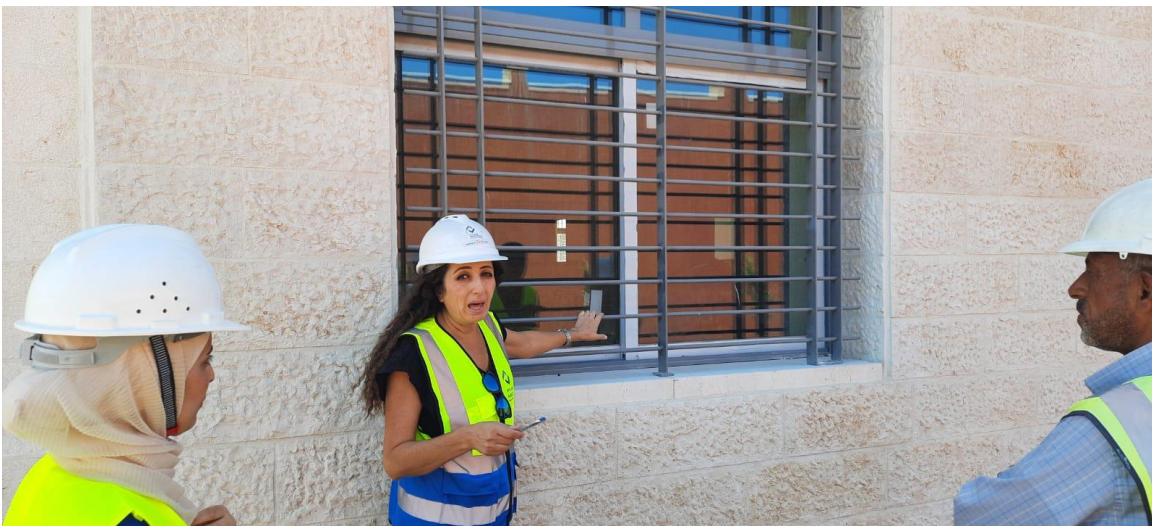
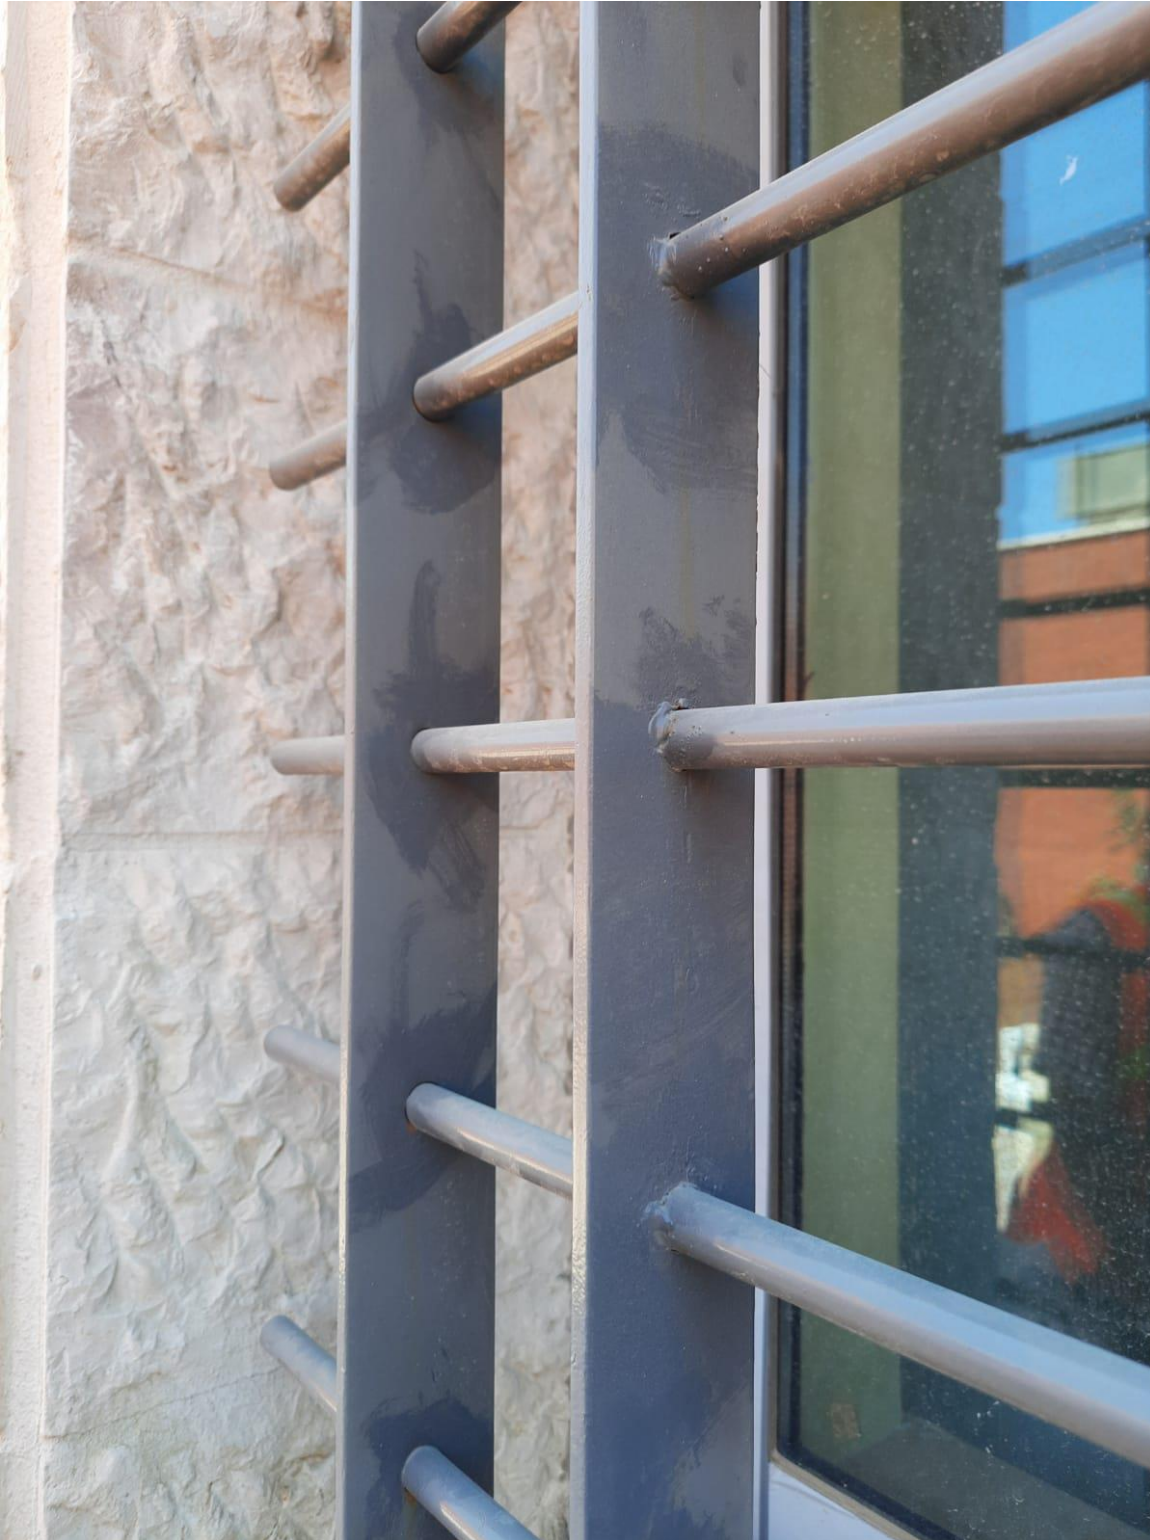
(Figure: 06 & 07)

The Contractor used different color of paint for the steel protections screens for a number of windows

The team requested the Contractor to rectify

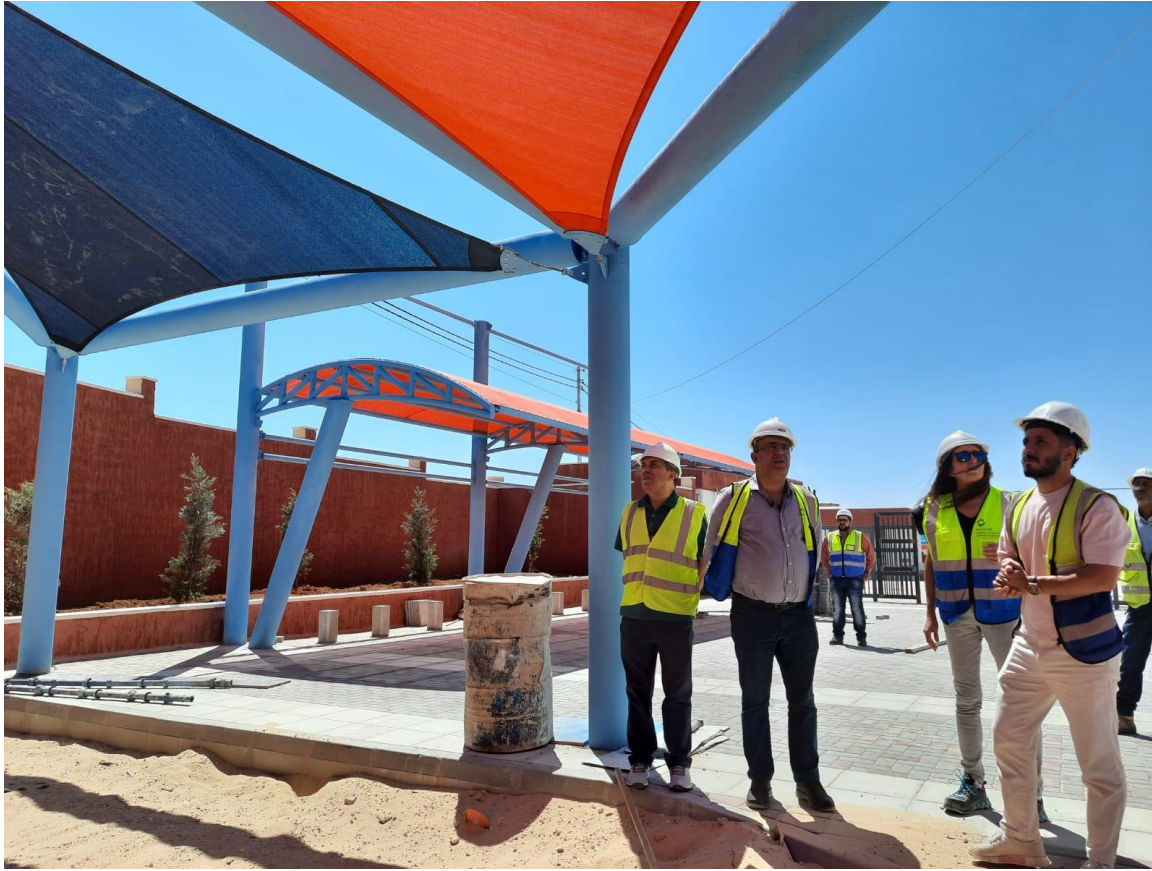
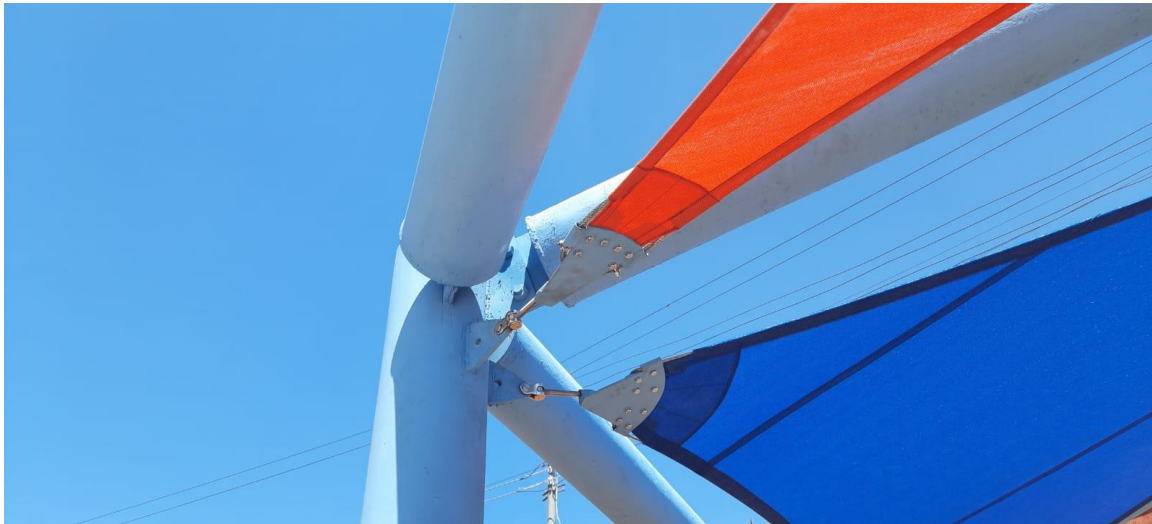
(Figure: 08 & 09)

The supervision team observed defects in the painting for the horizontal pipes of the shading. Also the fabric needs more tightening to reduce the movement. The edges of the shading foot at the sand pool needs to be rectified to avoid injuries of the users

No.	Description
1	The supervision team observed defects in the painting for the horizontal pipes of the shading. Also the fabric needs more tightening to reduce the movement. The edges of the shading foot at the sand pool needs to be rectified to avoid injuries of the users.
2	The team observed that the Contractor used different color of paint for the steel protections screens for a number of windows. The team requested the Contractor to rectify.
3	The team observed that the Contractor has completed the agricultural works in the site.
4	The team requested the Contractor to remove corrosion, clean and paint the manholes covers as per specifications.
5	The team inspected the prepared sample by the Contractor for the stone benches at the yard and requested the Contractor that the supports of the benches have to be fair face finish not colored plastering. Also, to use one stone piece of 6cm thickness instead of two pieces of 3cm thickness each.

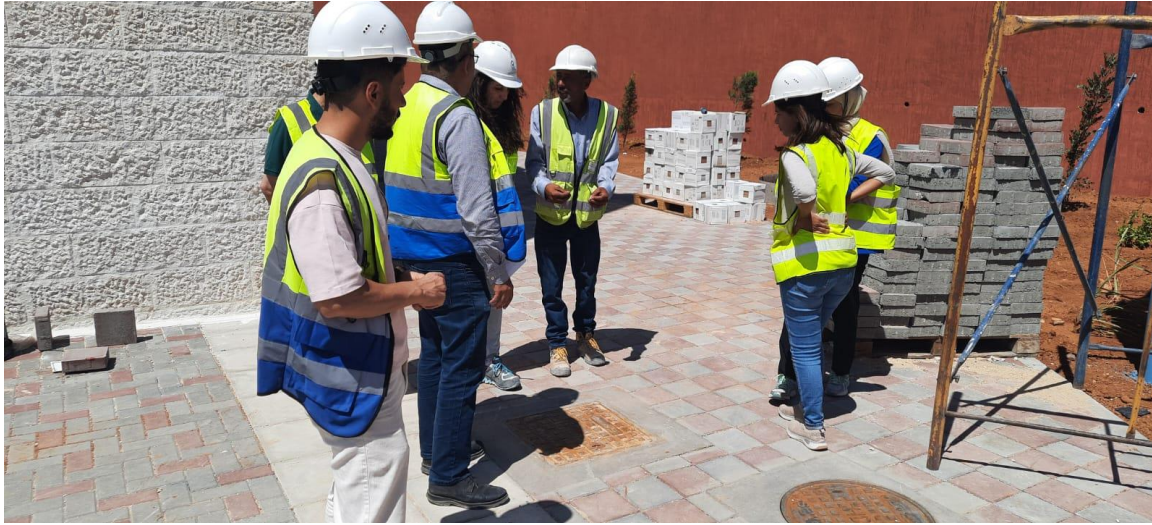
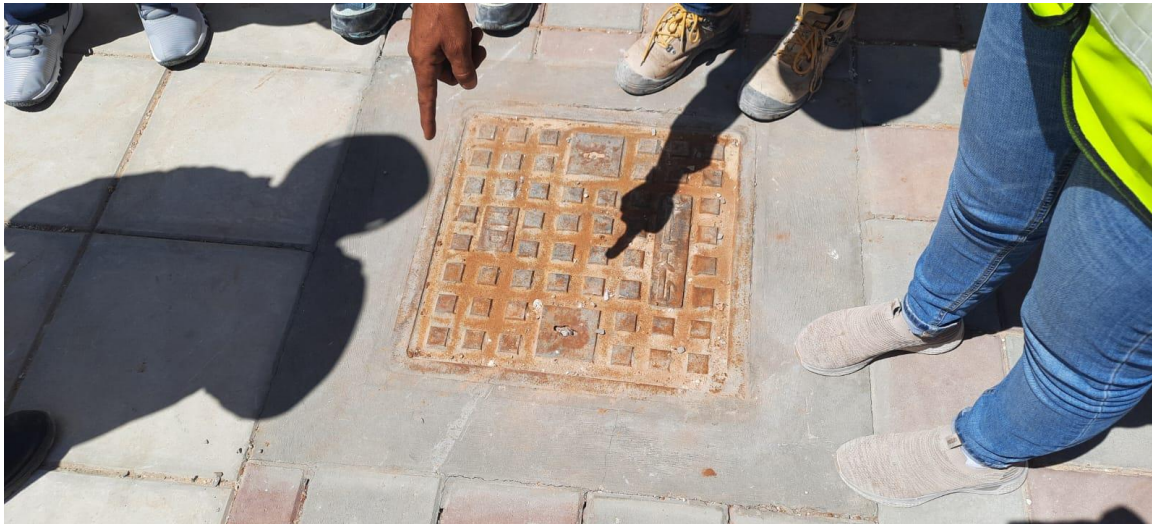
(Figure: 12 & 13)

The team requested the Contractor to remove corrosion, clean and paint the manholes covers as per specifications

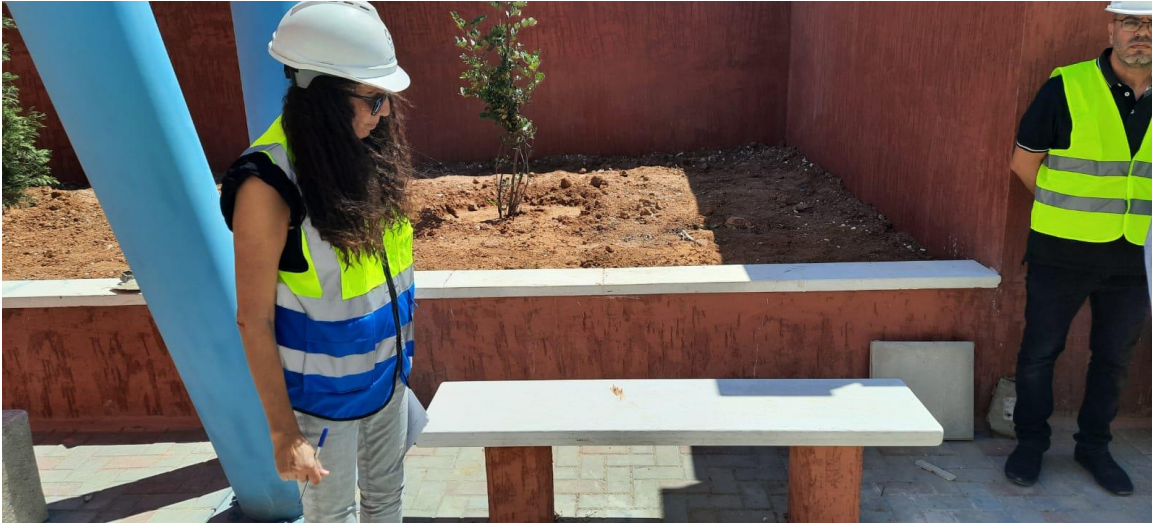
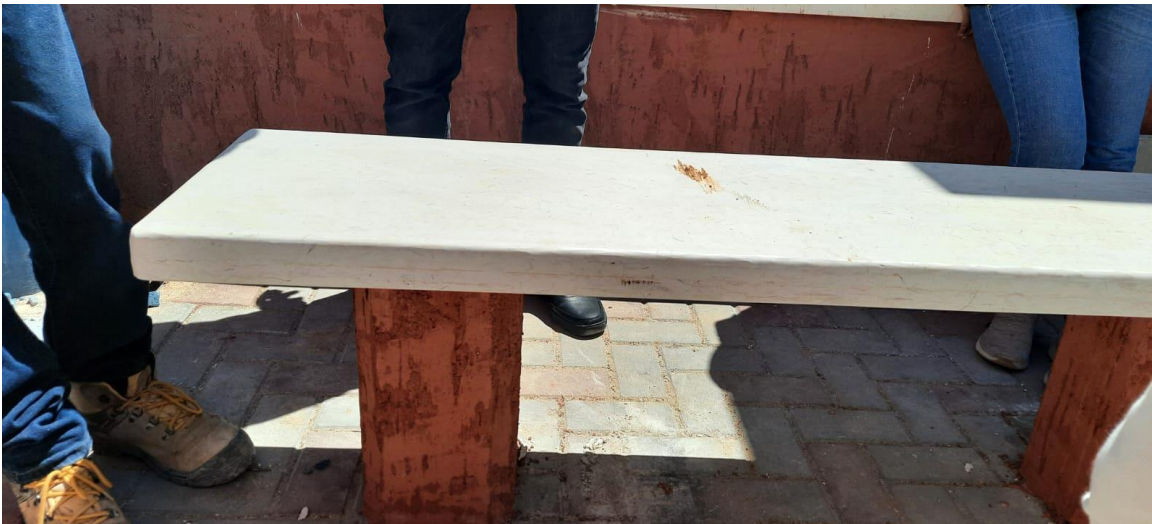
(Figure: 14 & 15)

The team inspected the sample prepared by the Contractor for the stone benches at the yard and requested the Contractor that the benches supports have to be fair face finish not colored plastering. Also, to use one stone piece of 6cm thickness instead of two pieces of 3cm thickness each

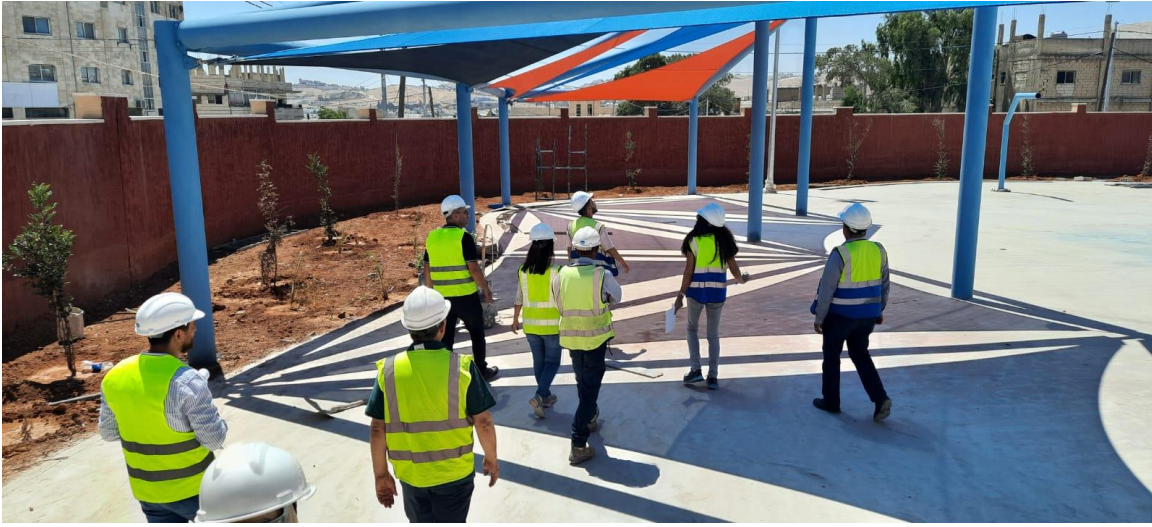
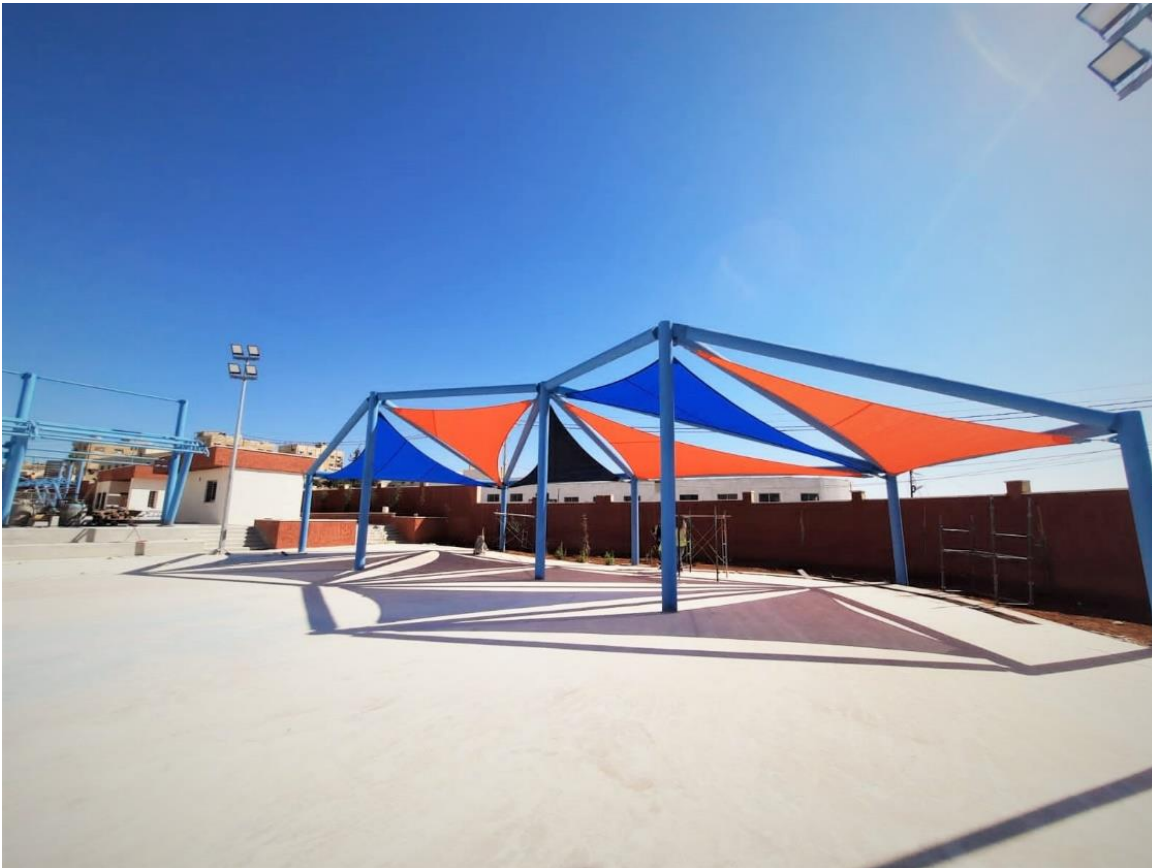
(Figure: 16 & 17)

The team observed that the fabric at the shading of the yard is not covering the whole area for protection from the sun. The Contractor was requested to rectify

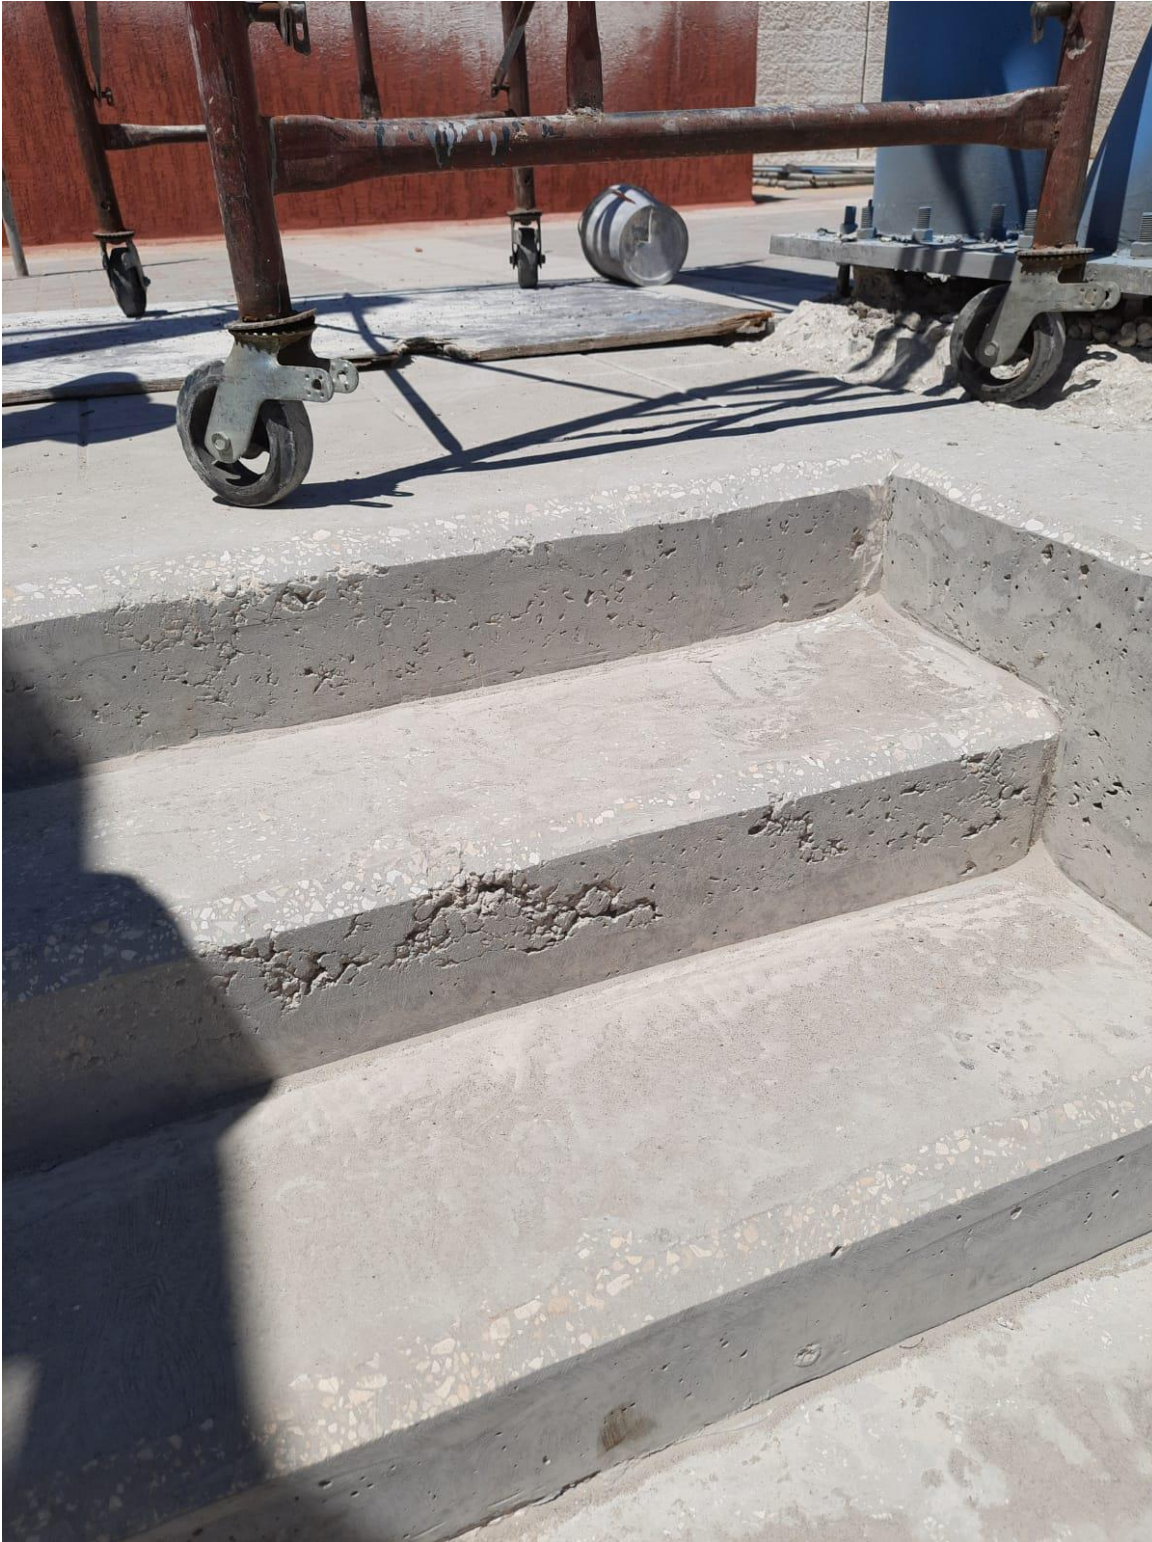
(Figure: 18)

The team observed voids in the casted concrete for the amphitheater

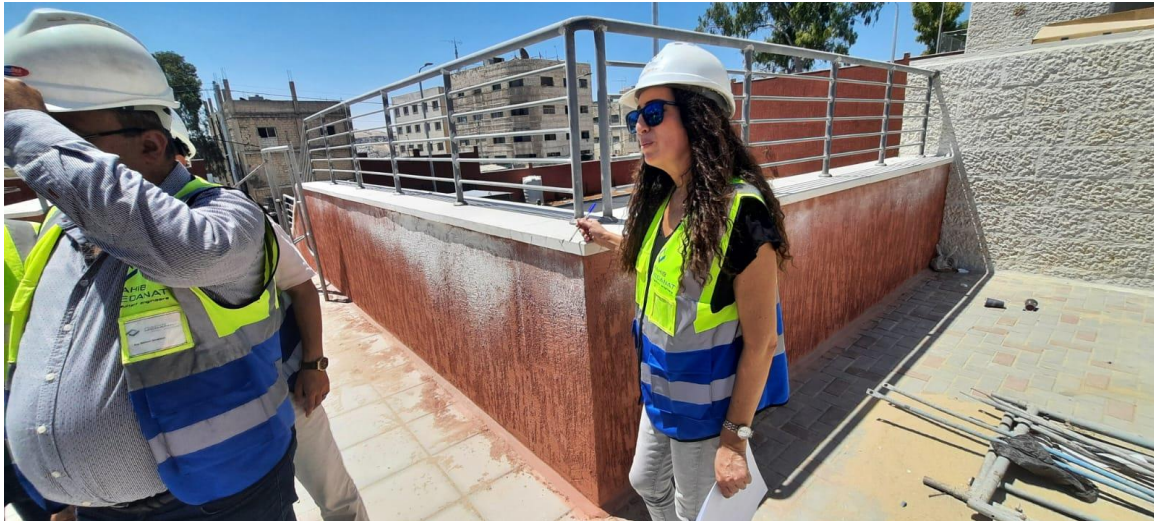
(Figure: 20)

The team requested the Contractor to clean the white dirt resulted from works in the stone coping or defects in the plastering material

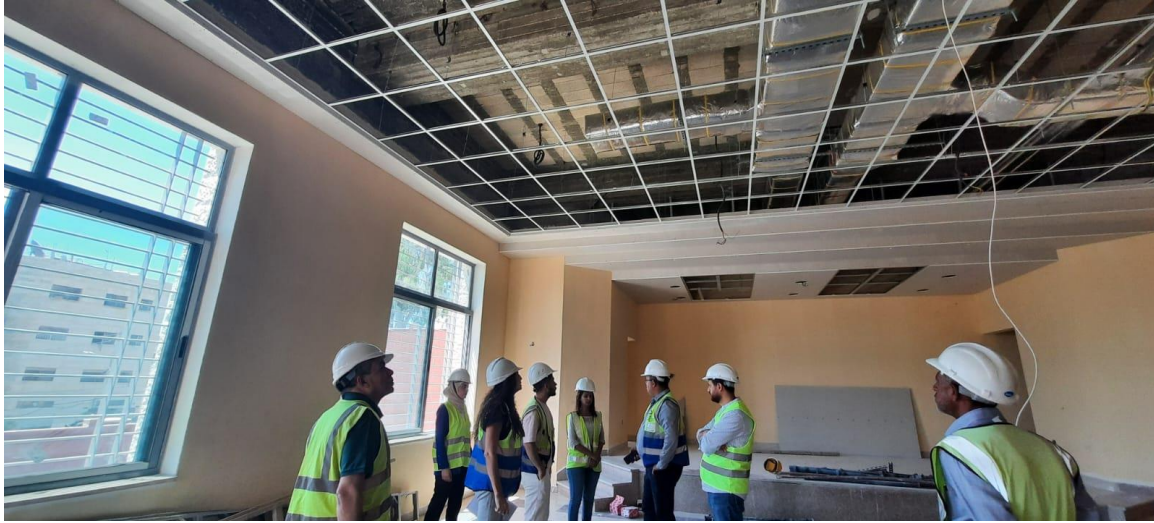
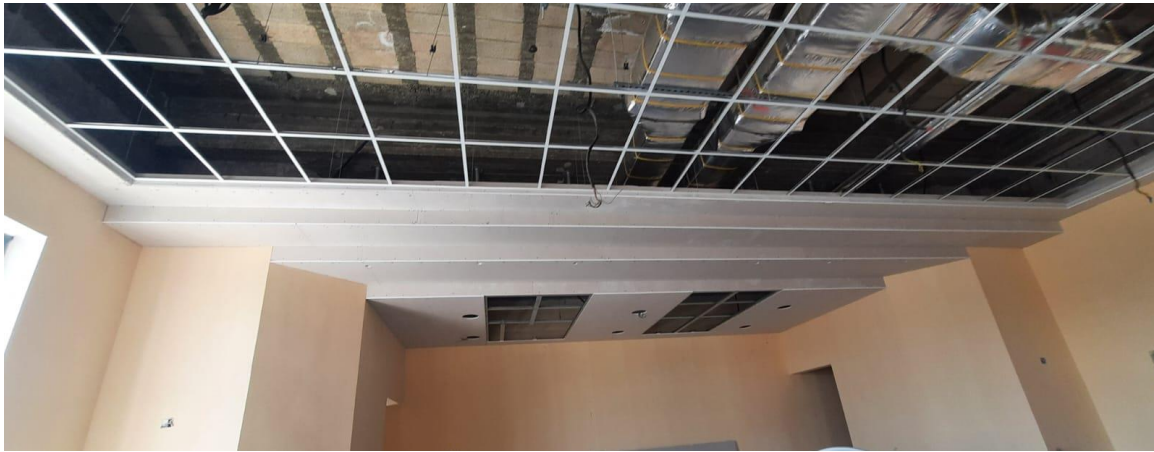
(Figure: 21 & 22)

The team stressed on the Contractor not to continue in the execution of the suspended ceiling for the multi-purpose hall unless the water penetration test for the roof has passed. (Note: The Water penetration test has failed for three times)

No.	Description
6	The team observed that the joints between ceramic tiles under the window sill are not compatible with each other. The Contractor took action immediately to fix the issue.
7	The team observed that the fabric at the shading of the yard is not covering the whole area for protection from the sun. The Contractor was requested to rectify.
8	The team observed voids in the casted concrete for the amphitheater.
9	The team observed that the Contractor started with the execution of asphalt for the parking area.
10	The team inspected the external colored plastering and requested the Contractor to clean all the white dirt and color resulted from works in the stone coping or defects in the plastering material. Also, the Contractor was reminded of one of the requirements of the specifications, which is to apply protective coating at the top of plastering
11	The team stressed on the Contractor not to continue in the execution of the suspended ceiling for the multi-purpose hall unless the water penetration test for the roof has passed. (Note: the Water penetration test has failed for three times).

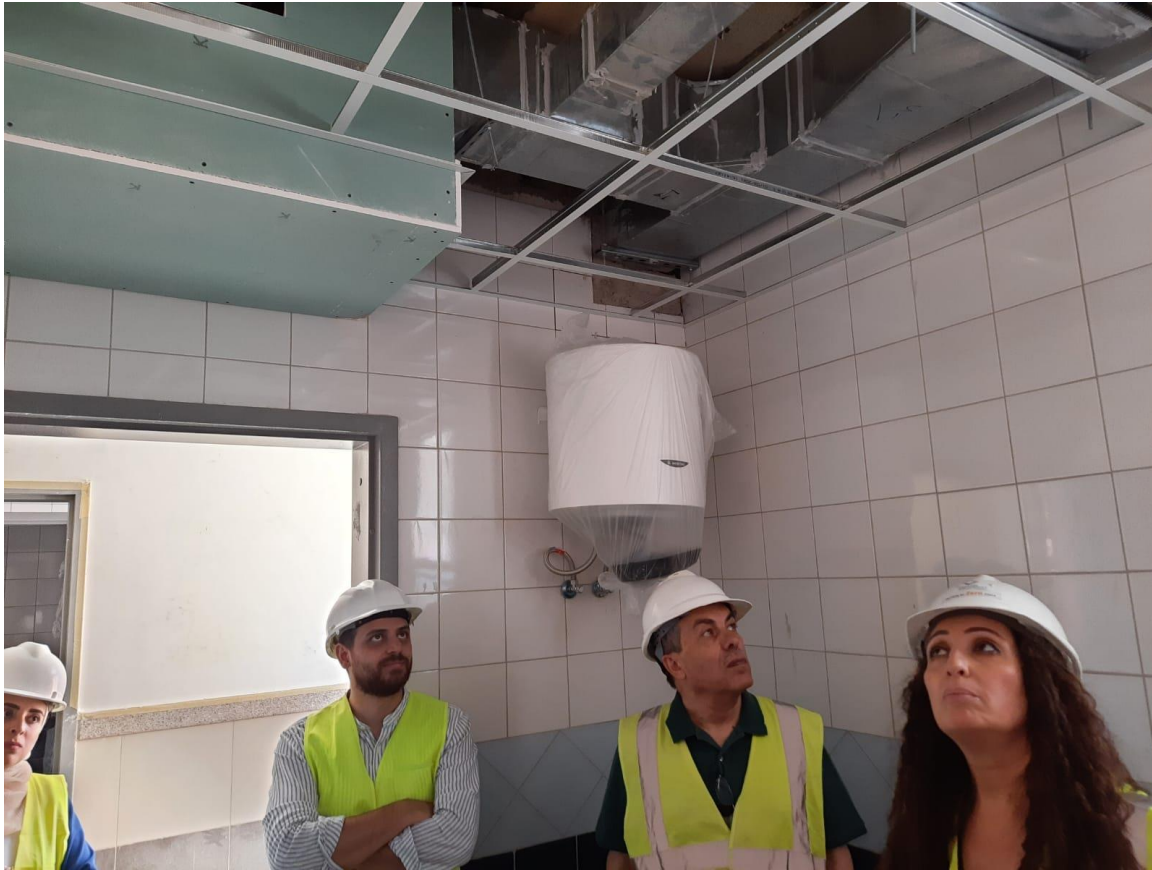
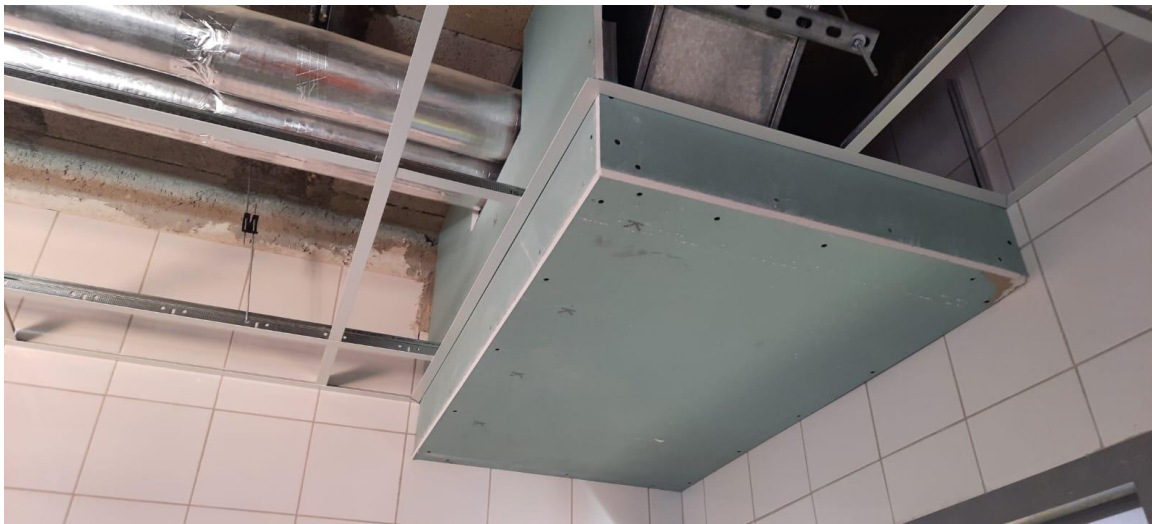
(Figure: 25 & 26)

The team inspected the suspended ceiling for the disabled toilet near the multi-purpose hall and observed a drop at limited area as the need to cover the mechanical duct at that part. This is not accepted reminding that the Contractor has not submitted coordination drawings in this regard to solve this case, the Contractor was requested to extend the dropped box to be connected with sanitary unit wall

12	The team observed that the granite coping at corridors is executed as required.
13	The team observed that the Contractor has executed part of the suspended ceiling for the disabled toilet near the multi-purpose hall with drop at limited area as the need to cover the mechanical duct at that part. This is not accepted reminding that the Contractor has not submitted coordination drawings in this regard to solve this case, the Contractor was requested to extend the dropped box to be connected with sanitary unit wall.
14	The team observed that the Contractor has executed the suspended ceiling for the women toilet at wrong level. The Contractor was requested to dismantle the said ceiling and re-fix at the right level.
15	The team observed that the Contractor delivered and fixed Matthews fans for the classrooms.
16	The team observed waving in the plastering of the ceiling at the toilets which led to gaps between the ceiling and the lighting fixture. The Contractor was requested to repair the plastering in order to avoid the said gaps.

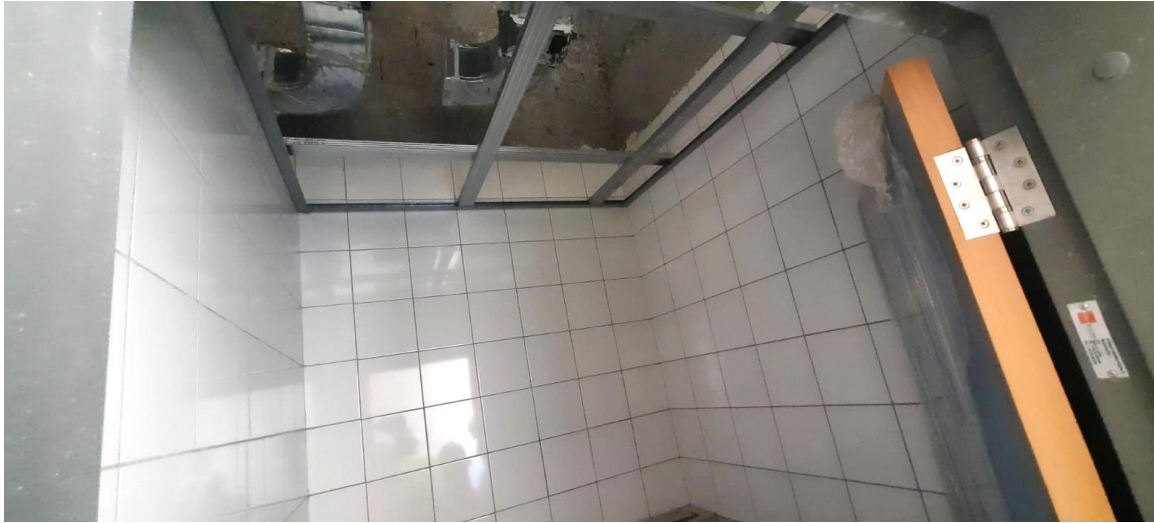
(Figure: 27)

The suspended ceiling for at women toilet is executed at a wrong level. The Contractor was requested to dismantle and re-fix it above the partitions' top level

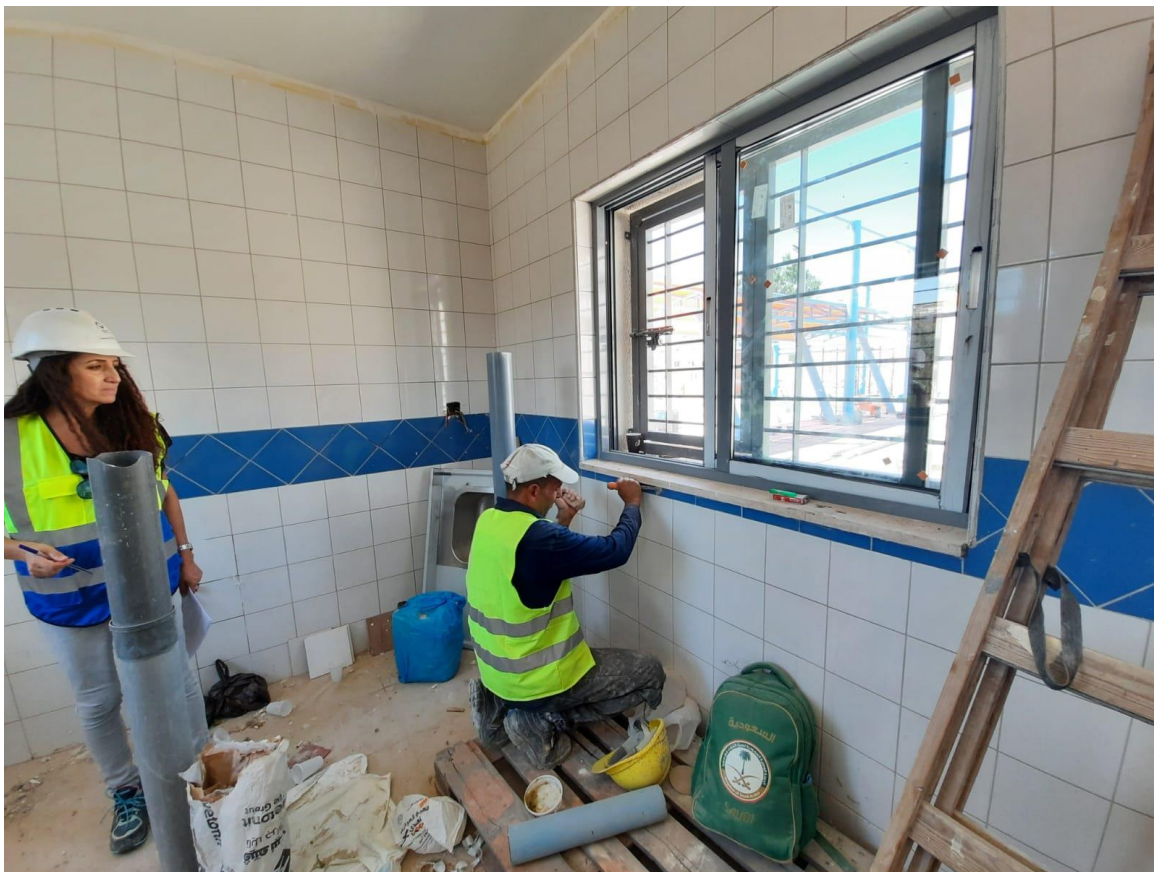
(Figure: 28)

The team observed that the joints between ceramic tiles under the window sill are not compatible with each other. The Contractor took action immediately to fix the issue

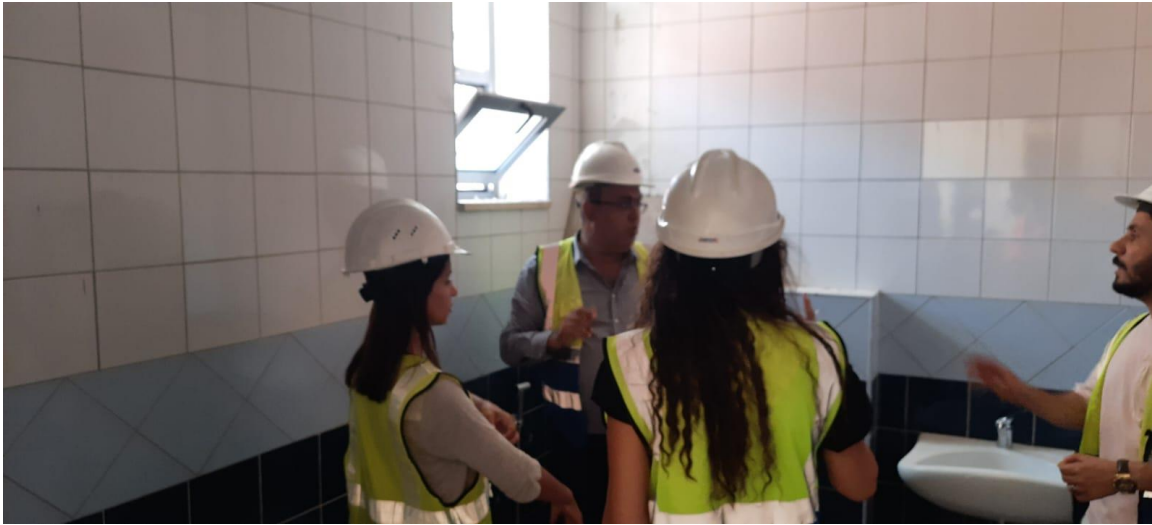
(Figure: 29)

The team reminded the Contractor that all the hinged windows at the toilets shall open at 45 degree

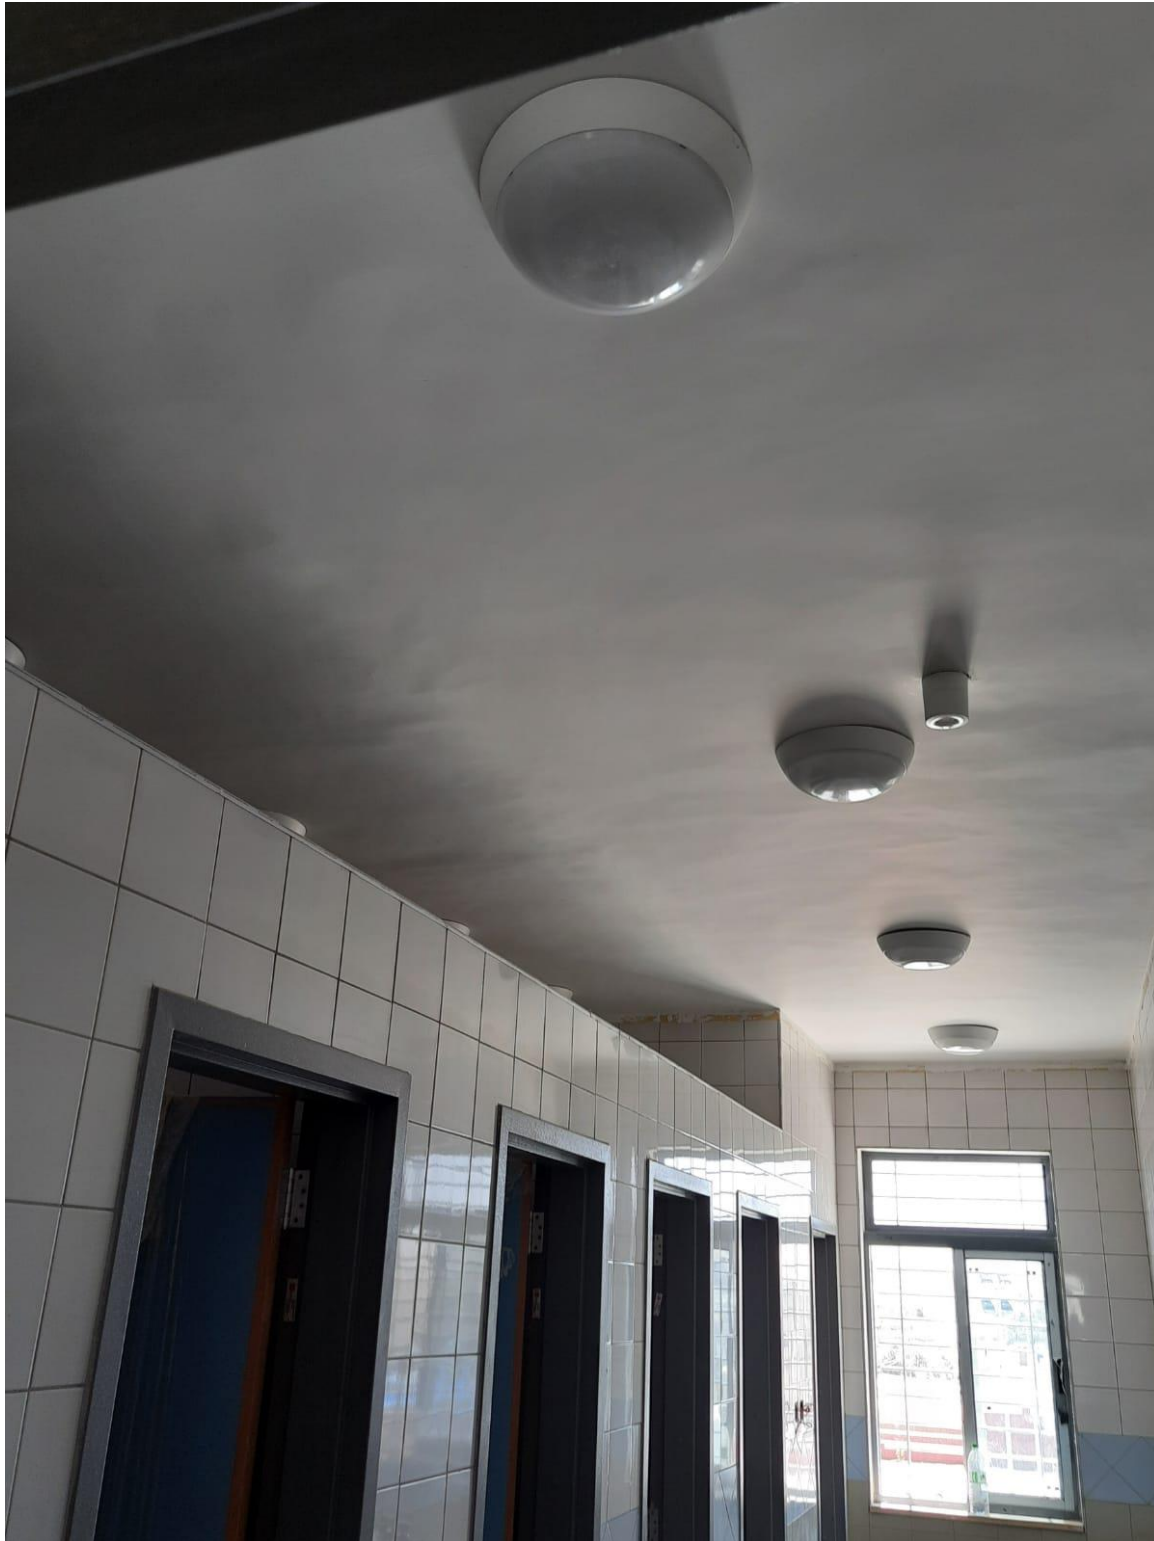
(Figure: 31)

The team observed waving in the plastering of the ceiling at the toilets which led to gaps between the ceiling and the lighting fixture. The Contractor was requested to repair the plastering in order to avoid the said gaps
