Consultant	Wahib Medanat Consultant Engineer	Rep No.	23-23072022
Contractor	Dijlah Establishment Constr. Contracting	Tender No.	(11/2019/USAID/SKEP/3/S) Schools for a Knowledge Economy Project (SKEP) - Phase (3) Package (1, 2)
Site Name	Jumana Bint Abit Taleb Basic Mixed School - Jerash	Day/ Date	Sat. 23/07/2022
Duration of Project	450 Calendar Days	Total Project Budget	8,314,983.735 JD

Visit Notes

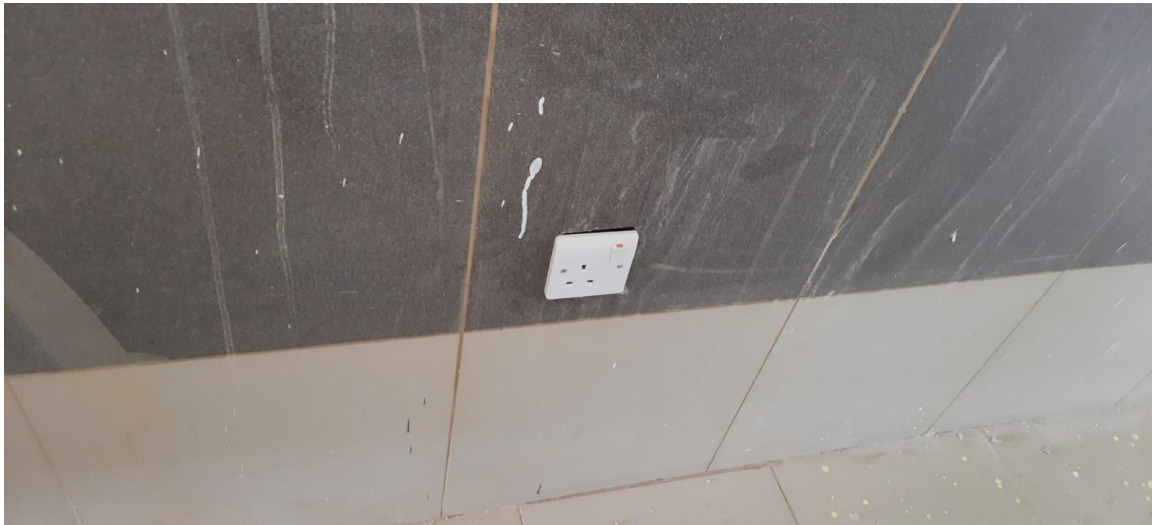
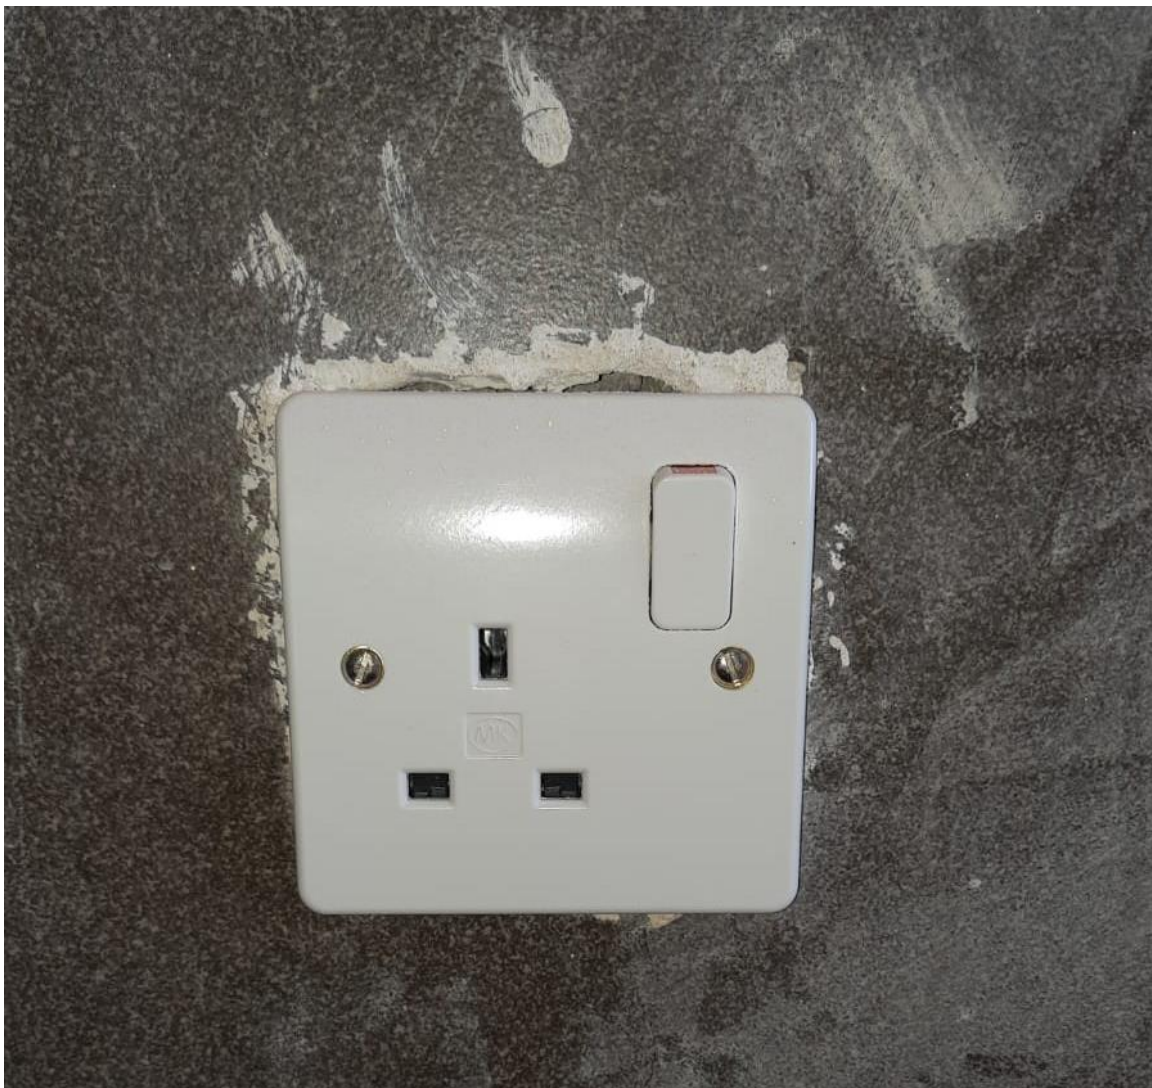
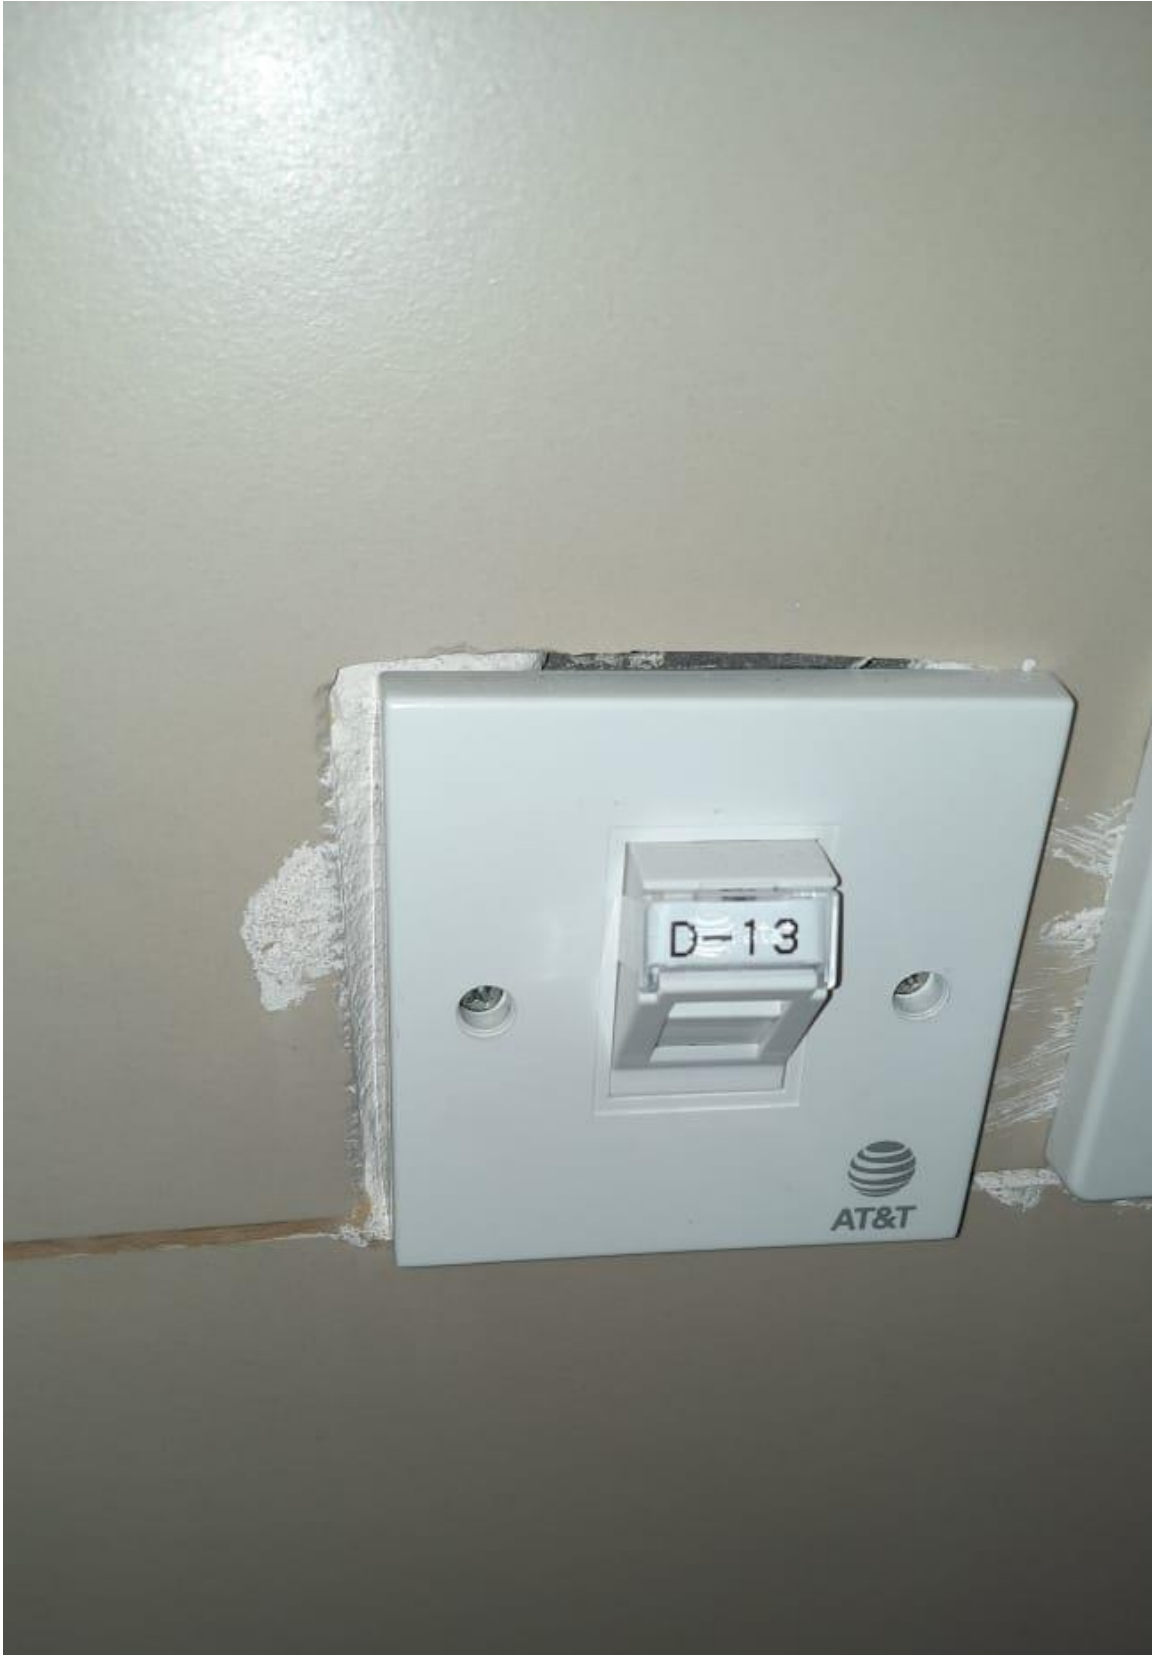
(Figure: 32, 33 & 34)

The team observed that the finishing work around the electrical sockets is done incorrectly. The Contractor was requested repair the said defects

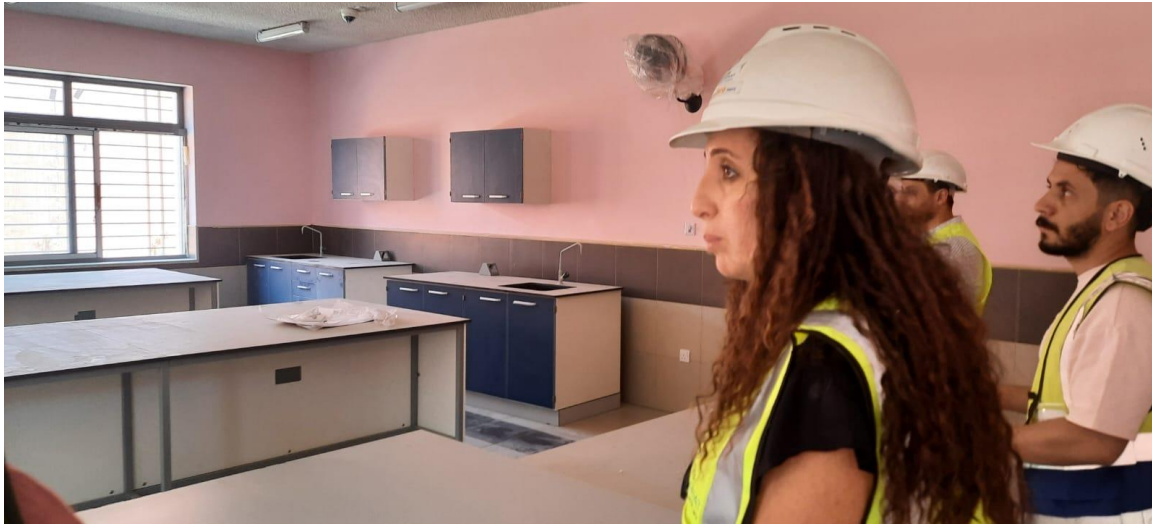
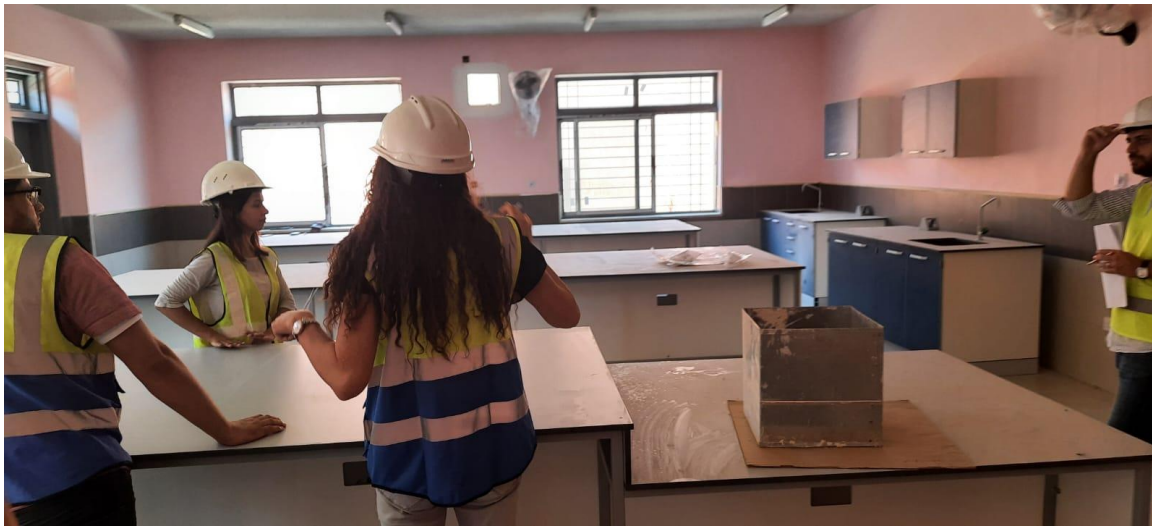
(Figure: 35 & 36)

The team observed that parts of the installed laboratories' do not comply with the approved color scheme

No.	Description
17	The team requested the Contractor to reduce the protrusion in the rainwater drainage pipe and execute the required slope to direct the drained water to the sidewalk.
18	The team inspected the fire hose cabinets at the corridors, and observed that the protrusion of the cabinets from the wall is not fixed despite what was agreed upon in the previous visit. The Contractor was requested to rectify.
19	The team reminded the Contractor that all the hinged windows at the toilets shall open at 45 degree.
20	The team observed that the finishing work around the electrical sockets is done incorrectly. The Contractor was requested repair the said defects.
21	The team observed that parts of the installed laboratories' do not comply with the approved color scheme.

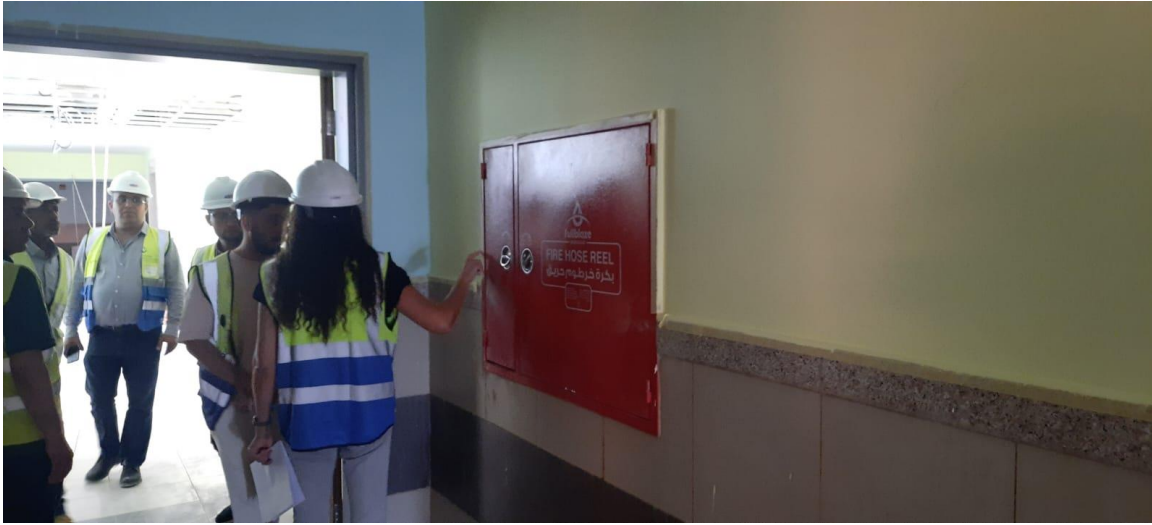
(Figure: 37)

The team observed that the protrusion of the fire hose cabinets from the wall is not fixed despite what was agreed upon in the previous visit
