SKEP III Home Office Support Site Visit Report

Consultant	Wahib Medanat Consultant Engineer	Rep No.	22-03062021
Contractor	Dijlah Establishment Constr. Contracting	Tender No.	(11/2019/USAID/SKEP/3/S) Schools for a Knowledge Economy Project (SKEP) - Phase (3) Package (1, 2)
Site Name	Thahr Al Sarow Basic School for Boys- Jerash	Day/ Date	Sat. 03/06/2021
Duration of Project	450 Calendar Days	Total Project Budget	8,314,983.735 JD

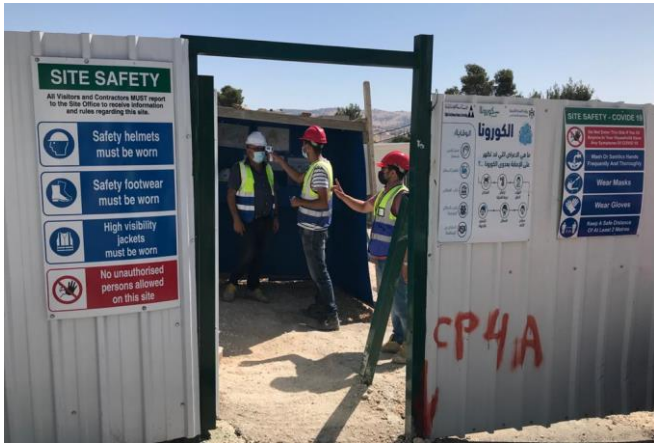
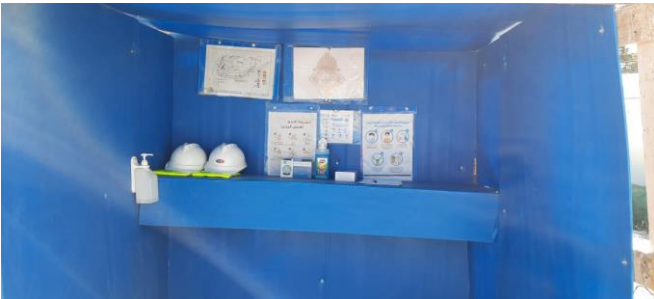
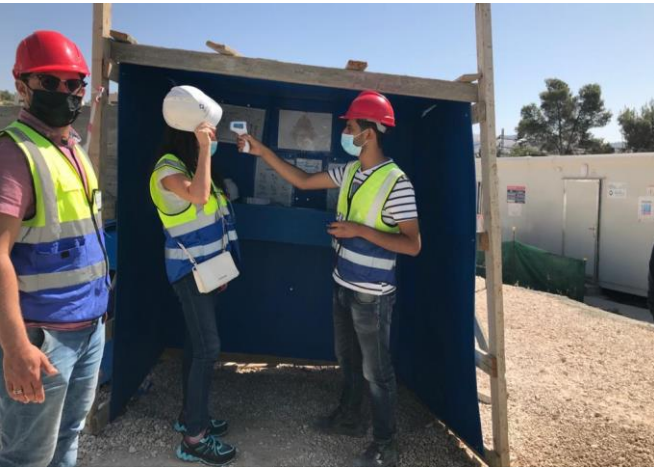
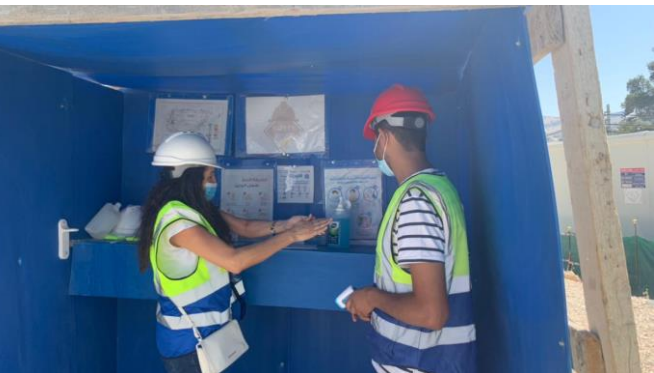
Temperature check, sterilization and signing visitors' attendance sheet at the entrance of the site, complying with Covid-19 Protocol

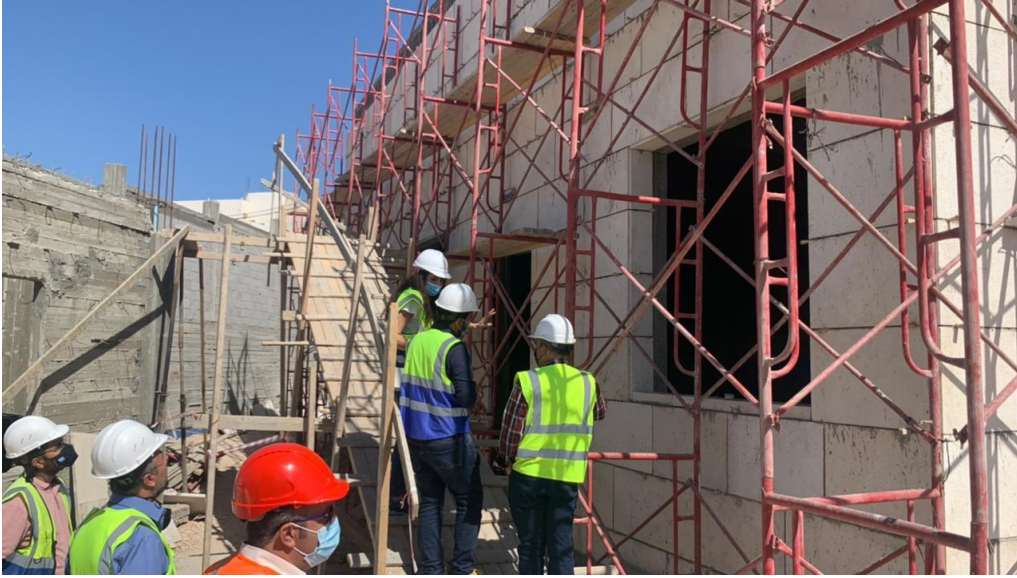
Quality check for the stone mock-up wall (not pointed). Notes were given to the contractor

No.	Description
3	<ul style="list-style-type: none">- Quality check for the stone mock-up wall (not pointed).• Window sill shall be two pieces not three.• Broken edges were noticed. The stones must not have broken edges.• The window stone frame must look as one piece. The pieces should be cut and built with more care for joints.• No objection to the place of installing the electrical boxes on a condition to be installed in a way to avoid cut in the pointing of spaces between built stone layers.• Number of broken stones were observed. Broken stones are not accepted and must be replaced and this to be avoided in executing the stone elevations. <p>Sample for stone pointing must be prepared in a later stage to be checked by the Engineer on the request of the Contractor.</p>

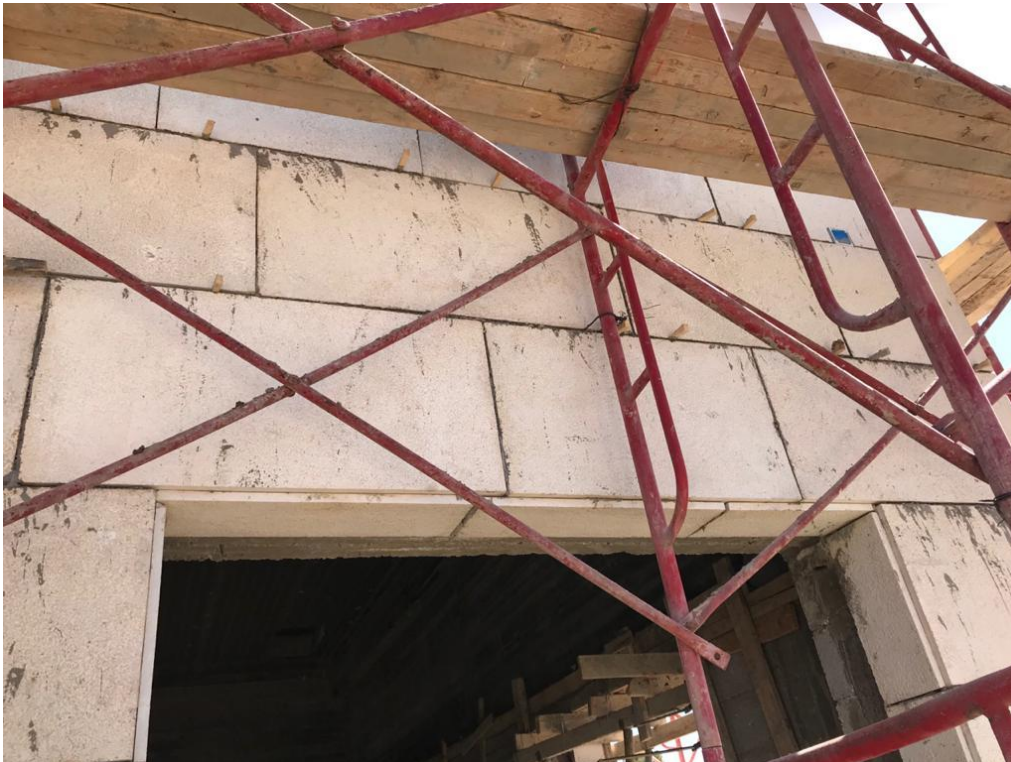
The window stone frame must look as one piece. The pieces should be cut and built with more care for joints

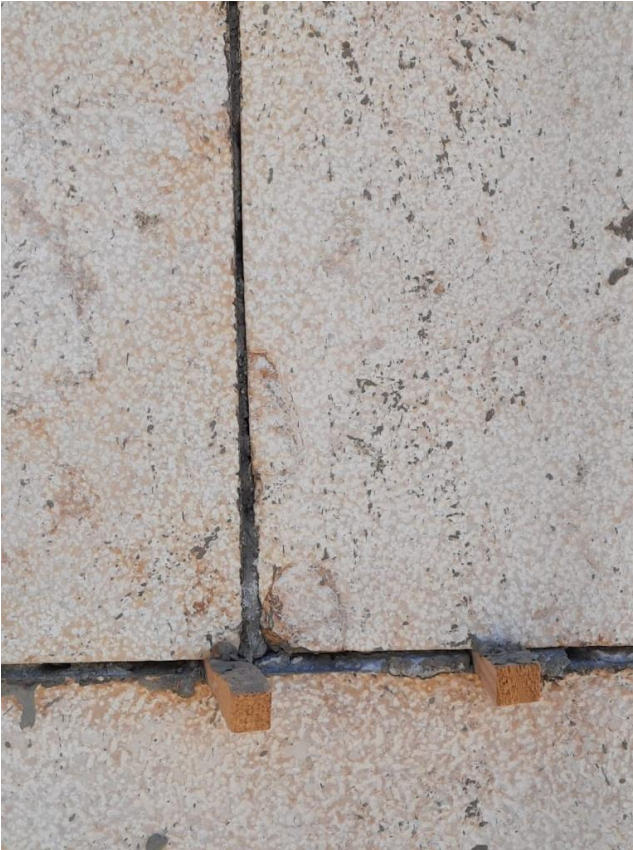
Number of broken stones were observed.

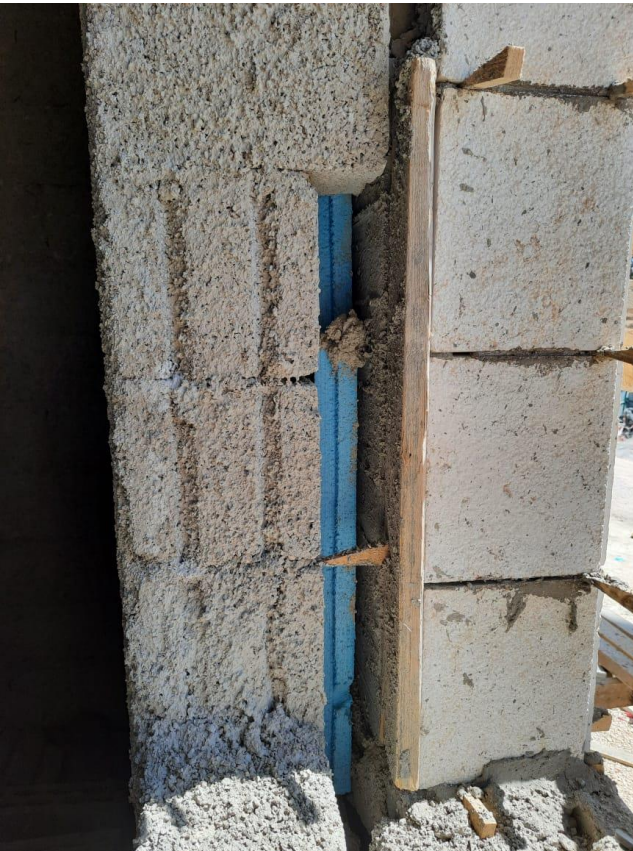
The Contractor was instructed to rectify the status of this end for window jamb by casting concrete section instead of block and mortar

No.	Description
1	1- Blockwork: The quality is acceptable in general. Narrow spaces must not be filled with mortar. Saw cut blocks must be used.
2	2- Window jambs: The end of blockwork with all details such as polystyrene should be ended at the openings with concrete edge not thin layer of mortar as observed.

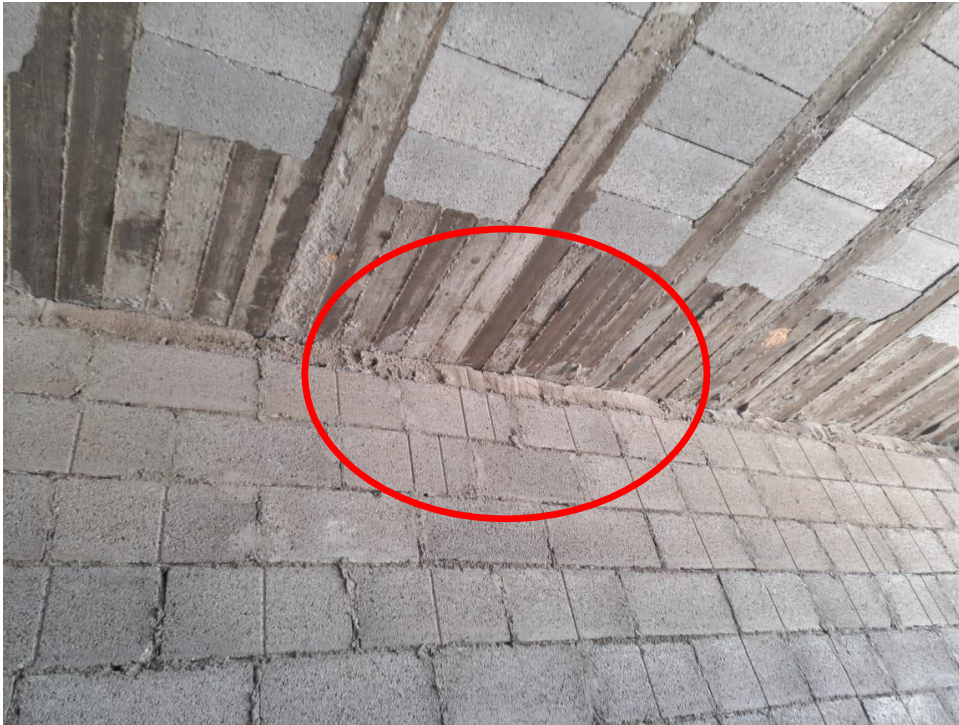
Narrow spaces must not be filled with mortar. Saw cut blocks must be used
Narrow spaces must not be filled with mortar. Saw cut blocks must be used

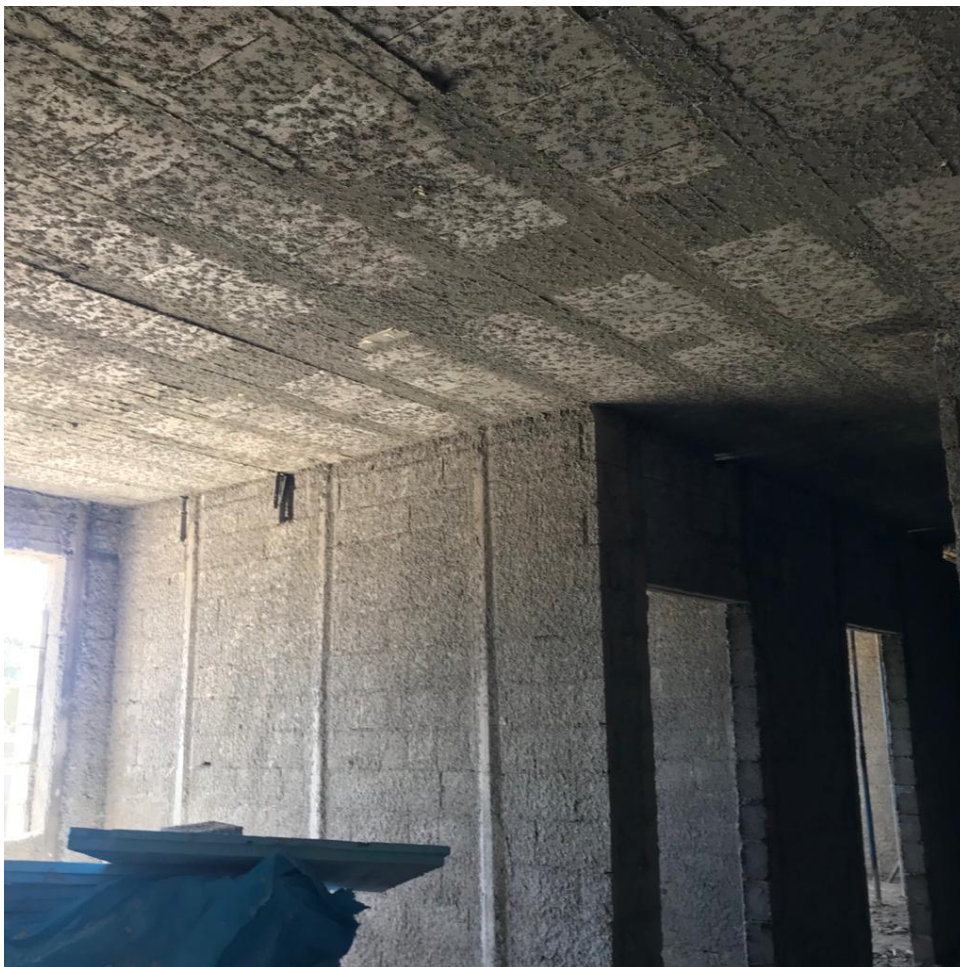
First stage of plastering work
