Construction Management of the Jordan School Expansion Project (JSEP) and the Schools for a Knowledge Economy Project (SKEP)

Site Visit Report Form

FTR # QR386

Program (JSEP or SKEP): SKEP III Package I
School Name: Thahr Al Sarow Basic School for Boys
Supervisory Engineer (SE) : Medanat Consultant Engineers
Construction Contractor (CC): Dijlah Contracting
Date and Time of Field Trip: May 23,2021
Date of Report: May 26,2021
Weather During Visit Sunny 24°
Prepared By: Osama Obeid CMTO/Trigon
Submitted By: Osama Obeid CMTO/Trigon

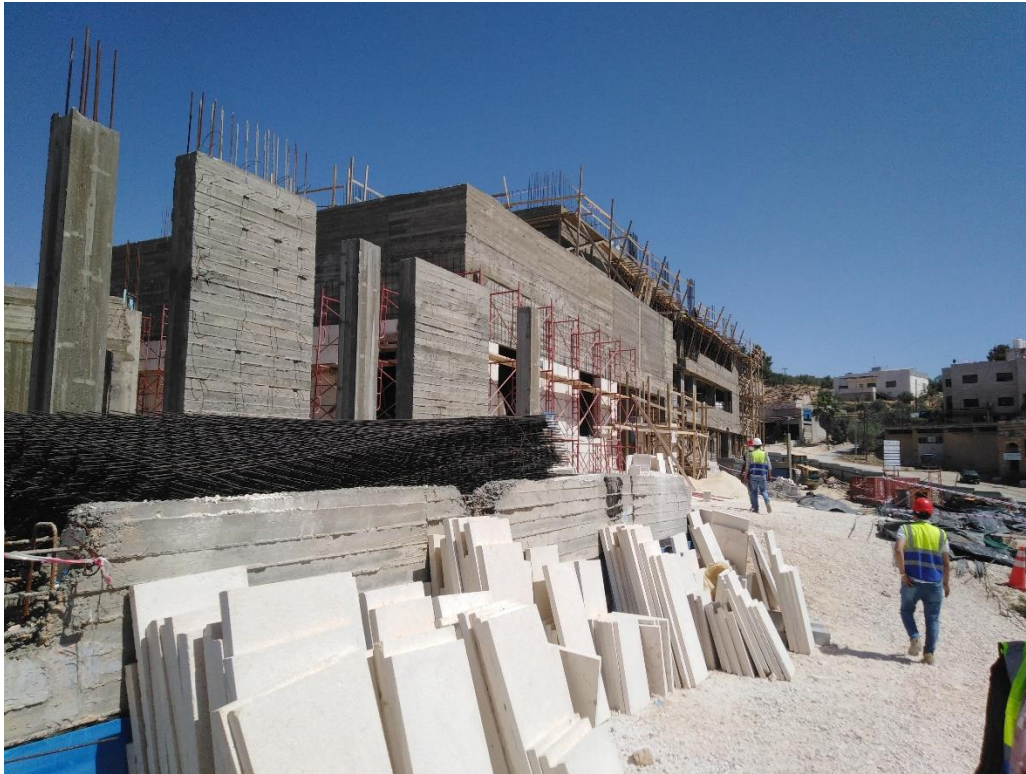
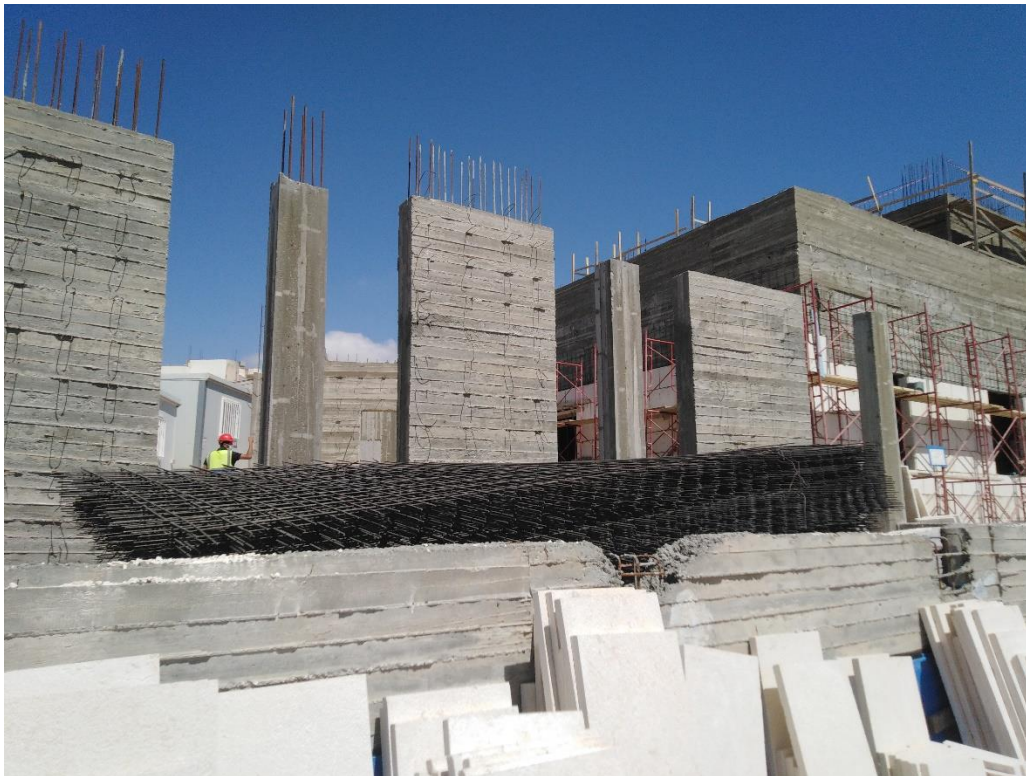
FIGURE #02&03:

The proposed project consists of four floors and roof building, in addition to another related site works. The project has an internal area of 4615 m² and external area 2827.0 m². Walls for ground floor is completed

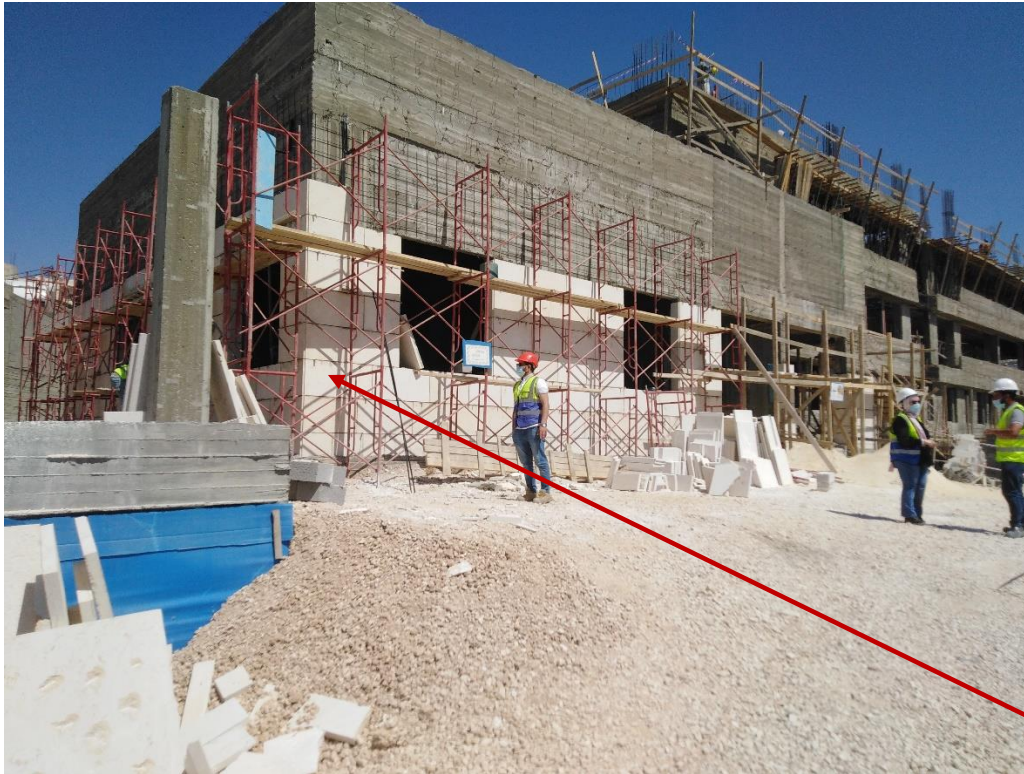
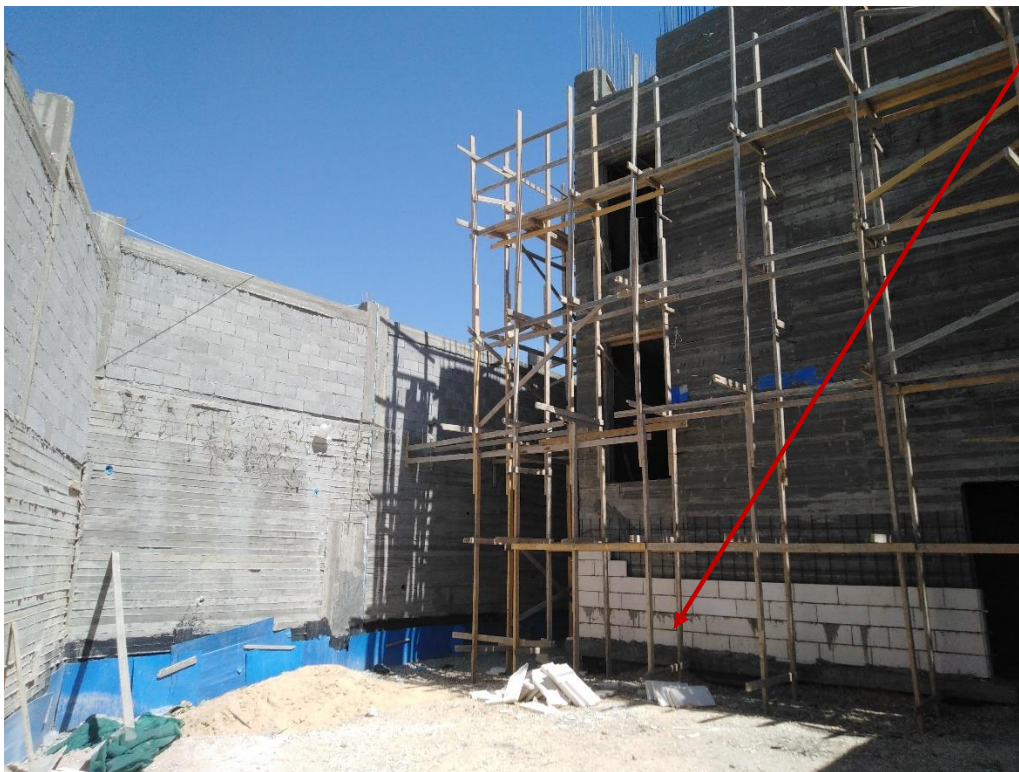
FIGURE #04&05:

*The CC prepared and installed Stone cladding (50*50 cm) & (25*25 cm) as a sample for SE comments/ approval.*

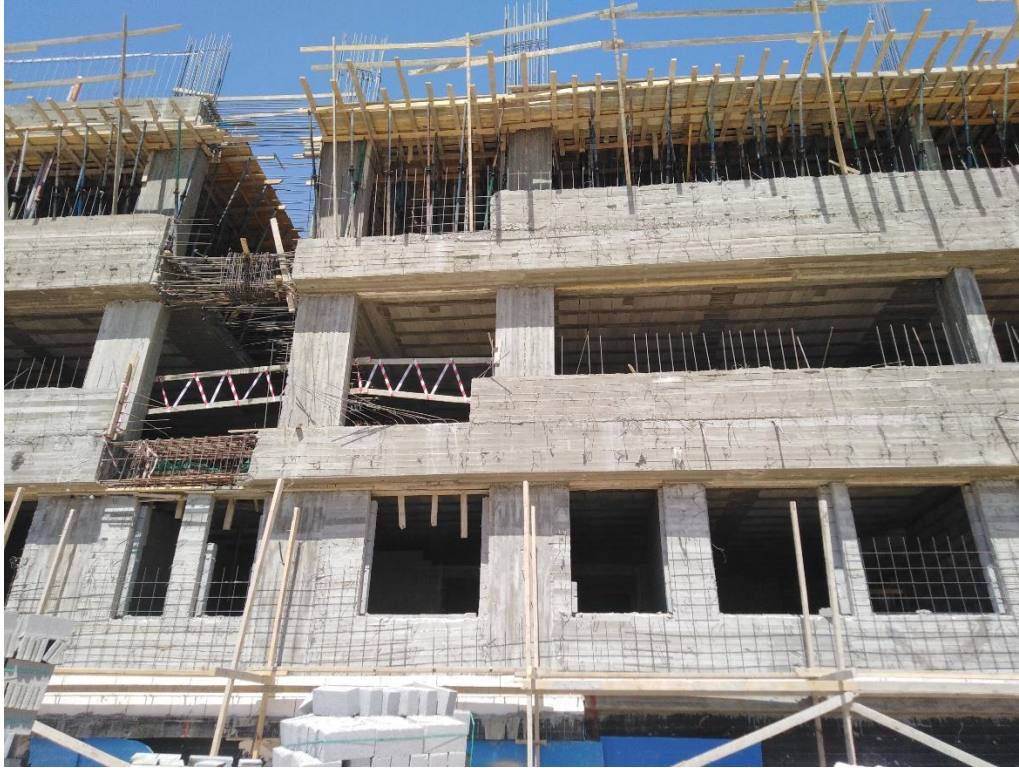
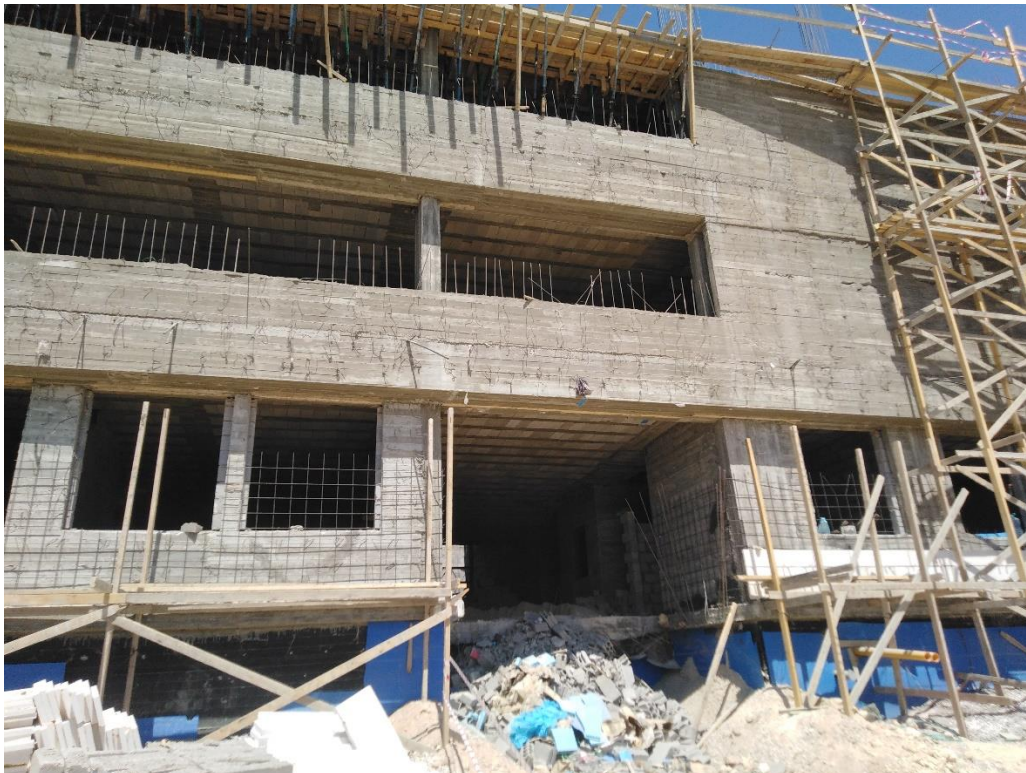
FIGURE #06& 07:

55% of the skeleton works is completed. Preparation works for placing concrete for the of the second floor slab (2nd part)

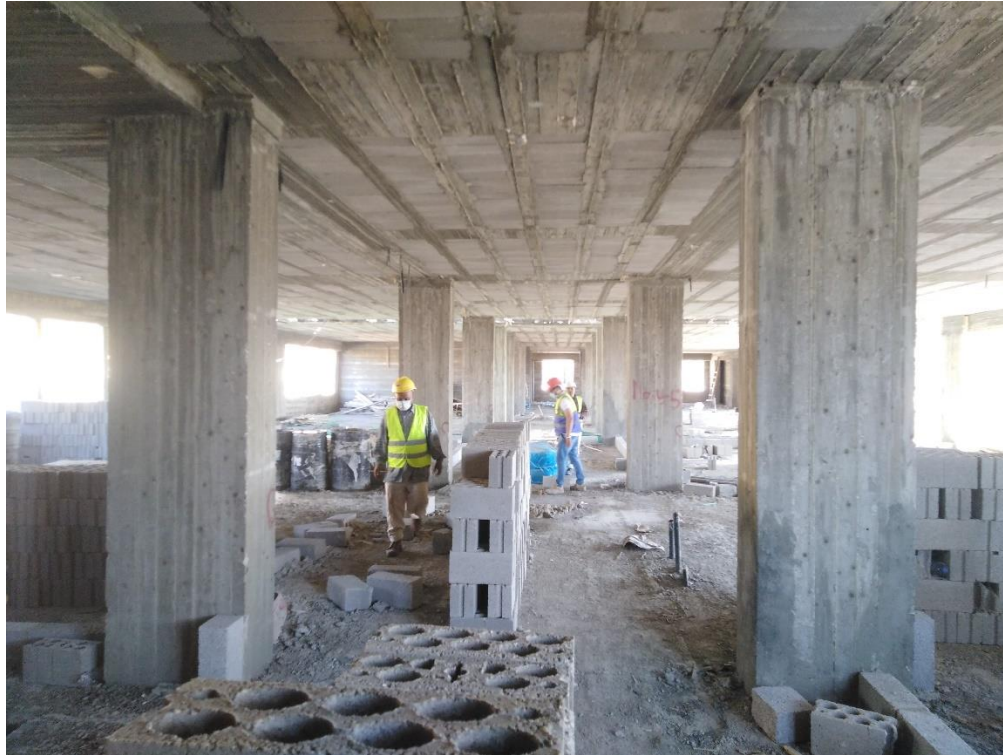
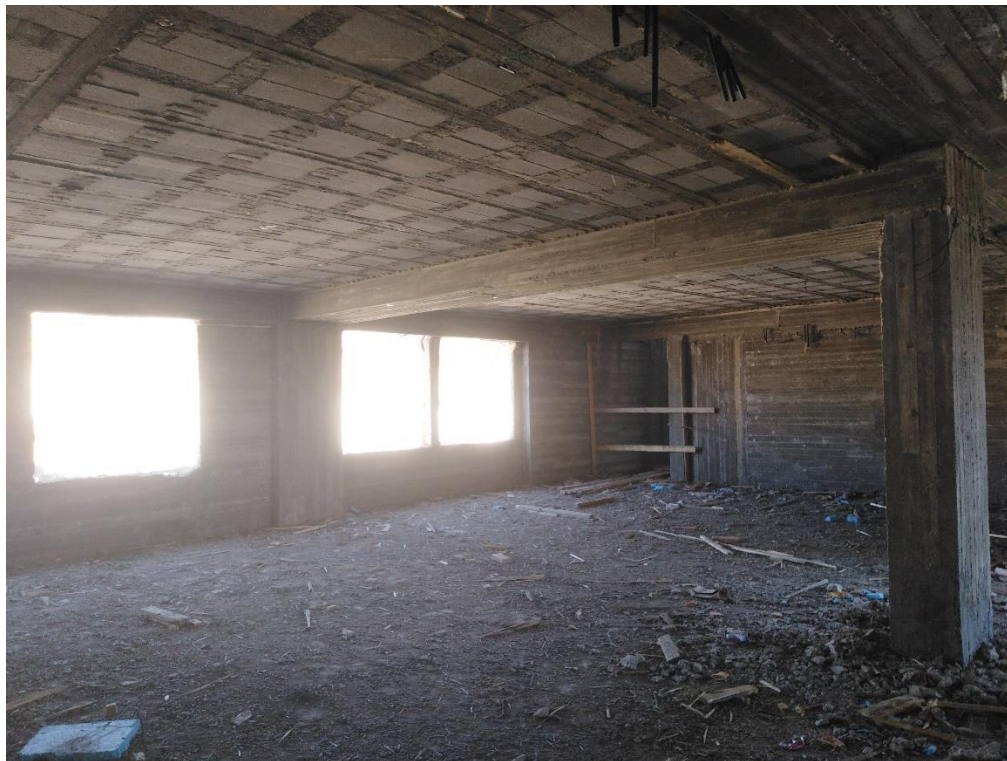
FIGURE #08 & 09:

*Preparation works for
building cement block
walls in the first floor*

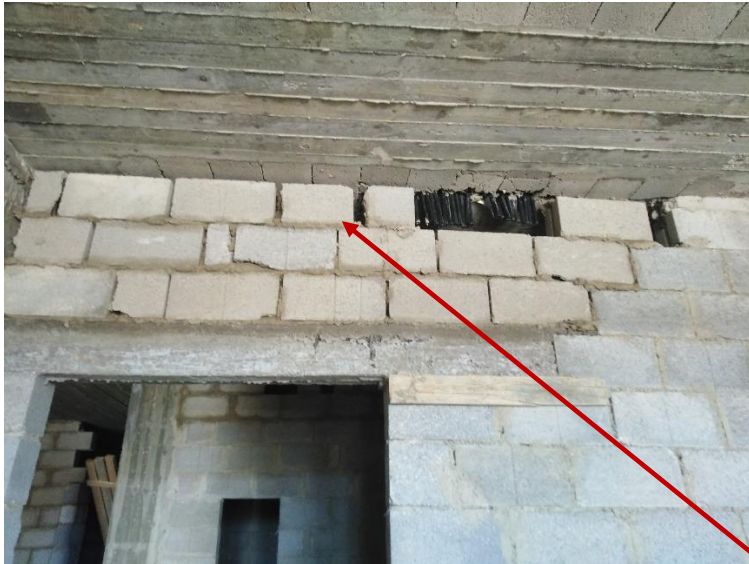
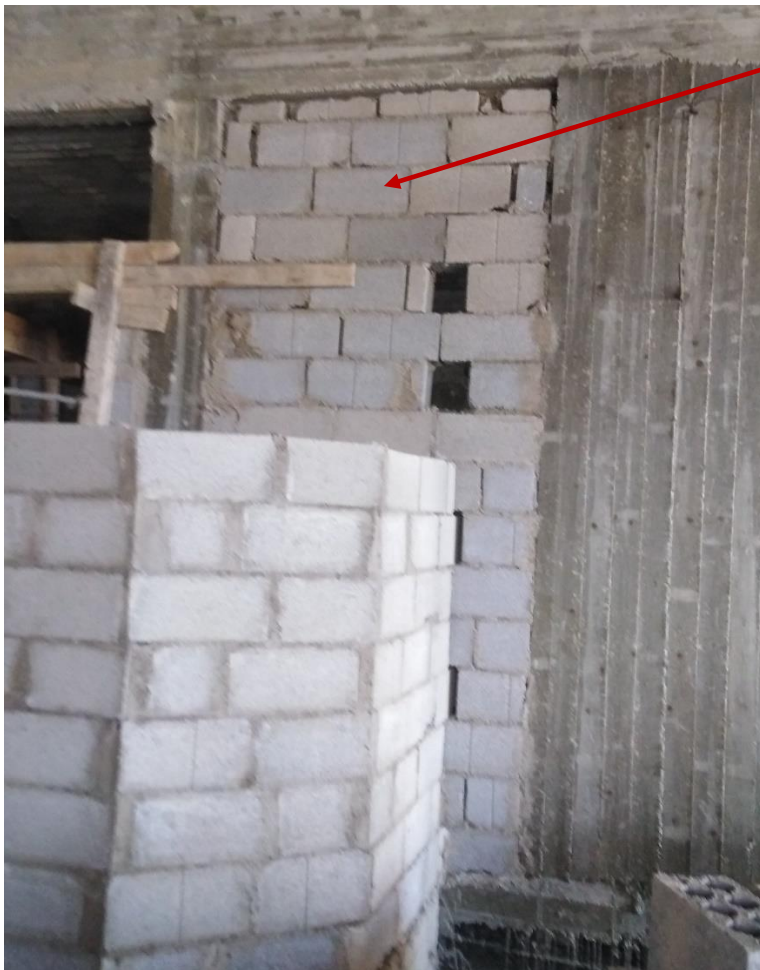
FIGURE #11 & 12;:

*Poor workmanship on
cement block work was
noticed in the ground
floor*

D. SuperStructural, Concrete, Masonry works				
1	Columns			
2	Beams			
3	Slabs	Y	Roughnes and segregation in concrete	Must be repaired with special materials
4	Roof			
5	Hollow Concrete Block (internal)	Y	Poor workmanship	Must be removed and build new cement blocks
6	Hollow Concrete Block (external)			
7	C-Channel			
8	Clading Natural Stones			
9	Electrical conuits/ sleeves			
10	Mechanical pipes/sleeves

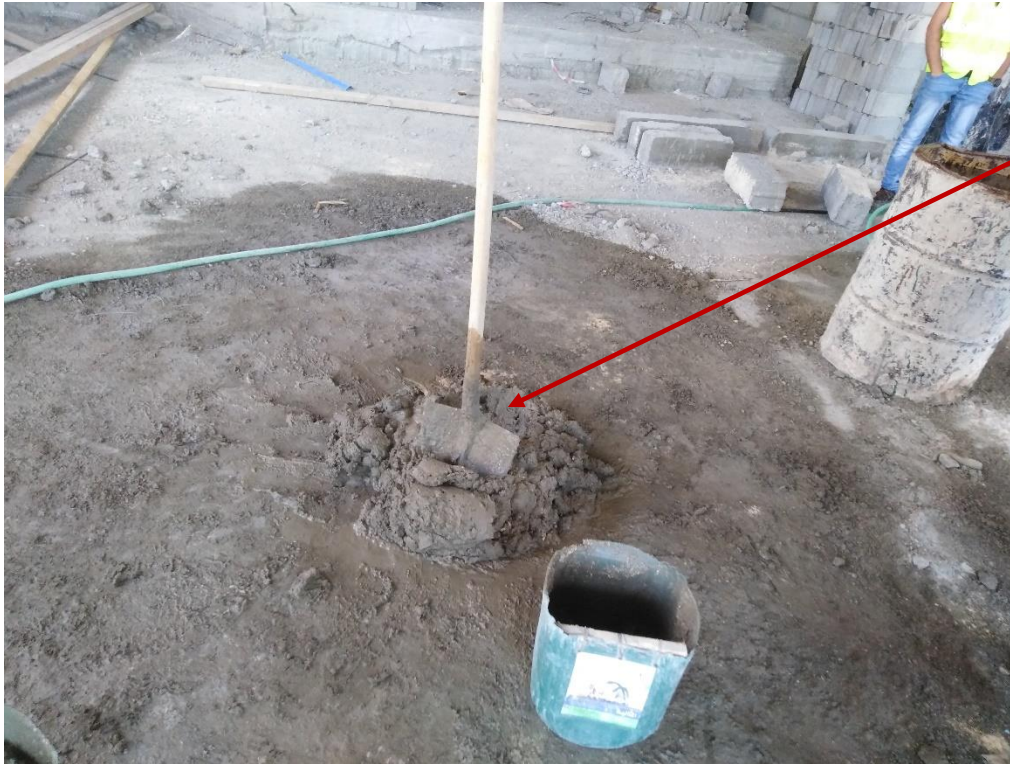
FIGURE #13

Mixing cement with water on the floor directly without using container

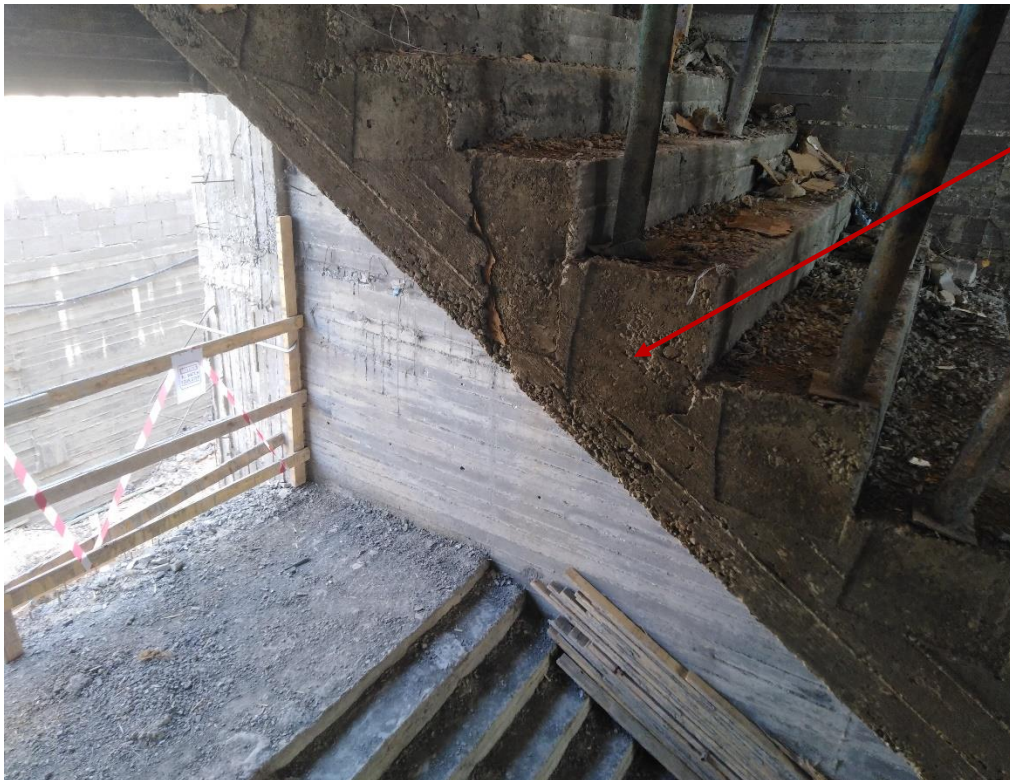
FIGURE #13

Roughness and segregation in concrete

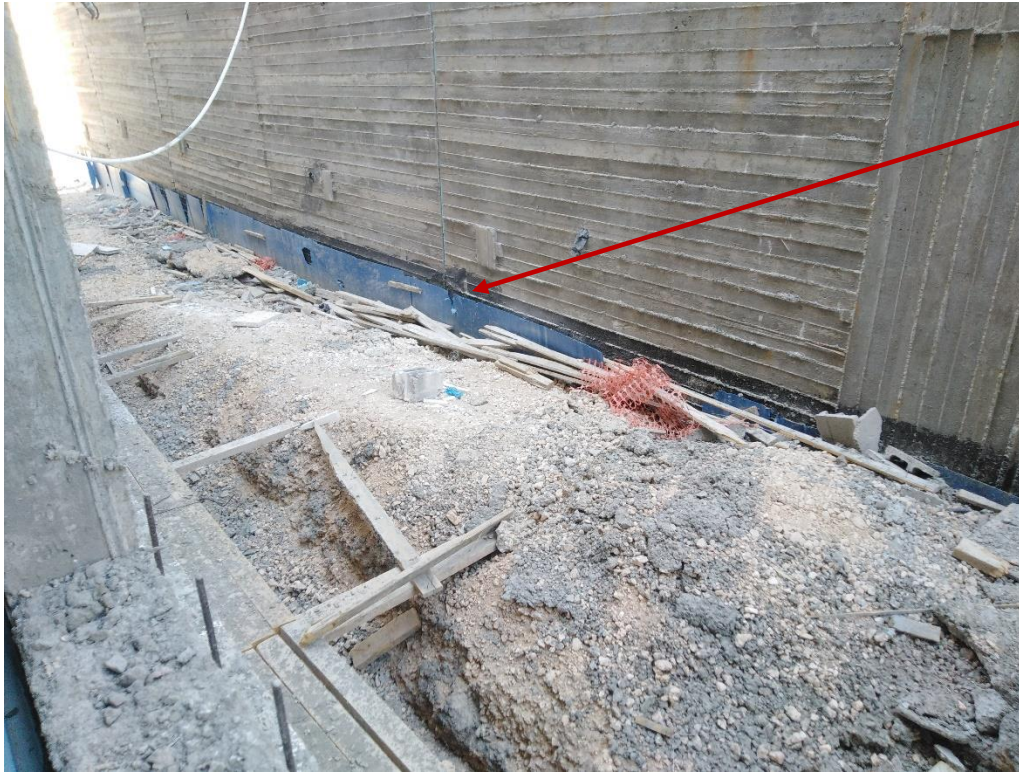
FIGURE #14

*Damaged of Cartonal
Sheets must be
replaced*
