School for Knowledge Economy Project (SKEP) Phase III – Package 1

Monthly Progress Report

No. 16

March, 2022

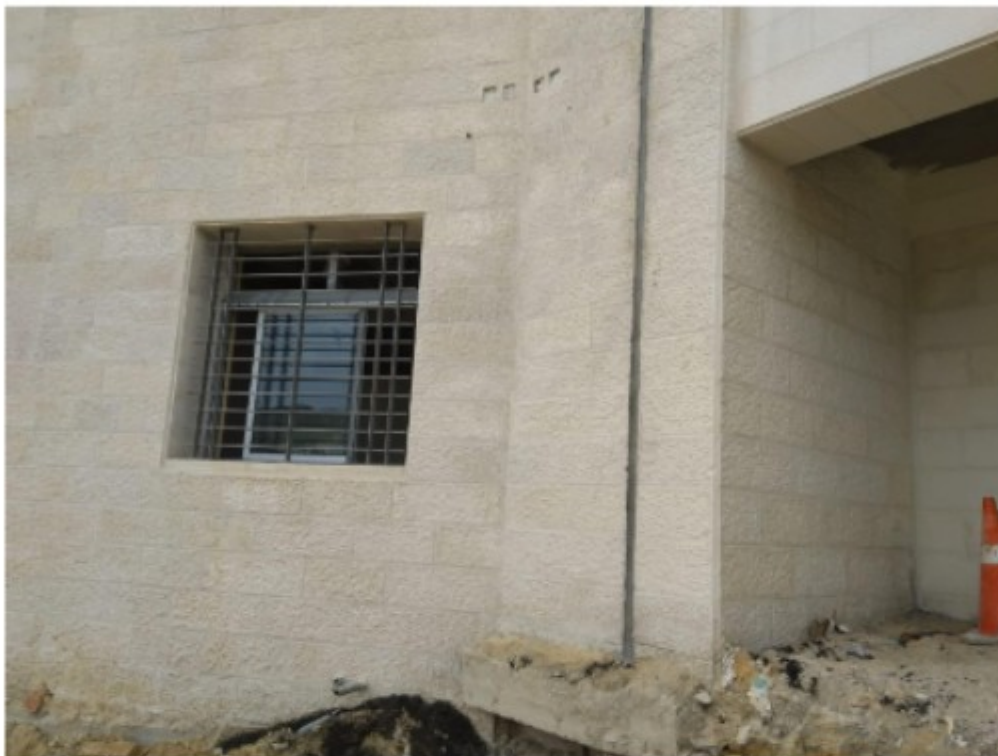
(figure:04)

The team discussed with the Contractor the issue of the executed external expansion joint

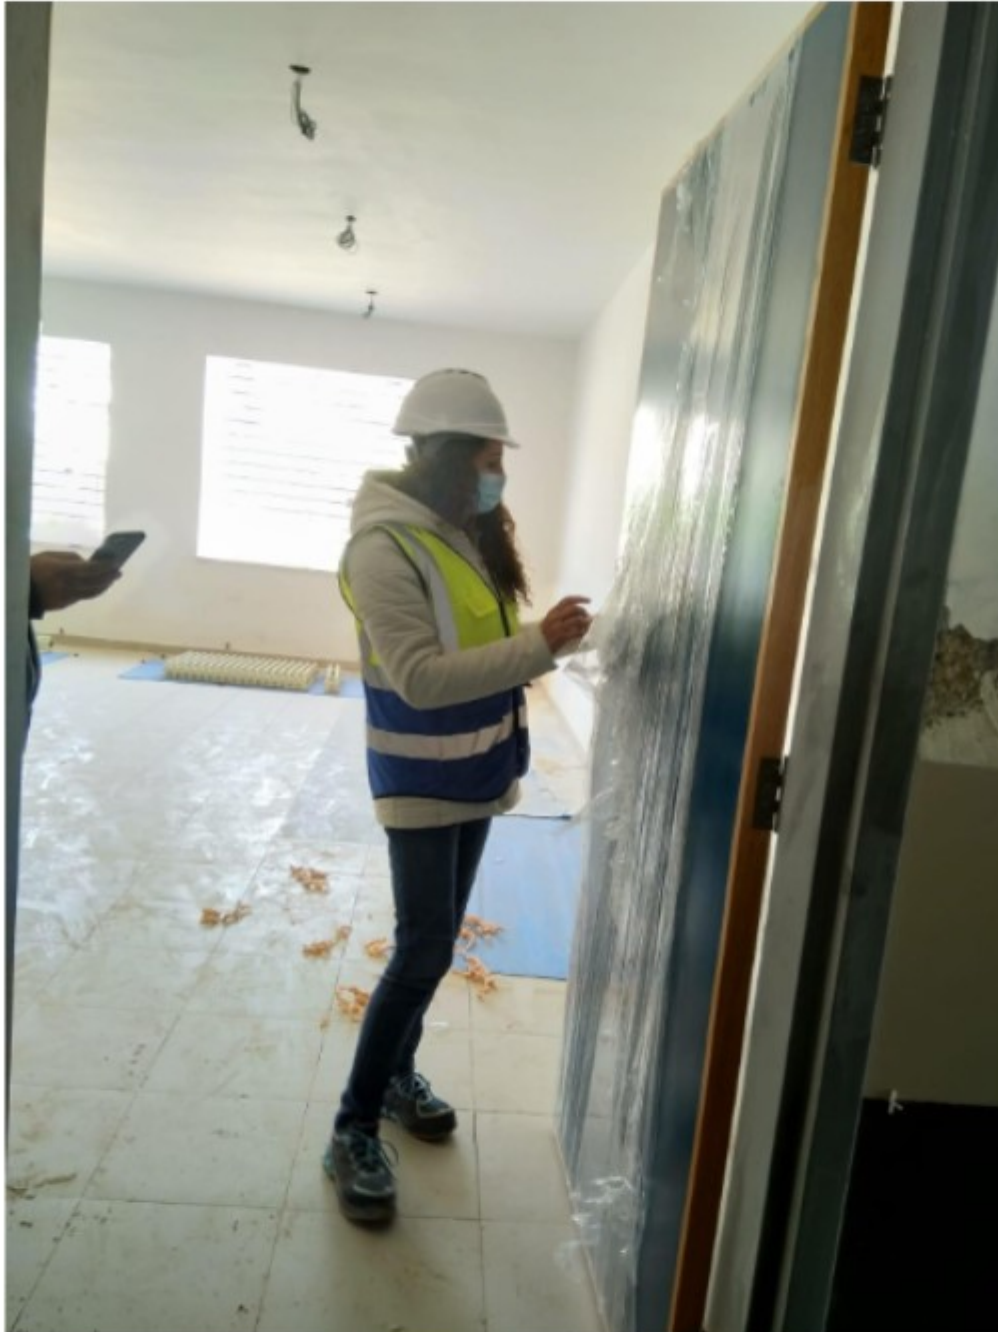
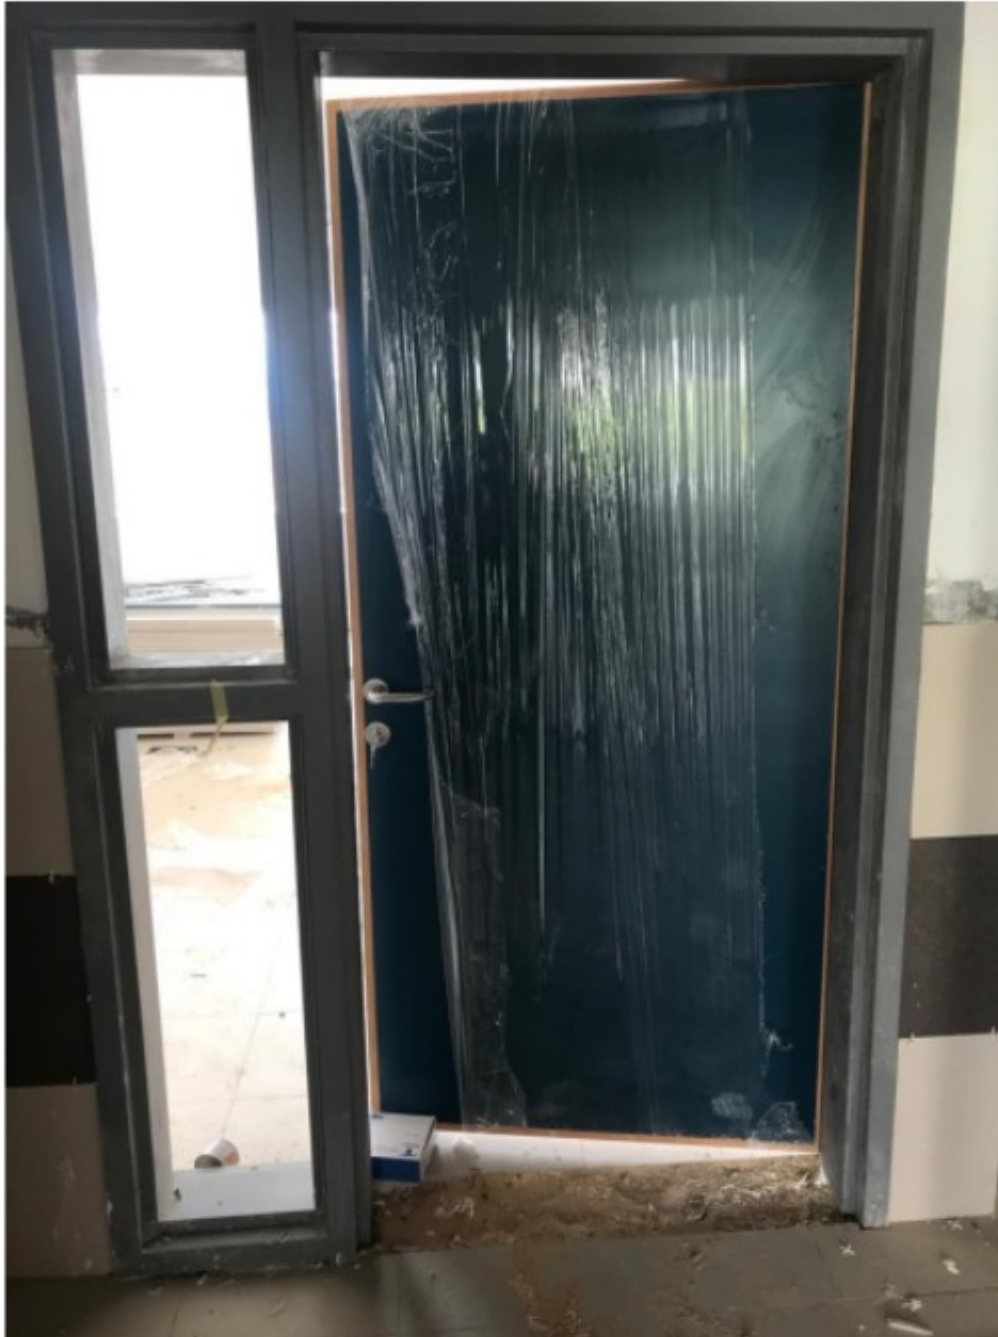
(figure:07)

The Supervision team inspected the installed door samples
(figure:07 & 08)

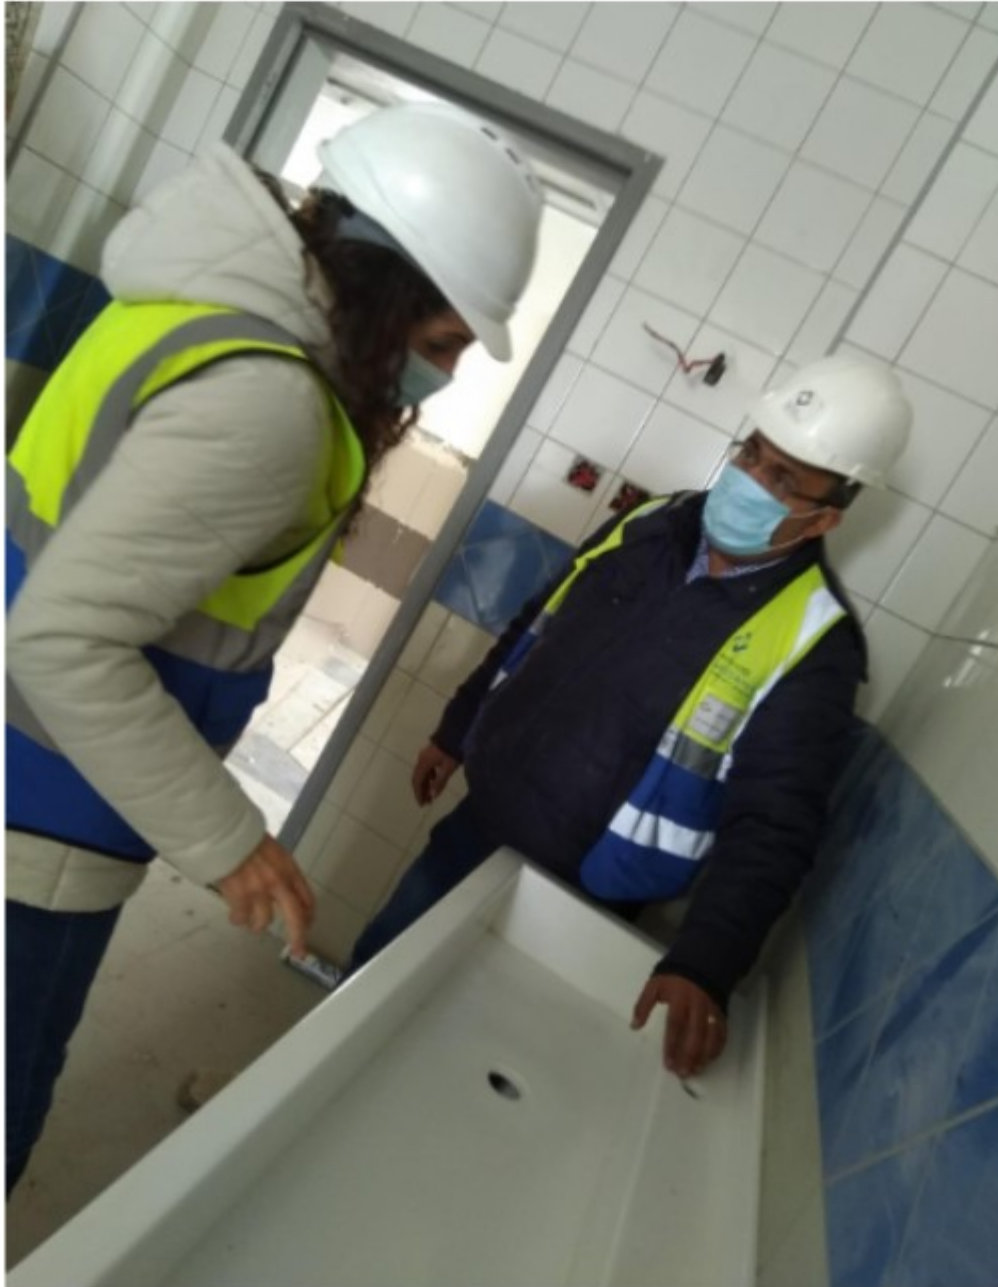
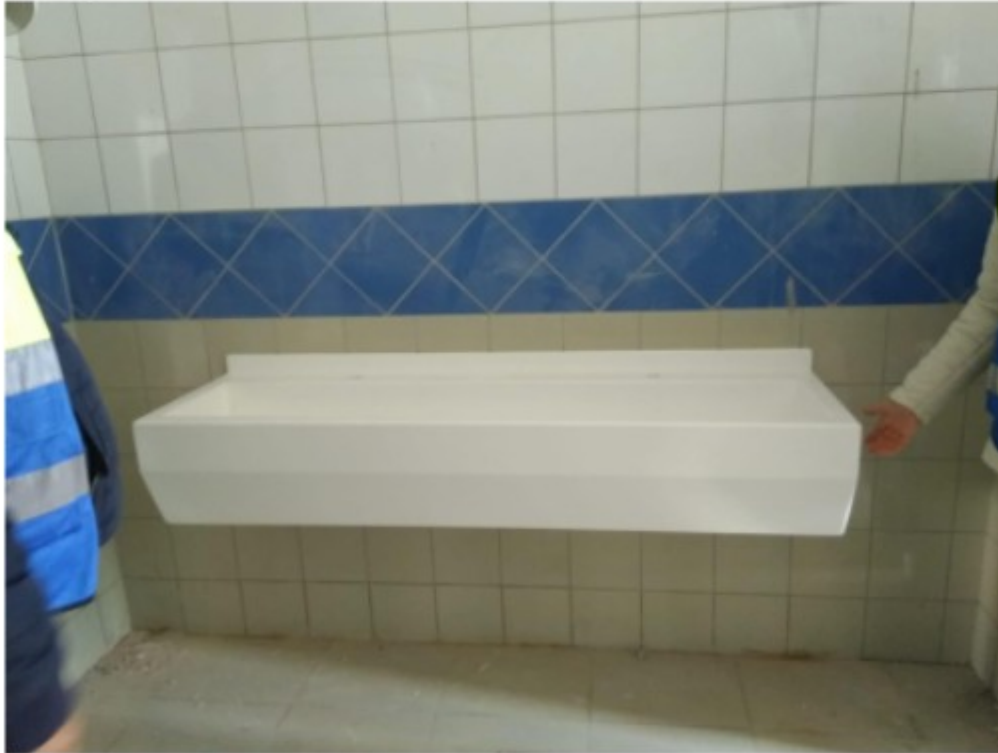
(figure:09)

The team inspected the installed wash trough sample and found it acceptable

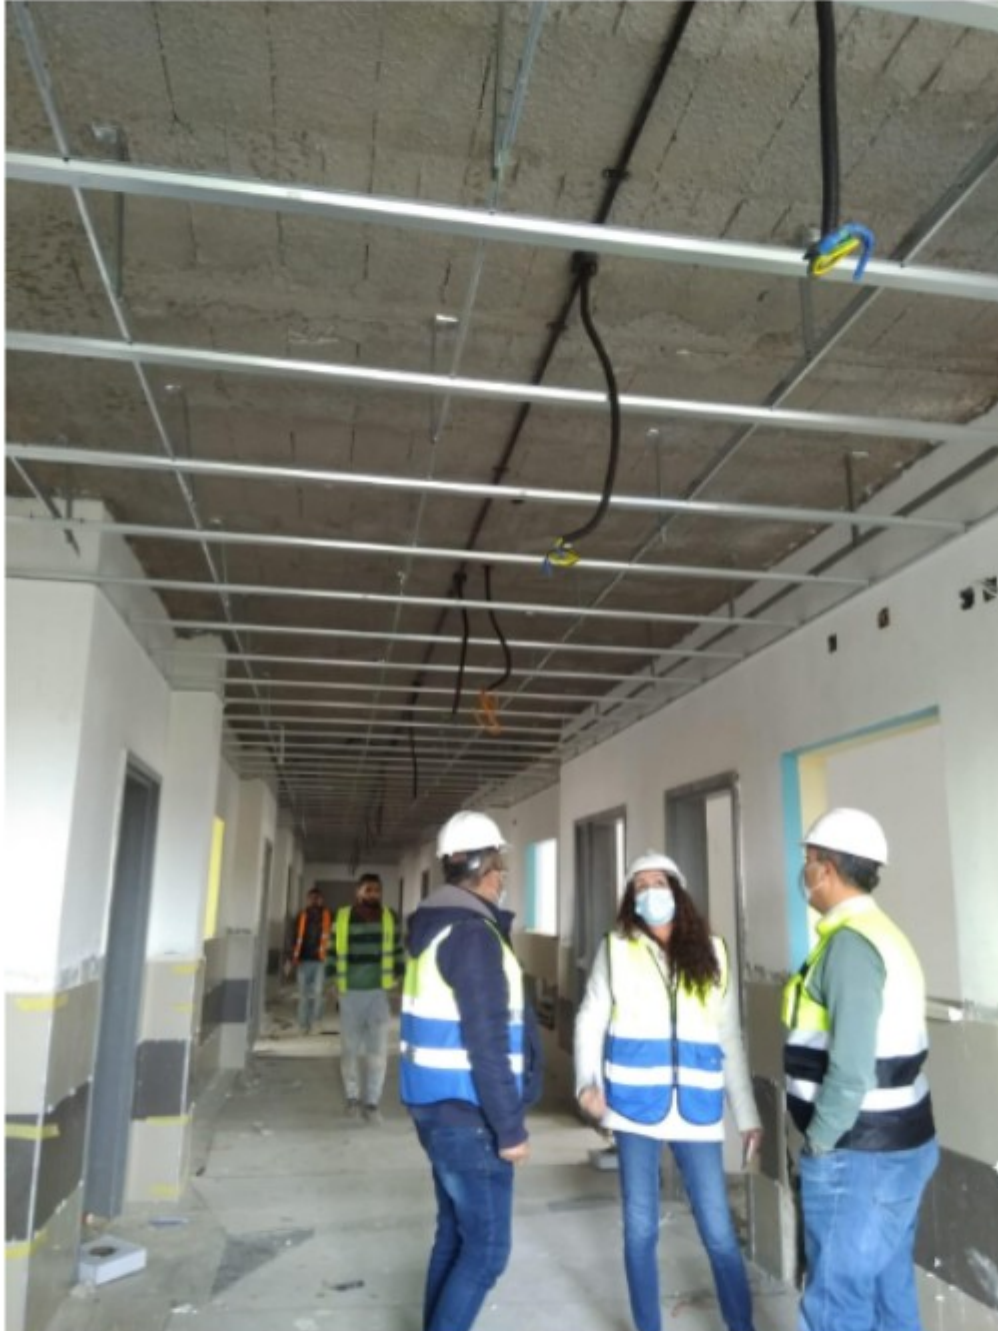
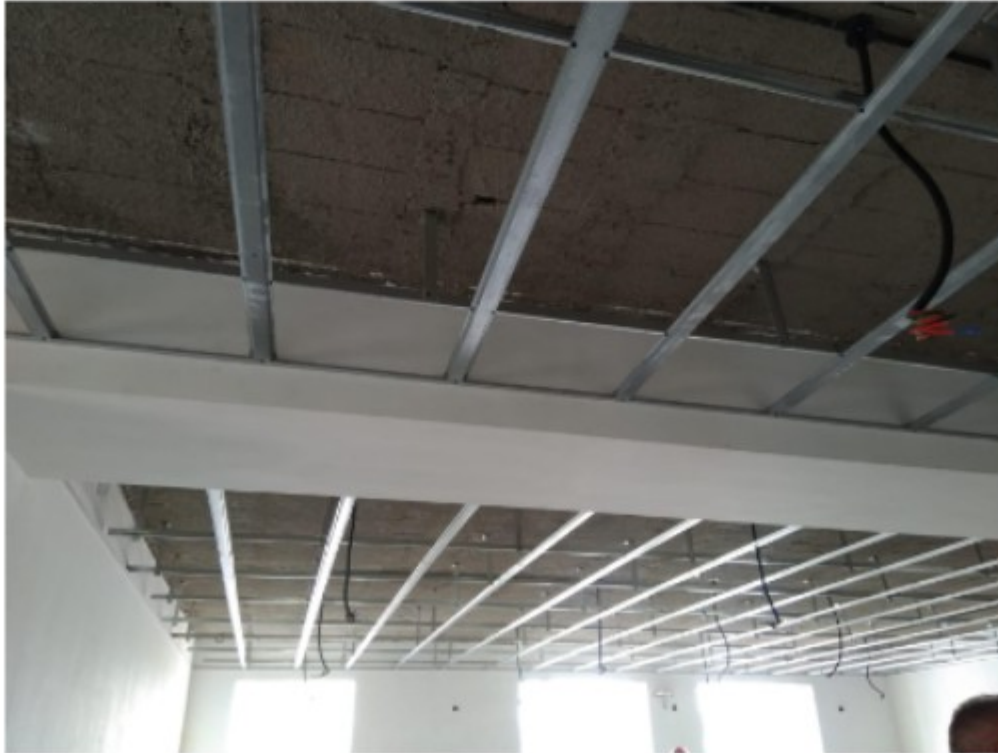
(figure:14)

The team observed that the Contractor started with installing the frames for the suspended ceiling at the corridor. The Contractor requested the supervision's instruction whether or not the hangers can be fixed to the rib beams

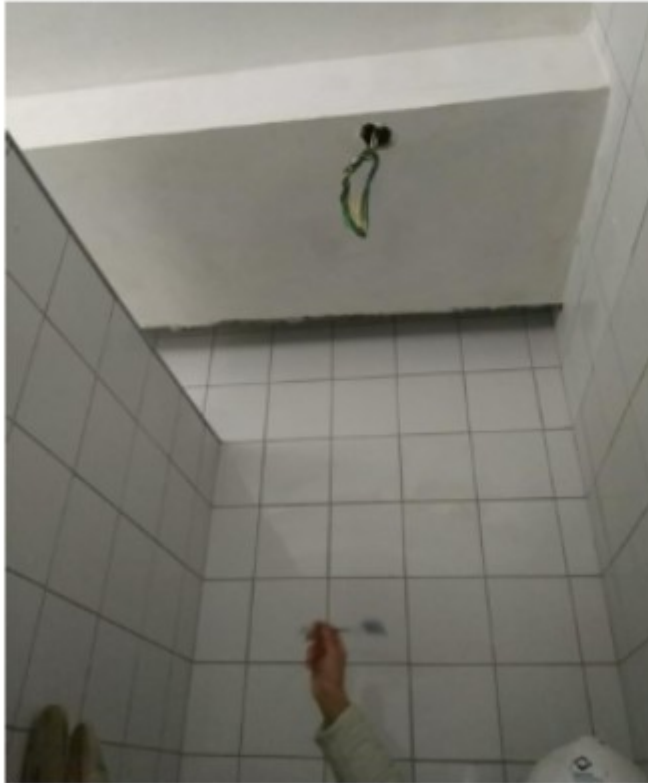
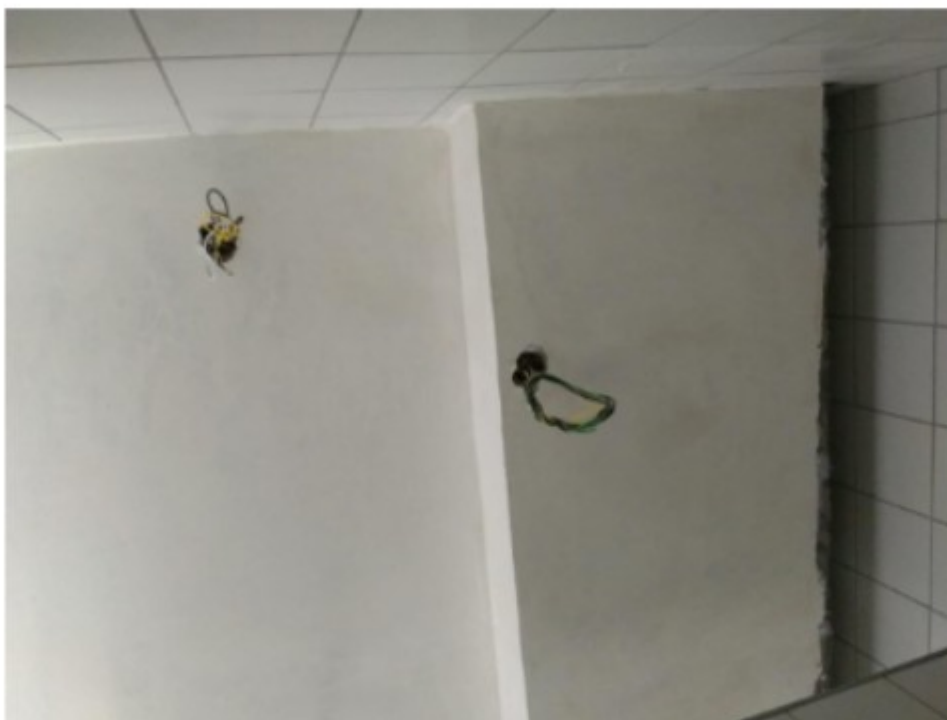
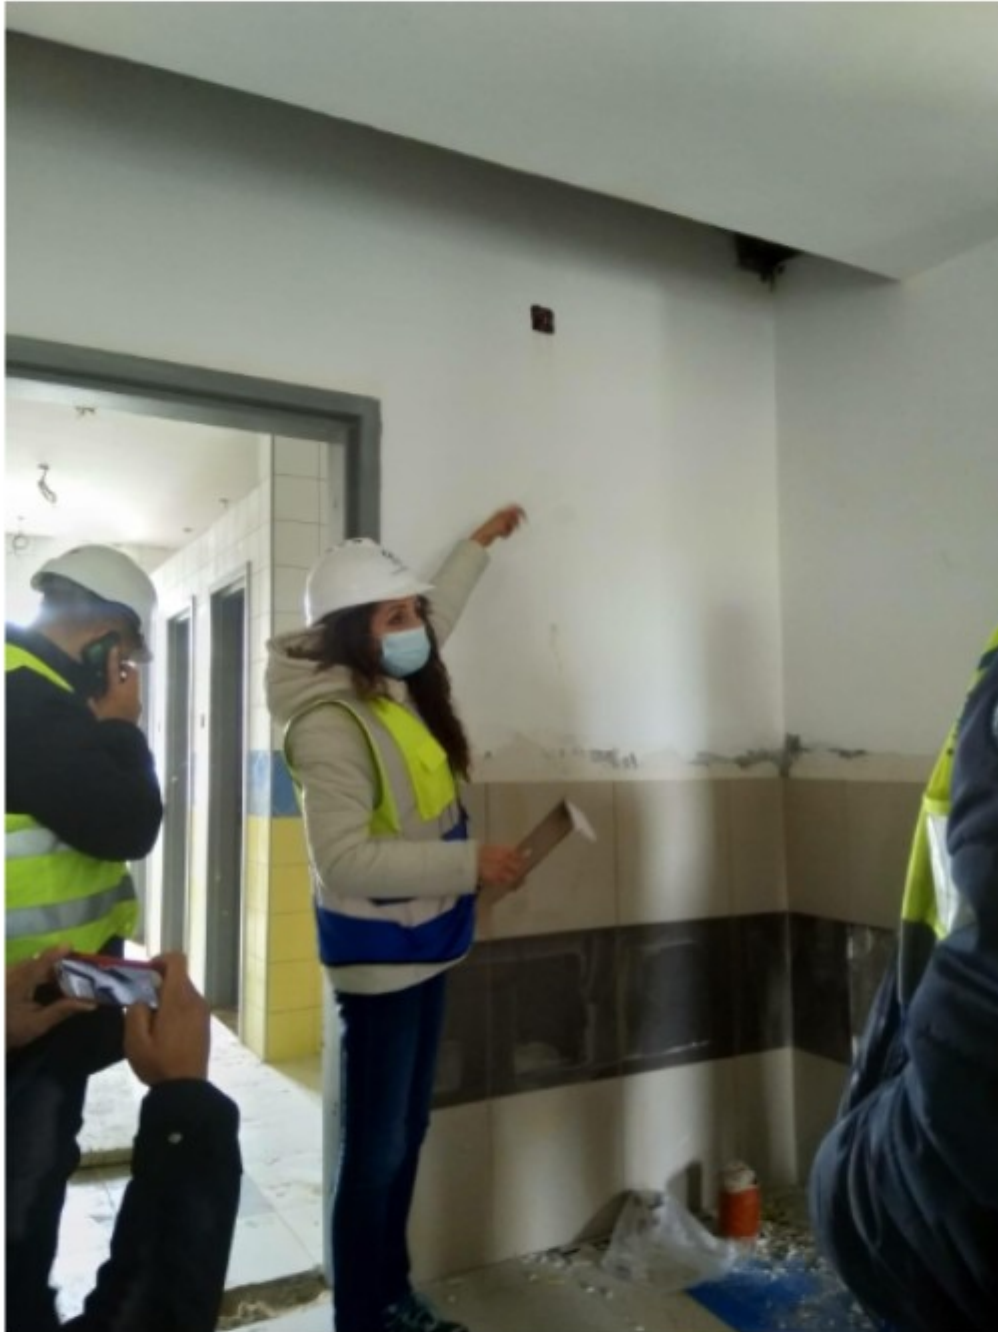
The team discussed with the Contractor the gap between some dropped beams and the walls at the wet areas and corridors. The Contractor was instructed to cover the gap with gypsum board installed appropriately and painted

And lower the level of the electrical box to avoid conflict with the level of the suspended ceiling

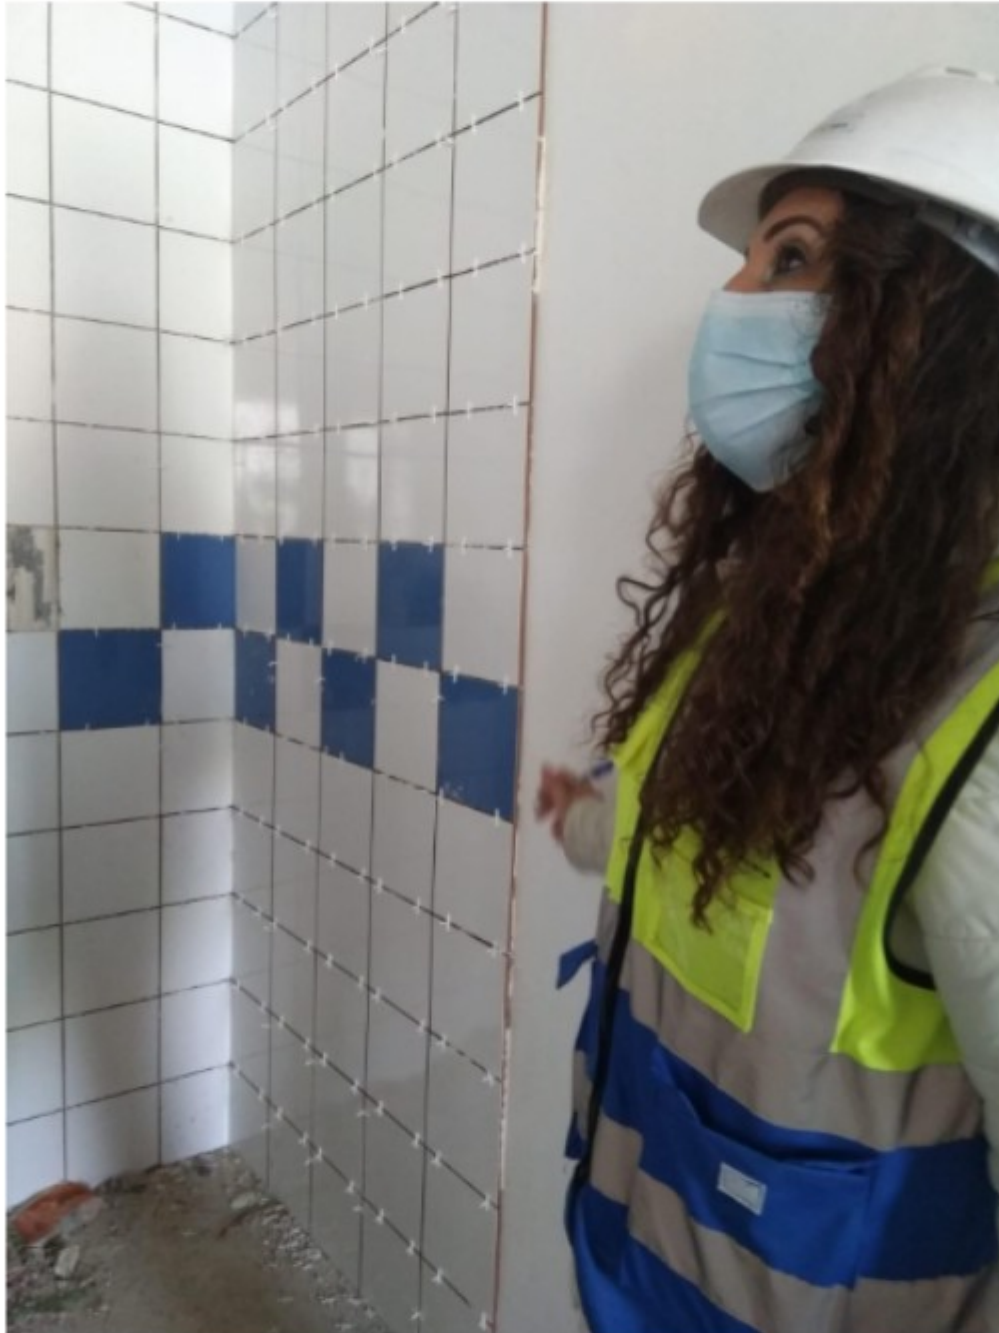
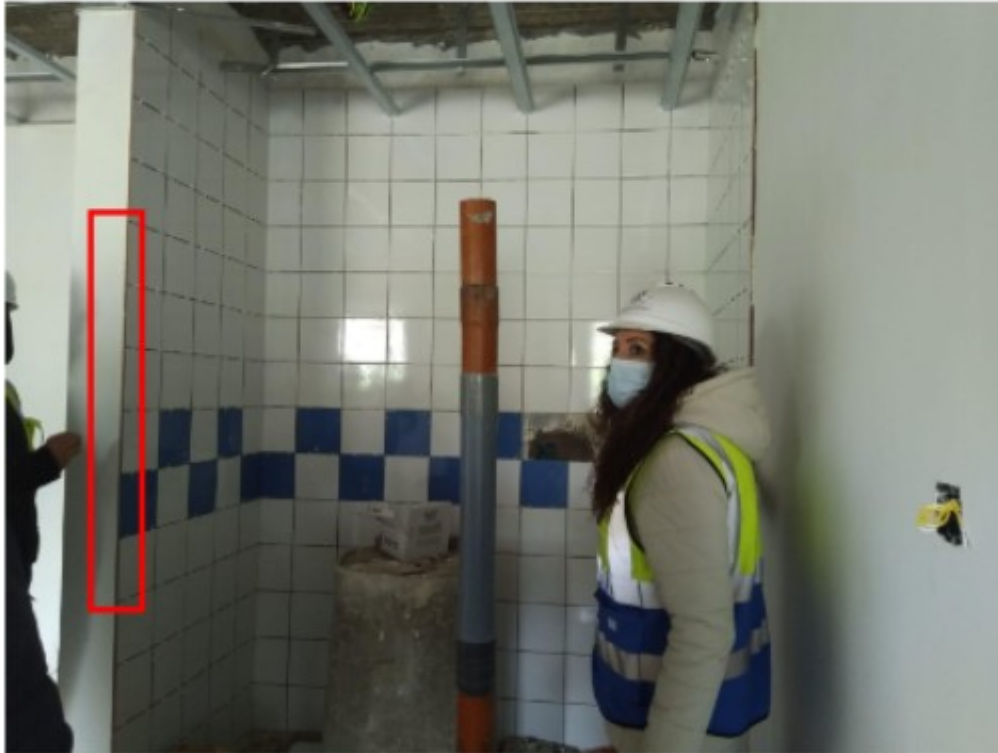
(figure:22)

The team requested the Contractor to install beads at the end of wall tiles of teacher center to insure the work quality and appropriate view

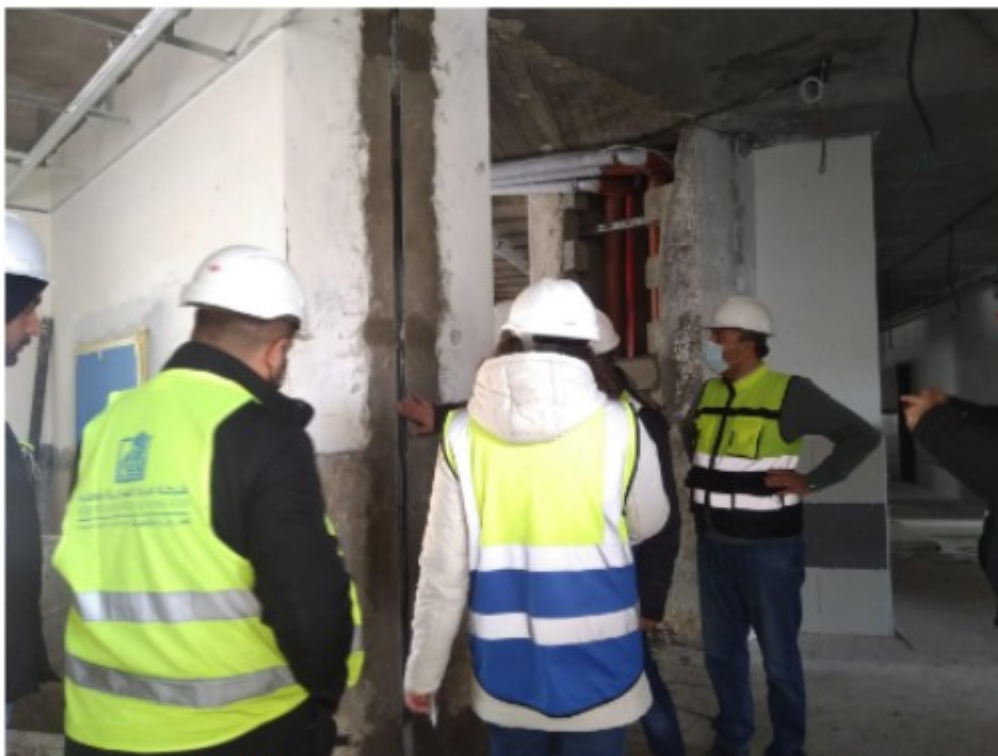
(figure:24)

Inspecting the execution of the internal expansion joint and discussing with the Contractor the architectural detail between the false ceiling and the internal expansion joint

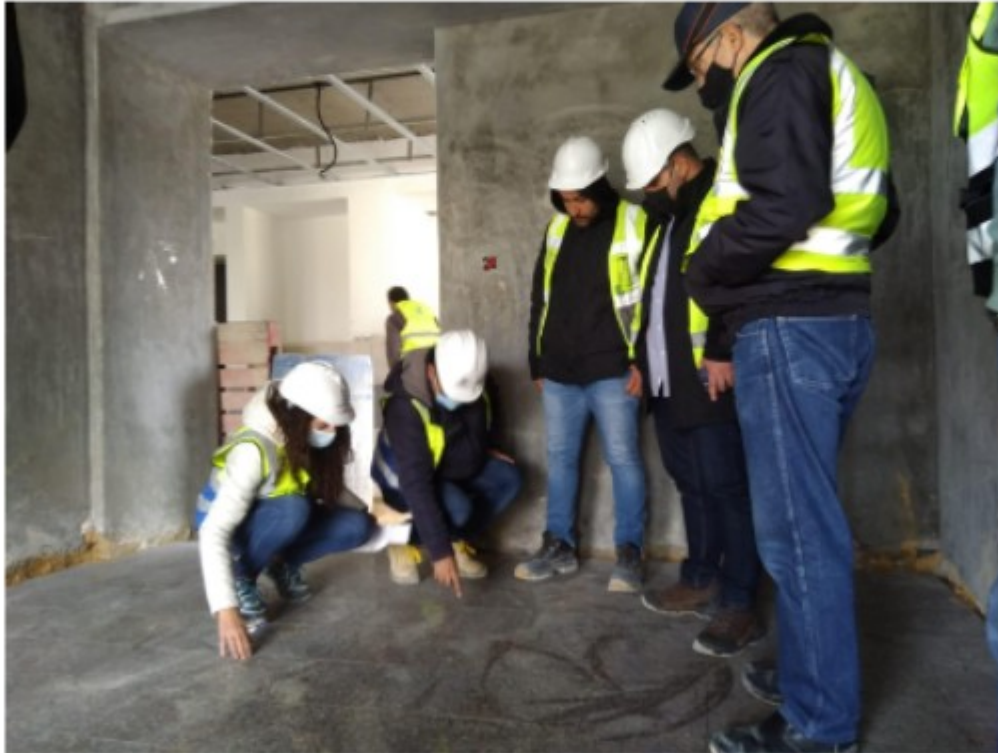
(figure:25)

The team inspected the granite tiling at the staircases landing and observed acceptable quality

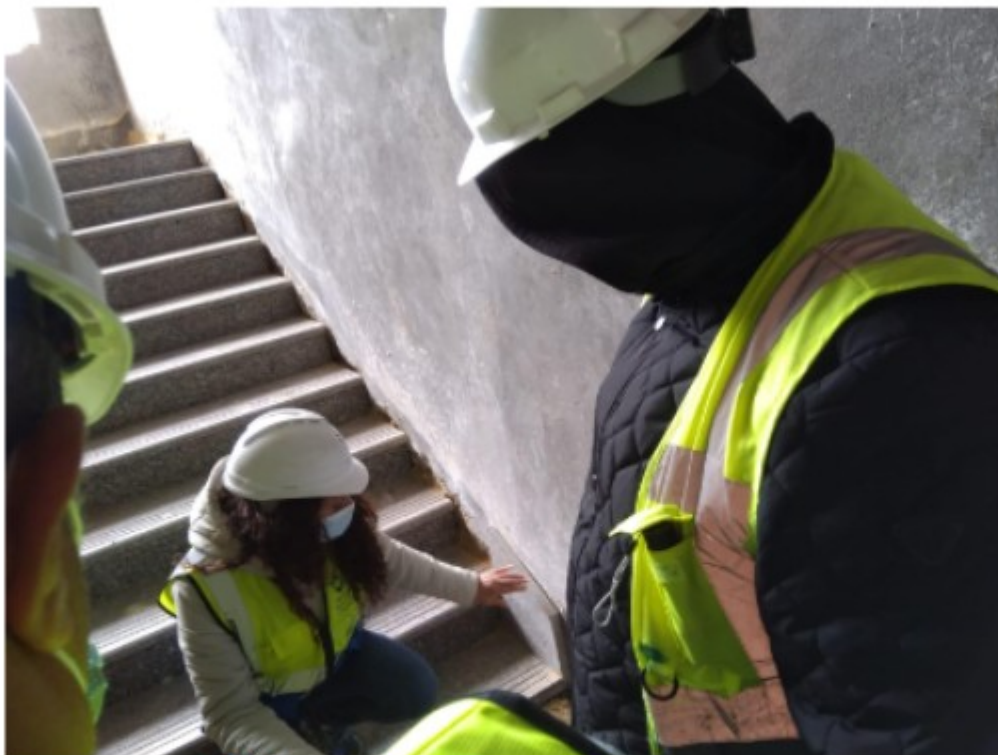
(figure:26)

The team inspected the details of the inclined granite skirting for the staircase and insured that the installation is acceptable

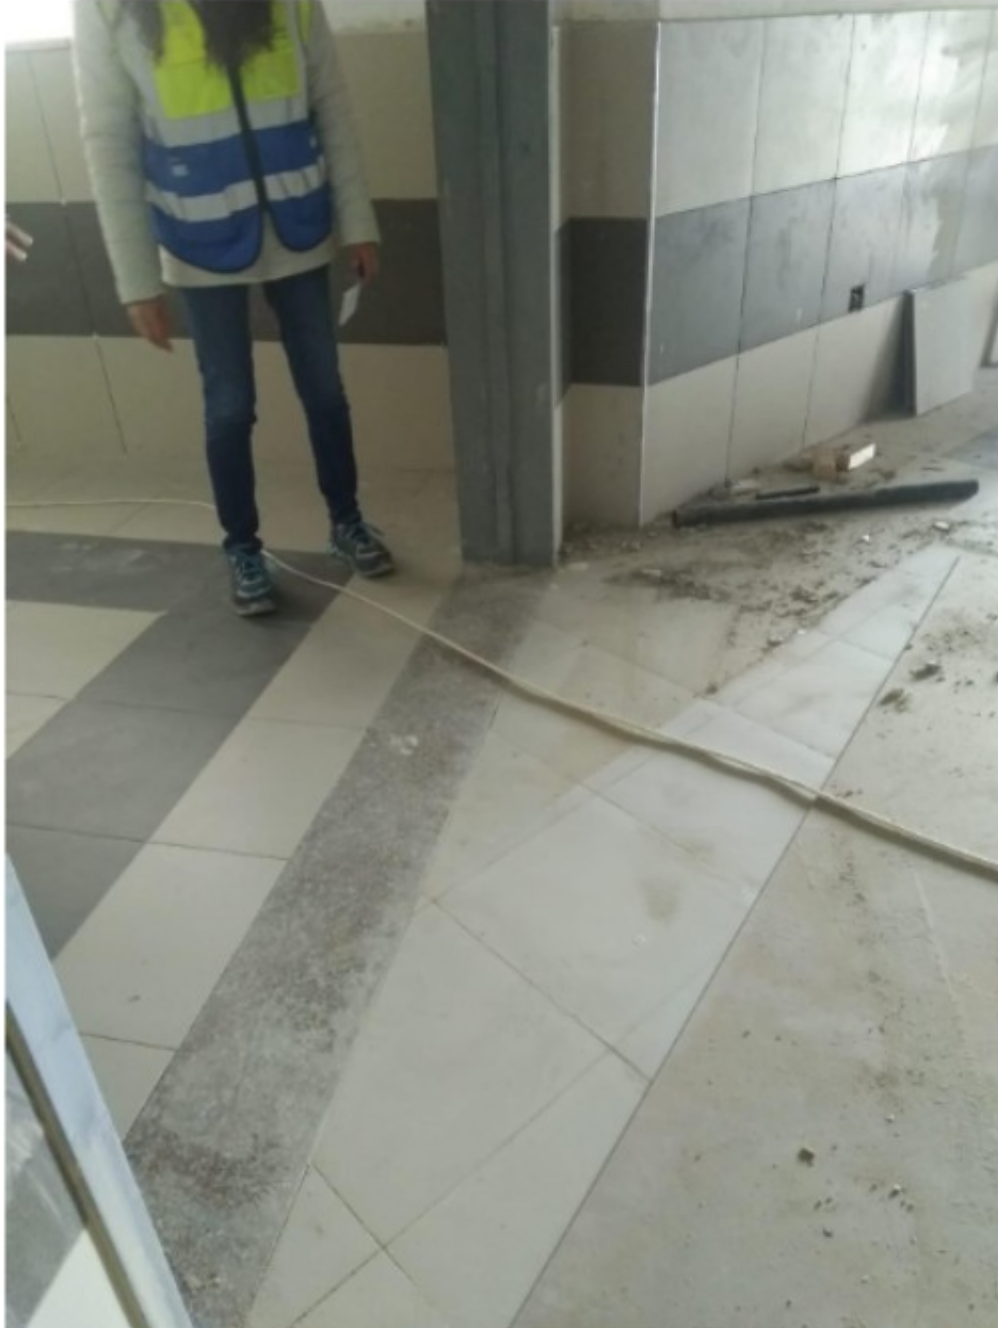
(figure:27)

The team inspected the installation of granite sill between corridors and ensured its appropriate installation

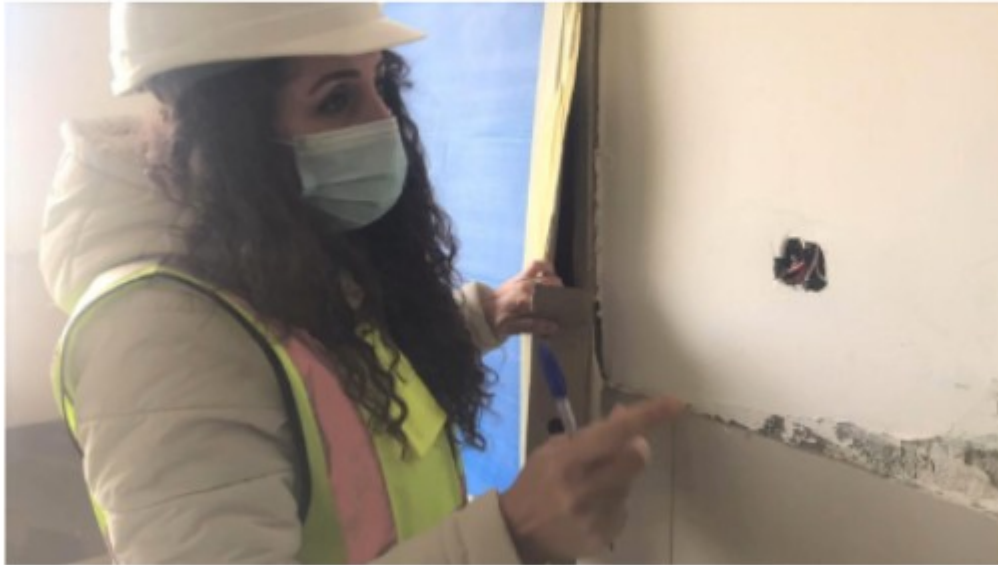
(figure:28)

Discussing the connection between the fire hose cabinets with the wall and to avoid any gaps

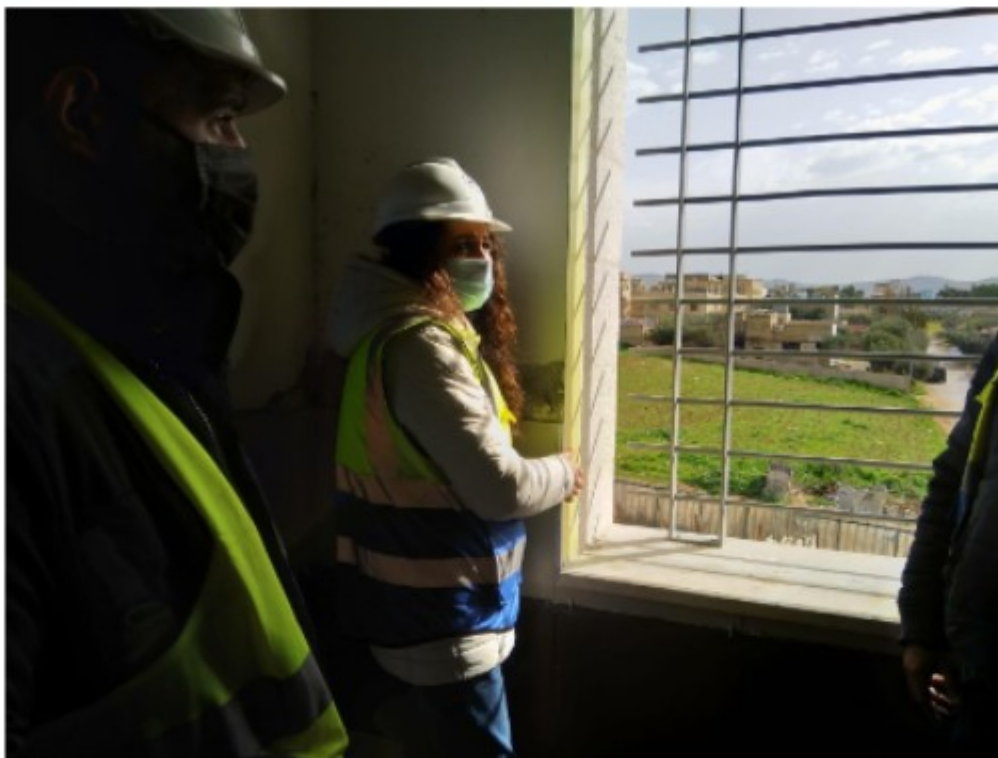
(figure:29)

The team discussed with the Contractor the continuation of granite to the window jambs up to the aluminum frame

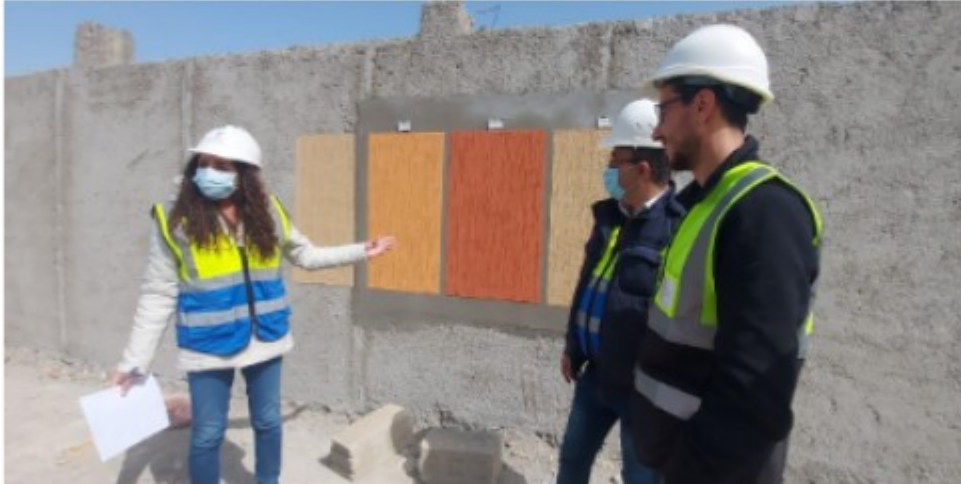
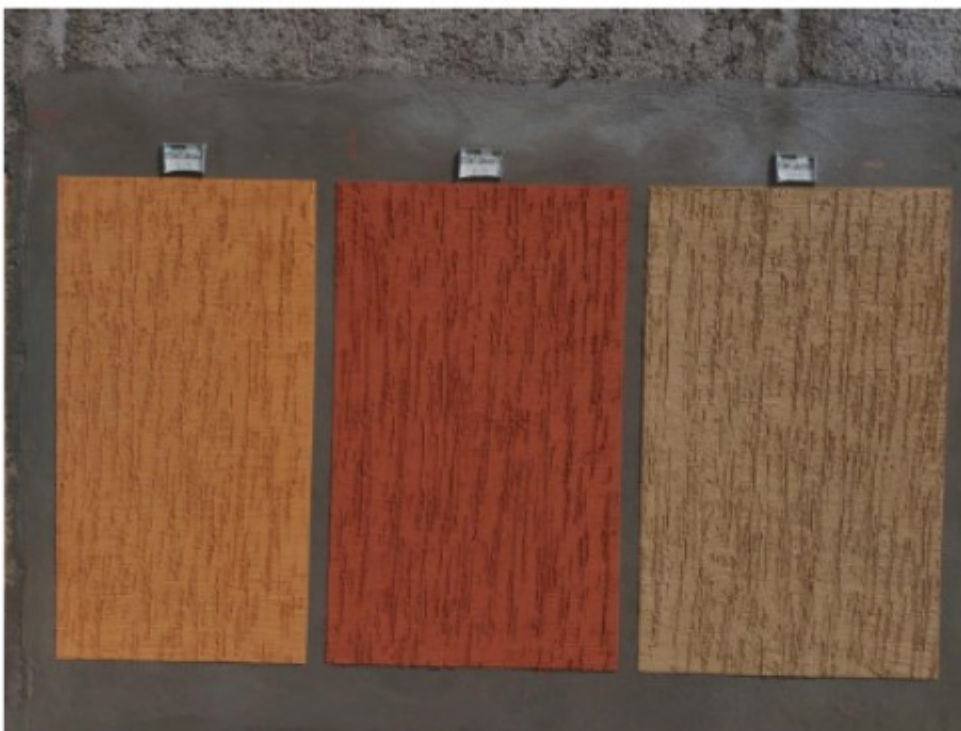
The team inspected the proposed samples of final finish (texture) for the external plastering. After discussion, the team informed the Contractor with the approved samples and instructed him to submit a method statement for the execution of higher walls

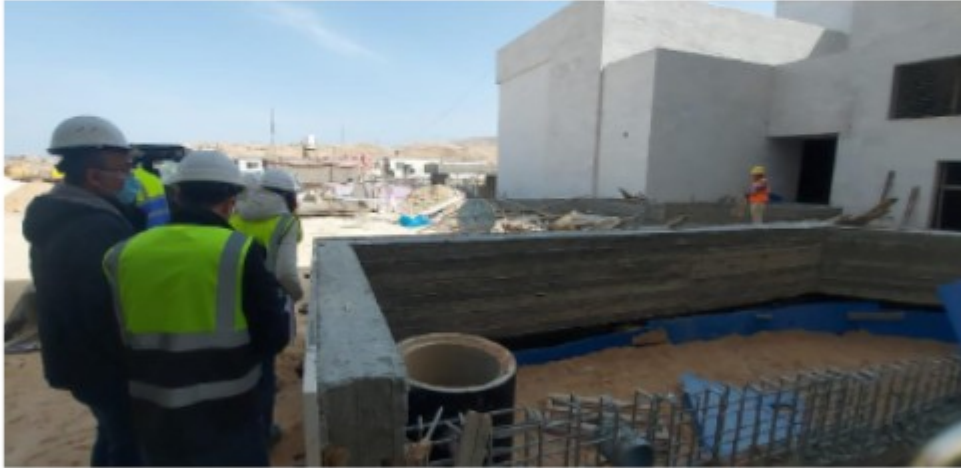
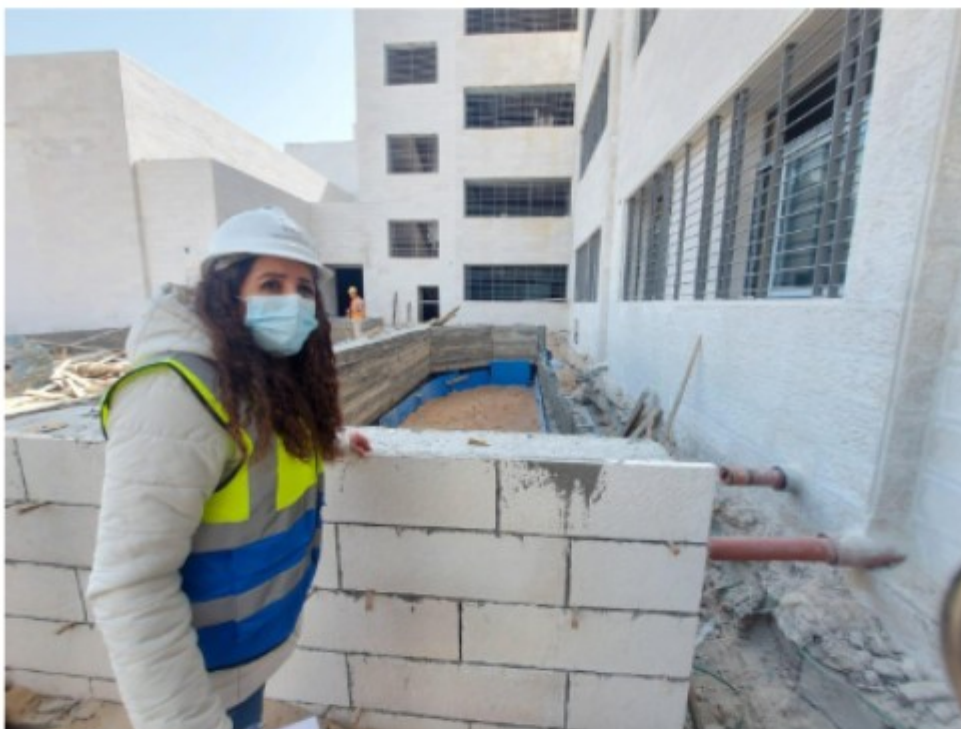
The team discussed with the Contractor the works related to the ramps in the site and advised him to submit a request for information for any levels not indicated on the drawings

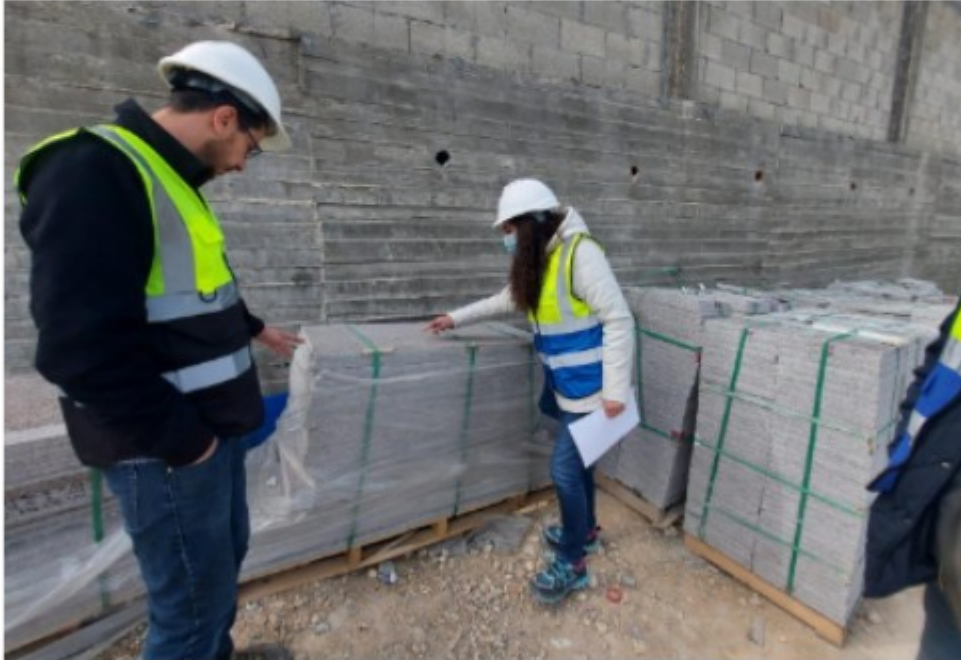
(Figure: 09)

The team inspected the delivered quantities of granite tiles and cladding and stressed on avoiding using any pieces with defects

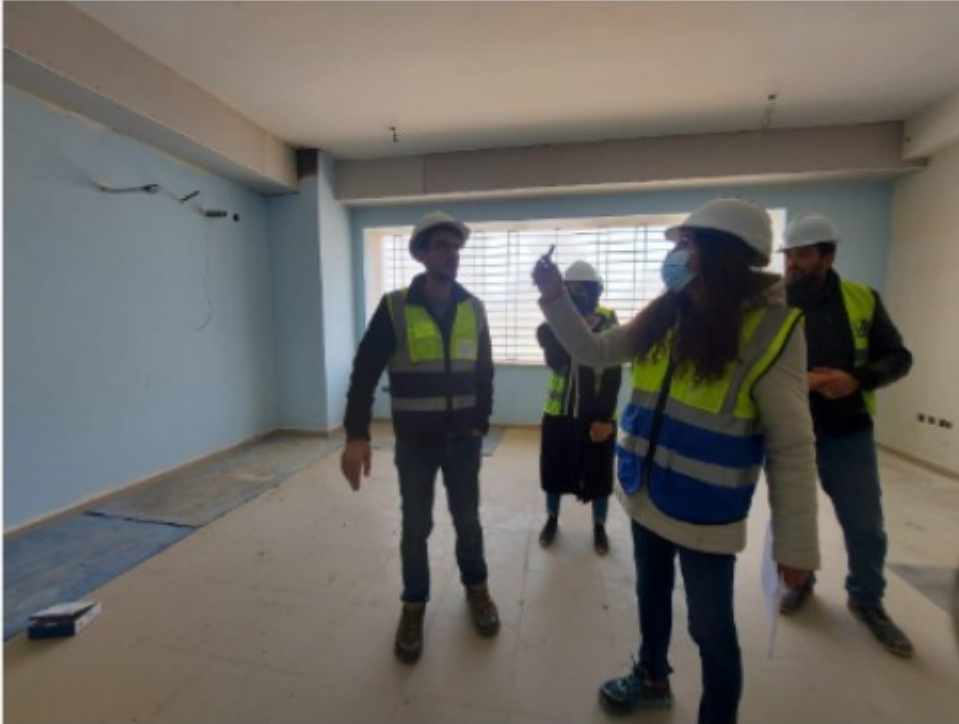
The team discussed the distribution of colors at the classrooms

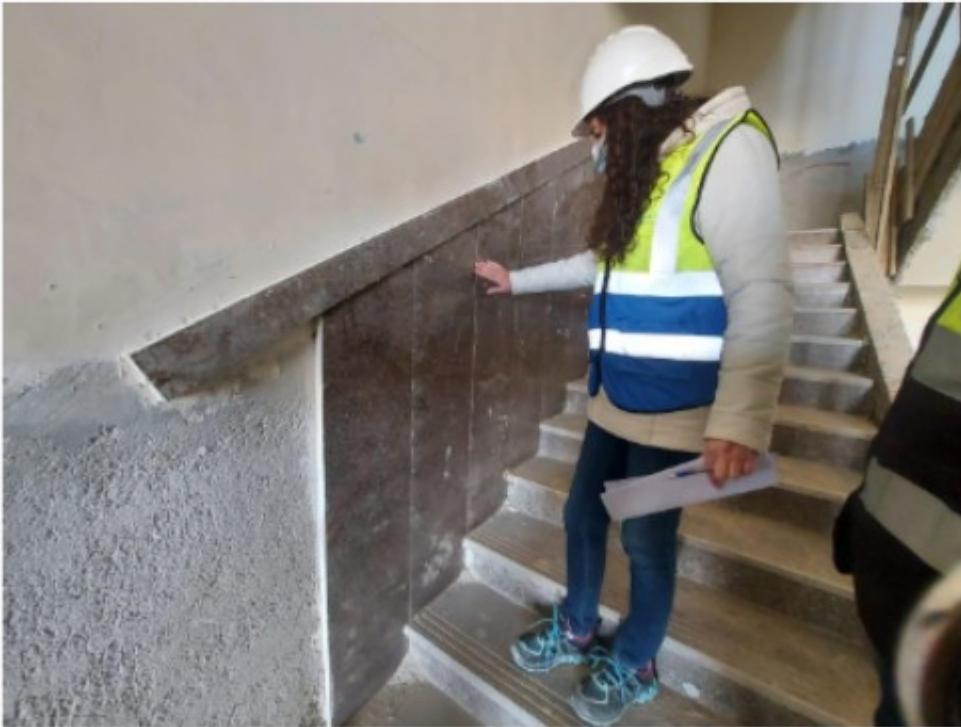
(Figure: 18)

The team inspected the sample prepared by the Contractor for the staircase granite cladding. The team pointed minor remarks to the Contractor. In general, the sample acceptable

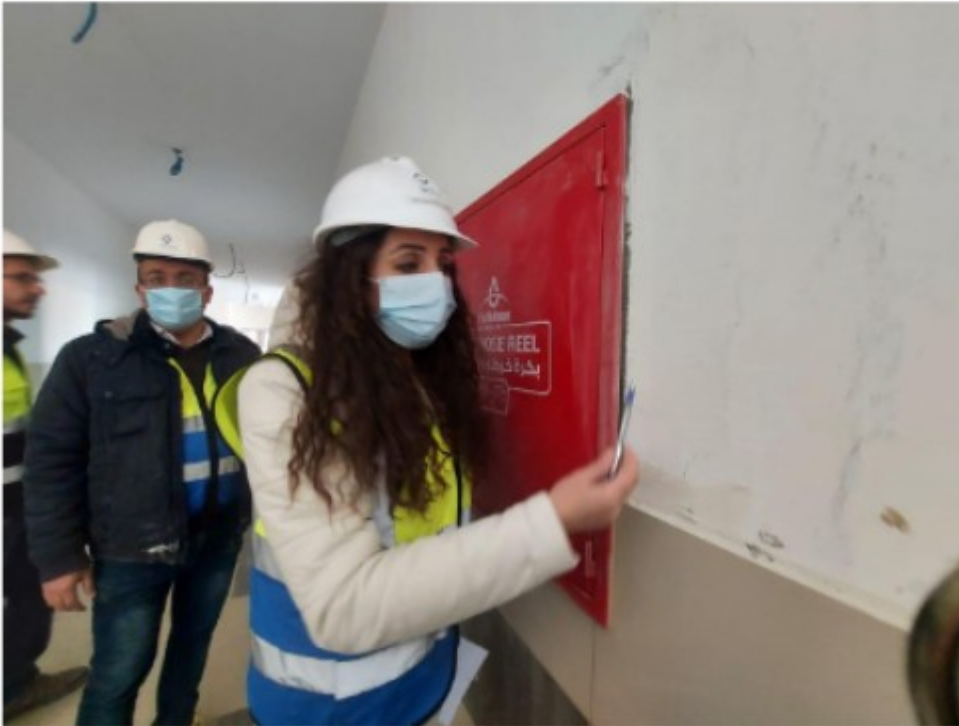
(Figure: 20)

The team discussed with the Contractor the installation of fire cabinets in the corridors and the connection with the installation of granite at walls and the prominence of the said cabinets
