School for Knowledge Economy Project (SKEP) Phase III – Package 1

Monthly Progress Report

No. 16

March, 2022

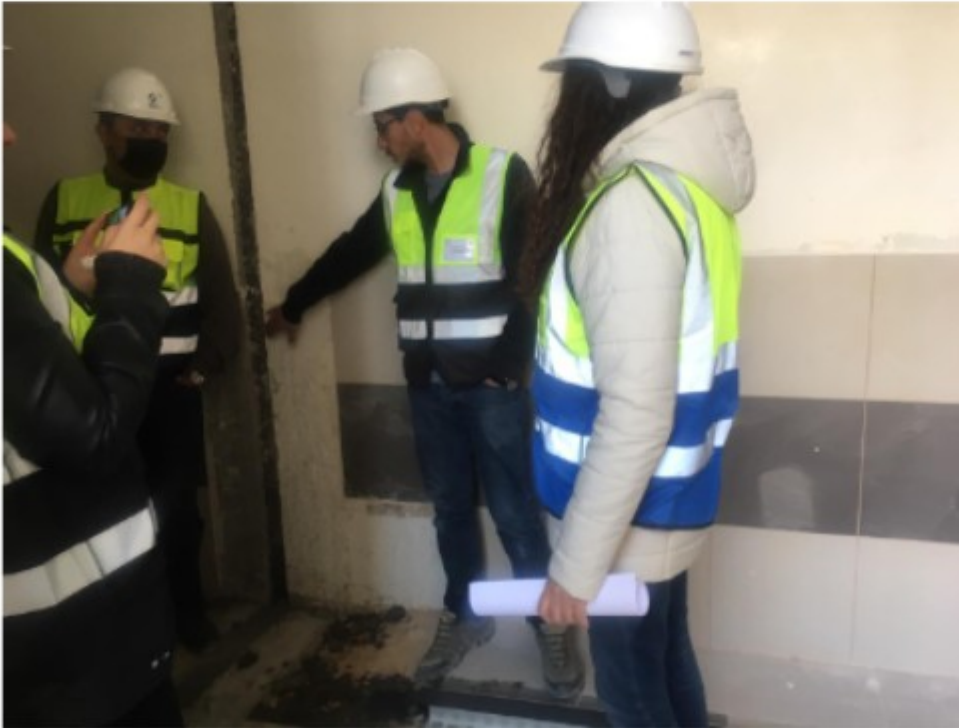
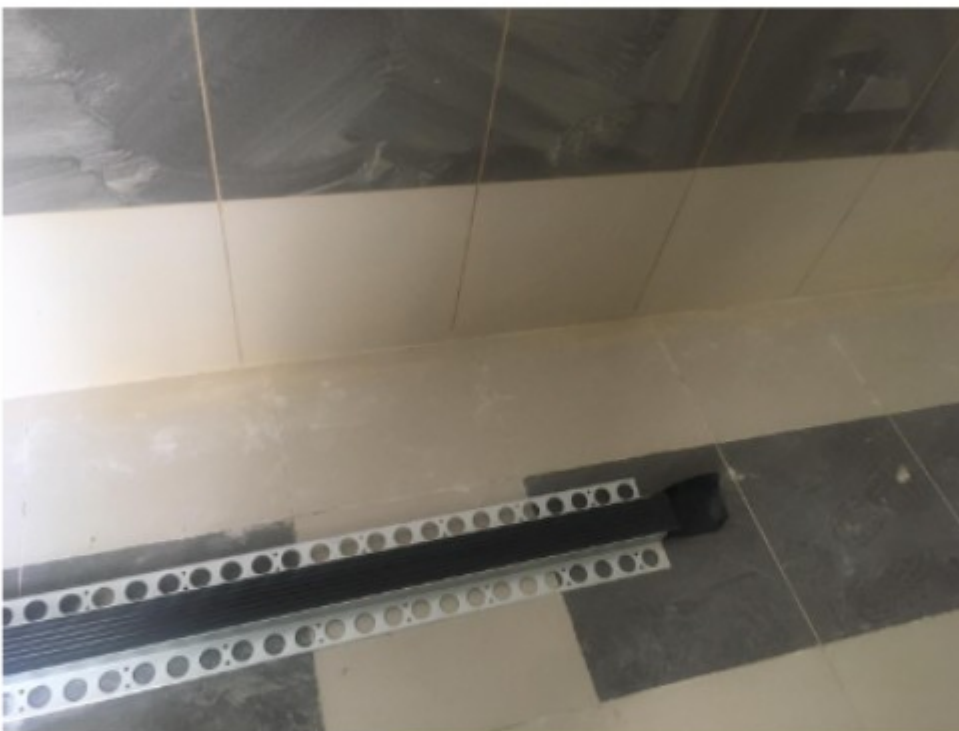
(Figure: 28)

The team inspected the executed sample of internal expansion joint. In this regard, the team stressed on the Contractor to comply with the approved sample as per contract and the expansion joint cover shall be recessed below the level of porcelain floor tiles

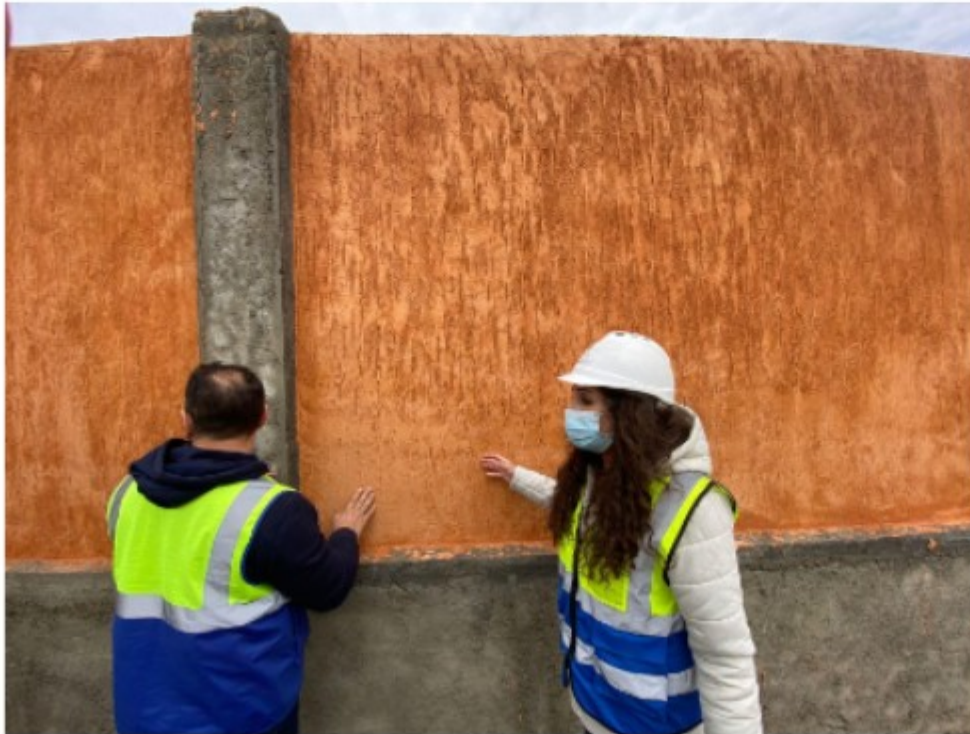
(Figure: 04)

The supervision team inspected the external plastering-final finish executed for some parts of boundary walls. The Contractor was requested to remove and comply with the approved sample

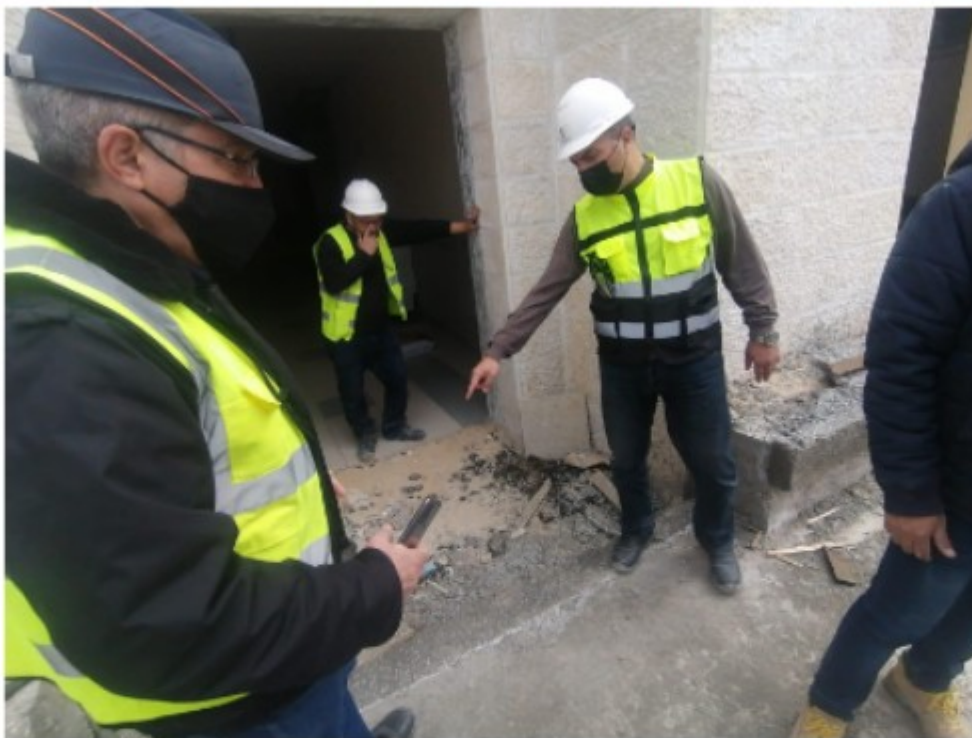
(Figure: 08)

Discussing the detail of the external expansion joint at the roof

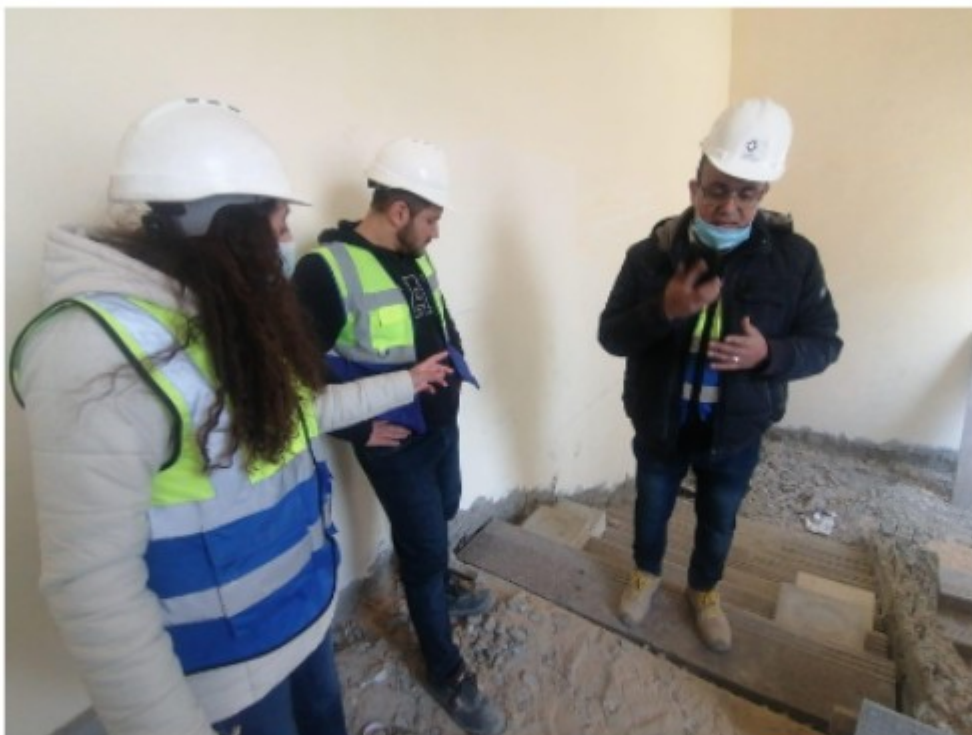
(Figure: 12)

The team requested the Contractor to re-check the levels of staircases, number of stairs in connection with the levels and similar requirements in the drawings

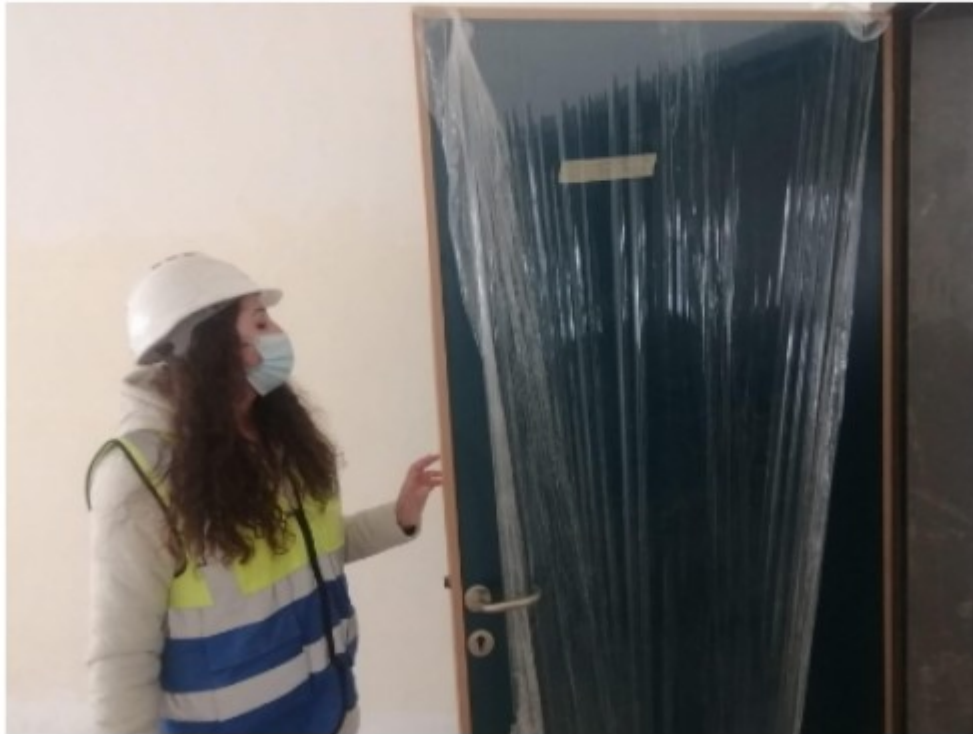
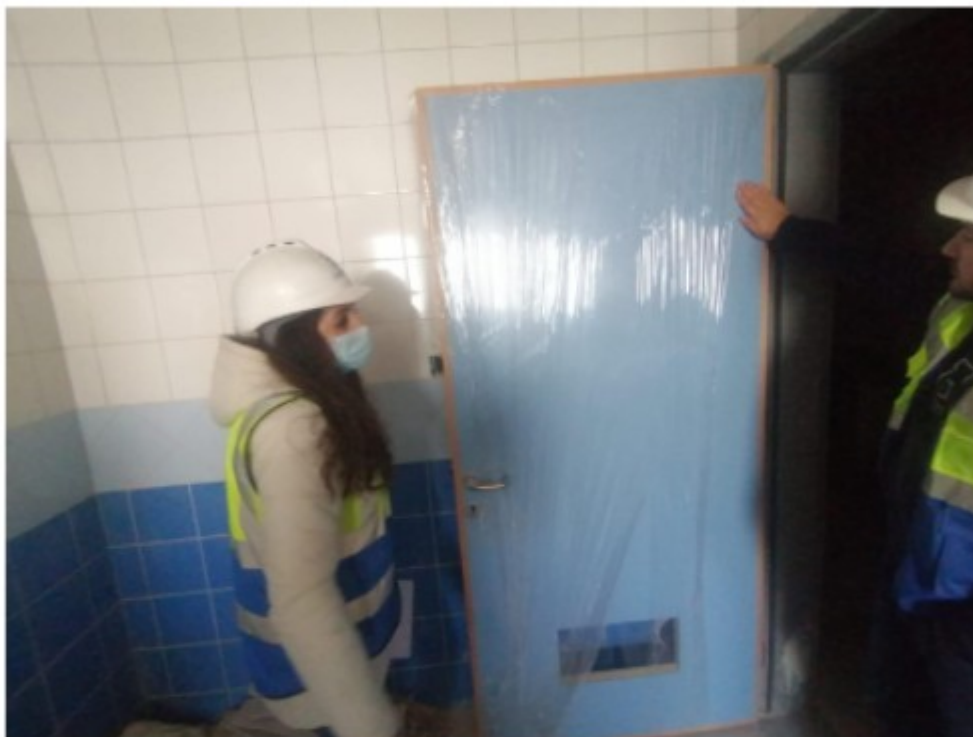
The team inspected the delivered wooden doors and pointed out to the Contractor to ensure that any door that has certain defects in the beech frame or similar defects should not be installed

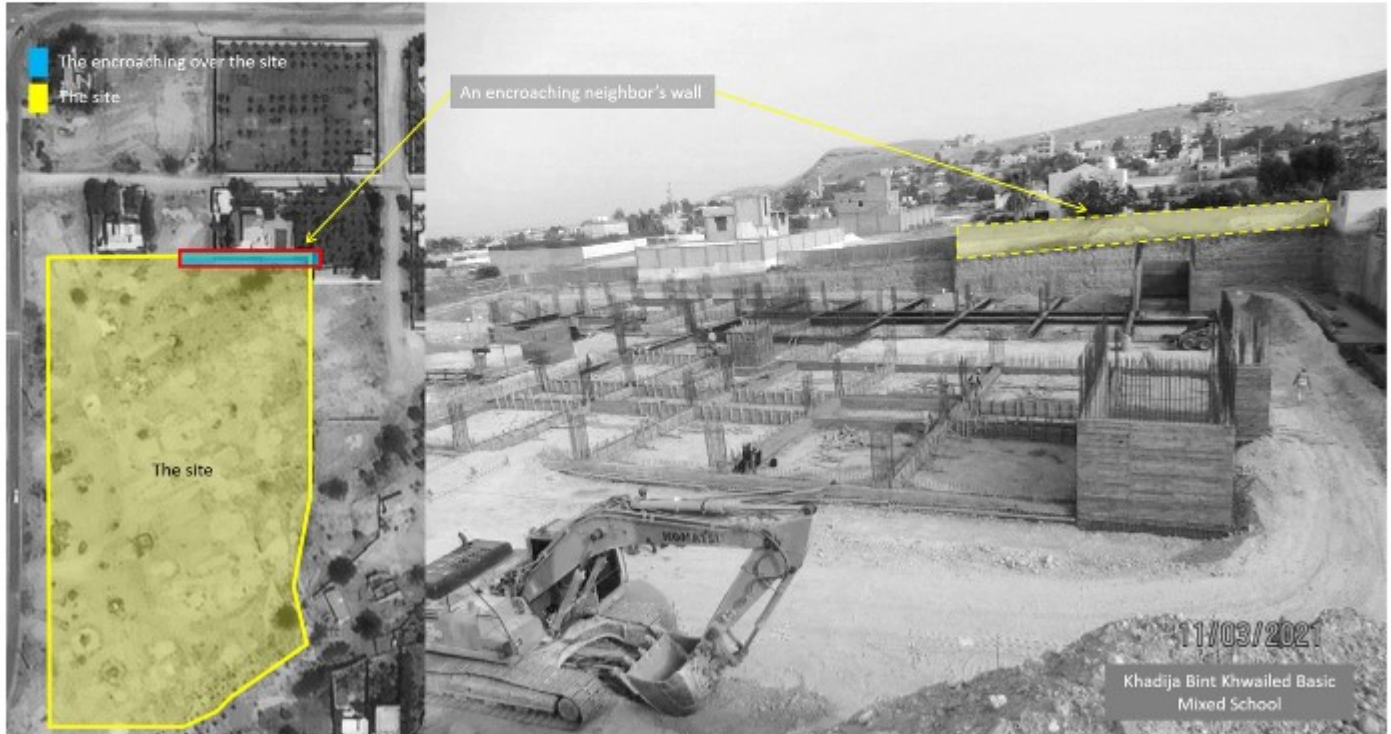
There is an encroachment of the existing neighbour's building toward the site
